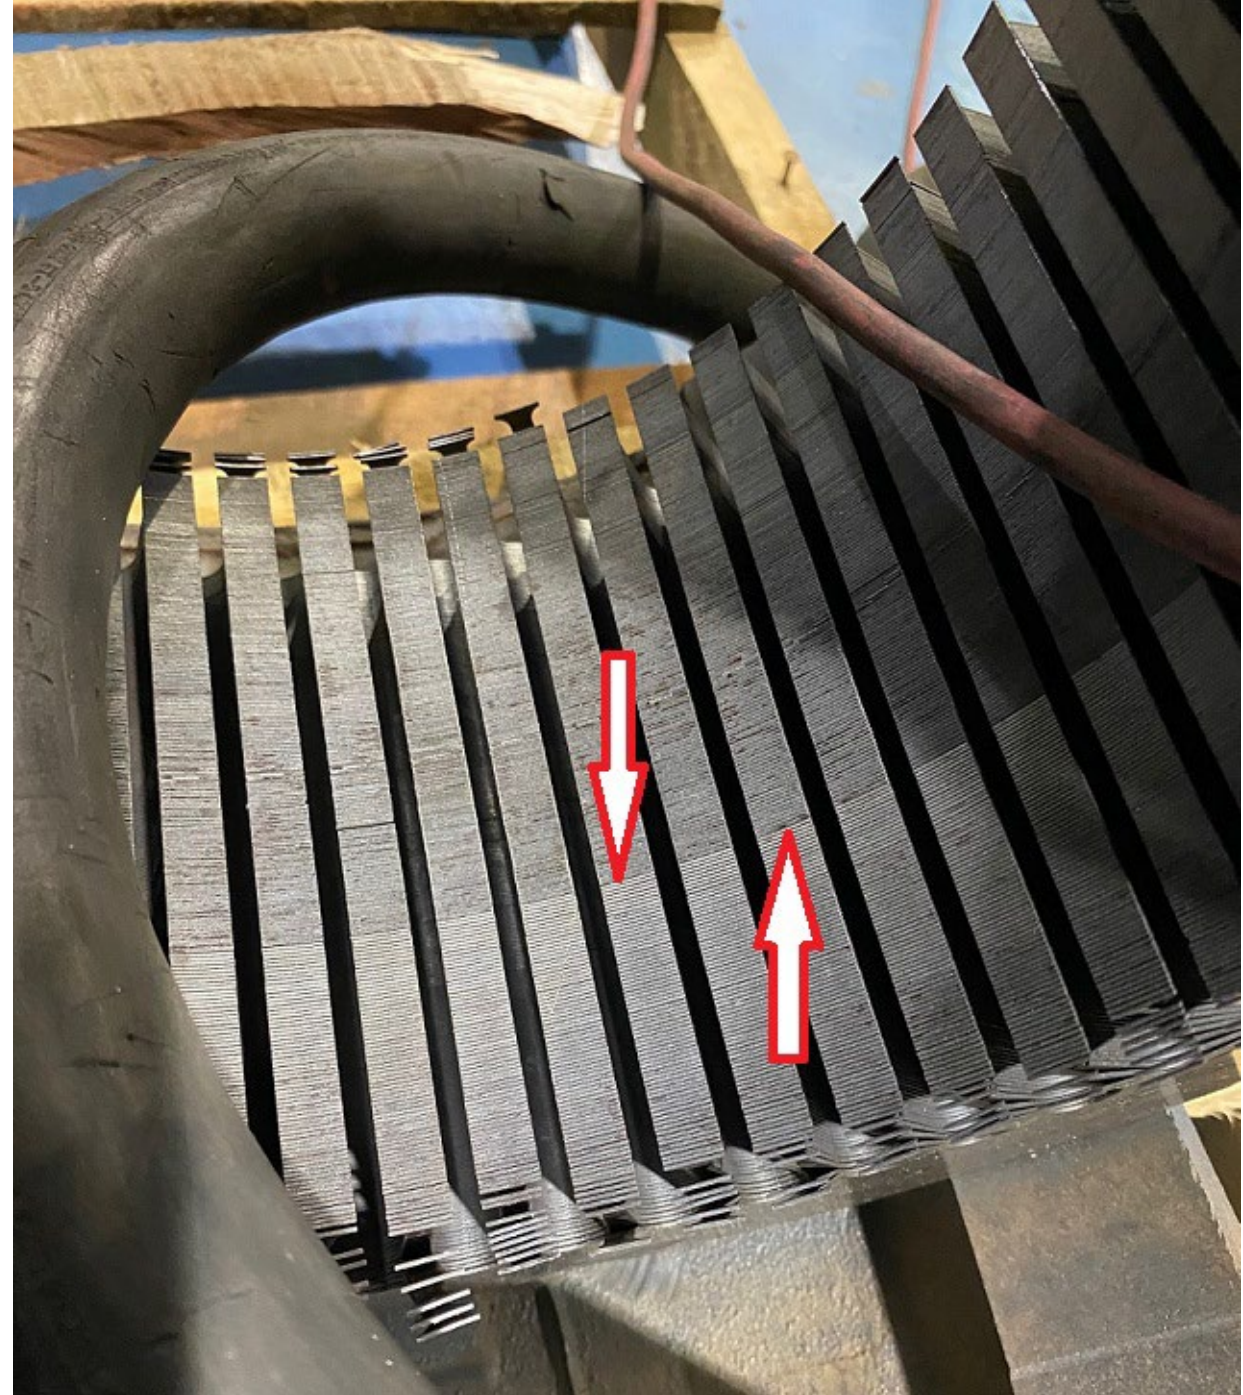
Stator. Arrows show discontinuity in lam appearance. (Newer looking closer to camera) End laminations were flared out during coil stripping

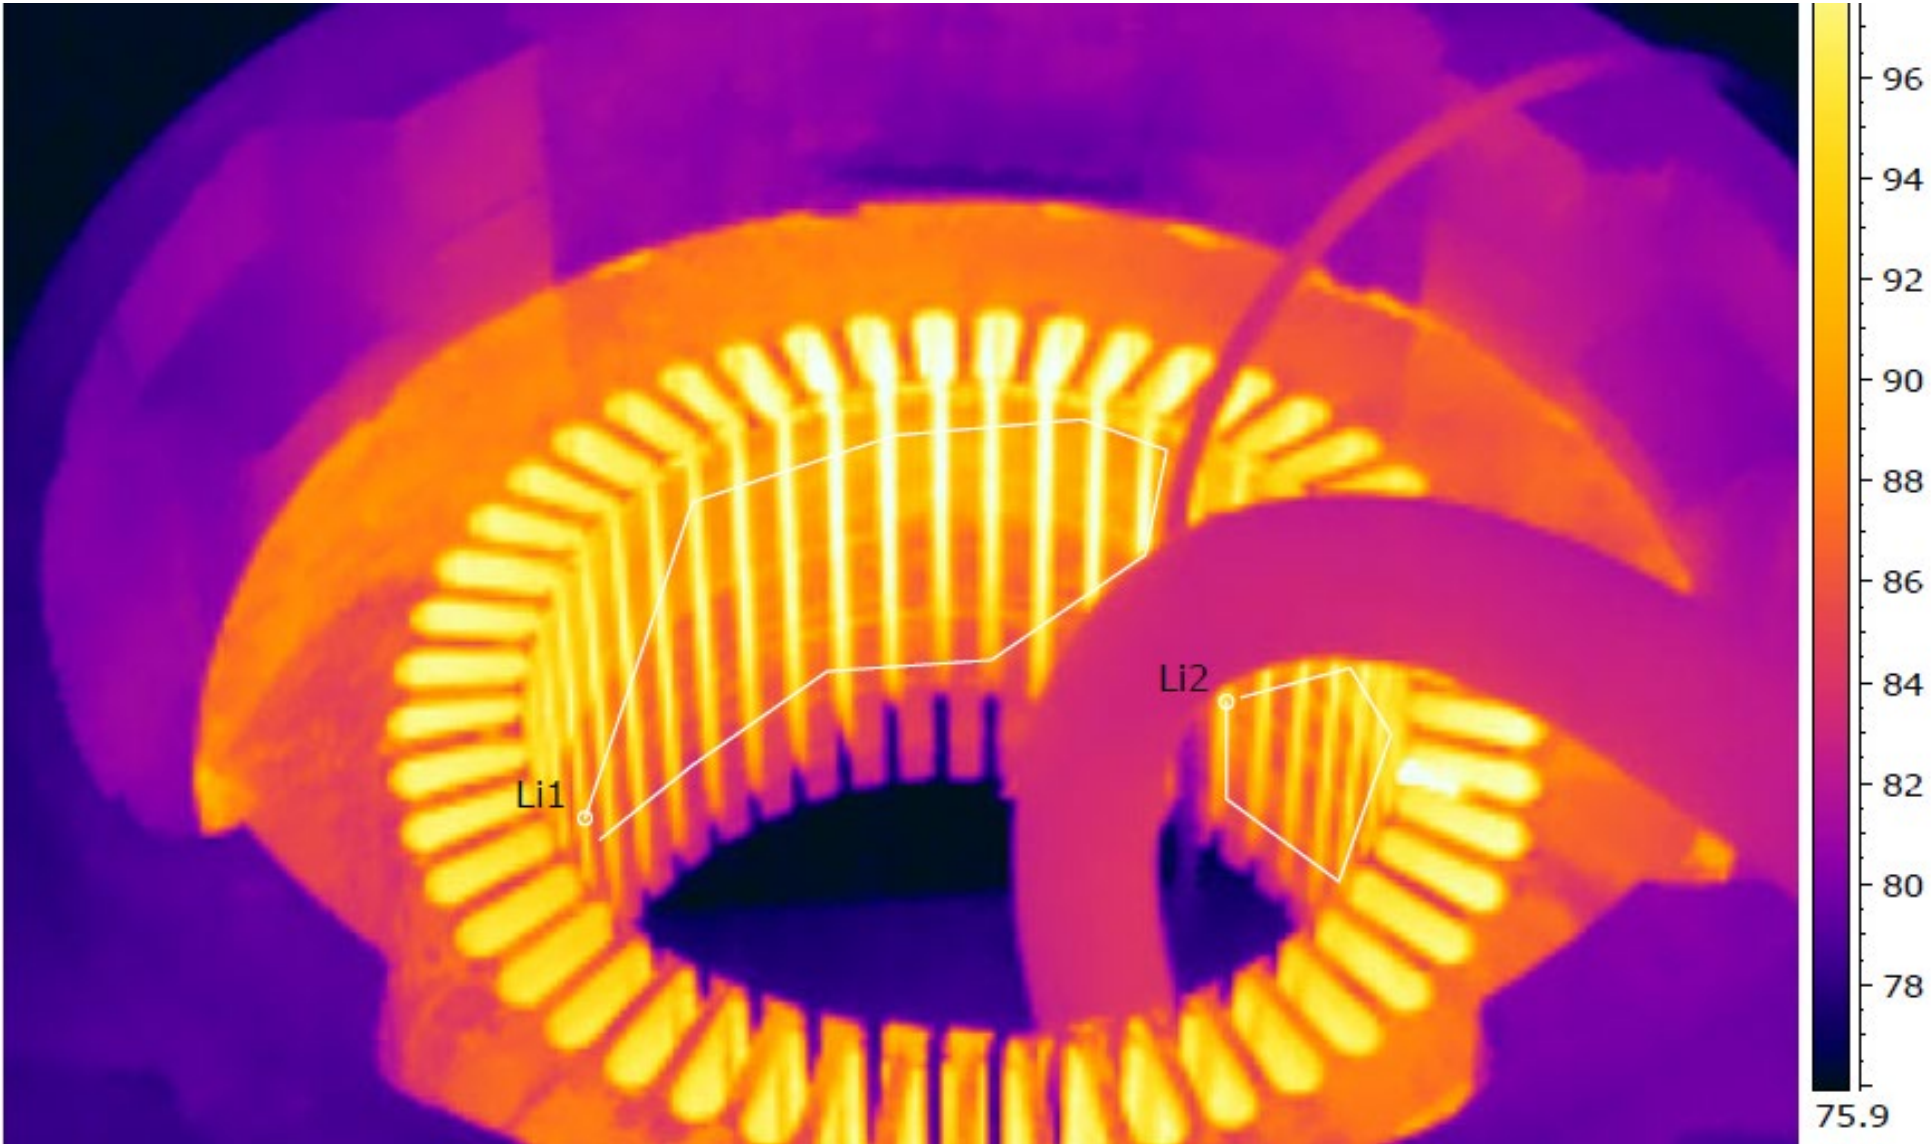
Stator tested again (vertically). Discontinuity in lams shows here (I think the newer shows up hotter)
