UNDERPINNING ANCHORING REPORTS

HELICAL PIER® FOUNDATION SYSTEMS CASE HISTORIES

Bulletin 01-9608
Rev. 9/99

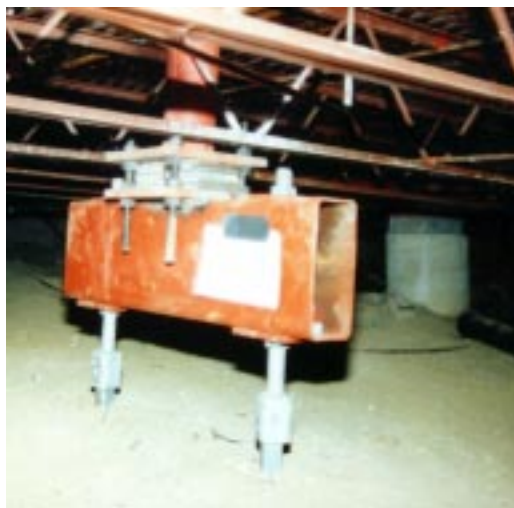
Mechanical connection of column to two Chance anchors required.

(Additional lateral bracing not shown in this photo.)

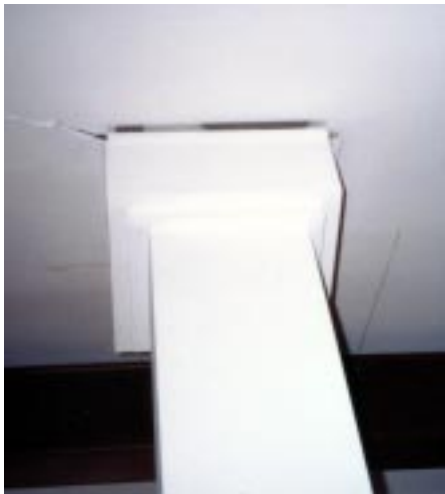
1"+ gap can be seen between column and ceiling.

Repair: Eighty-seven Chance HELICAL PIER[®] Foundation Systems screw anchors were installed through cored 6"-dia. holes in the slab on a 6' grid to allow the slab to be raised with a slab bracket on the top of the anchor. Average installation depth of the anchors was 10'. As the dead weight of the slab and the service live load totalled 40 PSF, the anchors were only required to support 1,500 lb. The 6"-dia. helices on the solid-steel 1½" square shaft were installed to a minimum torque of ____ ft.-lb. for a minimum load of 3000 lbs. per anchor using a portable 2,500 ft.-lb. hydraulic driver. Voids created by lifting the slab were grout filled.

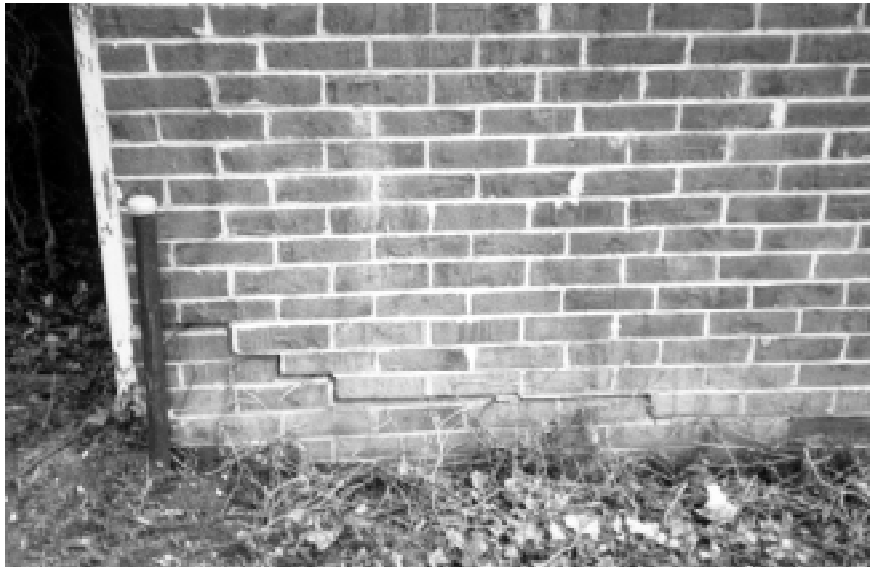
BEFORE

A 17-year-old house had settled approximately $\frac{7}{8}$ inch at a front corner. This settlement resulted in a $\frac{5}{8}$ inch horizontal crack along a 4-ft. section of the front and a 3-ft. section of the side.

A 2x3-ft. hole was dug at three pier locations. Two 10-inch diameter Helical Pier[®] Foundation Systems screw anchors were installed on the front and one on the side. Each anchor was installed to an 18-ft. depth with 2,500 ft.-lb. of torque for a load capacity of 25,000 lb. A foundation bracket was connected to each anchor and the footer.

The three anchors were loaded gradually to 14,000 lb. by simultaneously using three 10-ton Enerpac hydraulic jacks. This closed the $\frac{5}{8}$ inch crack to only $\frac{1}{16}$ inch and new mortar was installed.

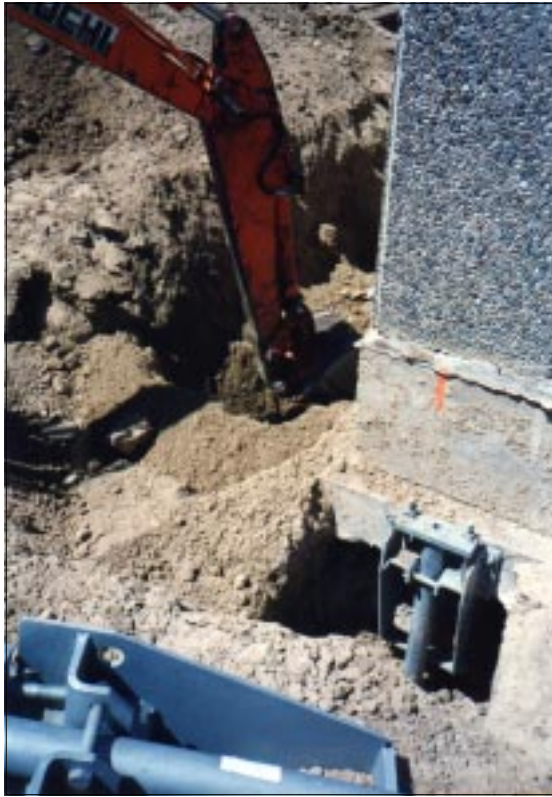
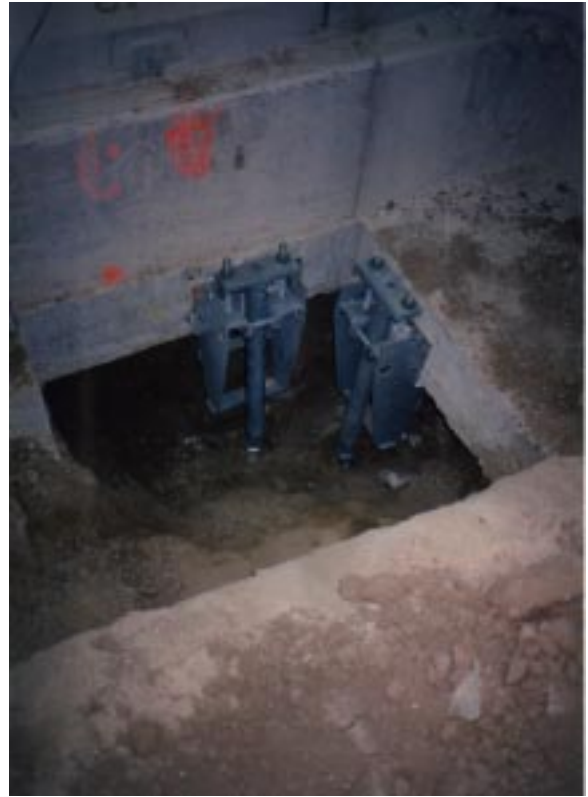
Heavy-Duty underpinning brackets installed outside and inside perimeter of foundation.

Chance Heavy-Duty underpinning brackets (40,000-lb. working capacity) connected the anchors to the foundation footing. 30-ton jacks were mounted on the brackets to lift the foundation in intermediate steps back to level.

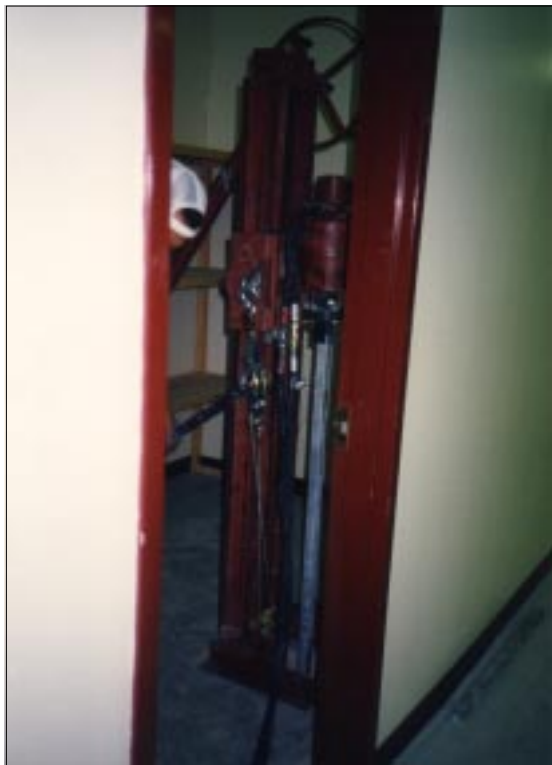
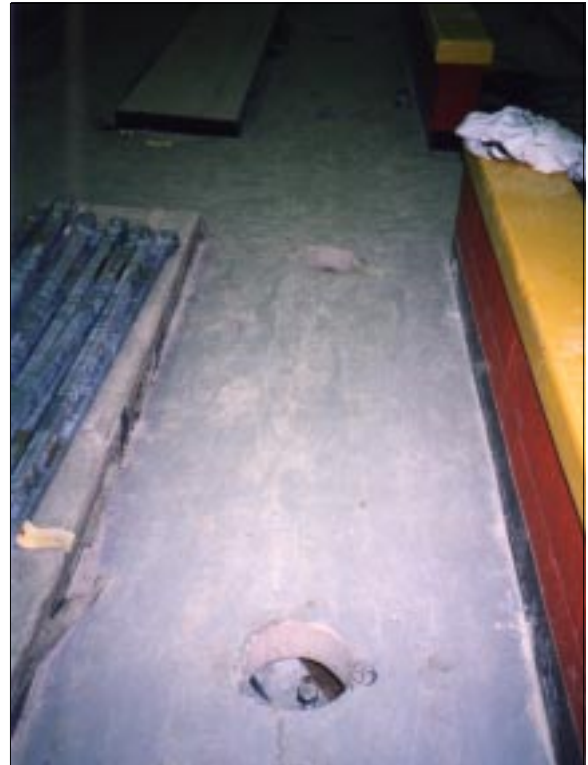
Slab-leveling anchor being installed and bracket bolt visible through core which was refilled after final adjustment.

The adjoining locker rooms were supported by 120 Chance screw anchors (each with an 8-inch-diameter helix on a 1 $\frac{1}{2}$ -inch-square shaft) and slab brackets on 6-ft. grids. These slab anchors were installed through 8-inch

holes cored through the slab to average depths of 20 feet for the 6 Kips design load. The anchors were installed by a custom-made 5,000 ft.-lb. portable drive rig bolted to the slab

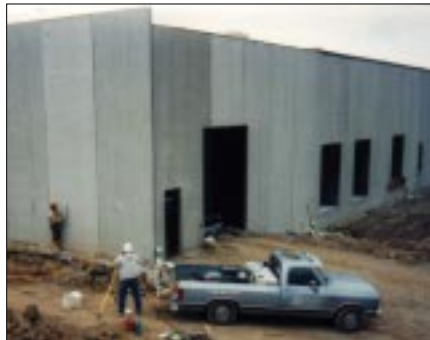
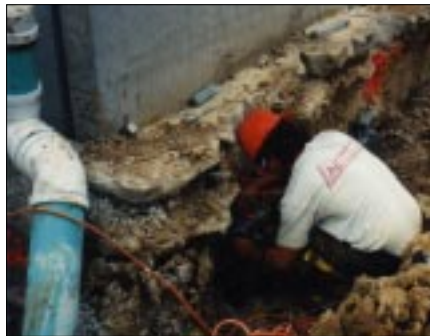
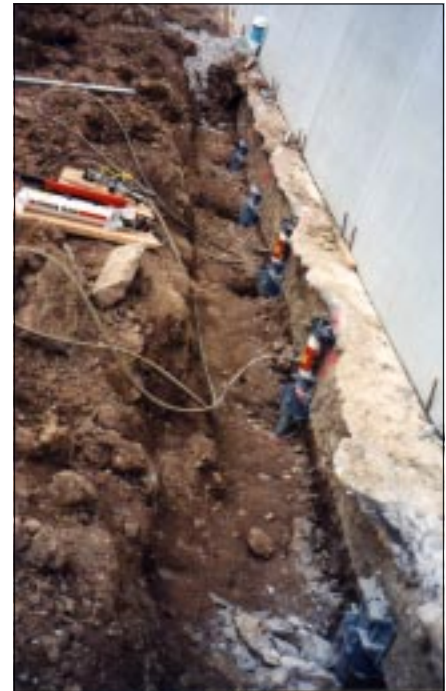
After the erection of the tilt-up panels and the placement of the steel roof, the southwest and southeast corners of the building settled approximately 1 to 3 inches. Standard penetration tests were performed by CTL Engineering to determine the consistency of the soil near the corners of the building. Blow counts, as low as 1 were encountered 6 to 10 feet below the footing elevation. The engineers concluded that the weak soil was probably a result of frozen soil being stripped and placed within the building area.

33 Helical Pier[®] Foundation Systems screw anchors were installed to an average depth of 20 feet. Lifting force of 15,000 to 20,000 pounds was applied. Amount of Lift: ¼" to 2¾".
