## 1 INTRODUCTION

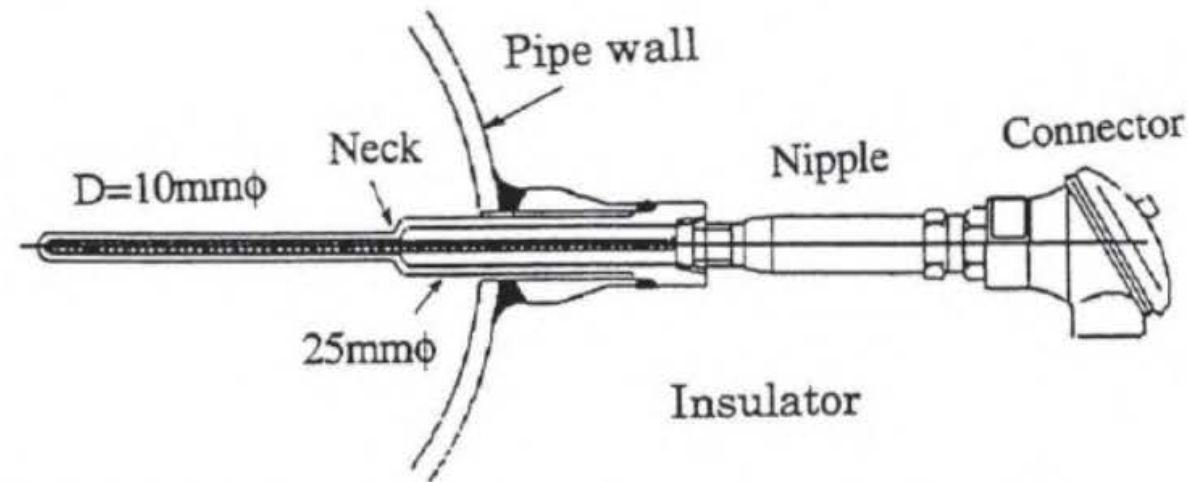
In December 1995, a thermocouple well was broken and liquid sodium leaked out of the intermediate heat transport system of the prototype fast breeder reactor Monju. Figure 1 shows the schematic of the thermocouple well. The well was broken at the neck where the diameter abruptly changes from 25mm to 10mm. This study deals with the technical investigation of the failure mechanism of the well and identification of the cause.

Fig.1 Schematic drawing of the thermocouple well.
