DESCRIPTION OF NON-CONFORMANCE REPORT:

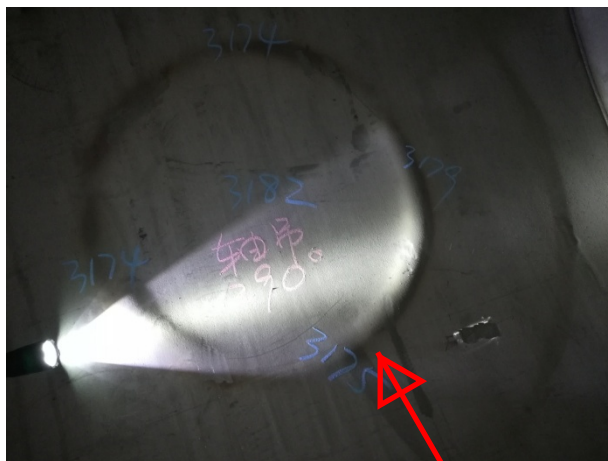
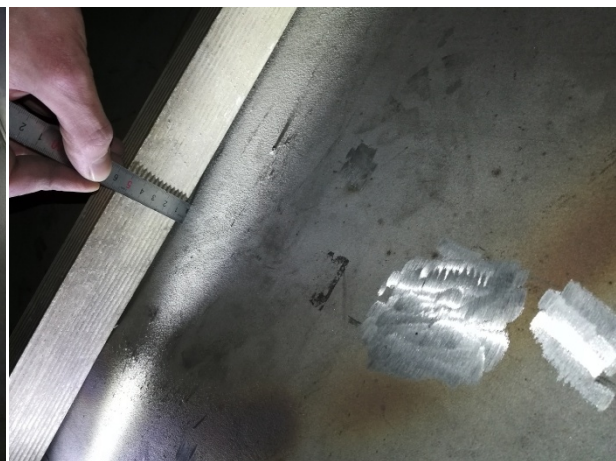
- For item No. C-1302, obvious sharp bend was found inside of shell at the position of two lifting trunnions, the Max. shell surface protuberance around 5mm (within $\phi 1117.6\text{mm}$ areas).

1. The current lifting trunnion structure requires too much welding between the lifting trunnion and the shell, which cause great heat input.
2. The thickness of the shell is relatively thin; even the temporary jigs have been applied to minimize the welding distortion, the shell surface protuberance in some point occurs.

inside of shell

lifting trunnion
