: Repairs & Coating of Jacketed Vessels

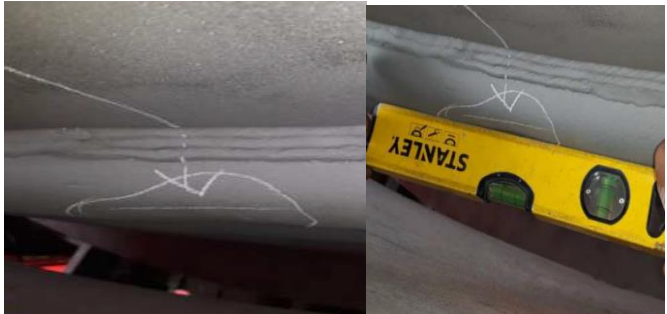
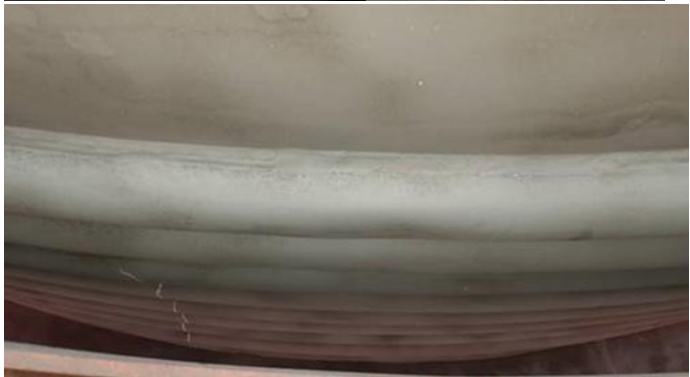
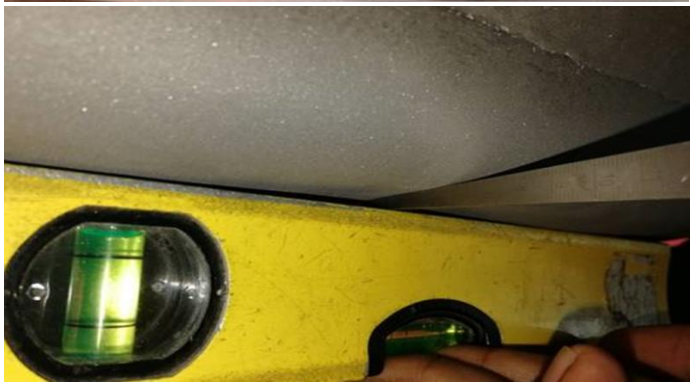
Action Item No.	Category	OPENED		Description	Action	Action By	Date Due (2 weeks)	CLOSED		Comments
		Date	SQS Report No.					Date	SQS Report No.	
1.	(MATL)	16-Mar-2021	FR#31	<p>@ V3304A: Shell External Surface</p> <p>Mechanical Damages (Dent) has been found on the below locations of Half tube surfaces.</p> <p>1st Half Tube from the Head</p> <p>1. Approximately 1.5 mm depth at one location @ 45° Orientation</p> <p>2. Approximately 3 mm depth at another location @ 105° Orientation; 400 mm distance from the LS weld.</p>

<p>DENT LENGTH OBSERVED IS 80MM</p>

<p>PT dent surfaces and perform pneumatic test to check the mechanical integrity which is approved by client dated 13-April- 2021. Test pressure : 721 psig.</p> <p>Areas to be tested are</p> <p>A) 1st and 2nd half tube from dish head Mechanical Damages (Dent) observed location at orientation 45° and 105.</p>	QICL	30-Mar-2021	Closed		<p>QICL provided dent length:</p> <p>DENT LENGTH OF 128 MM OBSERVED</p>

<p>QICL Performed the PT on the above identified locations and test results confirmed the no surface defects and found satisfactory. Reports# QICL /J915 /PT/ 3304A/ 03 & QICL /J915 /VIR/ 3304A/ 04 reviewed and Endorsed.</p> <p>Pneumatic test has been performed and found satisfactory.</p>

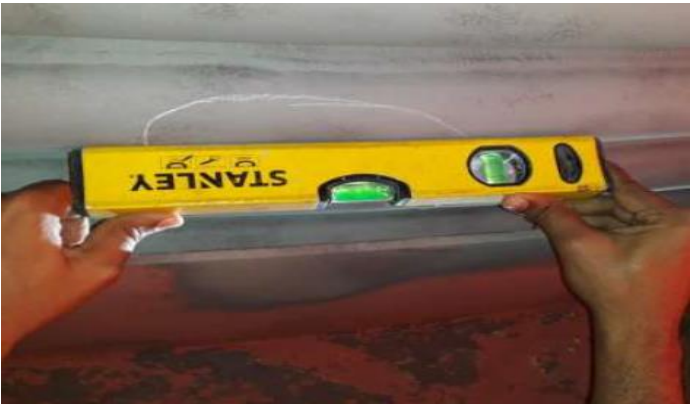
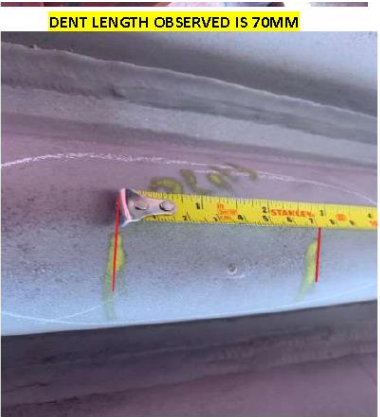
2.	(MATL)	16-Mar-2021	FR#31	<p>@ V3304A: Shell External Surface Mechanical Damages (Dent) has been found on the below location of Half tube surfaces. 4th Half Tube from the Head- Approximately 1 mm depth at one location @ 45° Orientation</p>

<p>PT dent surfaces and perform pneumatic test to check the mechanical integrity which is approved by client dated 13-April- 2021. Test pressure : 721 psig.</p> <p>Areas to be tested are 4th half tube from dish head Mechanical Damages (Dent) observed location at orientation 45°.</p>	QICL	30-Mar-2021	Closed	<p>QICL provided dent length:</p>

<p>QICL Performed the PT on the above identified locations and test results confirmed the no surface defects and found satisfactory. Reports# QICL /J915 /PT/ 3304A/ 03 & QICL /J915 /VIR/ 3304A/ 04 reviewed and Endorsed.</p> <p>Pneumatic test has been performed and found satisfactory.</p>

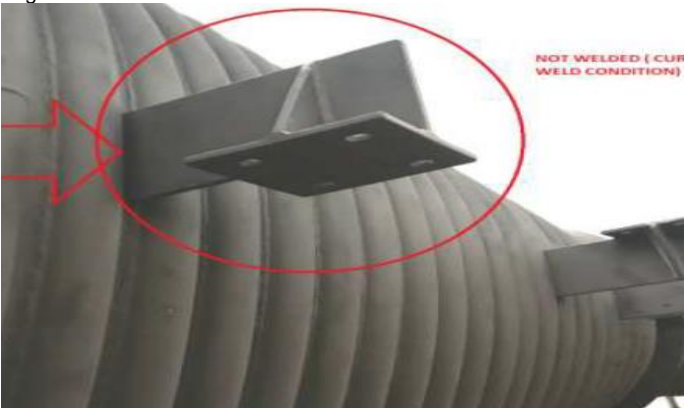
3.	(WELD)	16-Mar-2021	FR#30	<p>@ V3304A: Cone External Surface One support clip was not been welded – 2nd Cleat from the Insulation ring 2.</p>

<p>Weld the support clip per MHI fabrication dwg and R-stamp. MHI to provide Manufacturer data report and proof of NBR registration. QICL to develop welding procedure per NBIC, part 3 such that re-PWHT and re-hydrotesting are not required.</p>	MHI/ QICL	30-Mar-2021	Closed	<p>FR#47</p> <p>Manufacturer data report and proof of NBR were received from MHI dated 31-March-2021.</p> <p>QICL repair procedure QICL-J915-REP-01, rev. 1 , 24-March-2021 was approved by MDR.</p> <p>QICL done the welding as per approved WPS (03 R_0) Complete the Visual inspection and LPT Were found satisfactory.</p> <p>QCIL completed the R stamp Certification and submitted the AI signed Form R1 REPORT FOR REPAIR.</p> <p>(Ref email# From Mr. Sreeraj, QC Engineer, Dated on 22.06.2021)</p>

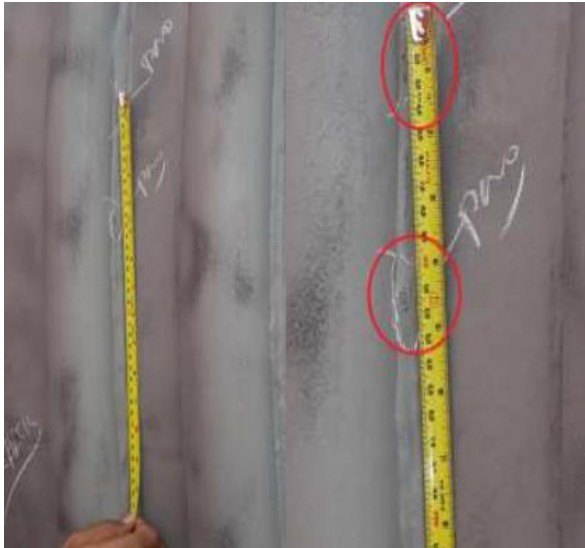
4.	(WELD)	16-Mar-2021	FR#31	<p>@ V3304A: Cone External Surface Weld defect (Cluster porosity) found on one Half tube weld surface. – 2nd Tube from the Insulation Ring 3 @ 315° Orientation, 300 mm distance from the LS weld.</p>

<p>Grinding to remove the porosity and perform the NDE. Check the thickness after grinding. The required thickness for pipe and weld is 6 mm minimum per MHI fabrication dwg.</p>	MHI/QIC L	30-Mar-2021	24-Mar-2021	FR#37	<p>Action by QICL: 1.QICL removed the porosity by grinding and performed the NDT. Inspection result found satisfactory. 2.. NDT reports# QICL/J915/PT/3304A/01, 02 were Reviewed and Endorsed.</p>

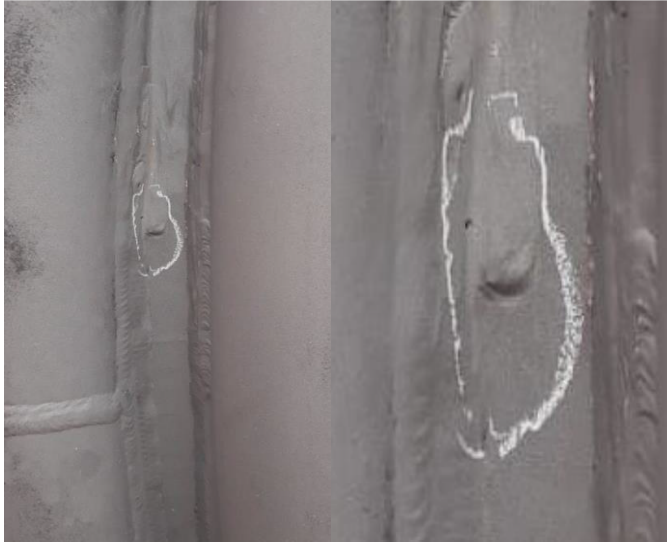
7.	(Weld)	16-Mar-2021	QICL-VIR-01	<p>Porosity observed at one location on one location at Half Pipe no#2 from man way M2 at orientation 0° to 270°</p>	Grind and PT, and recheck fillet weld size, 6 mm minimum.	MHI/QIC L	30-Mar-2021	24-Mar-2021	FR#37	<p>Action by QICL:</p> <p>1.QICL removed the porosity by grinding and performed the NDT. Inspection result found satisfactory.</p> <p>2.. NDT reports# QICL/J915/PT/3304A/01, 02 were Reviewed and Endorsed.</p>

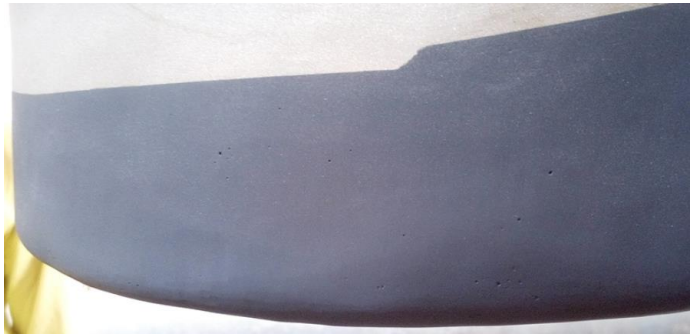
8.	MATL	15-04-2021	FR#56	<p>During visual inspection after primer coat on vessel internals observed pin holes on MH1 Plug (Bottom areas where requirement PFF Coating 20-50mm) That need to be repair before proceeding further coat.</p>

<p>1.This identified Pin holes on the base metal and these pin holes should remove (By buffing / Grinding) and NDT required on the grinded surface.</p> <p>2.For these repair activity (pin holes removal) QICL has completely removed the applied primer on the affected surface. Hence Heat treatment (backing) is required as per the coating application procedure.</p>	QICL & AMI	29-04-2021	15-04-2021	FR#57 & Supplier (AMI) Email Confirmation	<p>QICL Action: This identified Pin holes on the base metal and these pin holes were removed (By buffing / Grinding) and was done the NDT on the grinded surface. NDT report # QICL-J1915-PT-3304A-05 reviewed and found satisfactory.</p> <p>AMI action Supplier (AMI) confirmed that the reapplied primer is not required to be baked. Hence this observation was closed.</p>

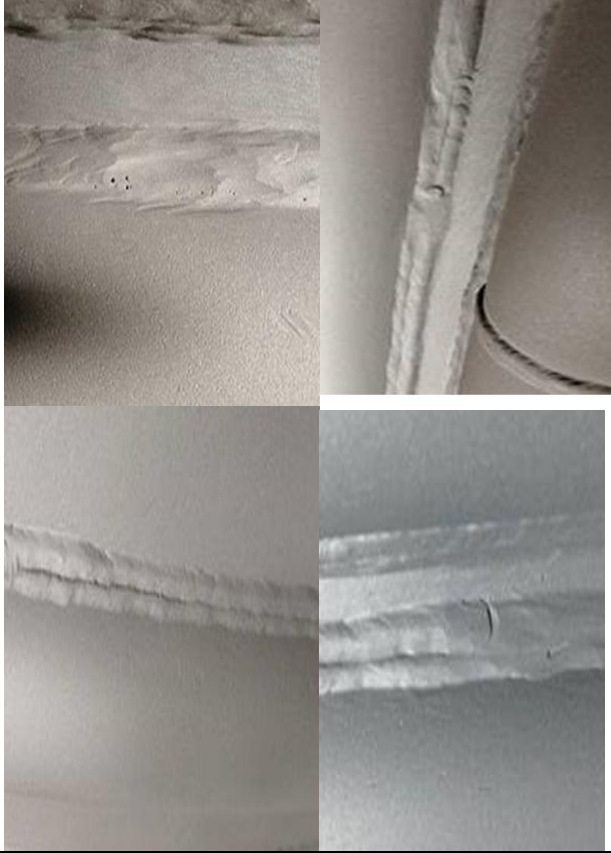
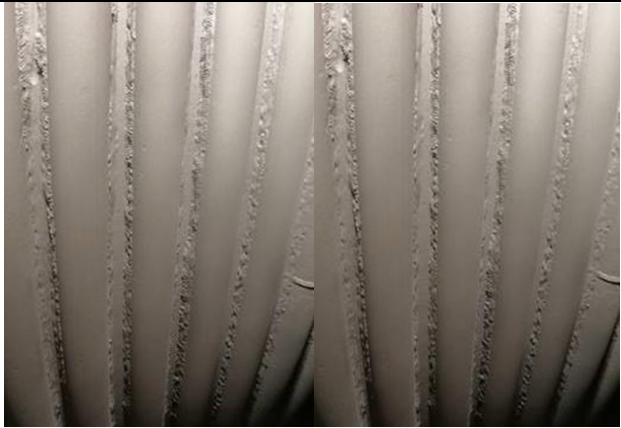
12.	WELD	28-04-2021	FR#67	Final surface preparation of exterior of vessel@ V3304A-Saddle Contact Areas 1 Some Weld spatters randomly found on the offered Blasted surfaces. 2 Cluster Weld porosity found at one location. 3 Weld layer /toe properly not merged, 4 Weld overlap, sharp edges and Poor weld profile noticed on most of Half Tube weld surfaces on the saddle contact areas. QICL needs to ensure the necessary surface preparation on the poor weld profiles to meet the painting specification / QICL approved procedure requirements.

External surface preparation for painting from spec: Before further surface preparation, all sharp edges shall be rounded to minimum radius of 1.5 mm. Particular attention shall be paid to: <input type="checkbox"/> Removal of weld spatter <input type="checkbox"/> Rounding off or chamfering of sharp edges (without damaging welds!) <input type="checkbox"/> Ensuring that all weld seams are continuous, smooth and rounded Grinding/buffing to meet the spec and to remove porosity, spatters, etc., PT and check the fillet weld size, 6 mm min.	QICL	12-05-2021	24-05-2021	FR#87	Action by QICL: 1.Weld spatters removed. All the Identified weld defects were removed (By buffing / Grinding) and was done the NDT on the grinded surface. Inspection reports # QICL-J1915-PT-3304A-Saddle-01 and QICL-J915-VIR-3304A—SADDLE-01 were reviewed and found satisfactory.

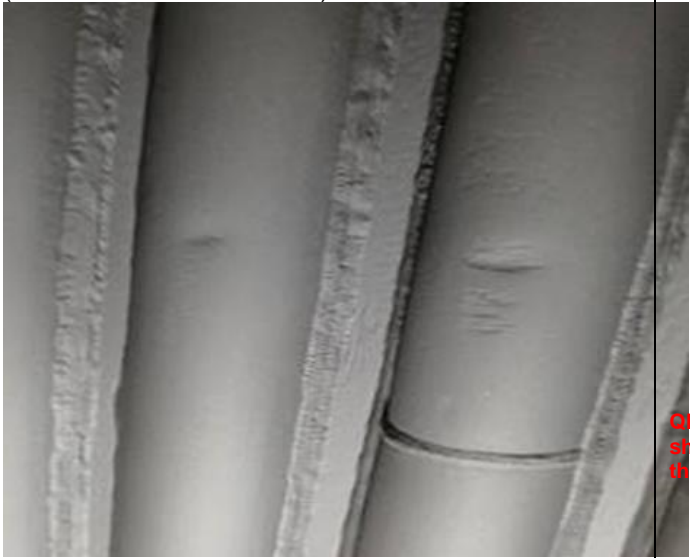
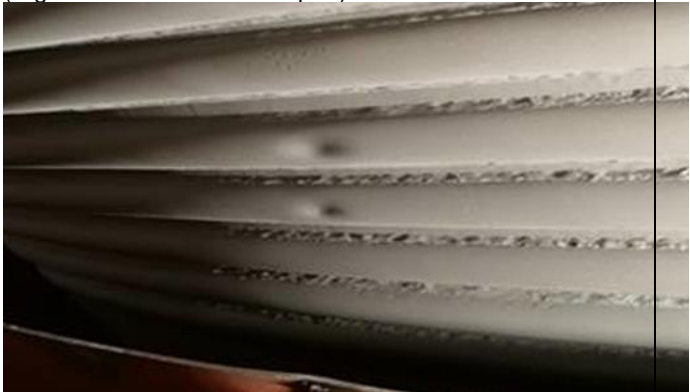
13.	MATL	28-04-2021	FR#67	<p>Final surface preparation of exterior of vessel@ V3304A-Saddle Contact Areas.</p> <p>Mechanical damage was found on the below half tube surfaces</p> <p>1 14th and 15th Half tube surfaces- From the Nozzle N9B (Left side view from cone Part)</p>

<p>QICL to measure the depth of the dent. If it is minor without sharp edges or corner, then grind, PT , check the pipe thickness(6 mm min) and pneumatic testing at 721 psig.</p> <p>2 13th and 14th Half tube surface- From the Nozzle N9B (Right side view from Cone part)</p>

QICL	12-05-2021	24-05-2021	FR#87	<p>Action by QICL:</p> <p>1.QICL measured the reported mechanical Damage and observed the maximum depth was 0.35 mm.</p> <p>2.NDT-PT was carried out on the damaged locations. Inspection results were found satisfactory. (PT report# QICL-J915-VIR-3304A/saddle/010 reviewed and Endorsed)</p> <p>QICL performed the Pneumatic Test on the Half tube surfaces to ensure the weld integrity at the reported dent Half tubes as specified in the Flash report# 67. The witnessed test result on the repaired Half Tubes were found satisfactory. Report# J915 /PNT/ 3304A/ 01)</p>

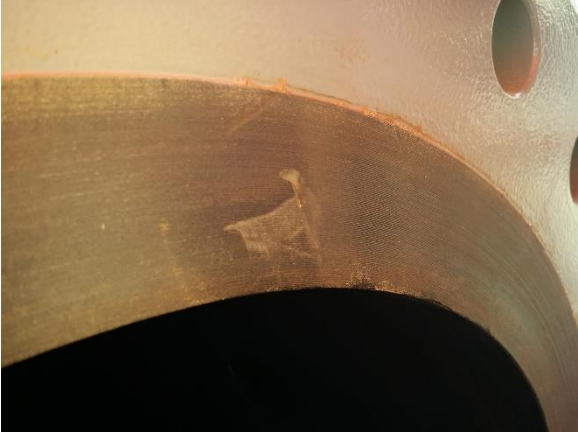
24.	MATL	05-06-2021	FR#97	Nozzle N7 flange serrations found to have damaged at 3 locations along the surface. The Damage seems to be some metal contact and it have created a depression on the serrations crosswise which may affect the integrity of the Nozzle under operation.

QICL		26/06/2021	Email#	NCR#124 issued to QICL for this identified nonconformance. This NCR was closed with Client approval "Use as is". Hence this punch point was closed.

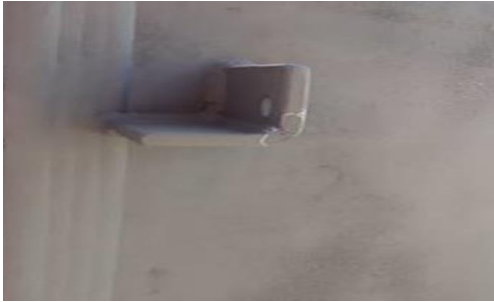
2.	WELD	17-April-2021	FR# 57 (QICL/J915/VIR/3304-B/01, item 5, 7)	@ V3304B: Head 1. Cluster porosity observed on one Insulation support clip weld surface @ 180° Orientation.

MDR: Grind to remove porosity	QICL	26-Apr-21	09.05.2021	FR#77	QICL Action Weld defects removed and NDT Performed. NDT Report# QICL/J915/PT/3304B/02 reviewed, Endorsed and found satisfactory

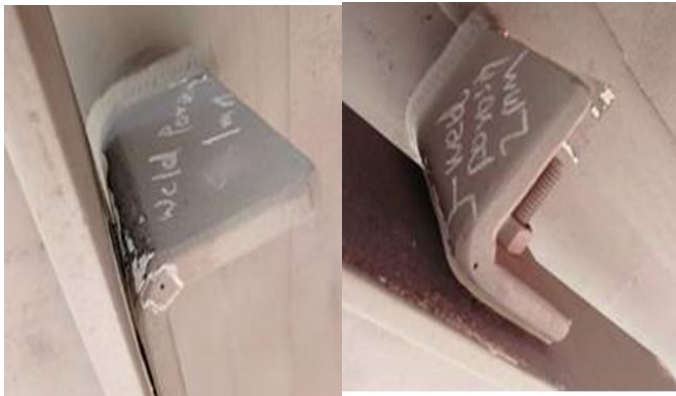
2. Porosity observed on Insulation support clips (2 nos) corner weld surface @ 90° Orientation.

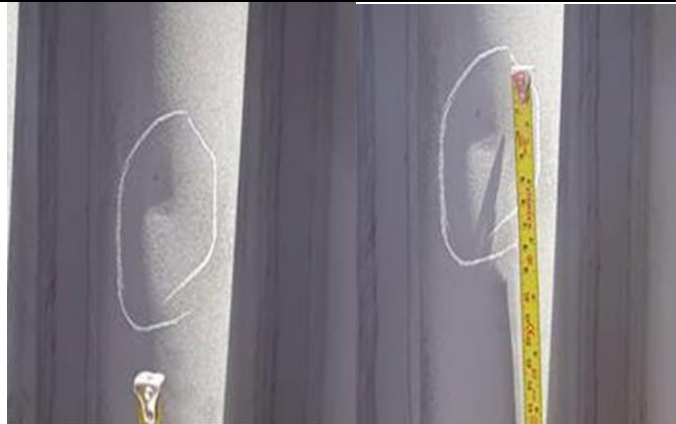
4.	MATL	17-April-2021	FR# 57 (QICL/J915/VIR/3304-B/01, item 2)	@ V3304B: Shell External Surface Mechanical Damages (Dent- 0.76 mm Depth up to 70 mm Length) has been found on the Half tube surface - 8th Half Tube from the Head @ 180° - 270° Orientation.	MDR: PT dent surfaces and perform pneumatic test to check the mechanical integrity. Test pressure : 721 psig.	QICL	26-Apr-21	09.05.2021	FR#73, FR#77	QICL Action: NDT performed on the Dent surface. Test result was found satisfactory. NDT Report# QICL/J915/PT/3304B/01 QICL performed the Pneumatic Test on the Half tube (Shell Side) to ensure the weld integrity at the identified

<p>Half tubes as specified in the Flash report# 57. The witnessed test result was found satisfactory.</p> <p>Test Report# J915/PNT/3304B/01 reviewed and Endorsed.</p>

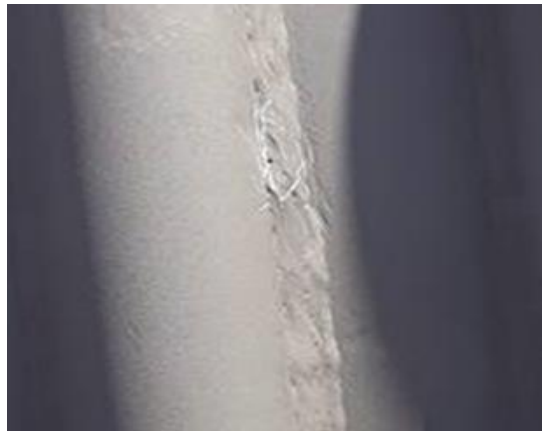
5.	WELD	17-April-2021	FR# 57 (QICL/ J915/VIR /3304-B / 01, item 3, 4)	<p>@ V3304B: Shell External Surface</p> <p>1. Pin hole (2mm Dia, 1 mm Depth) observed on one Half Pipe weld surface – 2nd Half Pipe from the Head @180° - 270° Orientation.</p>

<p>MDR: Grind to remove pin hole, PT and check the pipe thk and fillet weld size, 6 mm minimum.</p>	QICL	26-Apr-21	09.05.2021	FR#77	<p><u>QICL Action</u></p> <p>Pin hole removed and NDT performed on the Grinded surface.</p> <p>NDT Report# QICL/J915/PT/3304B/01 reviewed and Endorsed.</p>

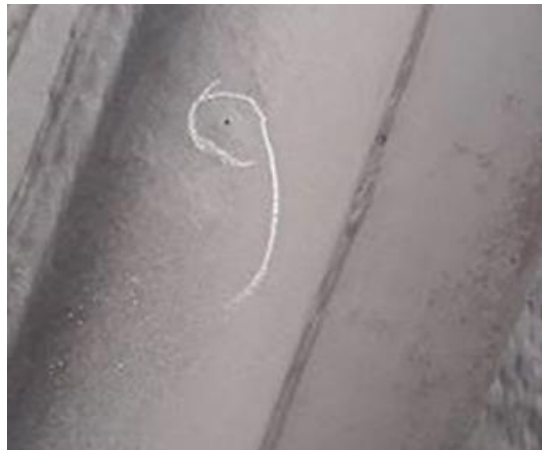
<p>2. Pin hole (1mm Dia, 1 mm Depth) observed on one Half Pipe surface – 9th Half Pipe from the Head @0° - 90° Orientation.</p>

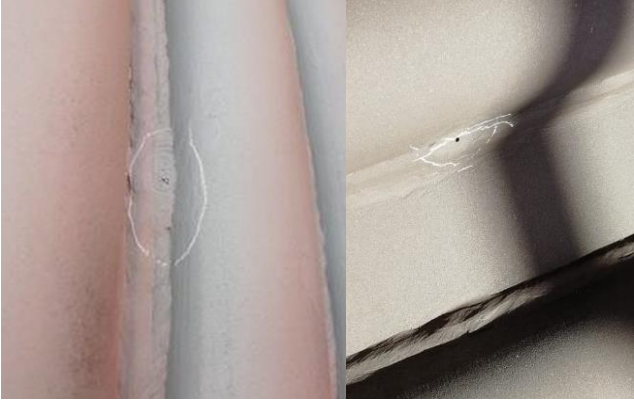
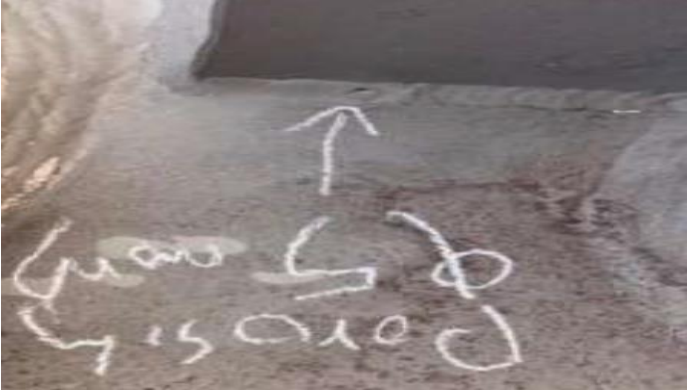
7.	WELD	17-April-2021	FR# 57 (QICL/ J915/VIR /3304-B / 01, item 6, 12)	<p>@ V3304B: Cone External Surface</p> <ol style="list-style-type: none"> 1. Weld defect (Cluster porosity) found on one Half tube weld surface. – 9th Tube from the Cone @ 180° Orientation. 2. Weld defect (Single porosity, 1mm Dia) found on the 1st one Half tube weld surface. – 9th Tube from the Cone @ 180° Orientation. 3. Weld defect (Single porosity up to 5 mm dia) found on the Insulation support Ring (1st Ring) @ 0° Orientation.

<p>MDR: Grind to remove porosity. PT and check the fillet weld size, 6 mm minimum.</p> <p>For point no.3 – Grind to remove porosity</p>	QICL	26-Apr-21	09.05.2021	FR#77	<p>QICL Action</p> <p>Weld defects removed and NDT Performed.</p> <p>NDT Report# QICL/J915/PT/3304B/02 reviewed, Endorsed and found satisfactory</p>

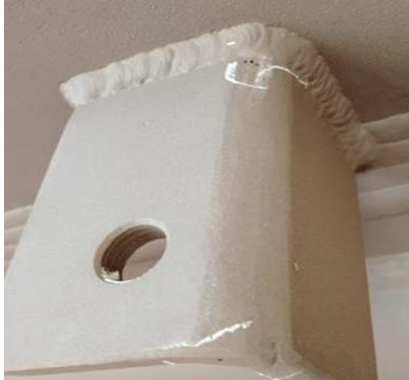
9.	WELD	18-April-2021	FR# 58 (QICL/ J915/VIR /3304-B /	<p>@ V3304B: Head</p> <p>Weld Defect (Cluster Porosity) observed on one Insulation support clips corner weld surface @ 270° Orientation. (Dia Less than 1mm)</p>		QICL	26-Apr-21	10.05.2021	FR#78	<p>QICL Action:</p> <p>Weld defects removed and NDT Performed.</p>

MDR: Grind to remove porosity. PT and check the fillet weld size, 6 mm minimum.					NDT Report# QICL/J915/PT/3304B/03 reviewed, Endorsed and found satisfactory.

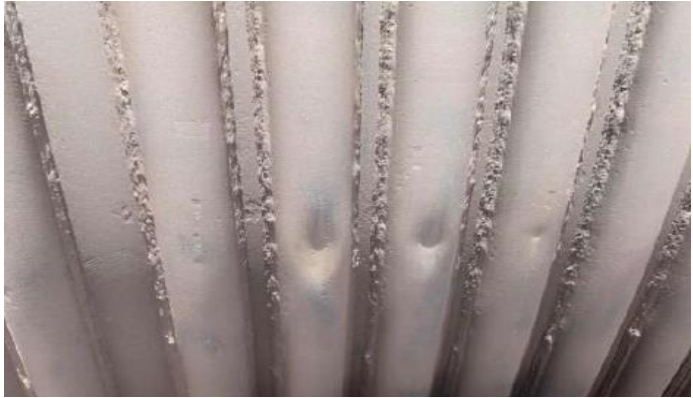
10.	MATL	18-April-2021	FR# 58 (QICL/J915/VIR/3304-B/01, item 16,17)	<p>@ V3304B: Shell External Surface</p> <ol style="list-style-type: none"> Mechanical Damages (Dent- 0.98 mm Depth up to 70 mm Length) has been found on the Half tube surface - 6th Half Tube from the Nozzle N9C @ 210° Orientation.

<ol style="list-style-type: none"> Mechanical Damages (Dent- 0.66 mm Depth up to 30 mm Length) has been found on the Half tube surface - 7th Half Tube from the Nozzle N9C @ 210° Orientation. Mechanical Damages (Dent- 0.81 mm Depth up to 6 mm Length) has been found on the Half tube surface - 7th Half Tube from the Dish head @ 180° - 270° Orientation. 	<p>MDR: Pipe # 6,7, QICL please re-examine and provide close up photos. If the surface is smooth without sharp edges, discontinuity, buckle or corner, may only need PT and pneumatic testing. Otherwise cut and patch will be required.</p> <p>Existing rough welds of half pipe to cone that does not meet weld profile and pattern, and not suitable for painting, shall be ground and PT, and check the fillet weld size, 6 mm minimum.</p> <p>For # 3, buffing lightly and smoothly. PT dent surfaces, and recheck pipe thickness. 6mm thick minimum.</p>	QICL	26-Apr-21	09.05.2021	FR#73, 77	<p>QICL Action:</p> <p>QICL performed the Pneumatic Test on the Half tube (Shell Side) to ensure the weld integrity at the identified Half tubes as specified in the Flash report# 58. The witnessed test result was found satisfactory.</p> <p>Test Report# J915/PNT/3304B/01 reviewed and Endorsed.</p>

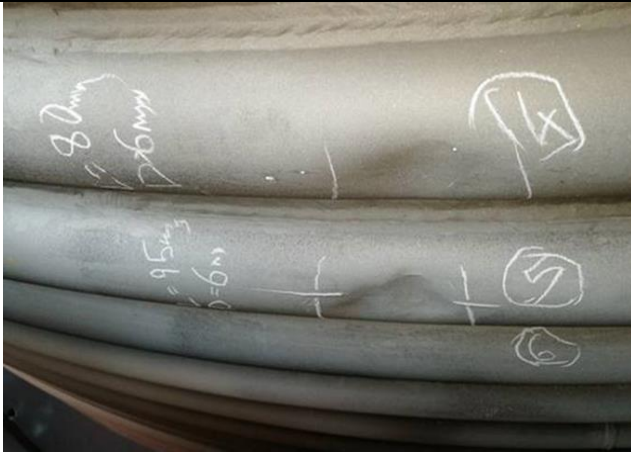
11.	MATL	18-April-2021	FR# 58 (QICL/J915/VIR/3304-B/01, item 9,10)	<p>@ V3304B: Cone External Surface</p> <ol style="list-style-type: none"> Mechanical Damages (Dent- 6 mm Depth up to 80 mm Length) has been found on the Half tube surface - 4th Half Tube from the Insulation Support Cleat 2B towards to Shell side @ 210° - 270° Orientation. Mechanical Damages (Dent- 6 mm Depth up to 95 mm Length) has been found on the Half tube surface - 5th Half Tube from the Insulation Support Cleat 2B towards to Shell side @ 210° - 270° Orientation. 	<p>MDR: Pipe # 4, 5, Cut and patch the dent section, PT root and final passes of butt welds and pneumatic testing at 72l psig, and R-stamp. QICL to provide repair procedure for approval.</p>	QICL	26-Apr-21	Closed	FR#71, 74, 77	<p><u>QICL action:</u></p> <ol style="list-style-type: none"> Dent section was removed as per the above recommendation. Splice / Patch fit-up was offered for the above repair locations. Patch materials (SA 333 Gr 6, Thick 7.62 mm) traceability was hard stamped on the surface. Fit up checked and found satisfactory. Fit up Inspection report# QICL-J915-V3304B-FTB-01 reviewed and Endorsed. Welding completed and found satisfactory. Reports# QICL/J915/JMH20-5-80058-ASME-VIR-01, QICL-J915/V3304B/WHS/01 were reviewed and Endorsed. NDT reports# QICL/ J915/ PT/3304B/ RT/01, 02 reviewed and Endorsed.

<p>4.QICL performed the Pneumatic Test on the Half tube (Cone side) to ensure the weld integrity at the reported dent Half tubes as specified in the Flash report# 58. The witnessed test result on the repaired Half Tubes were found satisfactory. Report# J915 /PNT/ 3304B/ PATCH/01)</p> <p>5.QCIL completed the R stamp Certification and submitted the signed Form R1 REPORT FOR REPAIR.</p> <div>

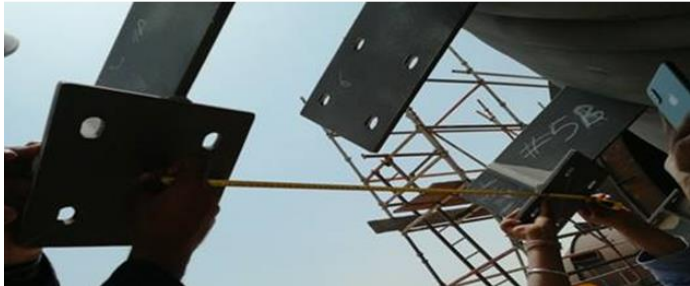
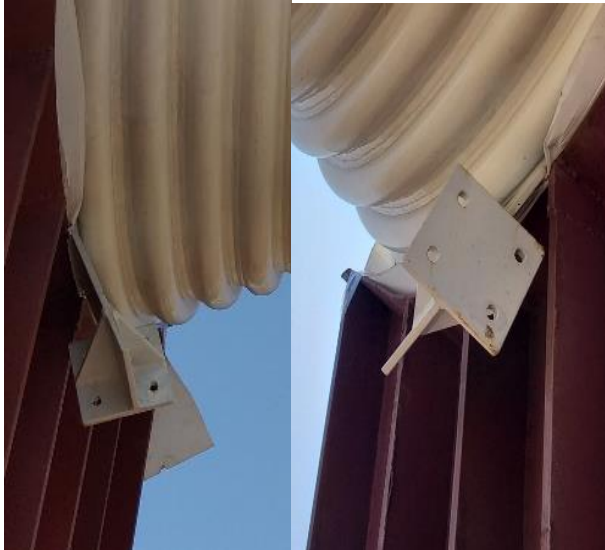
12.	MATL+WELD	18-April-2021	FR# 58 (QICL/ J915/VIR /3304-B / 01, item 8)	<p>@ V3304B: Cone External Surface</p> <p>One Insulation radioactive detector support cleat 5B was having bent and sharp edges due to Transportation Handling from MHI to QICL. The identified bent on the cleat was causes the incorrect elevation level (Up to 42 mm difference). This is not acceptable. NDT to be performed on the cleat weld joints to ensure the absence of any weld defect.</p> <div>

</div>	<p>MDR: Straight clip # 5B to the original position and line up center of bolt holes and end plates with clip # 7B based on MHI fabrication dwg HR01-25248-1(1/2), Rev 11. Clip to be perpendicular to vessel wall and center to center to be 977 mm between # 5B and 7B. PT clip welds to the cone surface</p>	QICL	26-Apr-21	09.05.2021	FR# 74, 77	<p>QICL Action:</p> <p>The observed bent was rectified by slight hammering (Indirect) on the bent clip surface. NDT-PT was performed on the repaired surface + existing welded surface. After completing the NDT QICL has been verified the Dimension (Distance between Radioactive cleat 5B& 7B) as per MHI fabrication dwg HR01-25248-1(1/2), Rev 11.</p> <p>This was ensured in QICL inspection report Inspection report# QICL/J915/V3304B/FDR/01. Report reviewed and Endorsed.</p> <p>NDT report# QICL/J915/PT/3304B/06 was reviewed and Endorsed.</p>

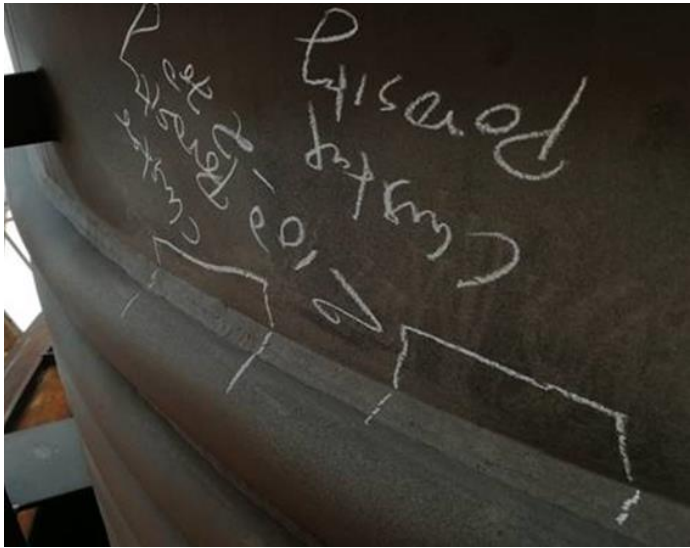
13.	WELD	18-April-2021	FR# 58 (QICL/ J915/VIR /3304-B / 01, item 11)	<p>@ V3304B: Cone External Surface</p> <p>Weld defect (Cluster porosity) found on one Half tube weld surface at two locations. – 1st Half Tube from the Insulation support cone Ring#3 @ 210°-270° Orientation.</p>

MDR: Grind to remove porosity. PT. Recheck fillet weld size, 6 mm minimum.	QICL	26-Apr-21	09.05.2021	FR#77	<p>QICL Action</p> <p>Weld defects removed and NDT Performed.</p> <p>NDT Report# QICL/J915/PT/3304B/02 reviewed, Endorsed and found satisfactory</p>

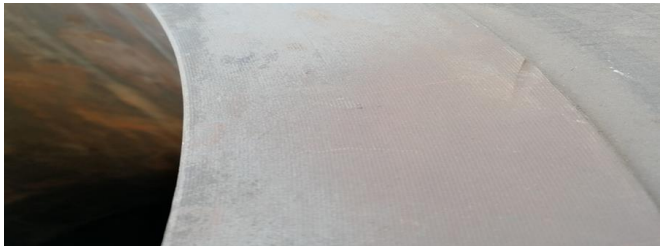
<p>2 Location 2: (Outer edge) Mechanical Damage (Imperfection) found up to 4 mm in radial projection. The observed imperfection is deeper than the bottom of the serrations. As per ASME B16.5 the Maximum allowed length is 6.4 mm. Hence it is accepted.</p>

<p>QICL to remove protrusions and resurface the face of flange</p>	QICL		28.06.2021	FR#117	<p>QICL Action: Supplier has removed the mechanical damage (4mm in radial projection with protrusions) on the Nozzle M1 Flange serration surface.</p> <p>Close visual Inspection carried out on the repaired area and was found imperfection max up to 4.4 mm length in radial projection.</p> <p>As per ASME B16.5 the maximum allowed radial projection of imperfections that are Deeper than the Bottom of the serrations is 6.4 mm. Hence it is acceptable</p>

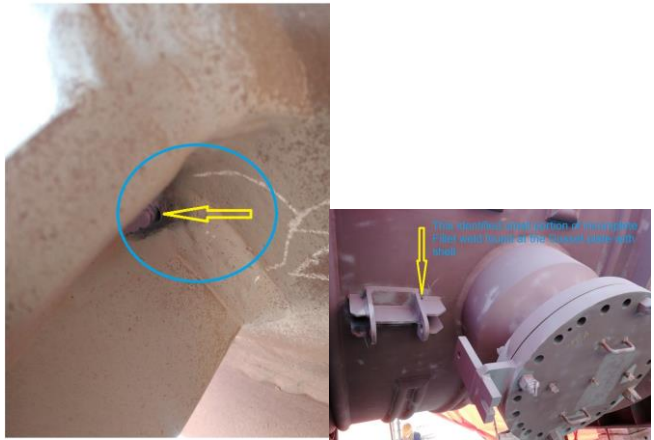
18.	(WELD)	13-Feb-2021	QICL report #J915/VIR /3306/01	<p>Incomplete weld (void) on the support lug of manway M2A</p>

<p>As advised by MDR void needs to be grounded off and associated NDT inspection has to be performed.</p>	QICL	30-Mar-2021	Closed	FR#21	<p>Corrective action was completed. NDT reports has been reviewed and found satisfactory.</p>

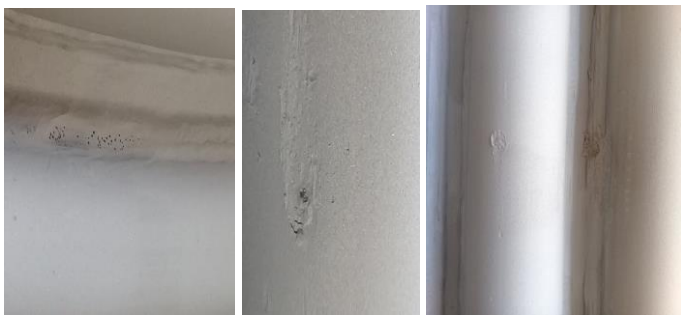
28.	CTG	08-04-2021	FR#50	<p>During primer inspection observed weld visual defects CONE TO HALF PIPE WELD</p> <p>i) Cluster porosity ii) Mechanical damages</p>

<p>i) – The porosity cluster appears as though preliminary grinding has already begun and yet severe porosity remains. This cluster is unacceptable and shall be removed. It appears from photo that significant weld metal will be required to be removed in order to clear the porosity. Thus resulting in a need weld metal restoration and invoking R-stamping weld repair.</p> <p>ii) – Lightly grind smooth. MT or PT shall be performed. UT thickness check.</p>	QICL	14-04-2021	10-04-2021	FR#54	<p>QCIL : Grind and NDE (LPT) were found satisfactory(Rep No: QICL/J915/VIR/3306/10) Dated 10 APRIL 2021.</p> <p>MHI : Verified the corrective action found satisfactory. ????</p>

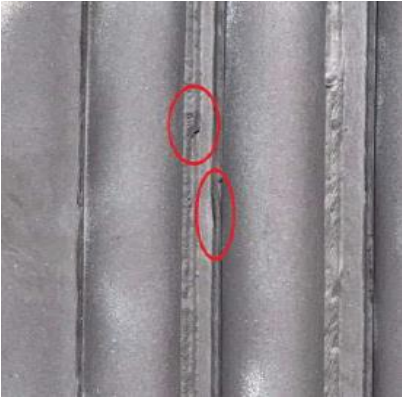
6.	WELD	07-04-2021	QICL report # J915/VIR/3305/02	<p>Weld undercut observed on 1st and 2nd half pipe at one location each from 1st insulation ring on shell at orientation 270° to 0°.</p>

Grind, PT and re-check weld size (6 mm min.) ..	MHI/ QICL	25-Apr-2021	Closed		<p>QICL Action: The identified weld defect was removed on the Identified surface and NDT performed. Test results was found satisfactory.</p> <p>NDT Report# QICL/J915/PT/3305/01 was reviewed and Endorsed.</p>

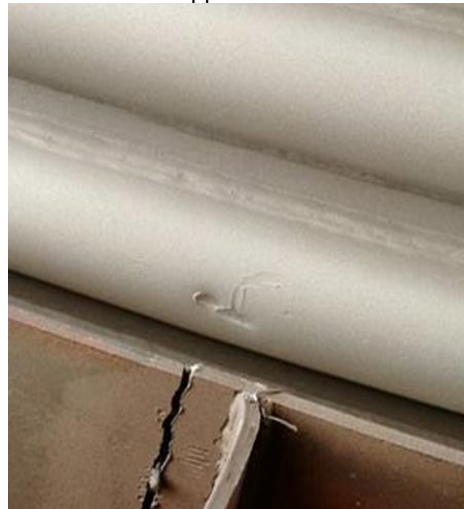
17.	MATL	29.04.2021	FR# 68	<p>Mechanical damage found on the below Half tube surfaces.</p> <p>1. 5th Half tube towards the cone end from the Insulation support # 2 @ 225° Orientation.</p>

Grind/buff smoothly and PT, and check pipe thickness (6 mm min.)			Closed	<p>QICL Action: The identified mechanical damage was removed on the Identified surface and NDT performed. Test results was found satisfactory.</p> <p>NDT Report# QICL/J915/PT/3305/02 was reviewed and Endorsed.</p> <p>UTG has been carried out on the smooth grinded surface and found the actual Thickness more than the required thickness.</p> <p>UTG Report# QICL-J915-V3305-UTG-01 was reviewed and Endorsed.</p>

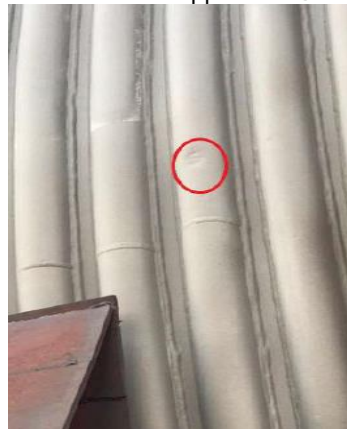
<p>2. 6th Half tube towards the cone end from the Insulation support # 2 @ 200° Orientation.</p>
