Mechanism of failure of three pile-supported structures during three different earthquakes

SUMMARY:

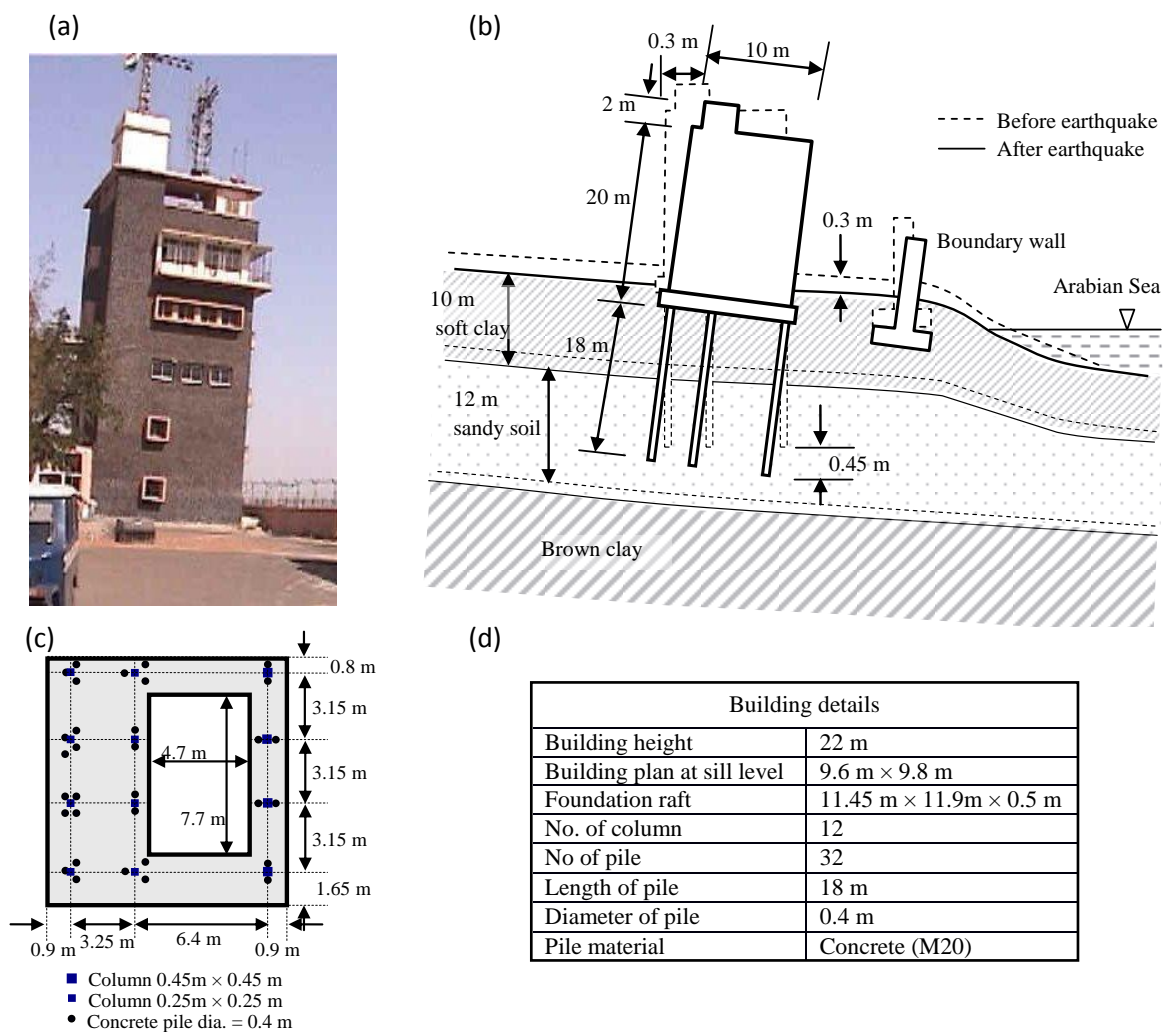
The Kandla Port and Customs Office Tower is a 22 m high six-floor building located in the Kandla port area very close to the waterfront. This pile-supported building leaned about 30cm at its top and separated from its adjacent building during the 2001 Bhuj earthquake. The building was founded on 32 short cast-in-place concrete piles. Each pile was 18m long and 0.4 m in diameter. The piles were passing through 10m of clayey crust and then terminated in a sandy soil layer. The loads from superstructure are transferred to the piles through the foundation mat, which eventually acts like a pile cap. The service load of the building is estimated to be 10749kN. The details of the calculations can be found in Dash et al (2009). Assuming equal sharing of the vertical loading, the static axial load per pile is about 336 kN. The Port of Kandla is built on natural ground comprising of recent unconsolidated deposits of inter-bedded clays, silts and sands. The water table is about 1.2 - 3.0 m below the ground level. Figure 1 shows the tilted building, schematic of its failure pattern, foundation plan and structural details of the building.

Figure 1. (a) Building A: Kandla Port and Customs Tower (b) Schematic of building's failure during 2001 Bhuj Earthquake (c) Foundation plan of the building showing piles, raft and columns (d) Details of the building. (Ref: Dash et al., 2009)

There were very little damage to the superstructure and all the damages were in the foundation. A numerical model was developed using SAP2000 to study the seismic response of the foundation during earthquakes (Dash et al 2009). The mat-pile-soil interaction model was used for the foundation

The analysis for service condition of the building shows that the maximum settlement of the building at service condition is about 0.2 cm, which is within the permissible limits as suggested in most of the codes of practice. The analysis shows that the foundation raft settled about 4.7cm at right top corner of the building plan during the earthquake. The mass distribution of the superstructure would hint that the building would tilt away from the creek (i.e. towards the eccentric building mass or towards the left in Figure 1(a)) as the centre of mass (CM) is on the left of the geometric centre of the building. However, the cut-out in the foundation mat shifts the centre of resistance (CR) even left of the centre of mass causing the building to lean towards right as in Figure 1 (a).

The pattern of the tilting of the building from the analysis matches fairly with that of the field observation. The total pile settlement predicted by the analytical study is 34.7cm (30cm is ground settlement + 4.7cm building settlement). In contrast, the observed settlement of pile tip is about 45cm which seems quite reasonable, if viewed in isolation.

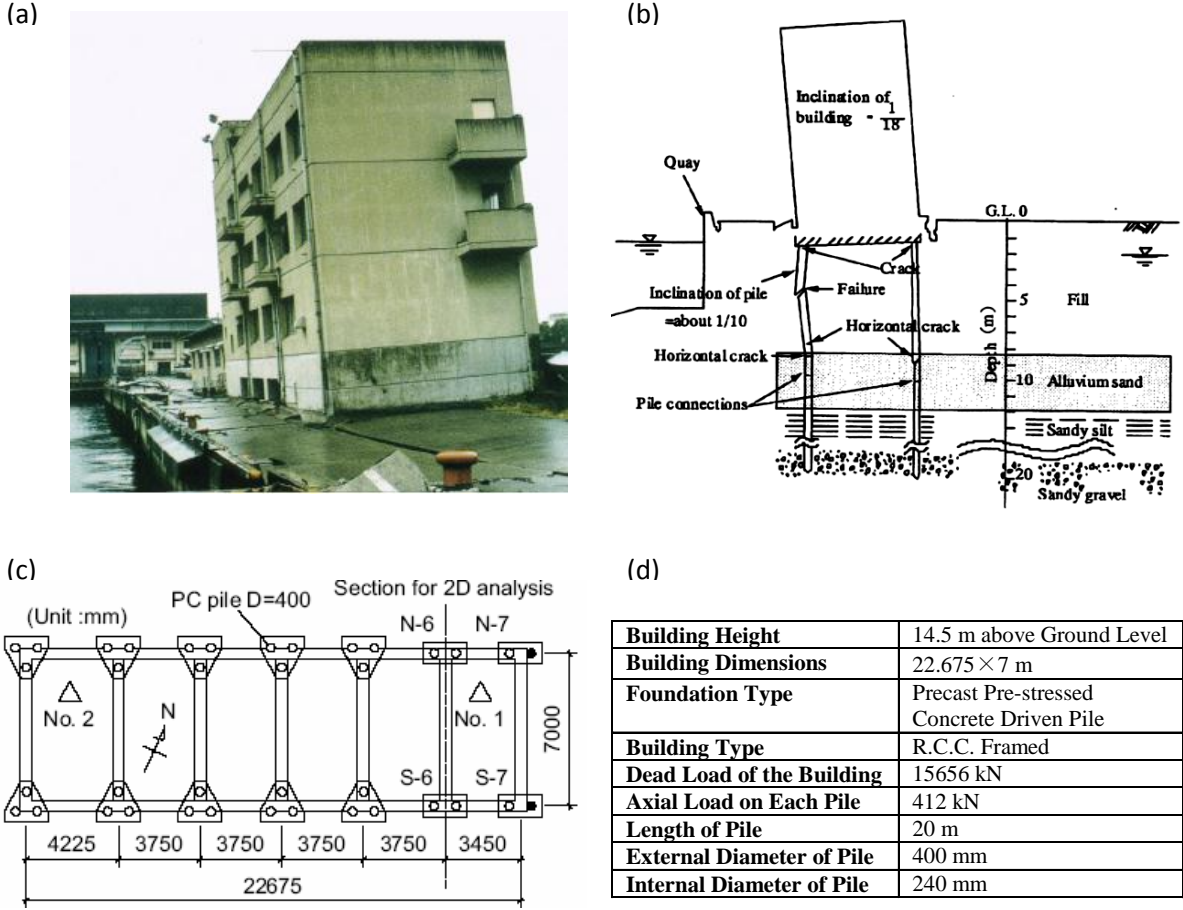
The four-storied firehouse building at the foot of the Kobe O-Hashi Bridge on Port Island moved and tilted towards the sea during 1995 Kobe earthquake. The building was founded on 400 mm diameter pre-stressed concrete piles of 30 m long (Tokimatsu et al., 1996). After the 1995 Kobe earthquake, the quay wall was displaced by 2 m towards the sea and the building tilted by 3 degrees. Post-earthquake excavation showed that compressional shear failure in piles occurred on the seaside with minor flexural cracks on the opposite side. From the soil report of Port Island, it was estimated that the top 18 m was likely to provide almost zero restraint to the pile (fill + liquefied soil + very low strength weak soil beneath the liquefied soil) (Bhattacharya 2003). The water table in the site was approximately 1.6 m below ground level. Hence, the length of the pile in liquefiable soil was about 16.4 m. Figure 2 shows the tilted building, the failure pattern of its foundation, foundation plan and building details.

Bhattacharya (2006) studied this case history to understand the mechanism of its pile failure. The piles were axially loaded heavily (412 kN each) and was laterally unsupported for 16.4m of their length due to liquefied soil layer. The factor of safety against buckling for the piles was found to be 0.81 (Bhattacharya, 2006). This suggests that the pile could probably have failed due to buckling at full liquefaction of the ground during the earthquake. The site was also subjected to lateral spreading, which could have made the piles to bend towards the direction of soil spread (i.e., towards sea side). The pile being hollow also indicates that it is weak in shear.

Figure 2. (a) Building B: Tilted firehouse building (b) Schematic of building’s foundation failure during 1995 Kobe earthquake (c) Foundation plan (d) Details of the building. (Ref: Bhattacharya, 2006)

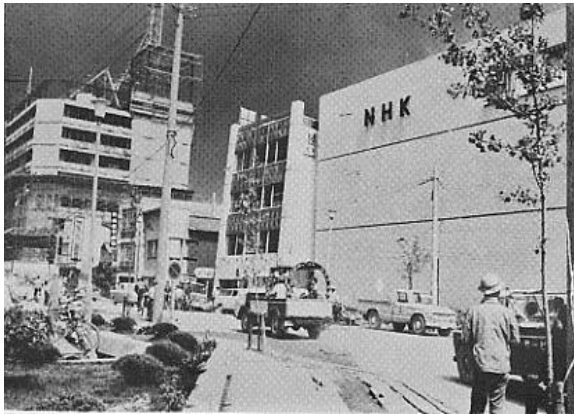
The NHK building in Niigata City is a four-storey R.C frame building supported on reinforced concrete piles, which tilted during the 1964 Niigata earthquakes. Widespread liquefaction and lateral spreading of the soil were observed near the building site. The piles have a diameter of 350 mm solid section and are 11 to 12 m long. The inclination angles of the building after the earthquake were 0.76° in long span direction (SN) and 0.23° in short span direction (EW). Twenty years after the 1964 Niigata earthquake, 74 piles were investigated by excavation and it was found that all of them were similarly damaged (see Hamada, 1992). Figure 2 shows the tilted building, damage pattern of piles after excavation, typical damage of a pile and the building details. The piles failed mostly at two positions, 2.5 to 3.5 m from the upper end of the piles and 2.0 to 3.0 m from the bottom as shown in the figure. The location of the water table is not documented in Hamada (1992). It is assumed that the water table is about 1.7m below the ground level. From the soil investigation report, the liquefied layer

Figure 3. (a) Building C: Tilted NHK building during 1964 Niigata Earthquake (b) Failure pattern of the piles observed after excavation (c) A typical pile failure pattern of this building (d) Details of the building. (Ref: Tazoh, 2007)

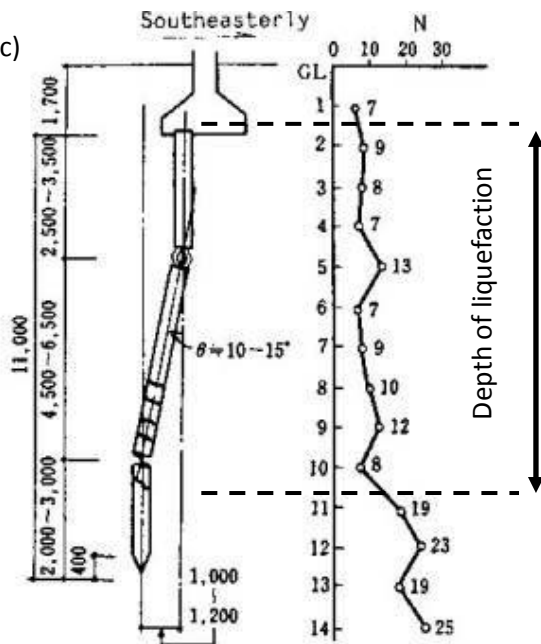
is most likely to be the top 11m. Thus the pile tip was only founded in 1m to 2 m in non-liquefiable layer. Hence the length of the pile in liquefiable soil is 9.3m (11m – 1.7m). From Figure 2 (c) it may be noted that the pile base rotated 10 to 15 degrees and this suggests that pile base was pinned. Hence the effective length of the pile (that is required for buckling load capacity estimation) is twice the length of the pile in liquefiable soil.

A buckling calculation shows that the pile was subjected to an axial load of 430 kN and the buckling load capacity (Euler’s elastic buckling load) is 520 kN. Hence, the factor of safety against buckling is about 1.2. It signifies that the pile could not have failed only due to buckling, but as the axial load is close to the buckling capacity of the pile, the bending moment in the pile if any could have amplified due to the P-delta effect.
