301 MISSION STREET SUPPLEMENT III

2-4-2021

Introduction

This report is the 19th in a series of engineering investigative reports on the conduct of the San Francisco Department of Building Inspection (DBI).

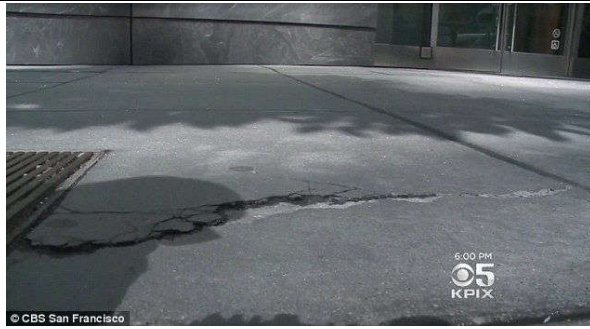
The news media had documented damage to the Millennium Tower's concrete sidewalks as early as August 1, 2016.

Figure 2: Downloaded from www.sanfrancisco.cbslocal.com, dated August 1, 2016.

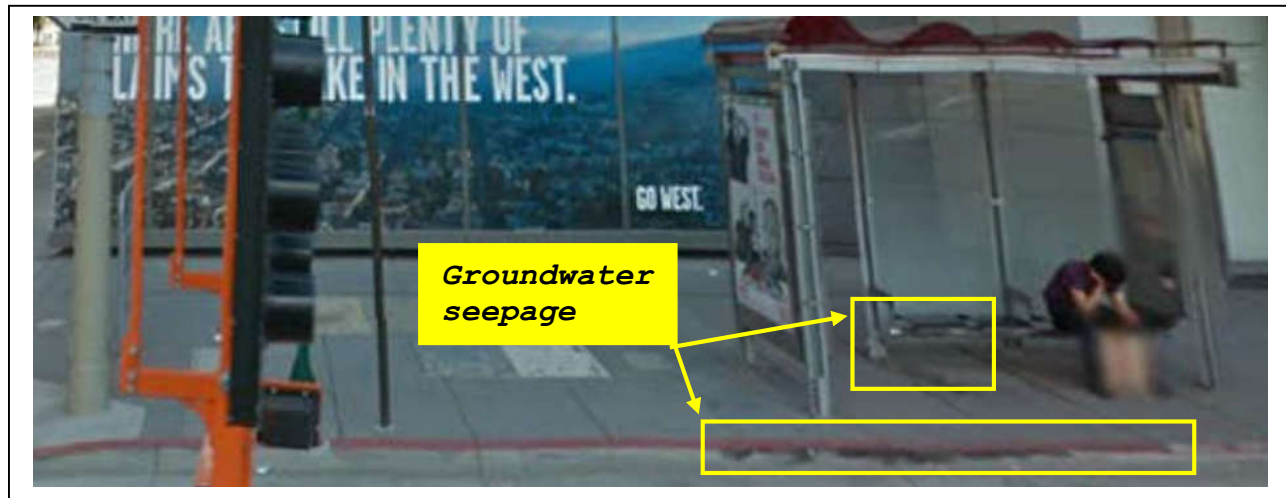
Figure 33: Annotated photograph of Fremont Street at the northern end of the block, dated February 2014; downloaded from Google Maps.

Based on Figures 33 to 75, the observed groundwater seepage onto the Fremont Street sidewalk and the damaged concrete curbs started from the north end of Fremont Street at Mission Street and proceeded southward along Fremont Street. It appears that the groundwater seepage onto the sidewalk preceded the damage to the concrete sidewalk curb.

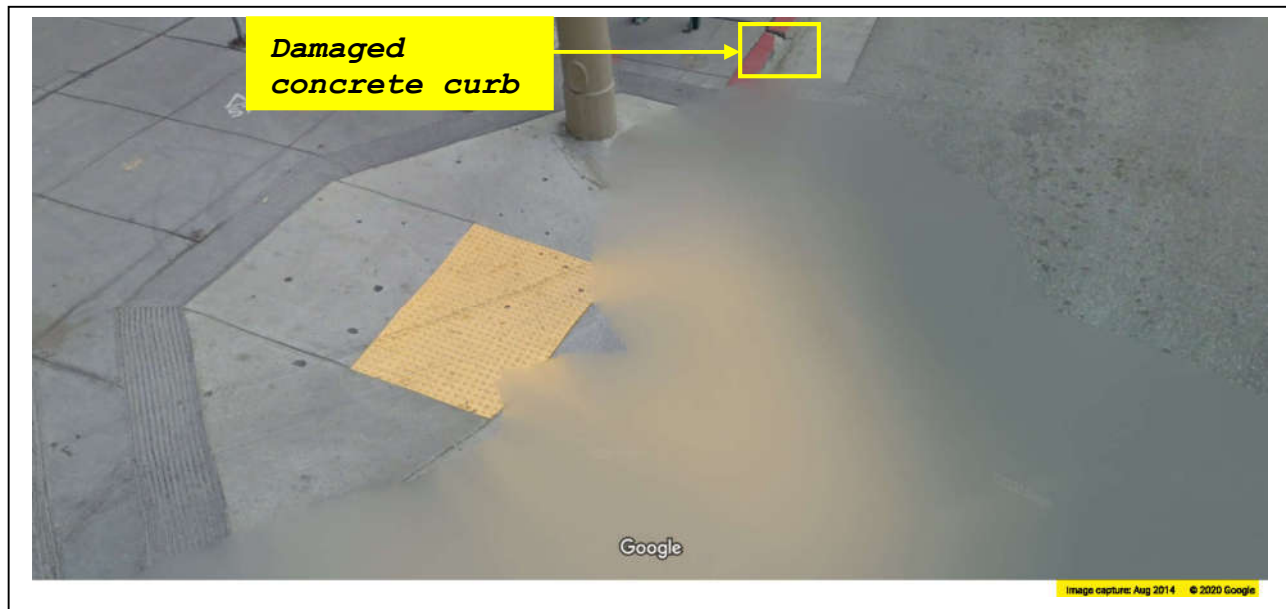
Figure 36: Close-up of left side of Figure 34, viewed from a different angle.

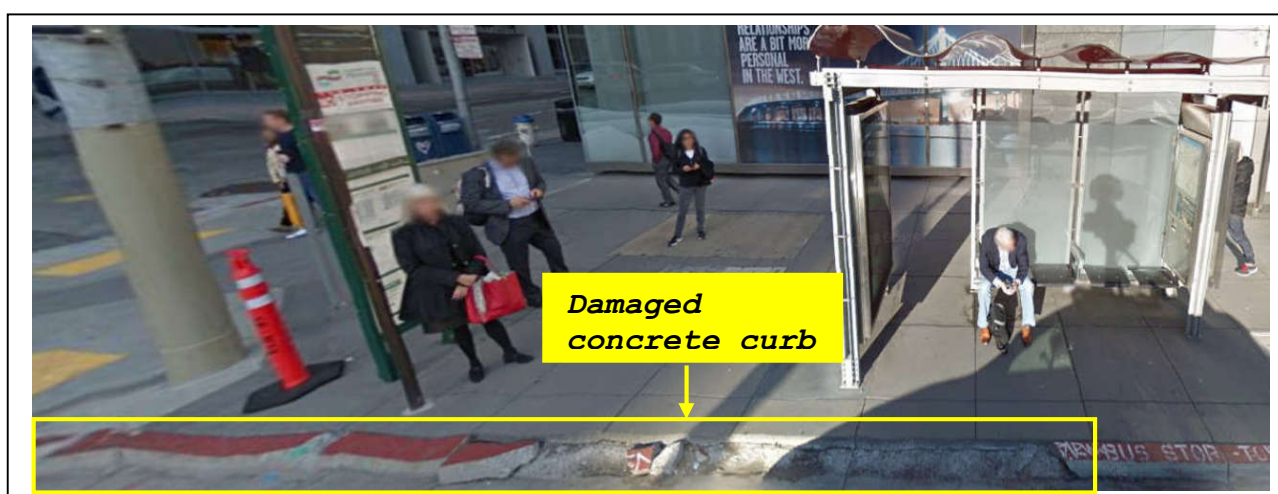
Figure 40: Annotated photograph of Fremont Street at the northern end of the block, dated February 2016; downloaded from Google Maps.

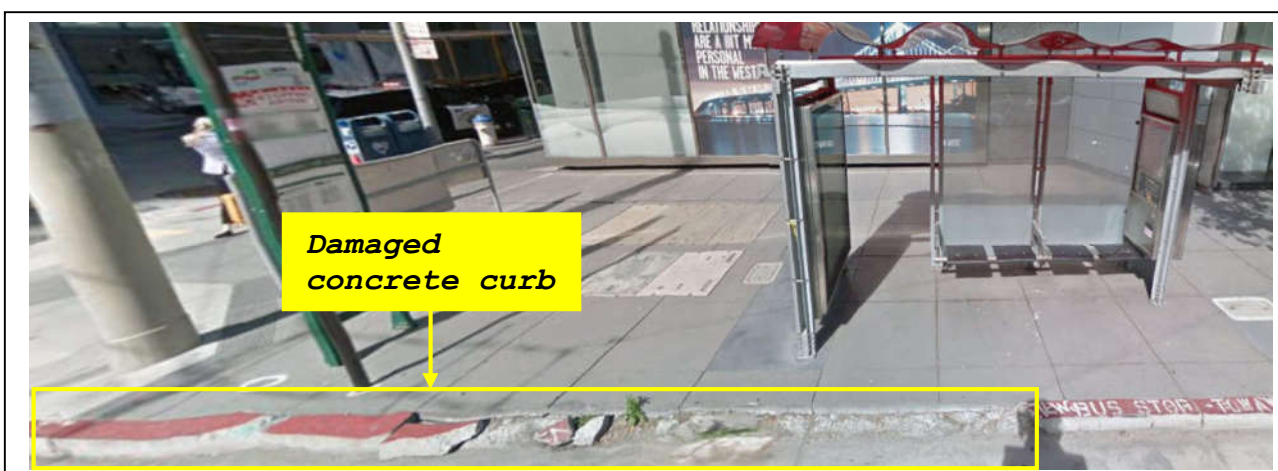
Figure 41: Annotated photograph of Fremont Street at the northern end of the block, dated April 2016; downloaded from Google Maps.

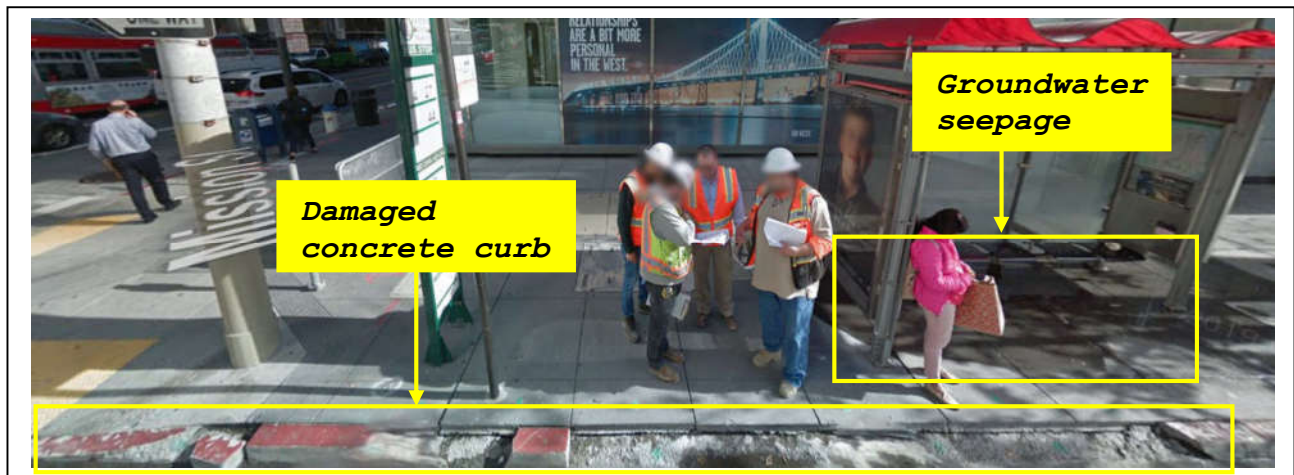
Figure 42: Annotated photograph of Fremont Street at the northern end of the block, dated October 2016; downloaded from Google Maps.

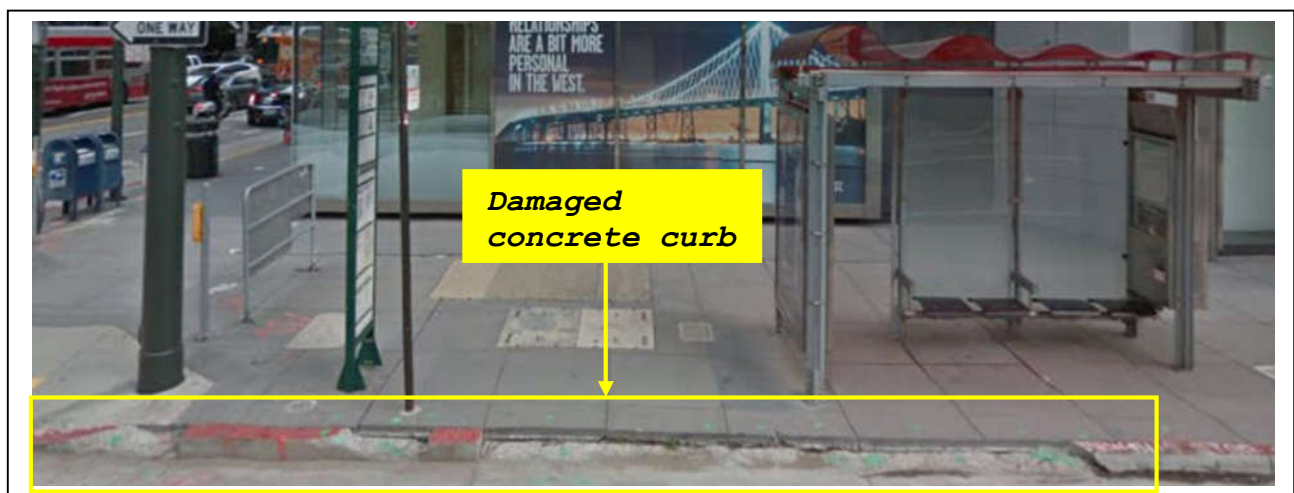
Figure 43: Annotated photograph of Fremont Street at the northern end of the block, dated February 2017; downloaded from Google Maps.

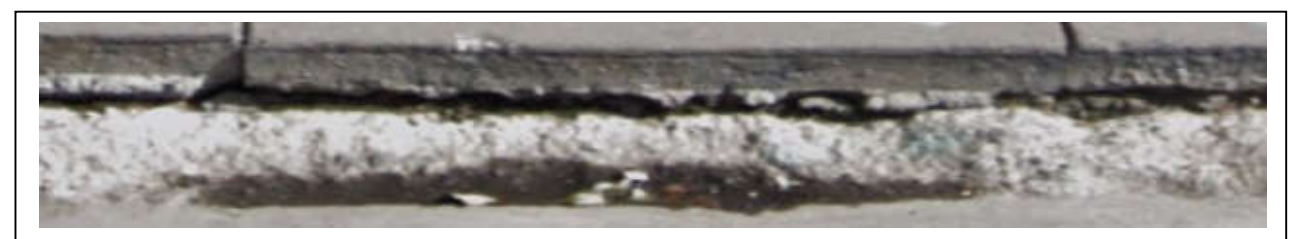
Figure 44: Close-up of damaged concrete curb shown in Figure 43.

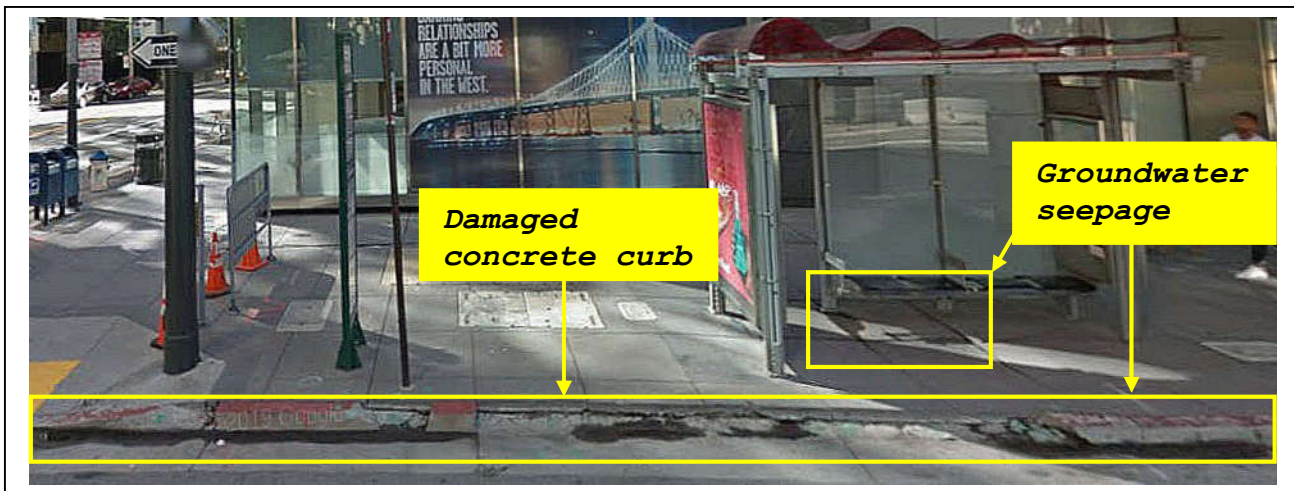
Figure 45: Annotated photograph of Fremont Street at the northern end of the block, dated April 2017; downloaded from Google Maps.

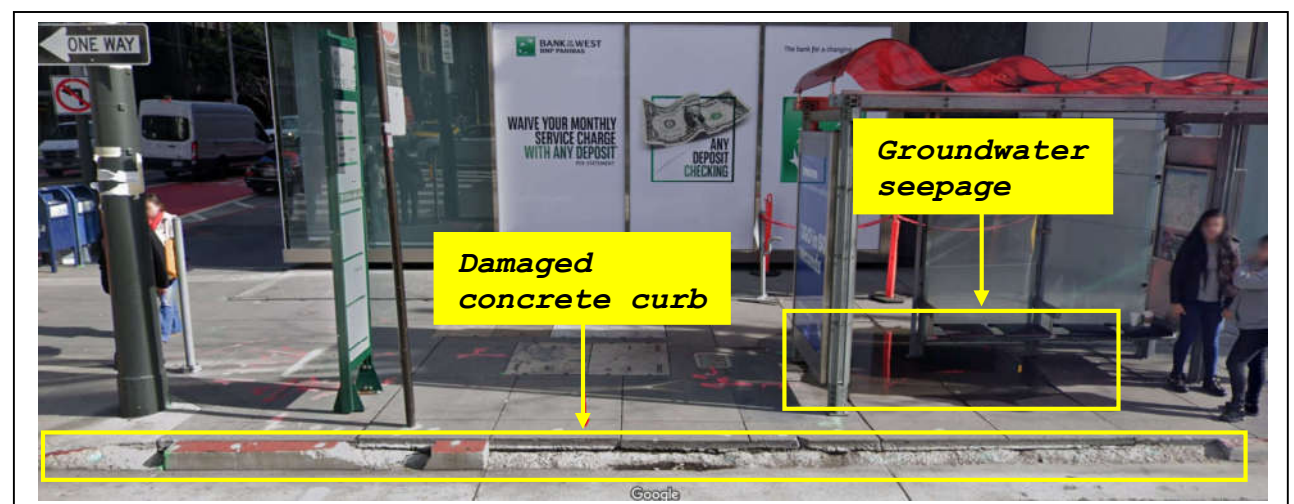
Figure 47: Annotated photograph of Fremont Street at the northern end of the block, dated February 2019; downloaded from Google Maps.

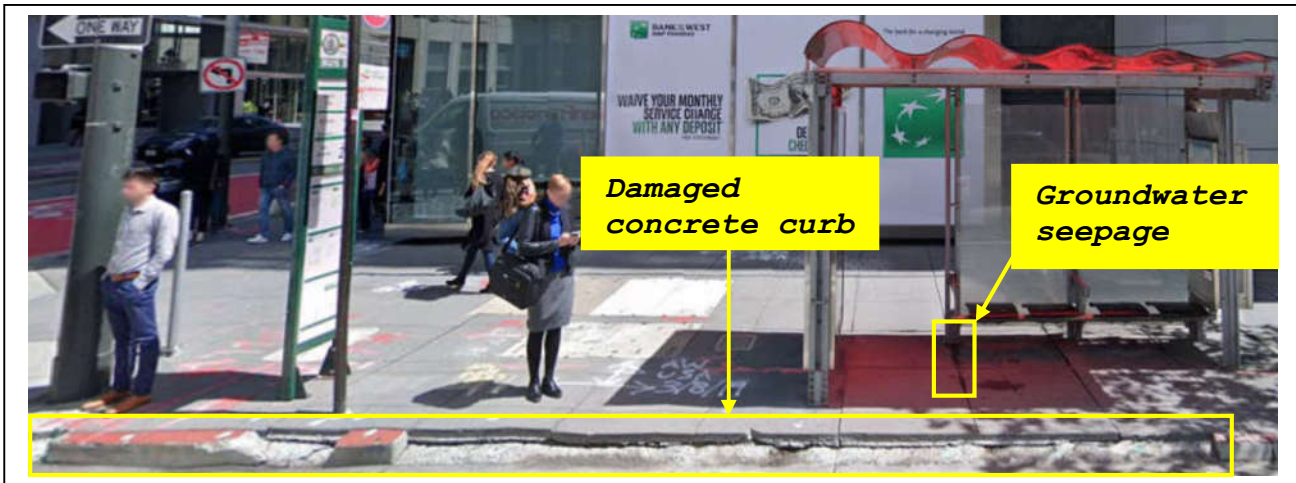
Figure 48: Annotated photograph of Fremont Street at the northern end of the block, dated April 2019; downloaded from Google Maps.

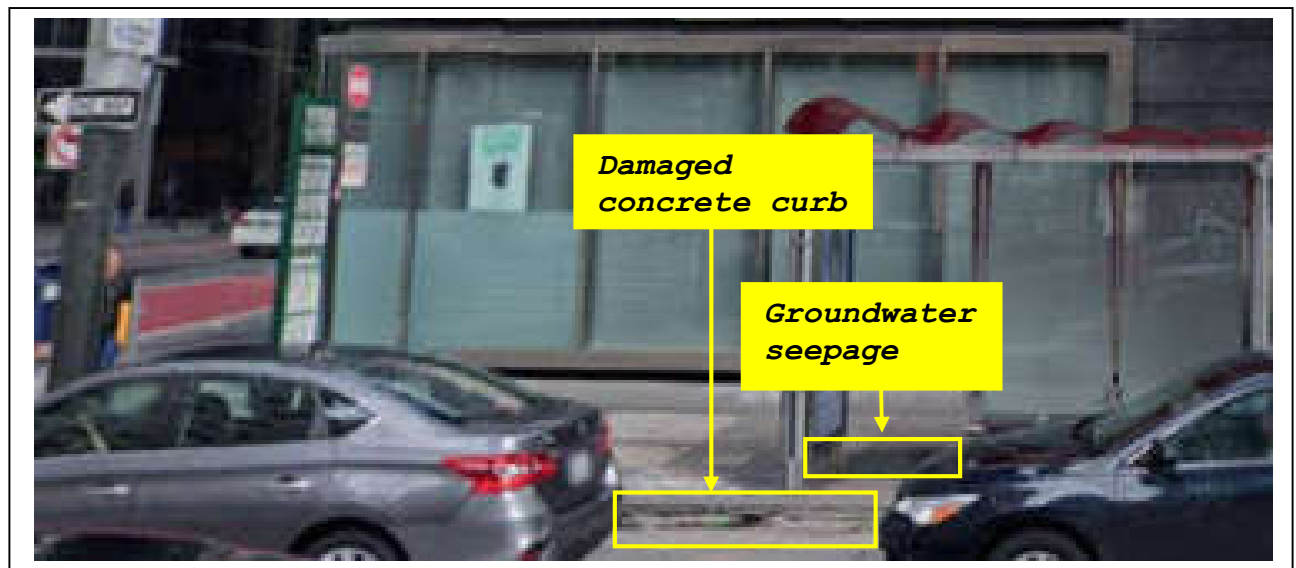
Figure 49: Annotated photograph of Fremont Street at the northern end of the block, dated January 2020; downloaded from Google Maps.

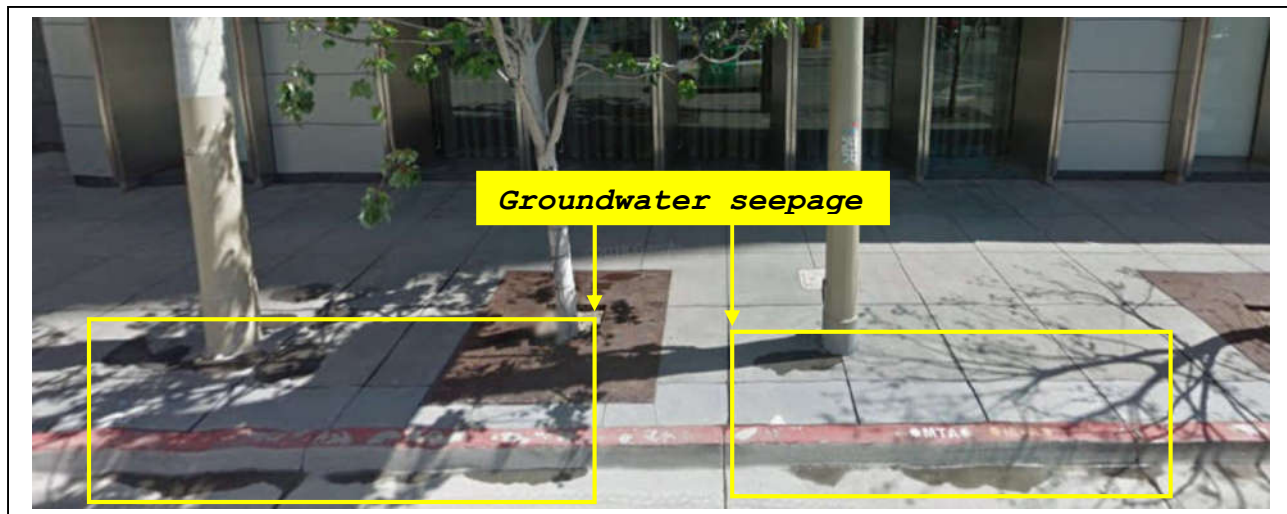
Figure 51: Annotated photograph of Fremont Street at the center of the block, dated April 2011; downloaded from Google Maps.

SEE FIGURES 51 TO 59 FOR GROUNDWATER SEEPAGE BUT LACK OF DAMAGED CONCRETE CURB.

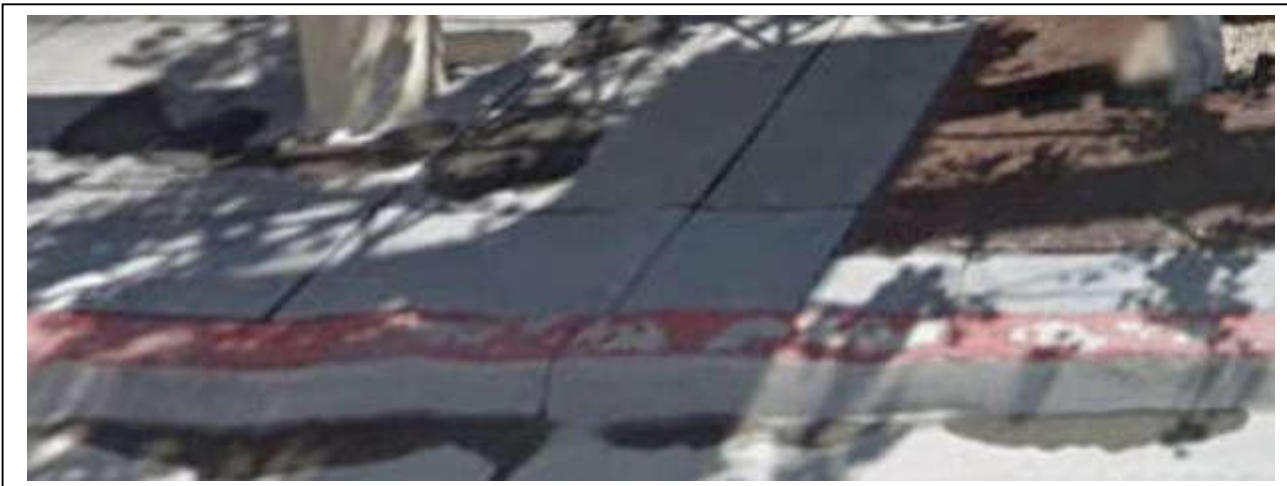
Figure 52: Close-up of the left side of Figure 51.

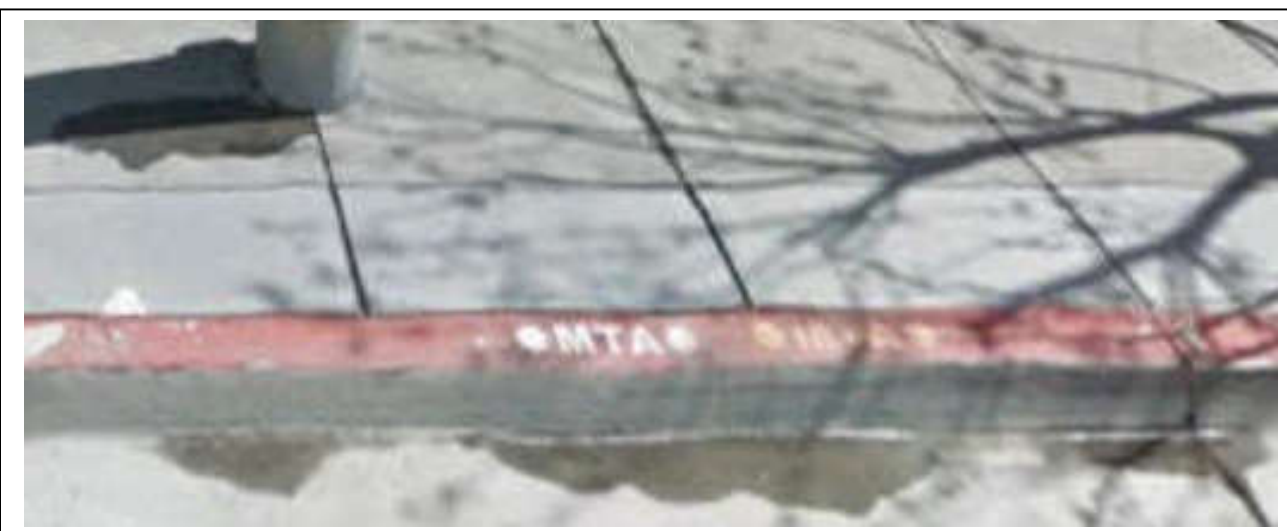
Figure 53: Close-up of the right side of Figure 51.

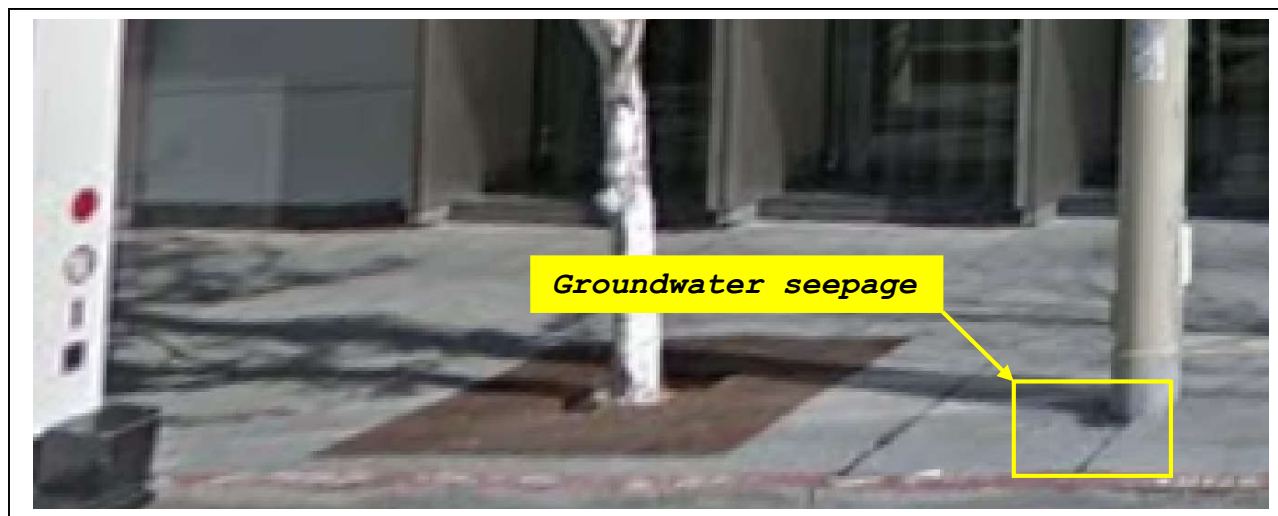
Figure 54: Annotated photograph of Fremont Street at the center of the block, dated October 2014; downloaded from Google Maps.

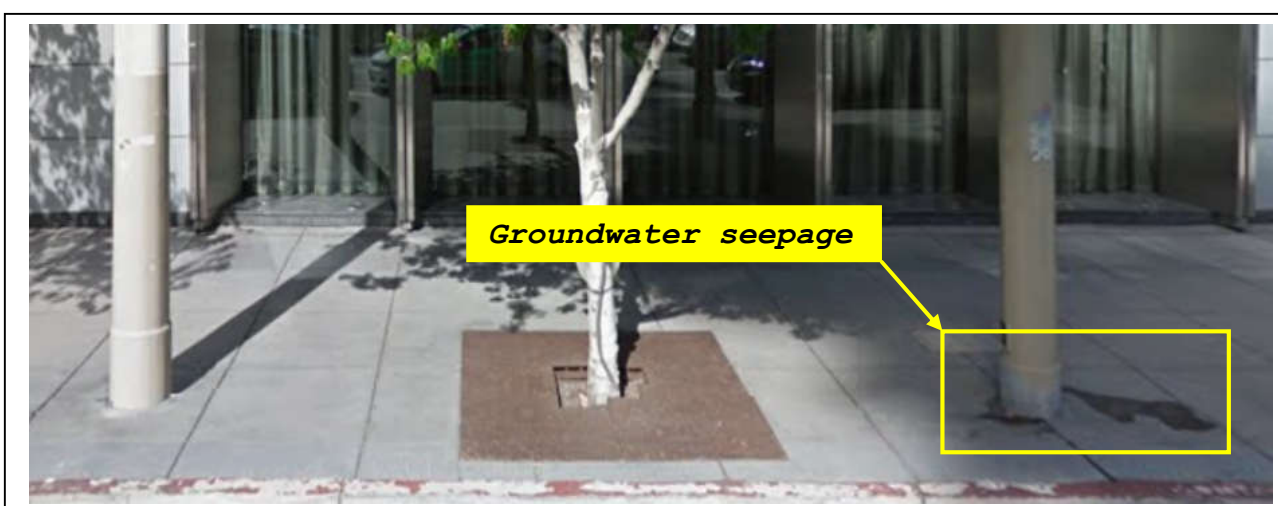
Figure 55: Annotated photograph of Fremont Street at the center of the block, dated April 2016; downloaded from Google Maps.

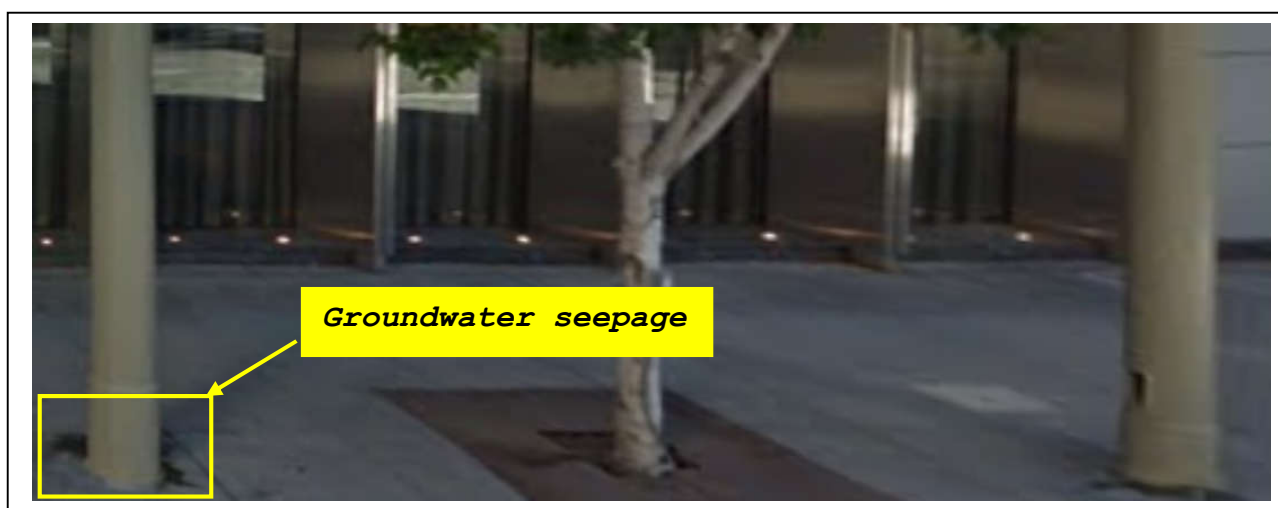
Figure 56: Annotated photograph of Fremont Street at the center of the block, dated April 2017; downloaded from Google Maps.

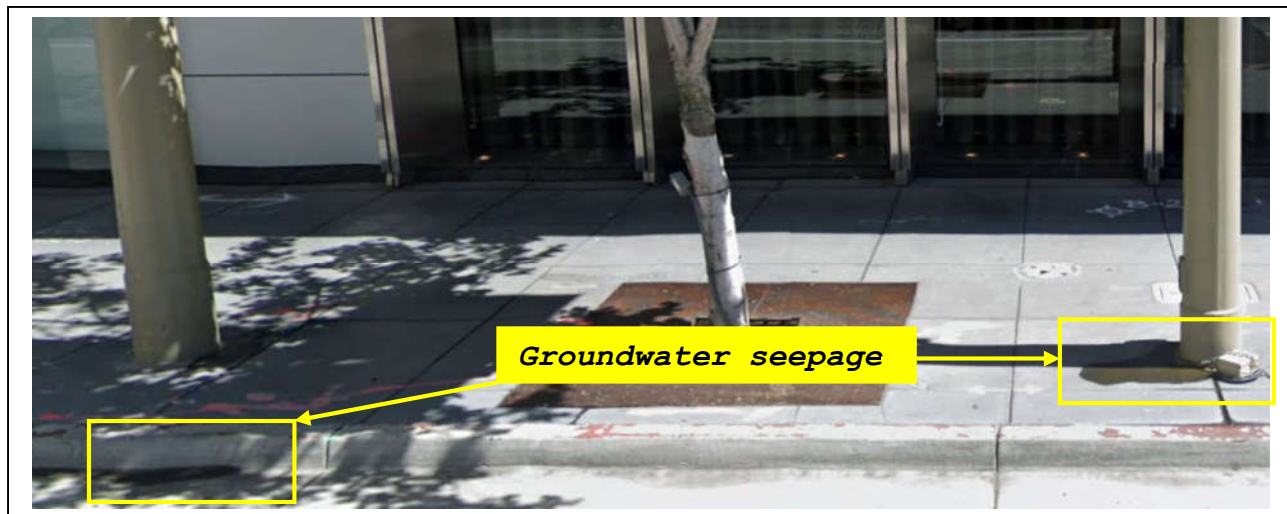
Figure 57: Annotated photograph of Fremont Street at the center of the block, dated April 2019; downloaded from Google Maps.

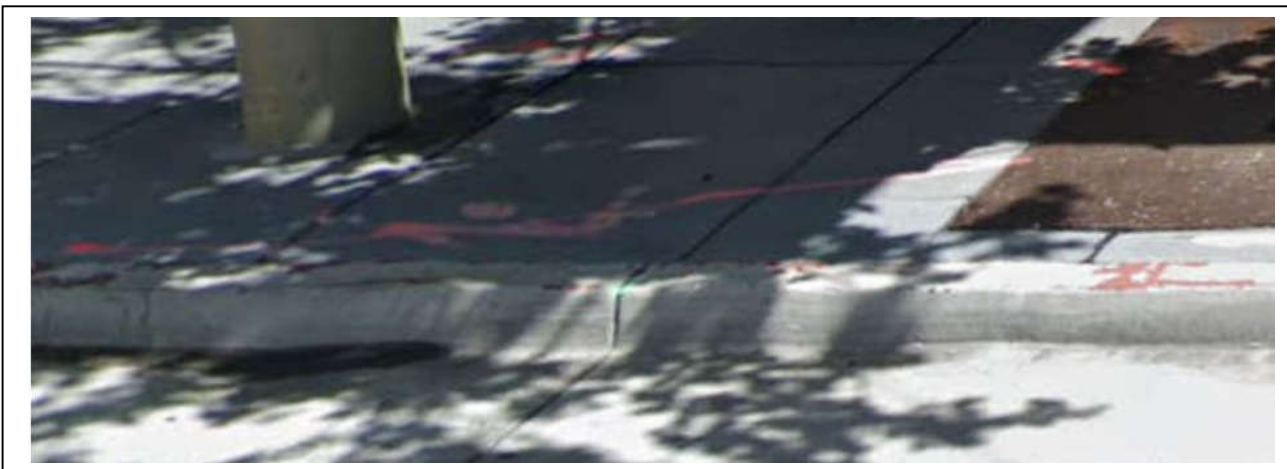
Figure 58: Close-up of the left side of Figure 57.

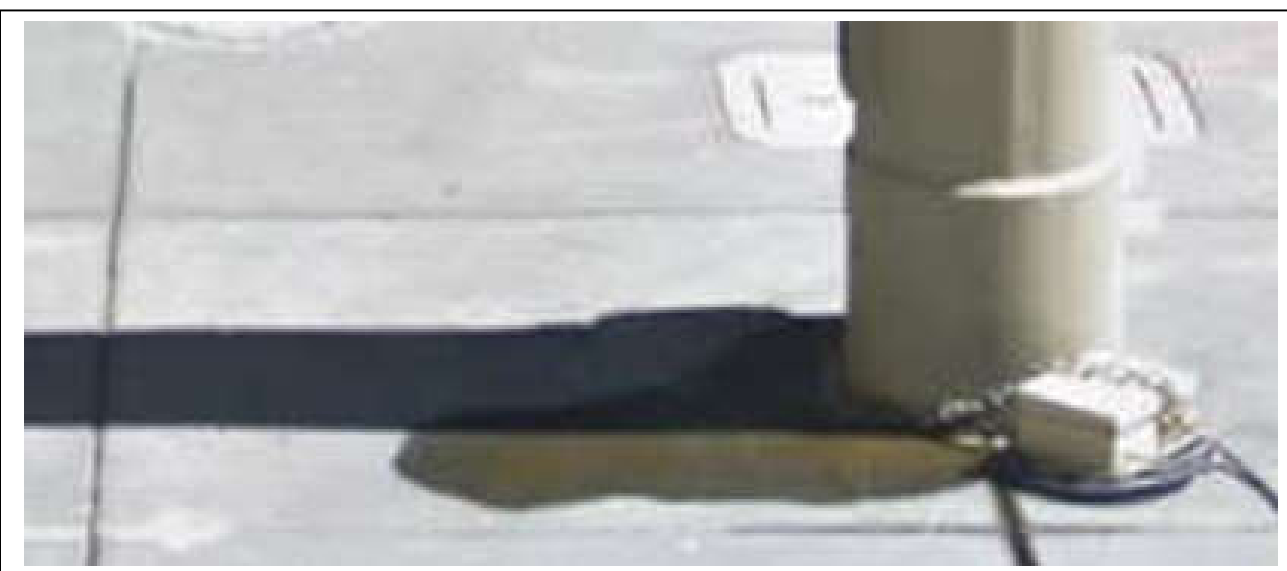
Figure 59: Close-up of the right side of Figure 57.

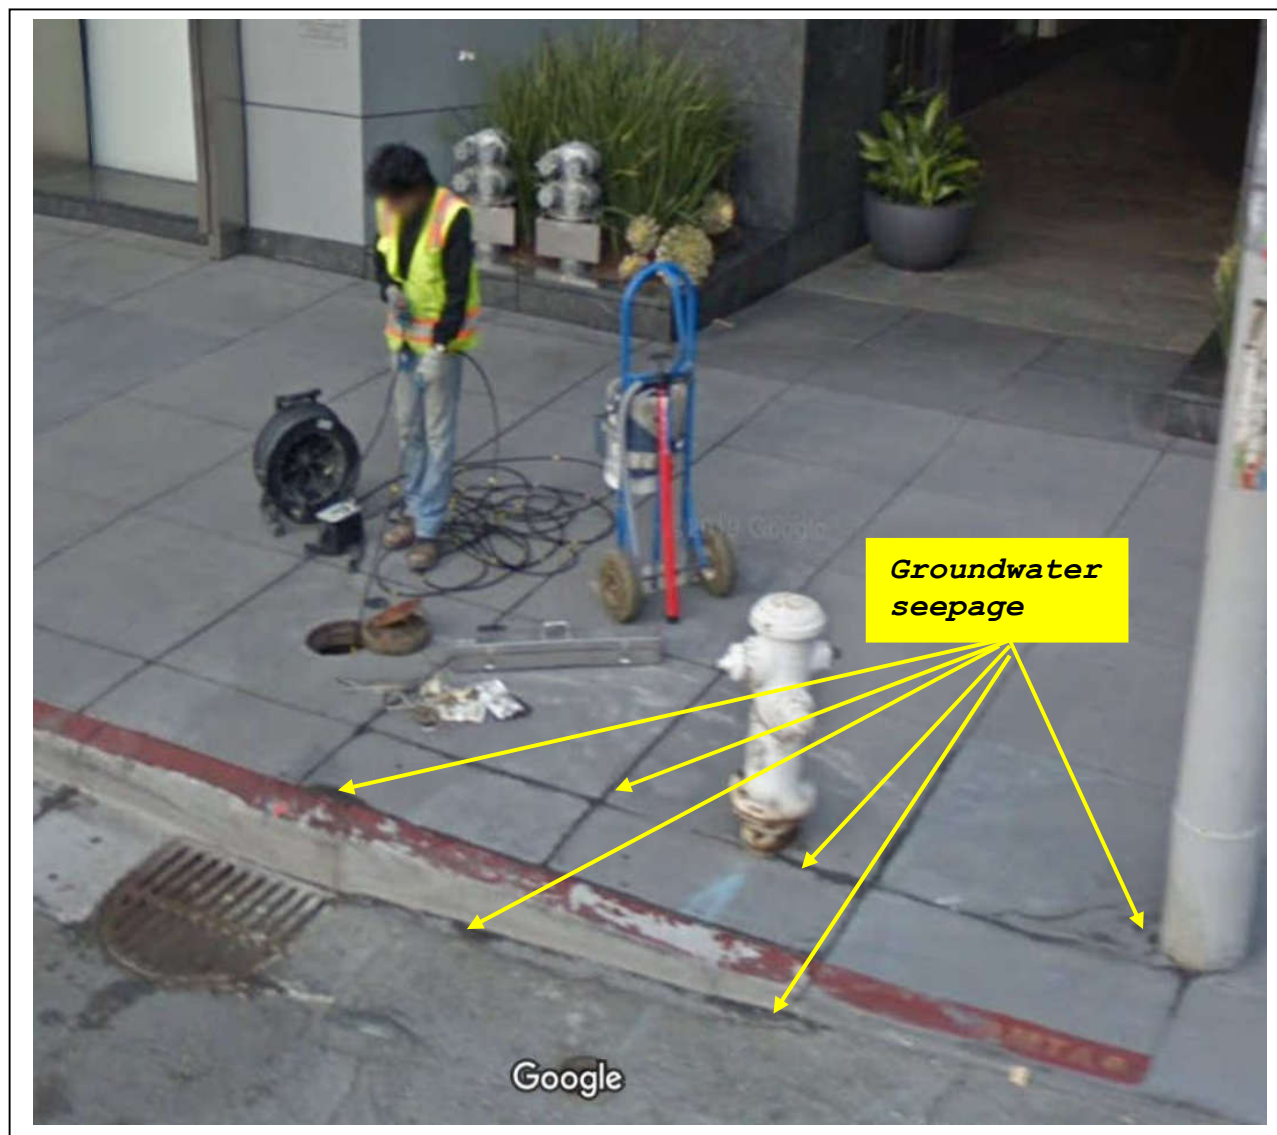
Figure 60: Annotated photograph of Fremont Street at the southern end of the block, dated February 2016; downloaded from Google Maps.

SEE FIGURES 60 TO 75 FOR GROUNDWATER SEEPAGE AND DAMAGED CONCRETE CURB.

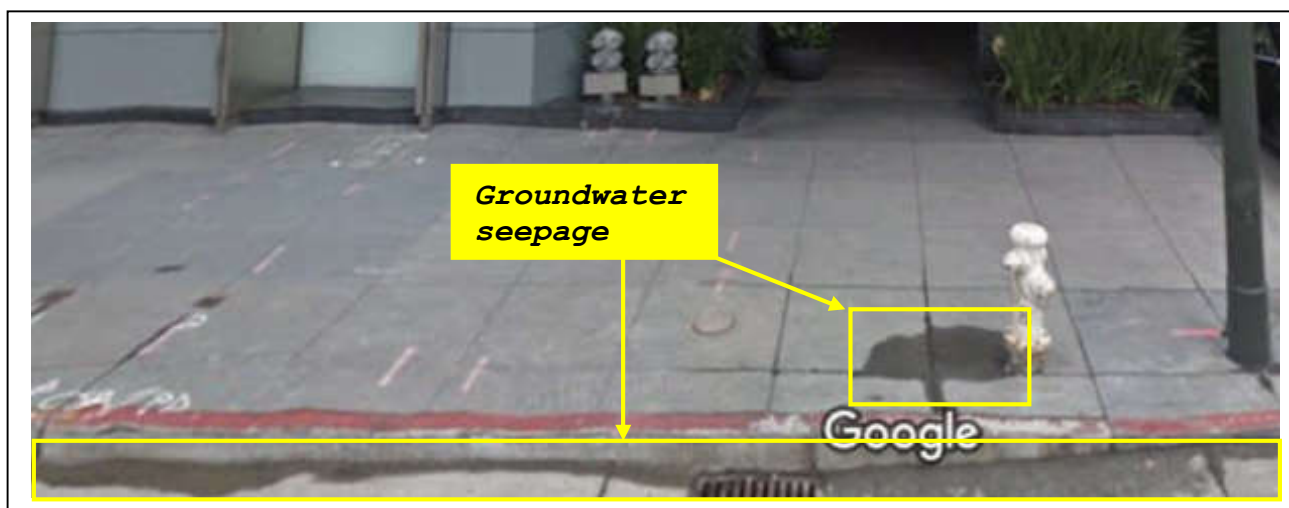
Figure 61: Annotated photograph of Fremont Street at the southern end of the block, dated October 2017; downloaded from Google Maps.

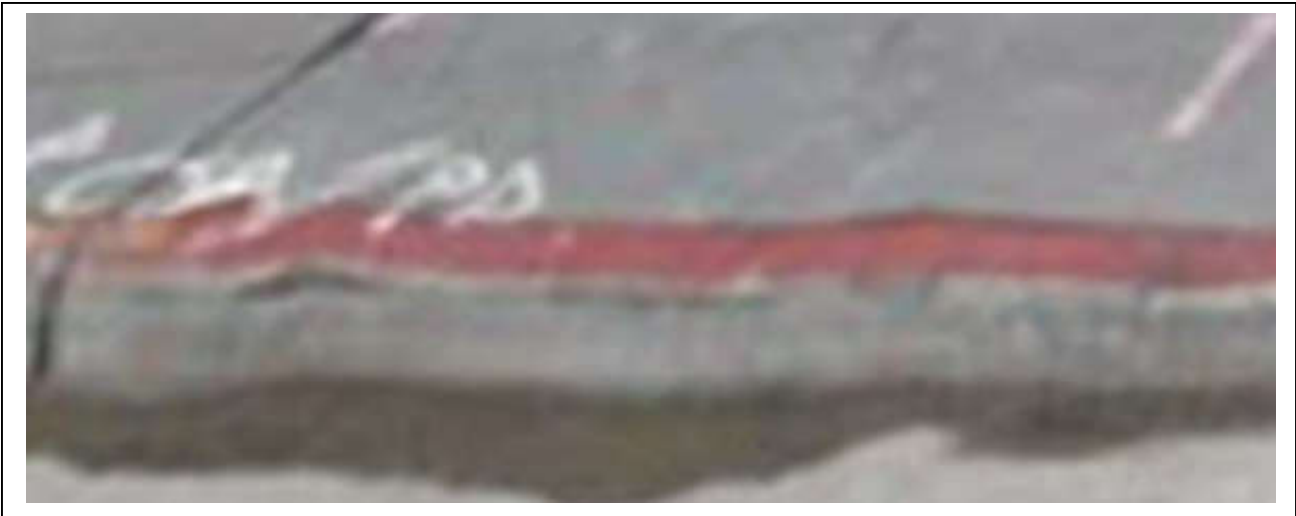
Figure 62: Close-up of the left side of Figure 61.

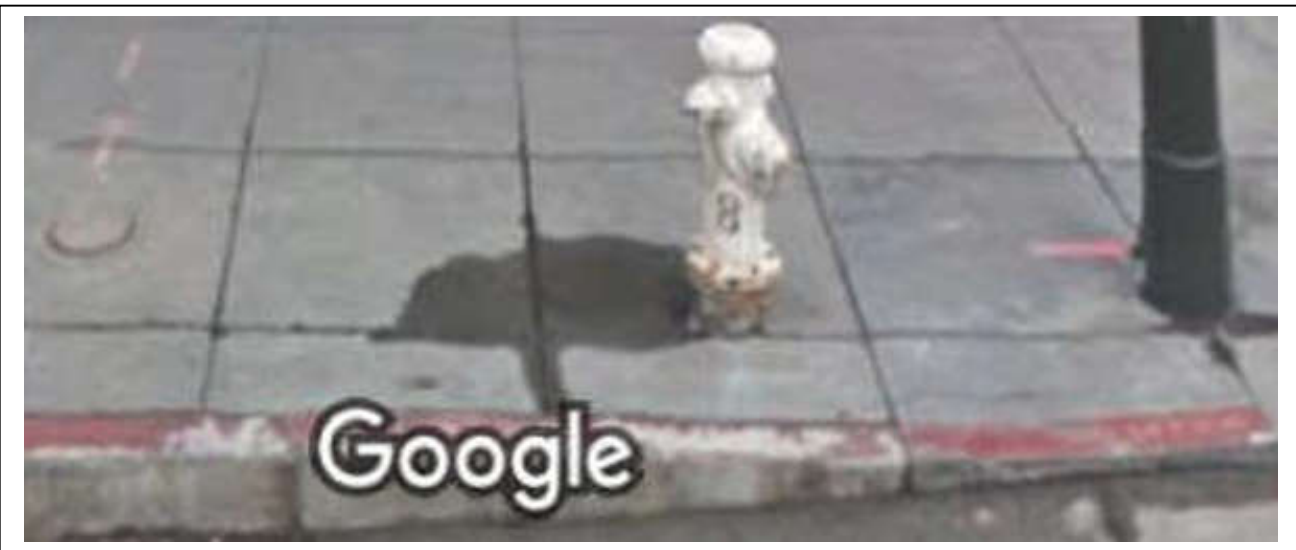
Figure 63: Close-up of the right side of Figure 61.

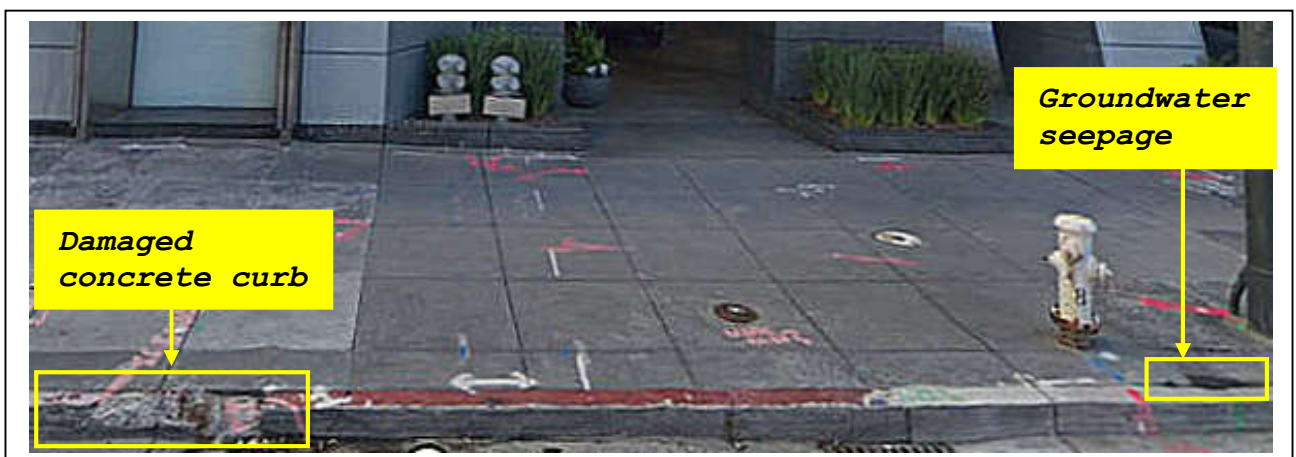
Figure 64: Annotated photograph of Fremont Street at the southern end of the block, dated December 2018; downloaded from Google Maps.

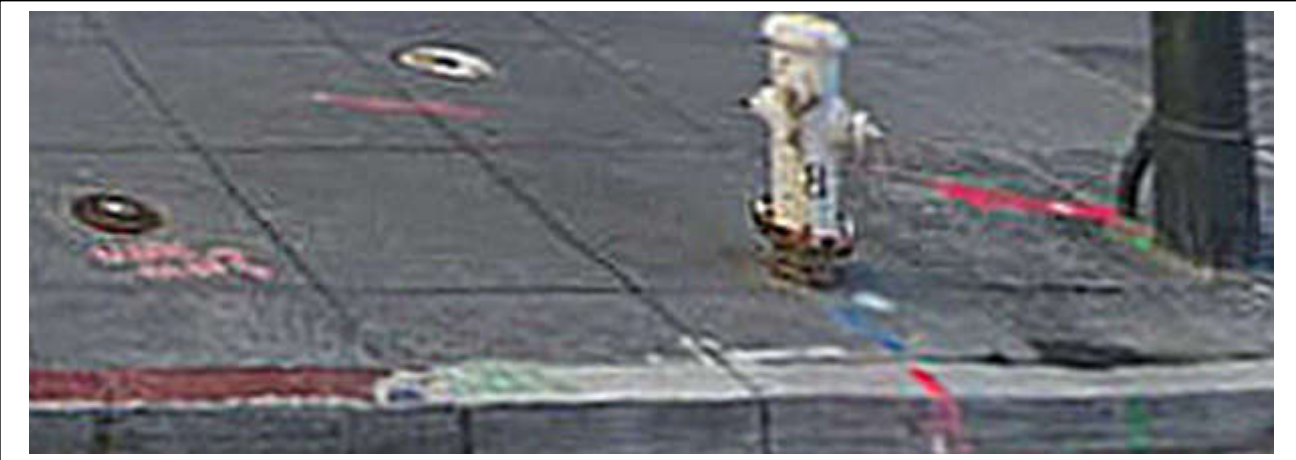
Figure 66: Close-up of the right side of Figure 64.

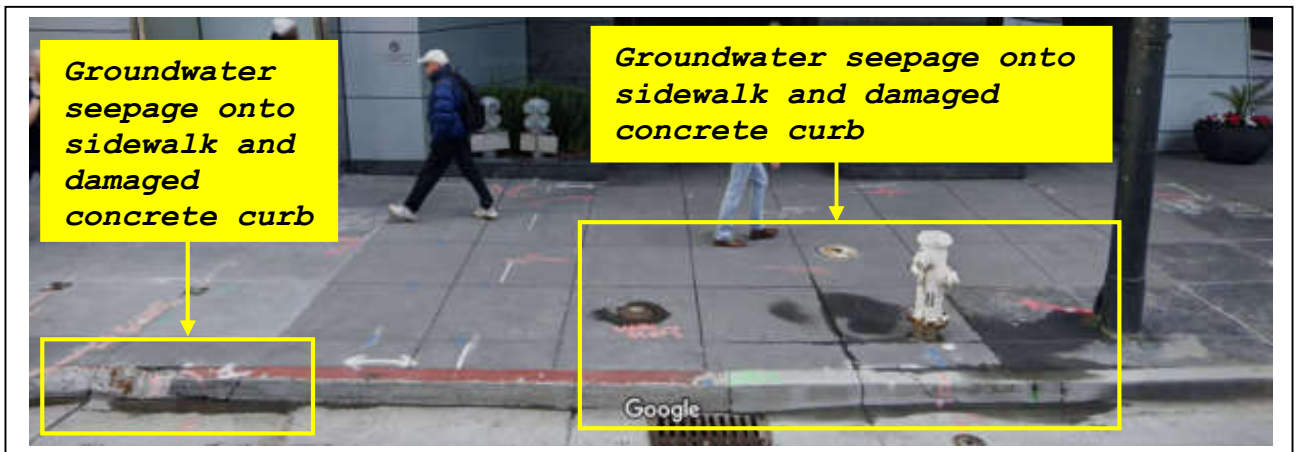
Figure 67: Annotated photograph of Fremont Street at the southern end of the block, dated February 2019; downloaded from Google Maps.

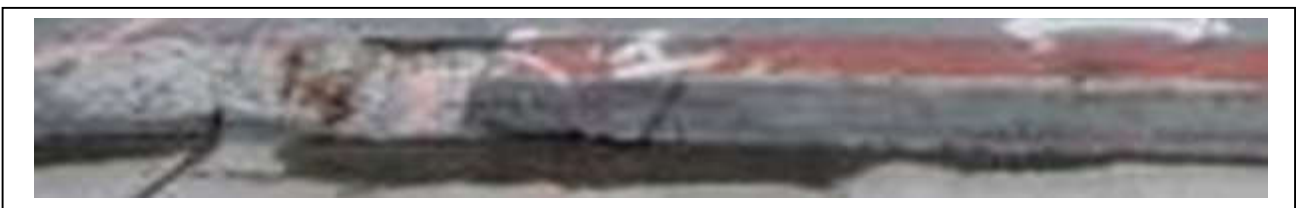
Figure 68: Close-up of the left side of Figure 67, showing the damaged concrete curb and groundwater seepage.

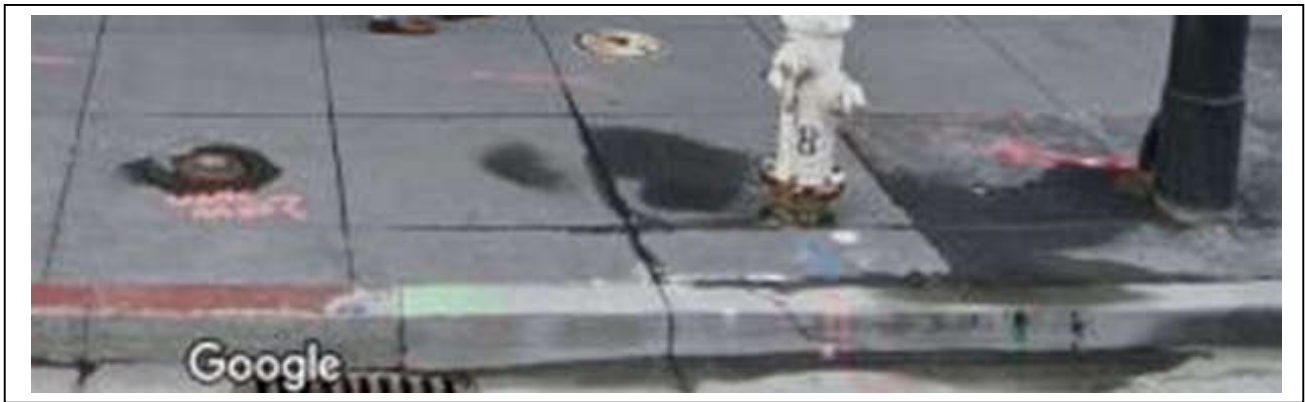
Figure 69: Close-up of the right side of Figure 67, showing the damaged concrete curb and groundwater seepage.

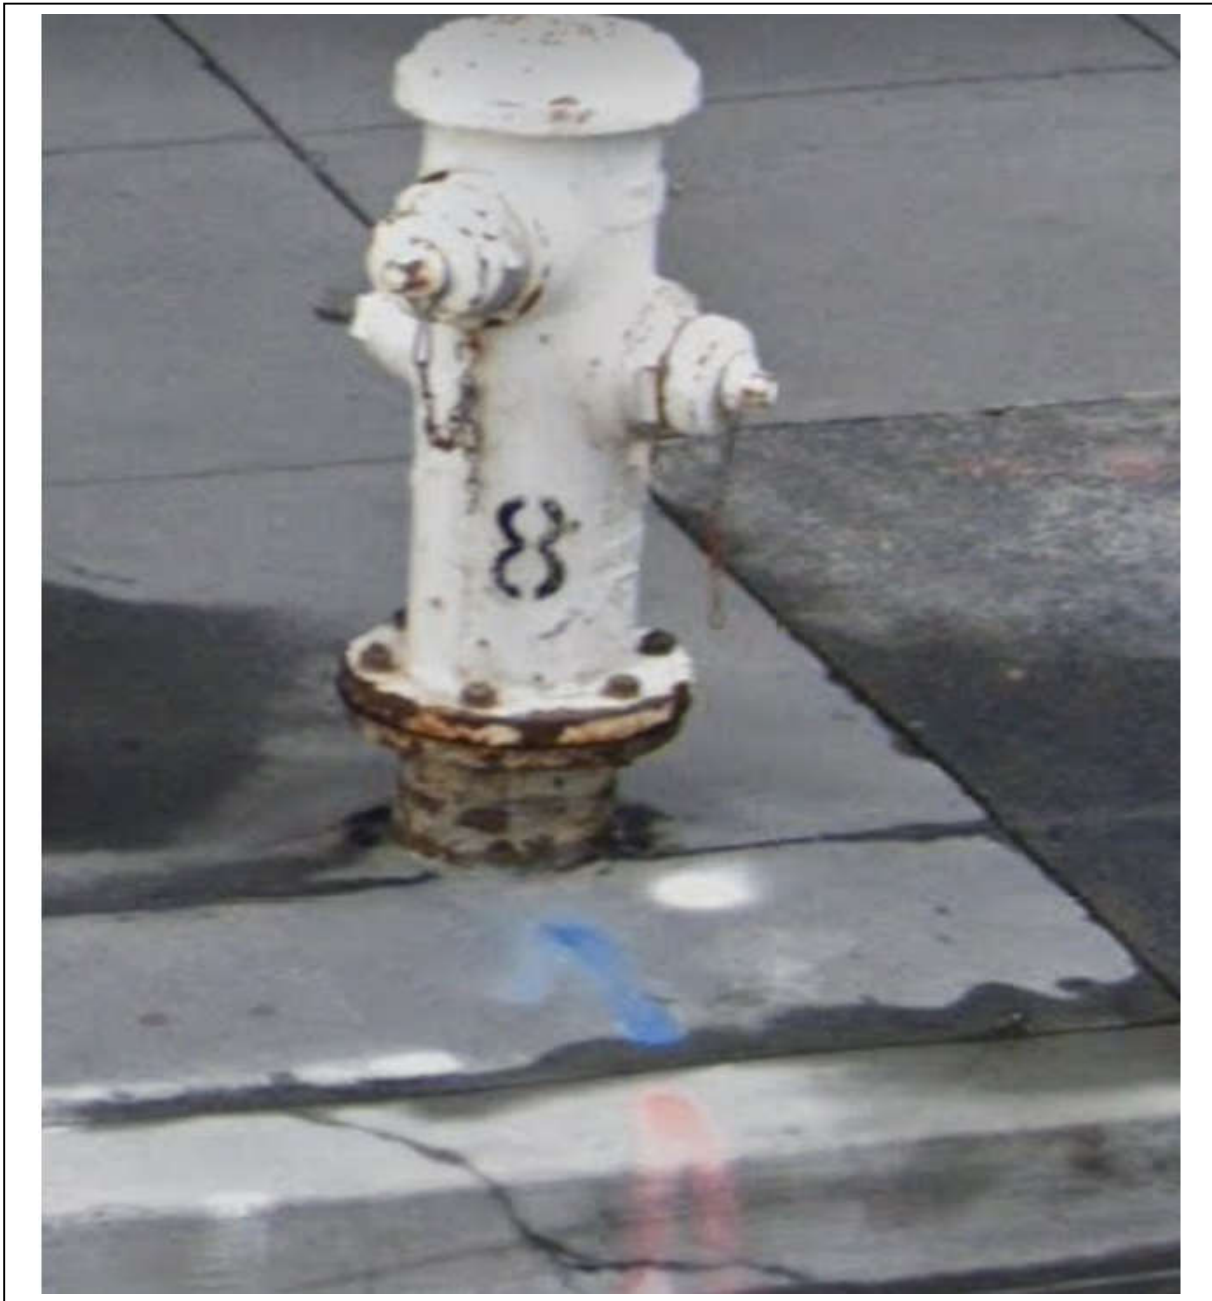
Figure 70: Close-up of Figure 69, showing the damaged concrete curb.

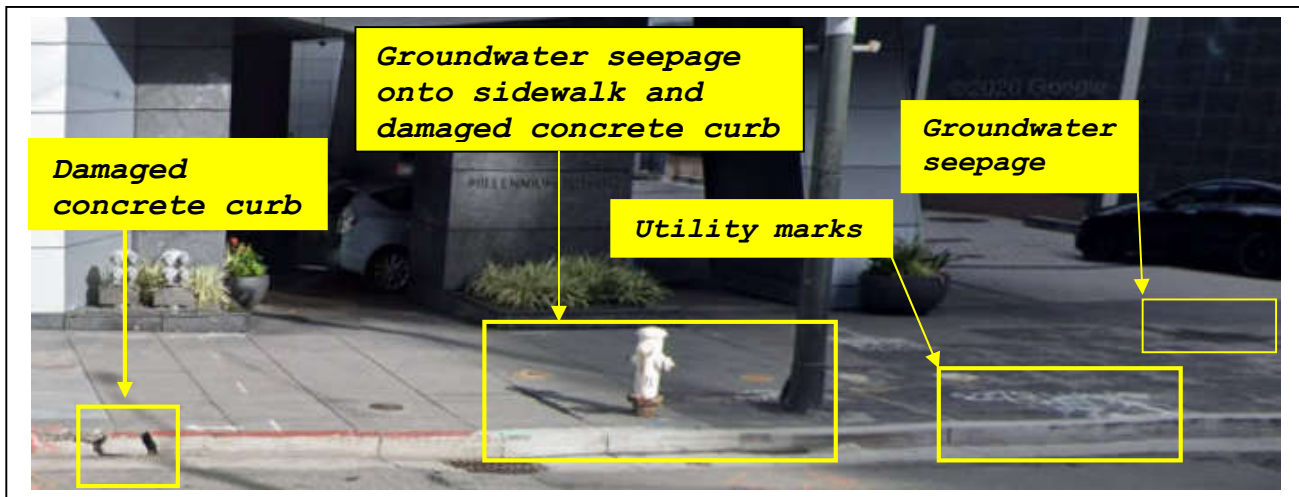
Figure 71: Annotated photograph of Fremont Street at the southern end of the block, dated January 2020; downloaded from Google Maps.

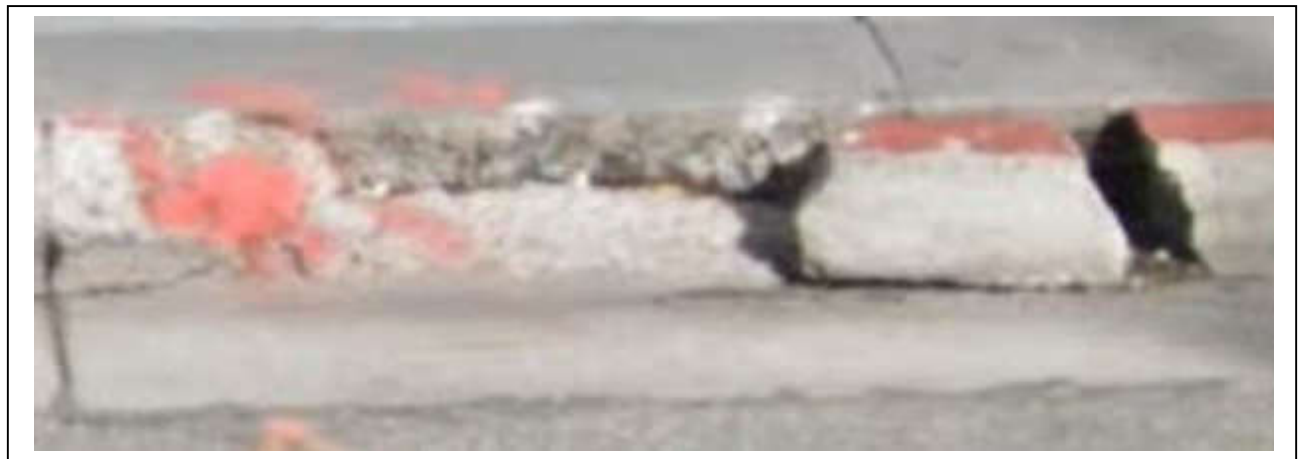
Figure 72: Close-up of the left side of Figure 71, showing the damaged concrete curb.
