301 MISSION STREET SUPPLEMENT III

2-4-2021

Introduction

This report is the 19th in a series of engineering investigative reports on the conduct of the San Francisco Department of Building Inspection (DBI).

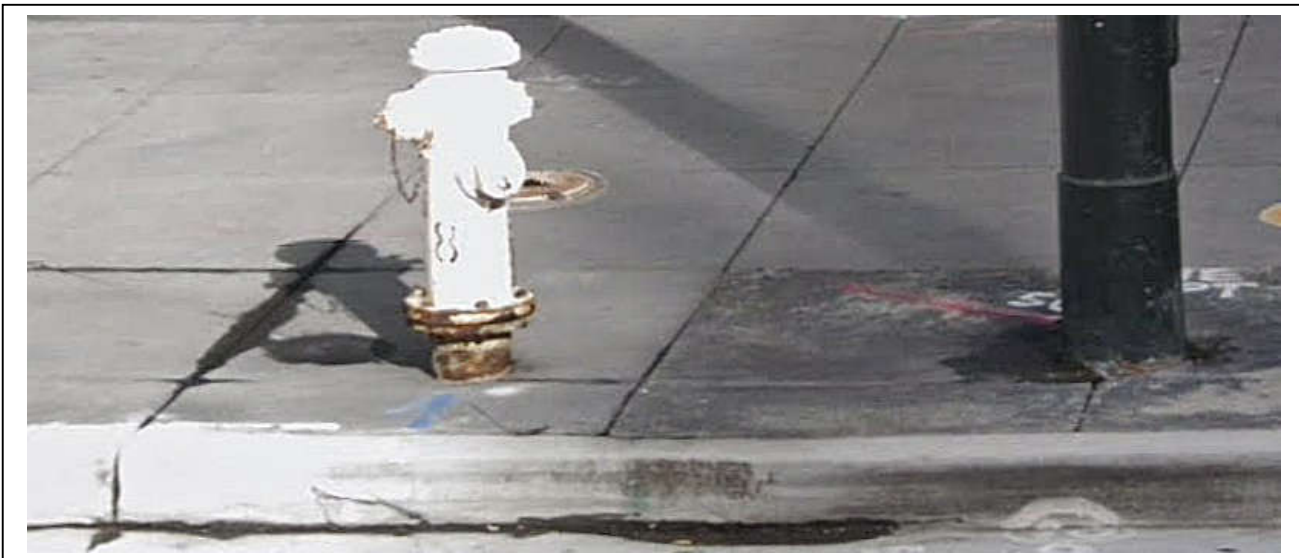
Figure 73: Close-up of the center of Figure 71, showing the damaged concrete curb and groundwater seepage.

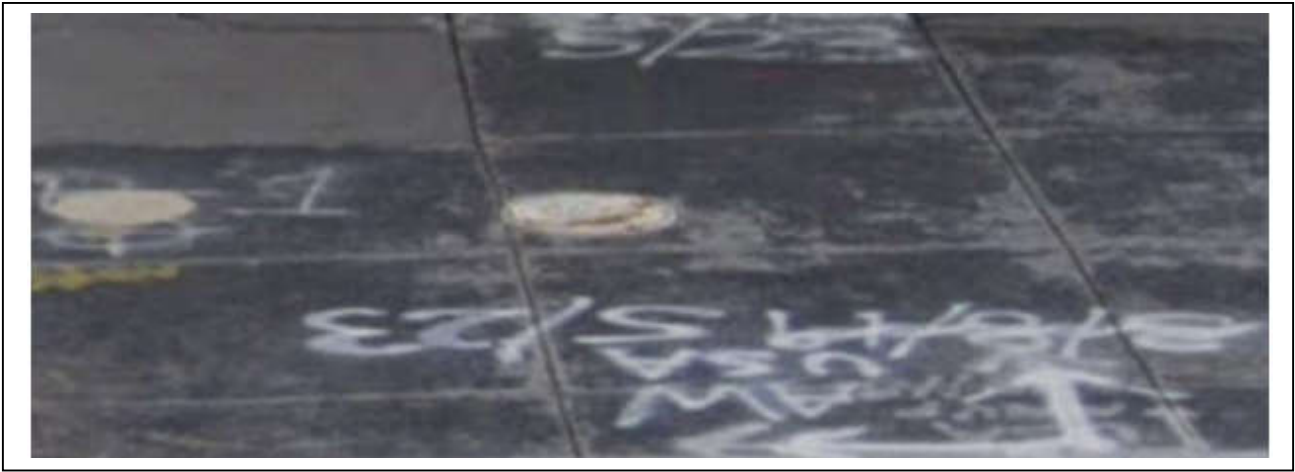
Figure 74: Close-up of the right side of Figure 71, showing revised utility marks painted on the sidewalk; the date 3/8/19 has been crossed out, and another date, 5/23, has been added.

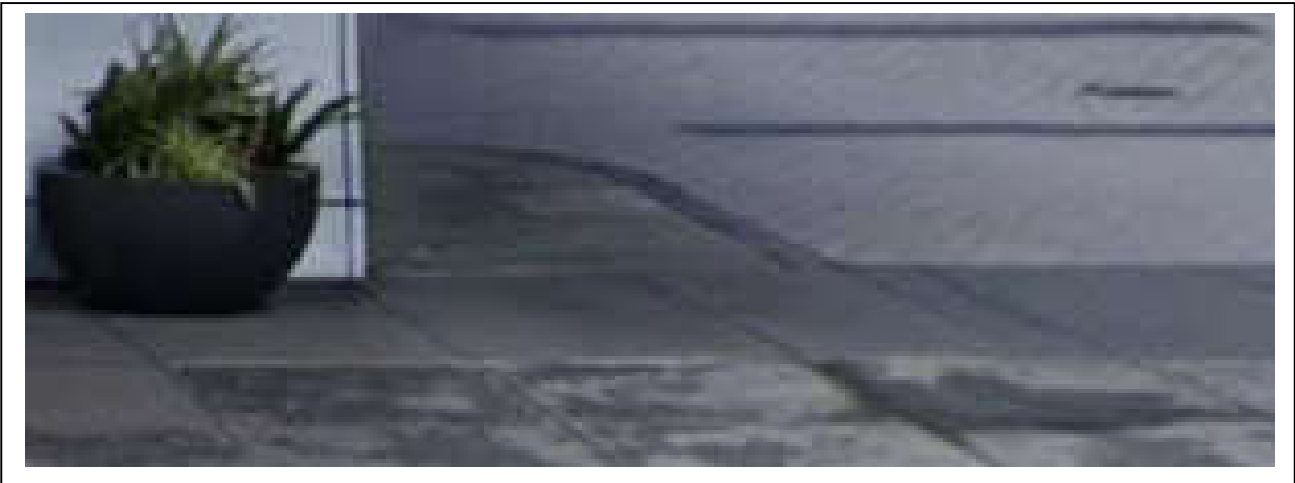
Figure 75: Close-up of groundwater seepage in Figure 71, viewed from a different angle.

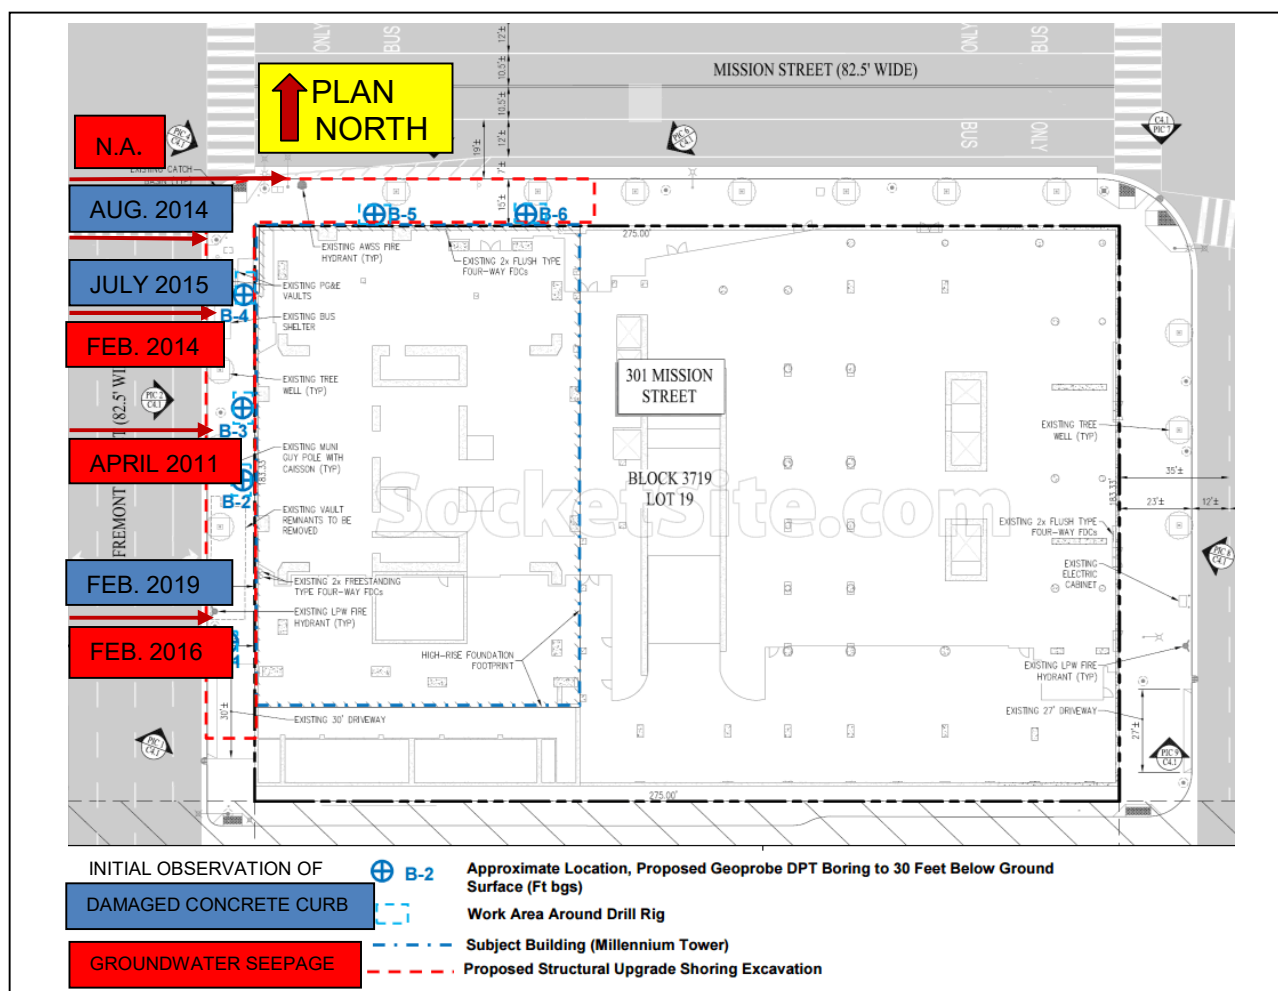
The left-hand side of Figure 76 summarizes the approximate dates and locations that groundwater seepage and damaged concrete curbs were documented by images on Google Maps.

Figure 76: Extract from the plan to fix the Millennium Tower, article dated March 12, 2019; downloaded from www.socketsite.com, with annotations by Carl C. Chan.

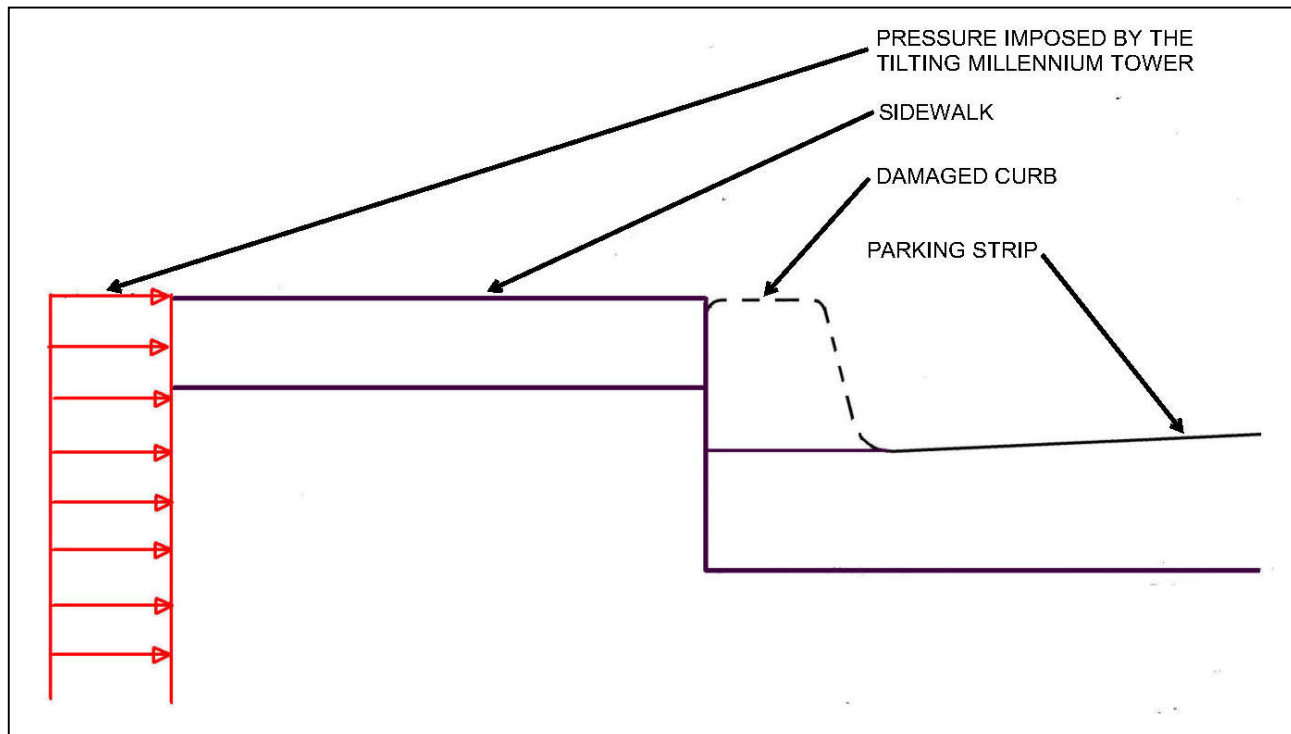
Figure 79 is a graphic representation of the pressure imposed by the tilting of the Millennium Tower's foundation wall via the concrete sidewalk, which caused damage to the concrete curb.

Figure 79: Annotated depiction of the concrete curb failure mode via pressure imposed from the tilting Millennium Tower.

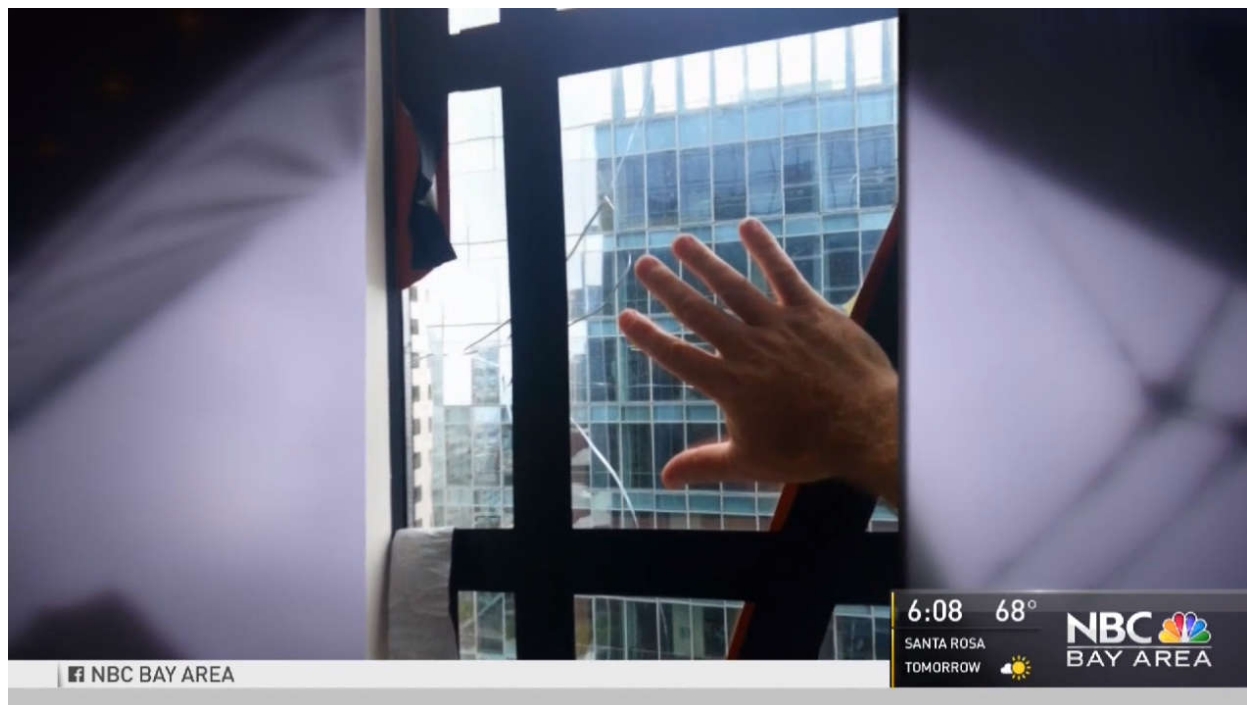
Figure 82: Page 1 of 2-page news article dated September 4, 2018, on the cracking of a window at the northwest corner of the Millennium Tower; downloaded from www.nbcbayarea.com.

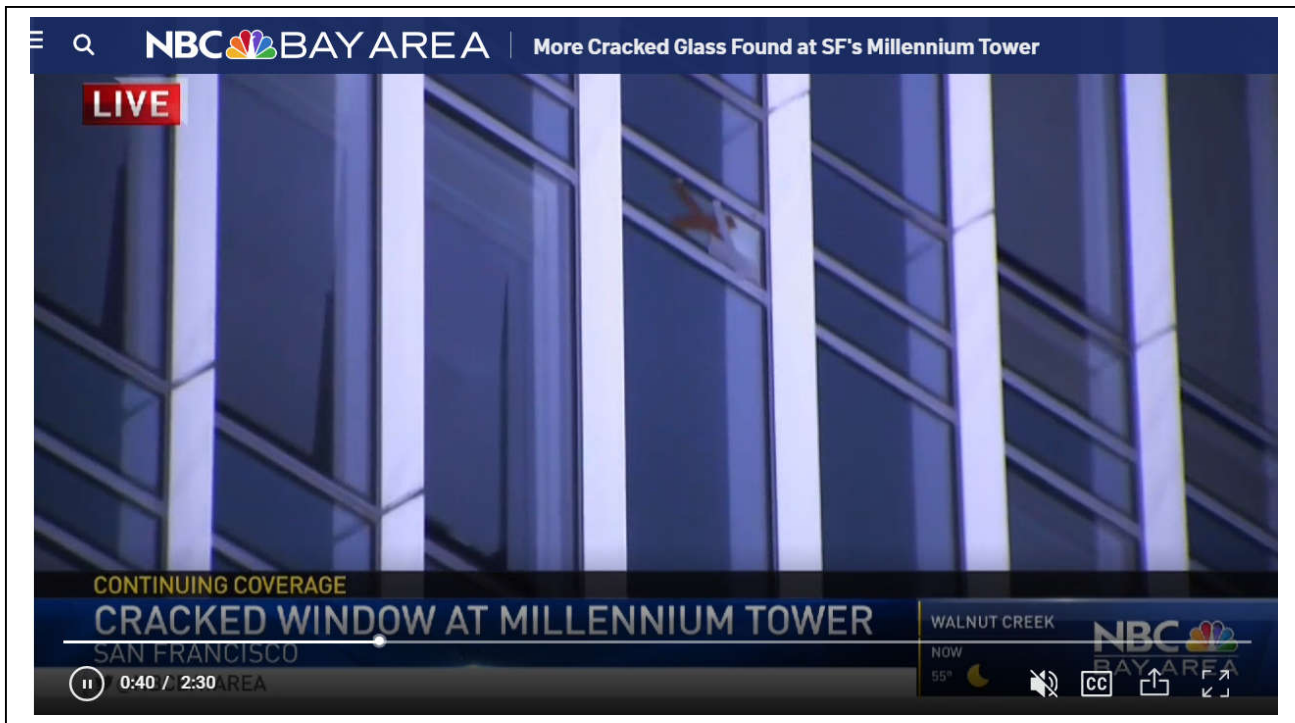
Figure 86: Page 2 of 2-page news article dated October 23, 2018, on the cracking of a window on the Fremont Street side of the Millennium Tower; downloaded from www.nbcbayarea.com.

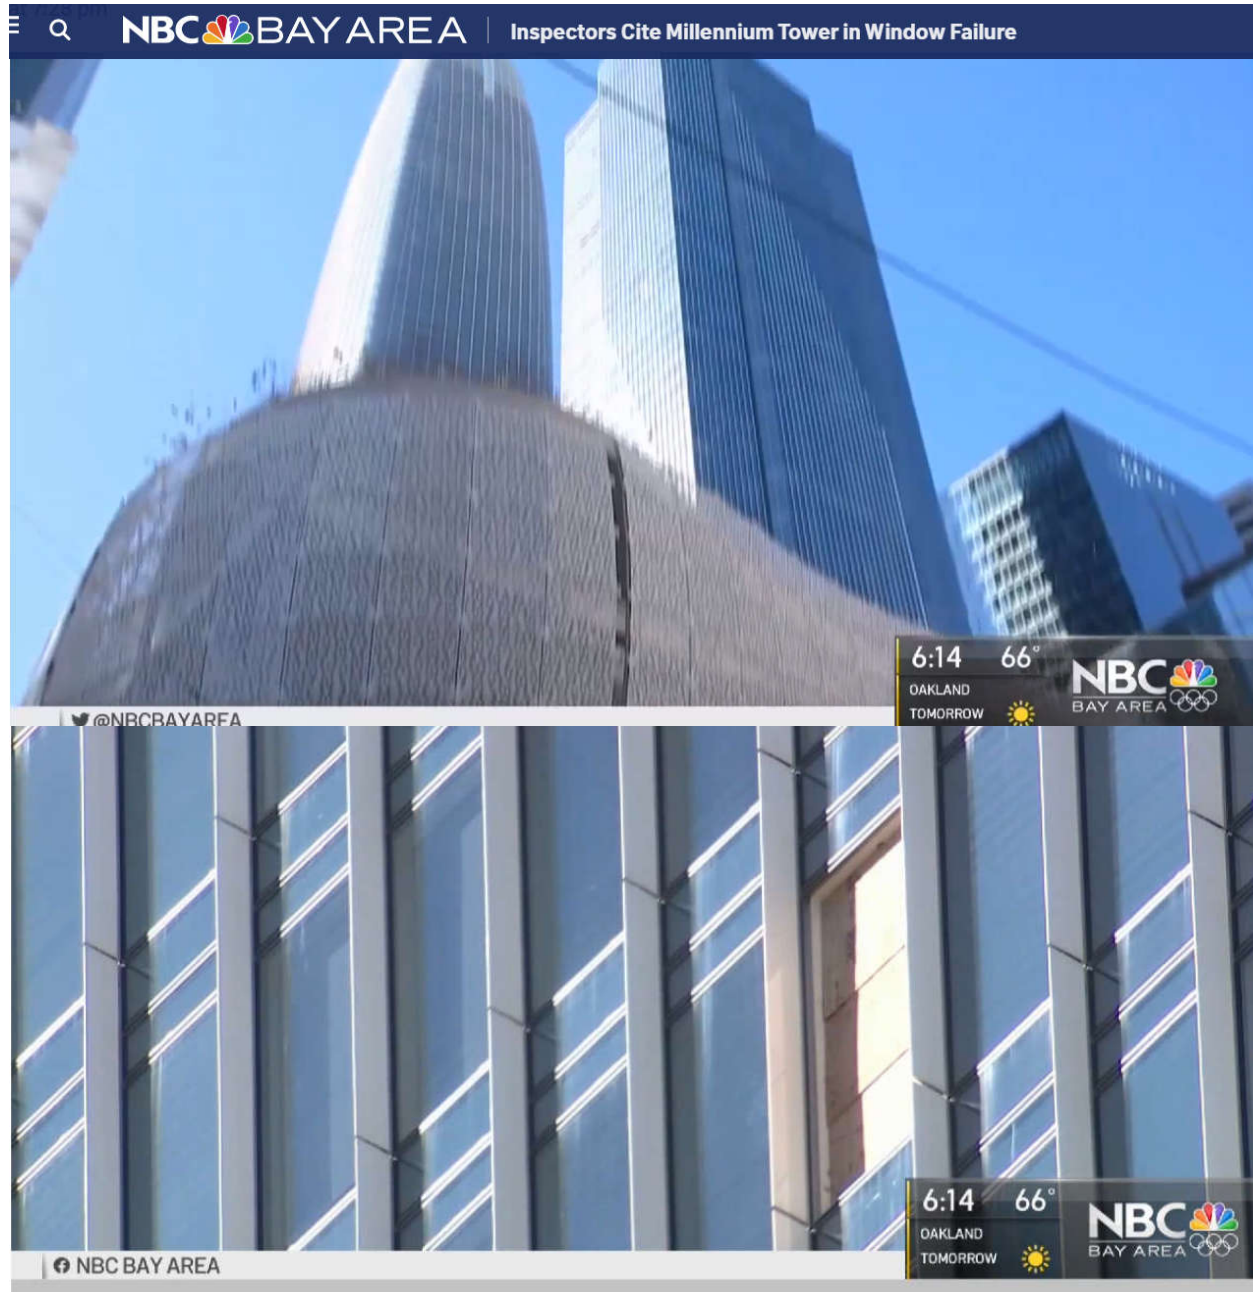
Figure 88: Page 1 of 3-page news article dated February 10, 2020, on window failure and cracking at the Millennium Tower on the side facing the Transbay Transit Center; downloaded from www.nbcbayarea.com.

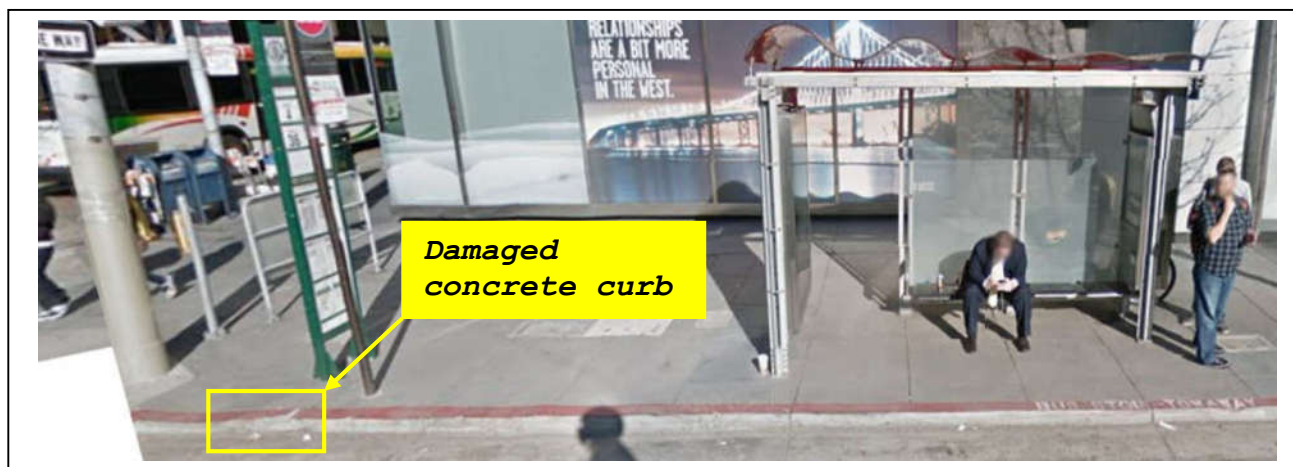
Figure 100: Annotated photograph of Fremont Street at the northern end of the block, dated January 2015; downloaded from Google Maps.
