AIRCRAFT CRASH CAUSED BY STRESS CORROSION CRACKING

H. J. Kolkman, G. A. Kool, and R. J. H. Wanhill

Department of Materials
National Aerospace Laboratory, NLR
Emmeloord, The Netherlands

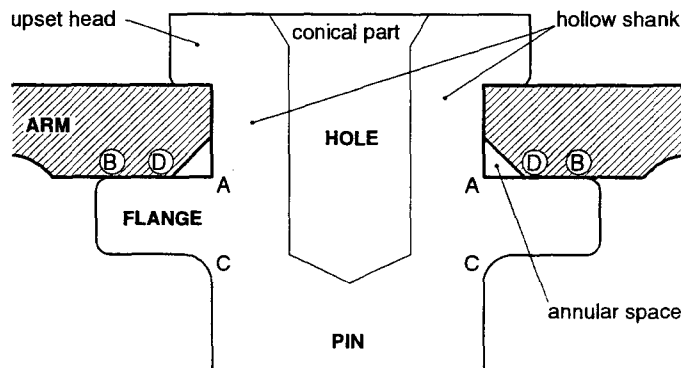
The third, fourth and fifth compressor stator stages of the engine under consideration contain variable stator vanes. The variable vanes are connected to the actuator rings by means of levers. Each lever is an assembly of an arm and a pin, see Fig. 1. The pins fit into the holes of an actuator ring. One of the fifth stage levers exhibited a broken pin. The fracture face was along AA in figure 1. A fractographic investigation was performed in order to determine whether the pin failure was a consequence or the cause of the crash.

Fig. 1 Schematic cross-section of the vane arm assembly

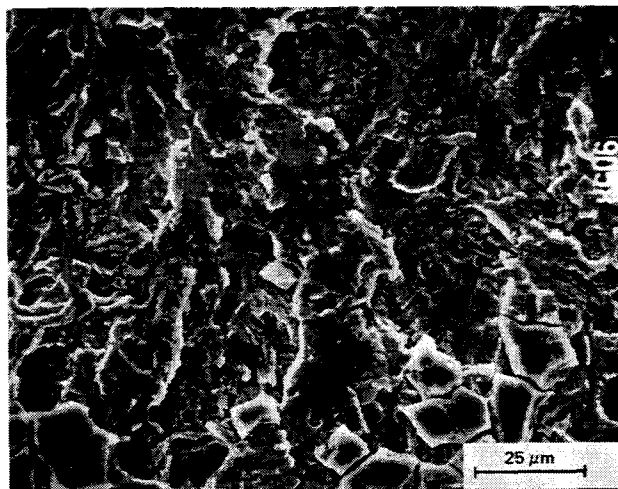
Fig. 2 Example of corrosion products on top of transcrystalline stress corrosion cracking (SCC) of the pin

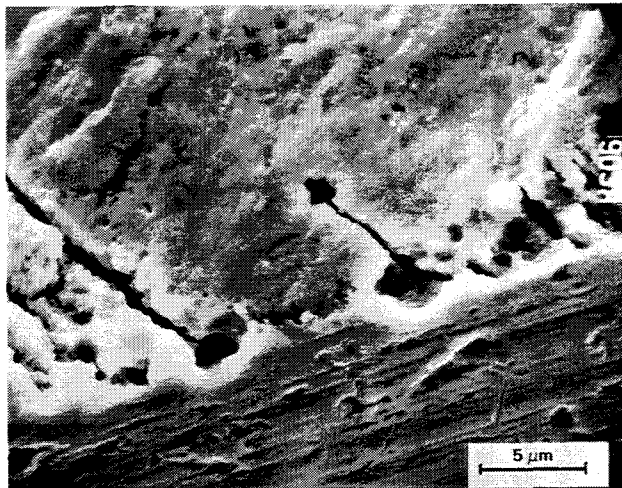
Macroscopic study of the fracture face revealed that little deformation had taken place, and the fracture face was very flat. In other words, it was highly unlikely that the fracture was created by overload during the crash. The fracture face of the pin was studied in more detail by means of SEM (Scanning Electron Microscopy). It was found that almost the entire fracture face showed the characteristics of transcrystalline SCC (Stress Corrosion Cracking); see Fig. 2. Characteristic corrosion pits, tunnels and slots [1, 2] were found near both the pin inner and outer perimeters; see Fig. 3.

Fig. 3 Example of corrosion pits and slots.
The lower part of the fractograph shows the inner perimeter and part of the surface of the central hole in the pin

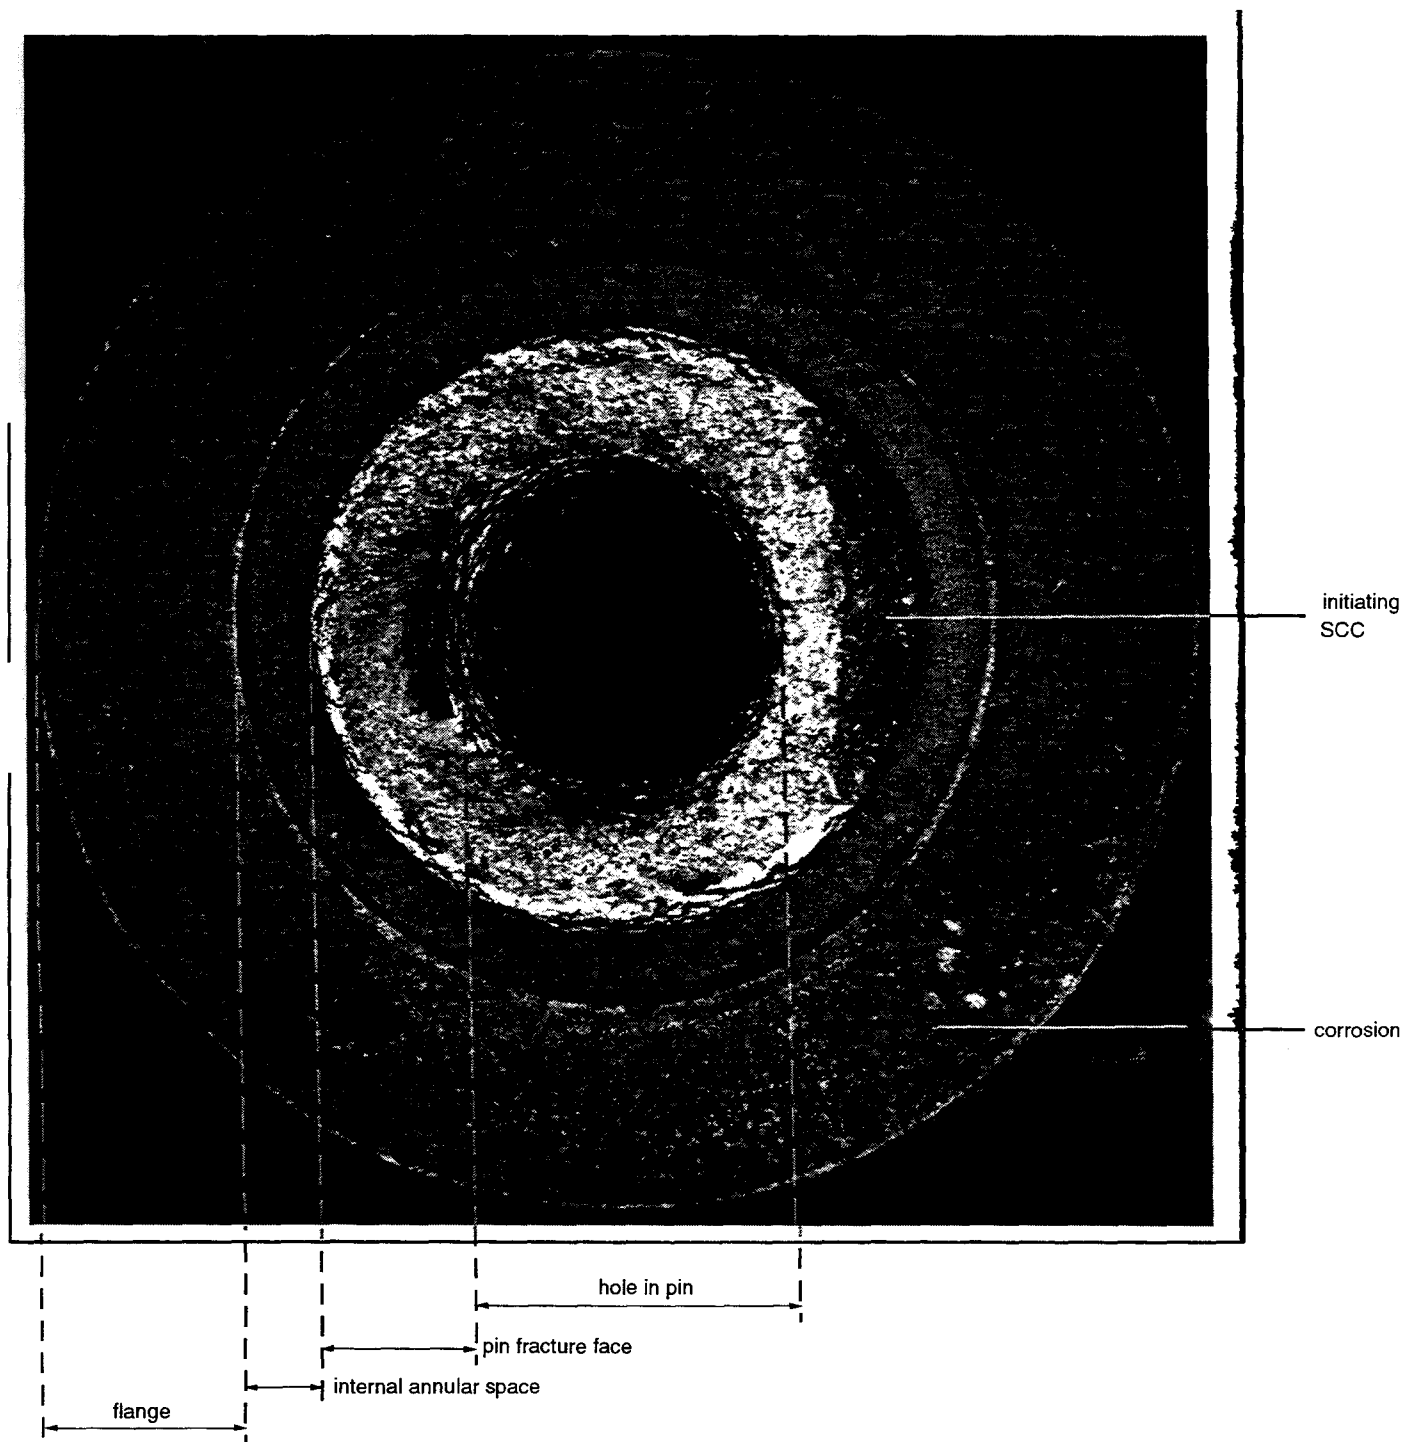
- Failure of the hollow shank (88 pins)
This fracture type occurred when an stress corrosion crack of some length was already present in the plane AA in Fig. 1. Figure 4 illustrates the resulting fracture face. The dull pre-existing SCC can be clearly distinguished from the shinier grey overload area caused by the tensile test. The amount of SCC could be quantified by determining the percentage of SCC in the fracture face by means of an image analyzer or from the decreased fracture load, or by measuring the maximum stress corrosion crack length (as percentage of the wall thickness).

- Fig. 4 illustrates the observation that SCC always initiated in the annular internal space.

Fig. 4 Result of tensile test. The plane of the photograph is along AA in figure 1; the viewing direction is downwards

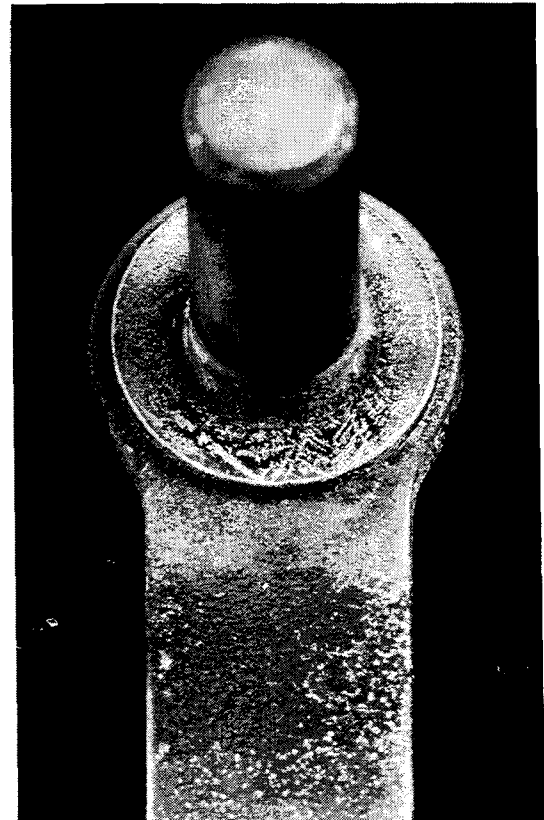
- On a number of lever arms salt deposits were present, e.g. see Fig. 5.

EDX (Energy Dispersive analysis of X-rays) in the SEM revealed that these deposits consisted of the harmless CaSO_4 and the corrosive NaCl . Because of aerodynamic reasons (stagnation of the by-pass air near obstacles) this salt had not been deposited on all lever arms. There was a close relationship between the presence of these deposits and the

Fig. 5 Extreme example of salt on vane arm

From the forementioned observations the following scenario follows. During flight the salt in the by-pass air deposited on a number of lever arms (Fig. 5). During shutdown periods with high relative humidity the deposits absorbed moisture from the air so that a concentrated salt solution was obtained. This salt solution was able to penetrate any opening between the vane arm and the flange of the pin (along BD in Fig. 1). Hence the observed flange corrosion (Fig. 6) can be explained by crevice corrosion of the relatively less noble pin material. Finally the salt solution reached the unsealed annular internal space (see Fig. 1) and supplied the aggressive environment for SCC of pin material in the highly stressed area near A.

The main cause of the crash was that the engine manufacturer selected an SCC-prone material (Nitronic 60) for the pins of the levers of the compressor variable vanes in the design stage. The solution has been to change the pin material. The first levers with the new pin material were delivered less than five months after the accident. The frequent inspections on the levers with the old pins were continued until all these levers had been replaced.

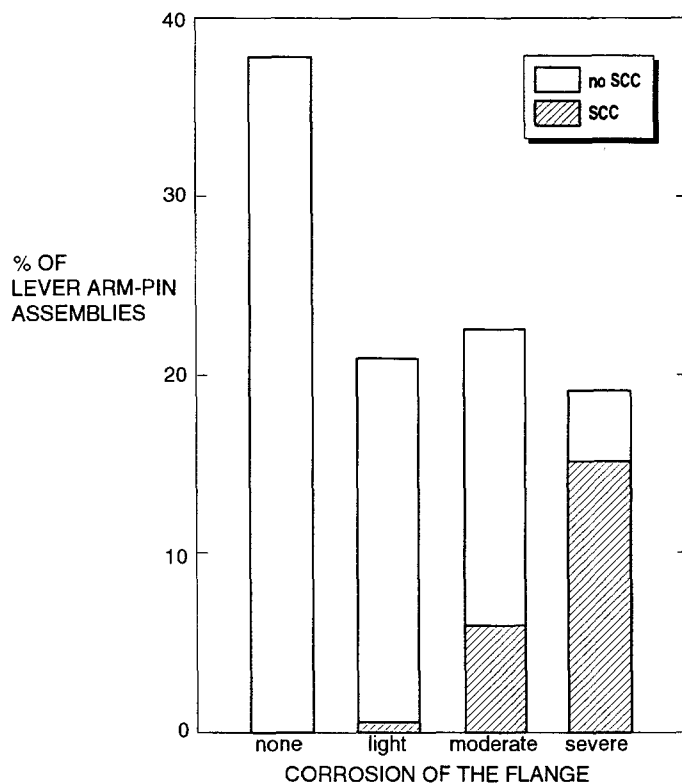
- For a number of levers the sides of the flanges facing the arms (BD in Fig. 1) were corroded; the other sides of the flanges were always in good condition. There was a close relationship between corrosion of the flange of a particular pin and the occurrence of SCC, Fig. 6. The aforementioned salts were also found on the corroded flanges.
- For some levers many NaCl crystals were found in the internal annular space. Although this observation was relatively rare, it seems unlikely that this NaCl was introduced during production.

Fig. 6 Relationship between the occurrence of SCC and corrosion of the flange
