Effluent buffer transfer pipework

All of the pipework shown in this document is “original” i.e. it was installed 8 months ago

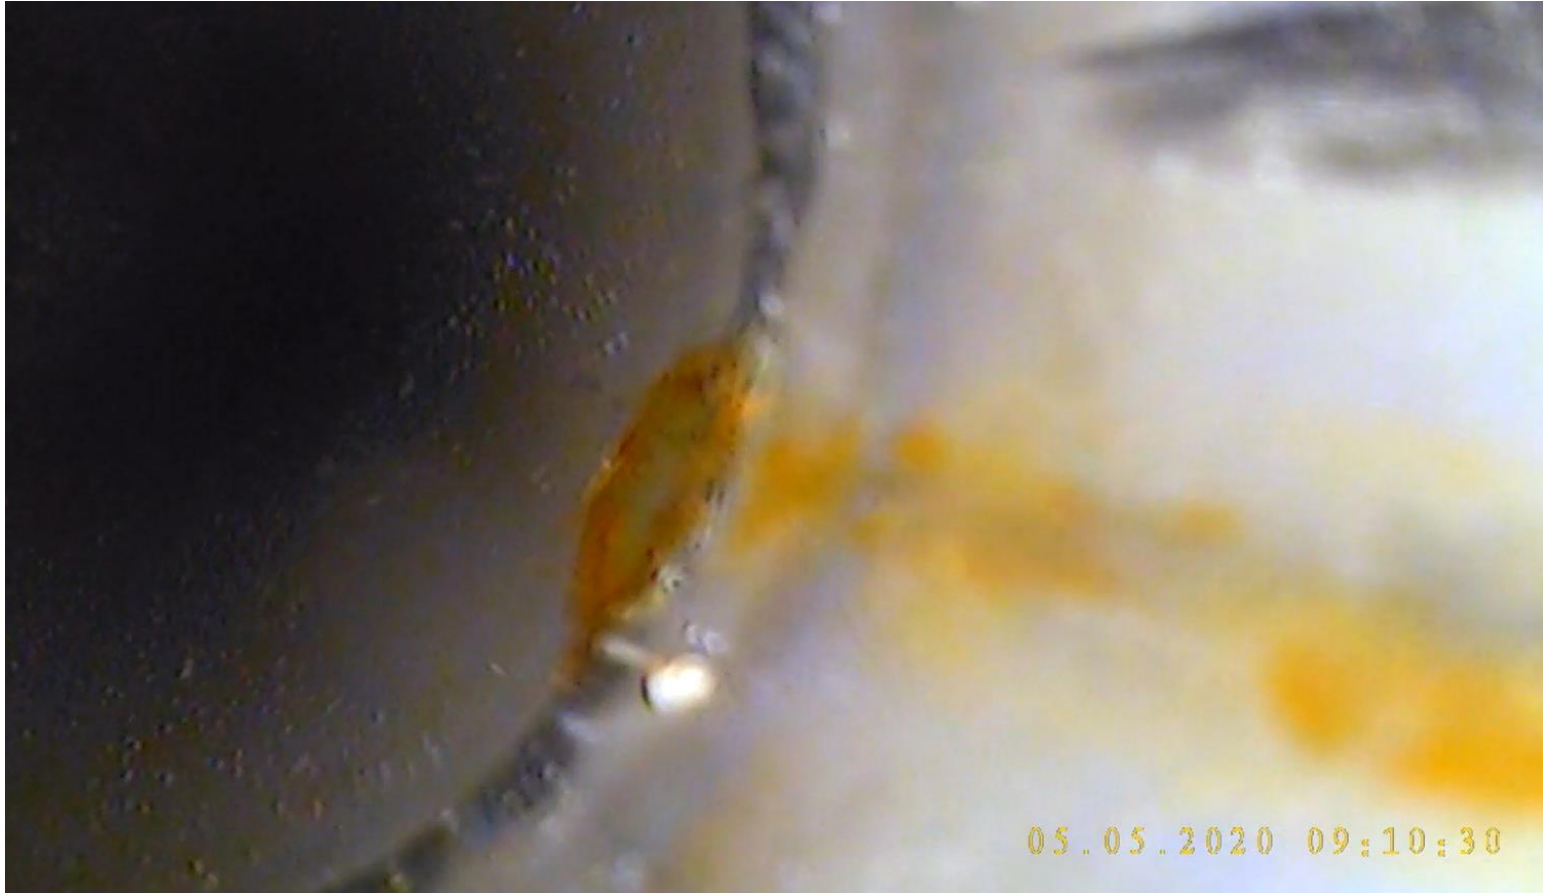
3

Camera dislodged the lump that can be seen on photo 2, the above photograph shows what was underneath

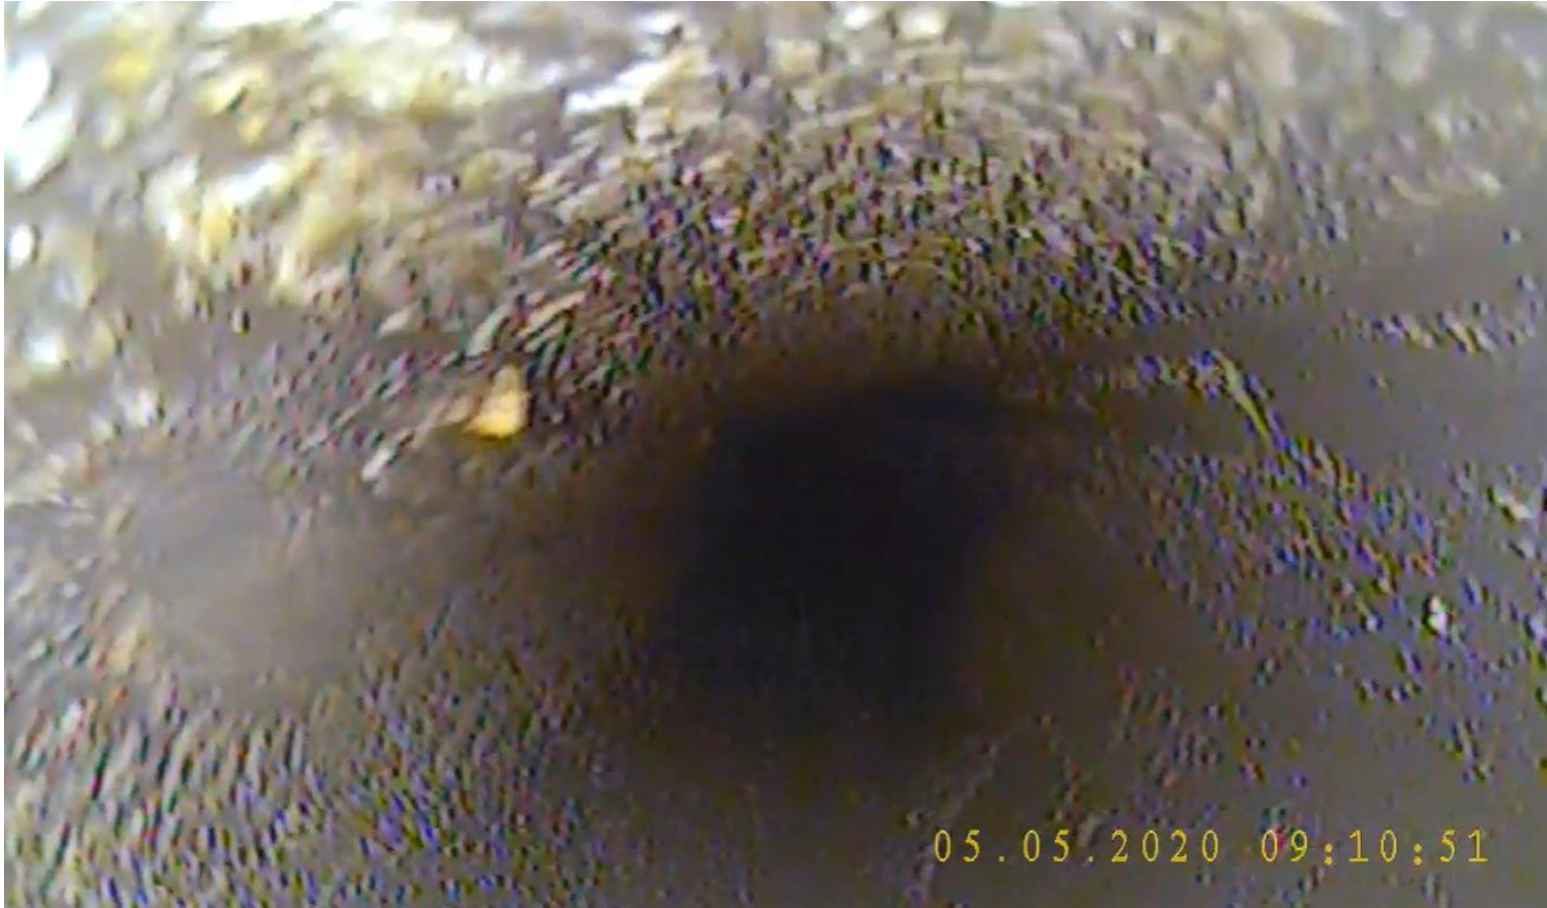
5

Possible evidence of pustule on pipe wall (not near a weld seam)

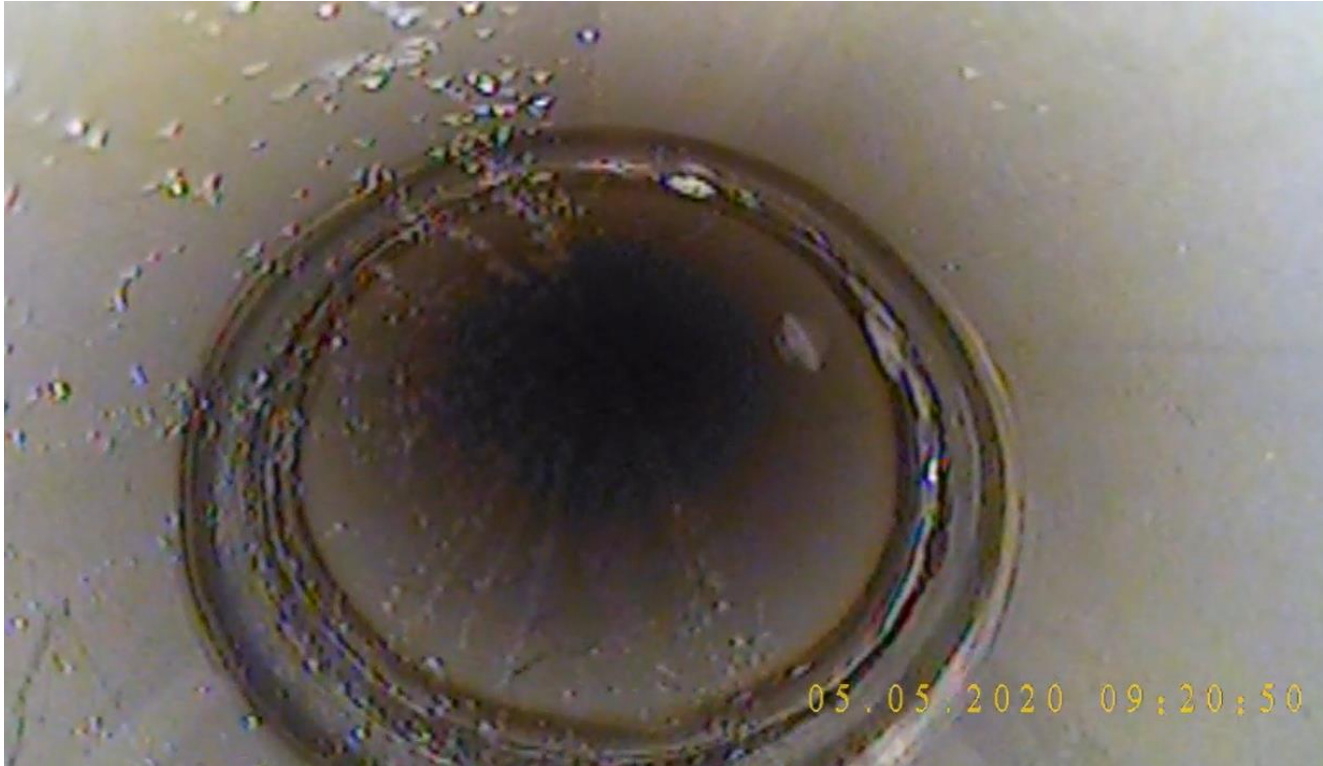
12

This section of pipe is on a re-circulation loop, it is in contact with the same fluids as on the other photos. Could the turbulence be helping stop any pustules from forming?

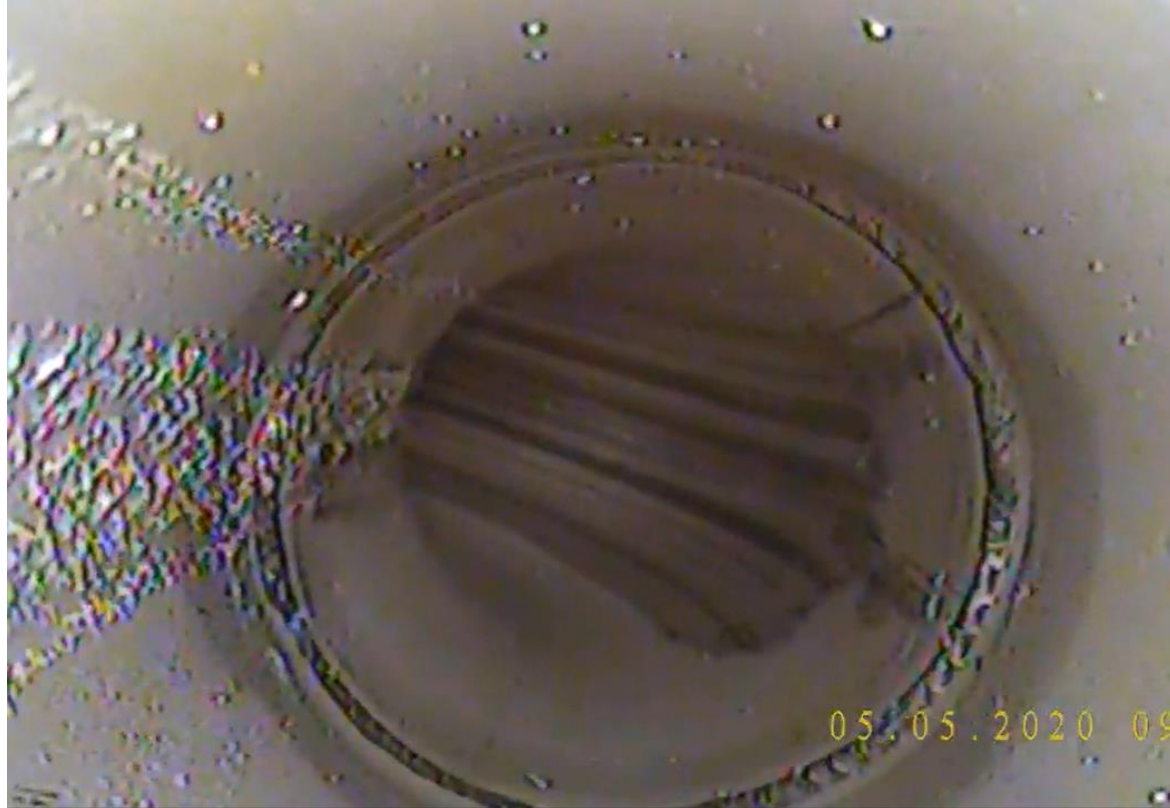
13

This section of pipe is on a re-circulation loop, it is in contact with the same fluids as on the other photos. Could the turbulence be helping stop any pustules from forming?

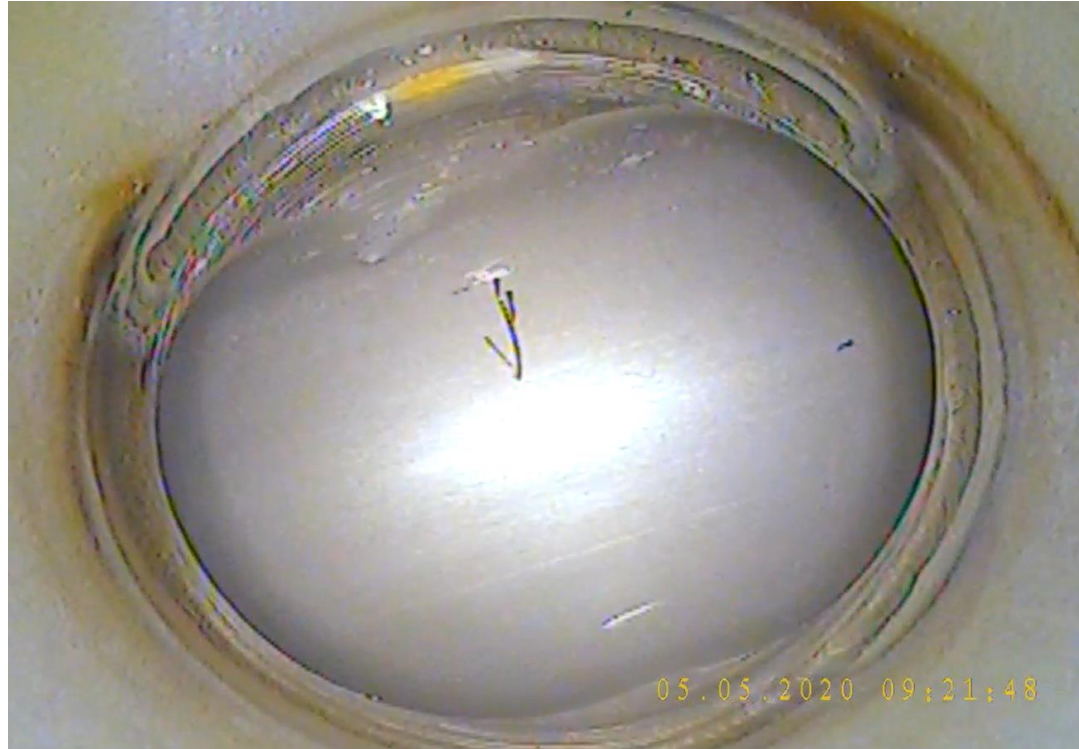
14

This section of pipe is on a re-circulation loop, it is in contact with the same fluids as on the other photos. Could the turbulence be helping stop any pustules from forming?

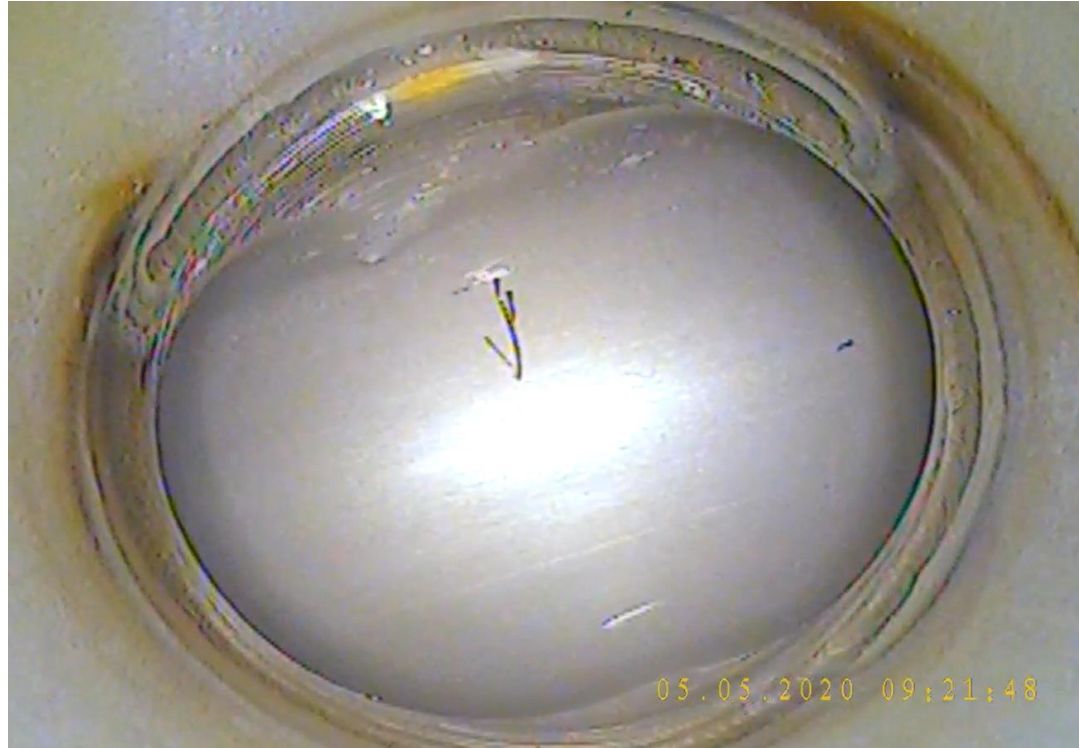
15

This section of pipe is on a re-circulation loop, it is in contact with the same fluids as on the other photos. Could the turbulence be helping stop any pustules from forming?
