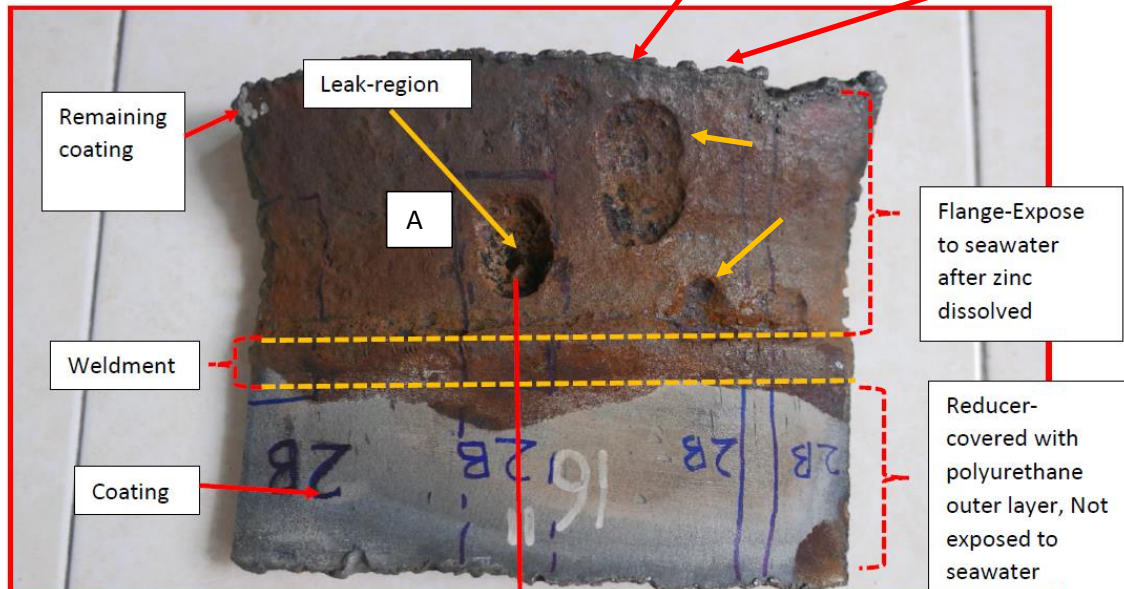
Photo 3: Flange outer surface after cleaning showing pits ( yellow arrows)and pit with hole/leak (A).

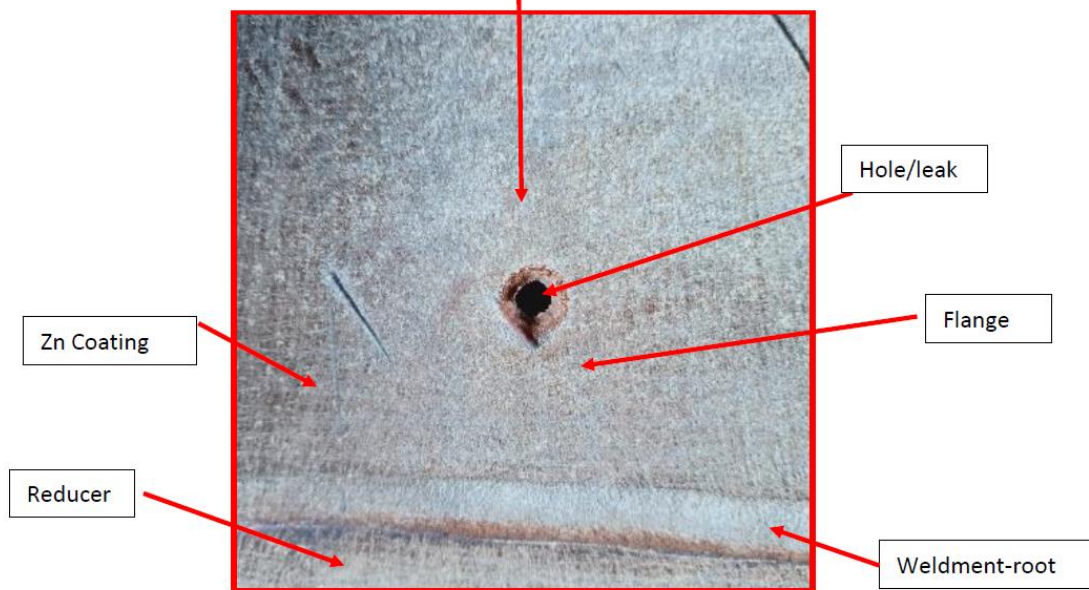
Photo 4: Inner surface corresponds to Photo 3.
