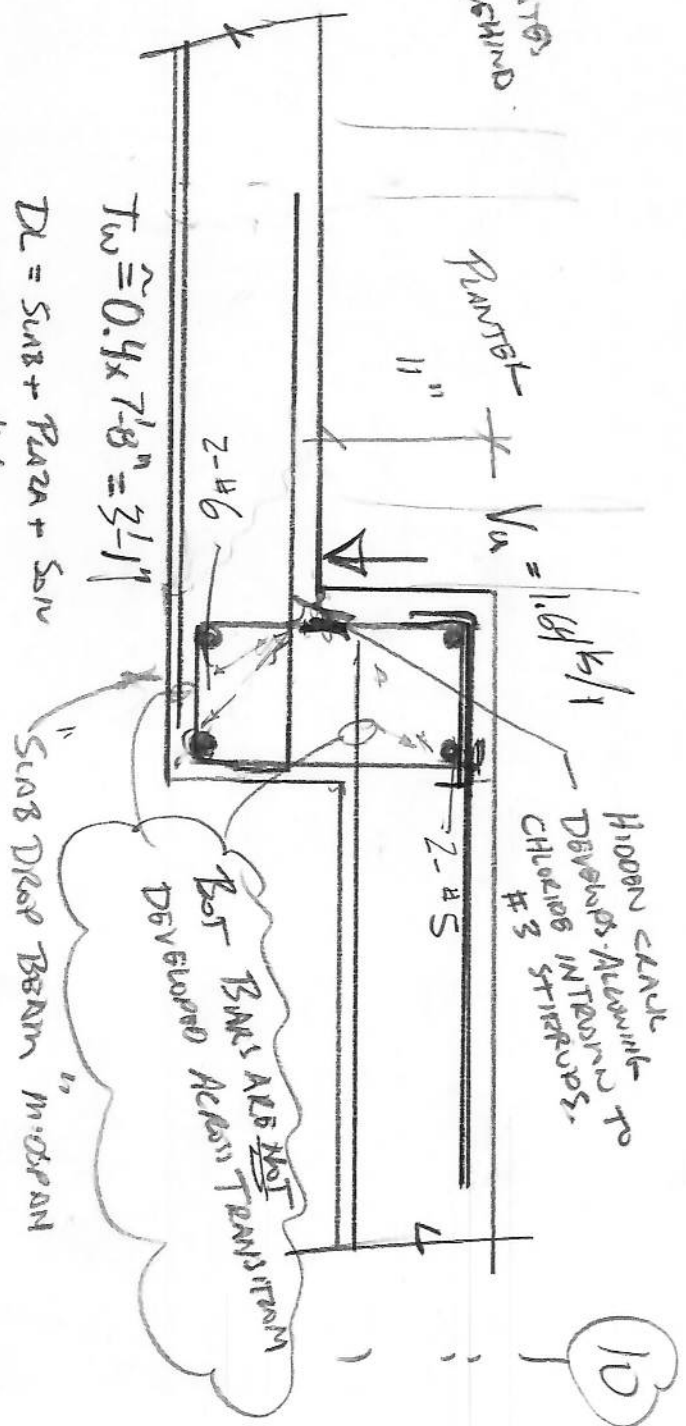
#1 FLEXING JOINTS, HIDDEN CLACK BEHIND PANTERS

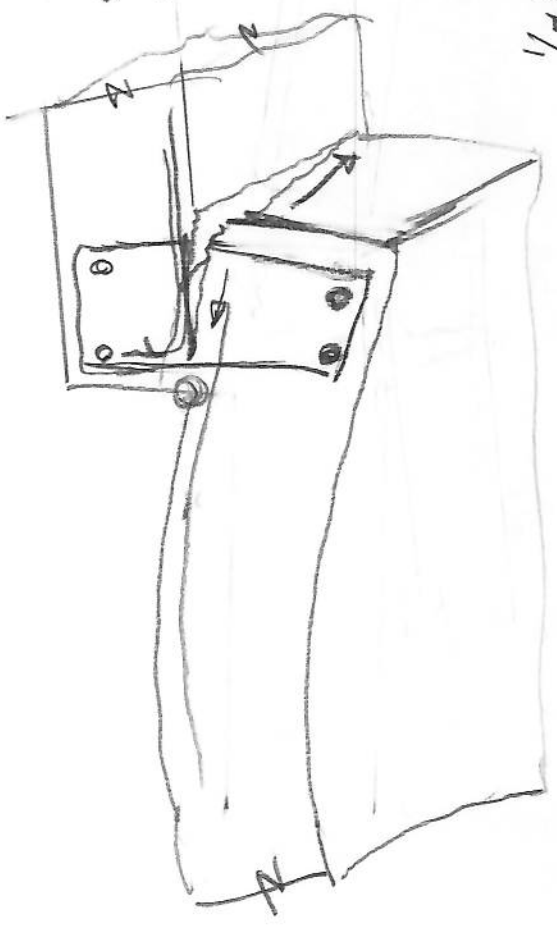
$T_w \approx 0.4 \times 7'8" = 3'1"$
 $D_L = S_{UB} + P_{AZA} + S_{DN} \approx 0.4 k/l$
 $V_u = 1.64 k/l$

#2 INTIM #3 STRIP IS FULL DISTRIBUTION AND CEAC PROPAGATE IN DEPTH AND ALONG-BEAM. MOMENT REDISTRIBUTES TO ADJACENT COLUMN LINES. THIS REDISTRIBUTION MAY BE THE CAUSE OF STRUCTURAL NOISE, CRACKS, AND EXPERIENCED DEFLECTIONS.

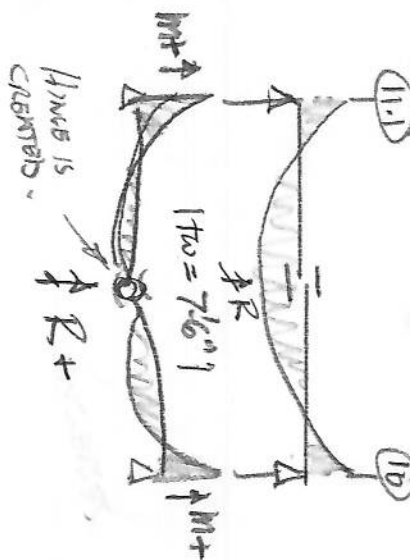
#3 AS MIDSPAN JOINT FAILS, MOBE LOAD IS PLACED ON SCAB DROP BEAM, $\phi M_n \approx 870 \text{ k}$

ACTUAL LOAD
 $9\frac{1}{2}'' \text{ SABS} + 5\frac{1}{2}'' \text{ PRAZA} = 0.19 \text{ k/ft}$ $T_w = 7.6''$
 $3\frac{1}{2}'' \text{ SOL}$

$w_{DL} = (0.19 \times 7.5' + 0.24 \times 3') = 2.1 \text{ k/ft} \rightarrow w_{MAX}$

THEORETICALLY, SCAB DROP BEAM STARTS TO YIELD. MOBE NOISE MOBE DEFLECTION,

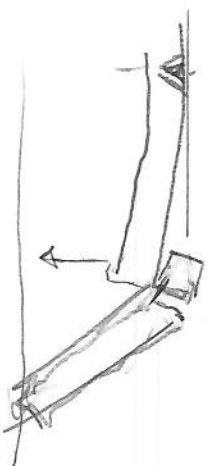
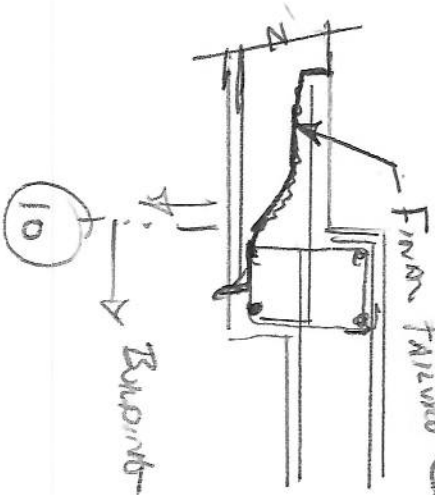
#4 AS SCAB DROP BEAM FAILS, MOBE MOMENT IS ATTRACTED TO GRID LINES 11.1 AND 10. HOWEVER, SCAB HAS MINIMAL NEGATIVE MOMENT BEHIND. AT GRID 10, THE TOP BARS DEBARRINATE AND THE SCAB FAILS. THIS WOULD BE A LOAD CRASH.

#5. MIDSPAN SCAB DROP BEAM CONTINUES TO YIELD UNTIL FAILURE AT 11.1 (SHEAR, YIELDING?)

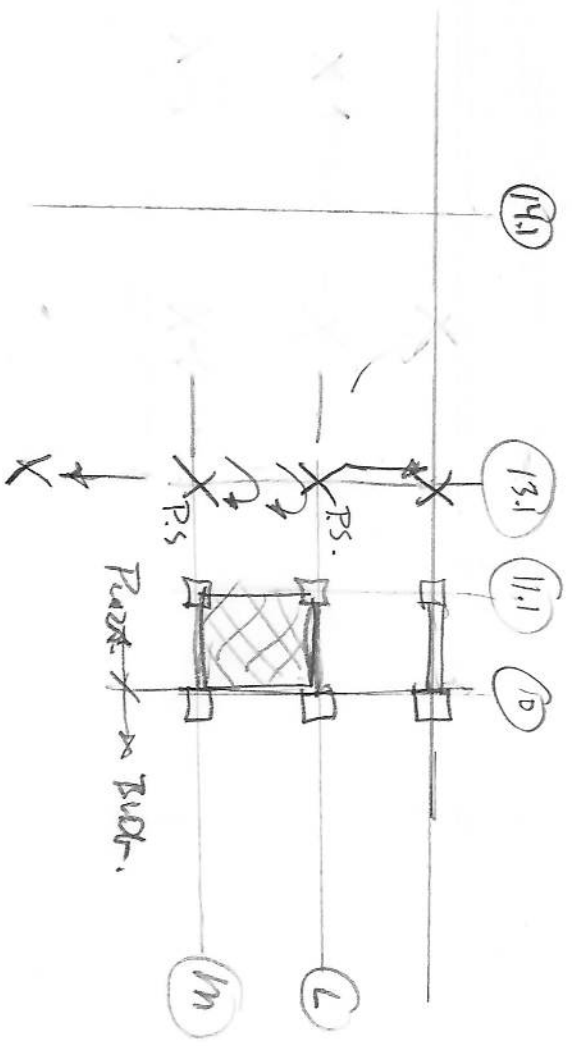
#6 FLOWED OF SLAB AT 11.1 REDISTRIBUTES MOMENT + LOAD TO 13.1 WHERE SLAB FANS
 SUPPORTS IN 2-WAY PUNCHING SHEAR - CAUSING PROGRESSIVE COLLAPSE TO ADJACENT SLAB
 COLUMN CORNERS.

#7 SLAB HANGS ON BEAM ATTACHED TO
 COLUMN AT K/D OVERLAPPING COLUMN IN
 MOMENT + AXIAL LOADS.
