MC 1st FLOOR LEVEL DECK INVESTIGATION SUMMARY

CHAMPLAIN TOWERS
SOUTH
8777 COLLINS AVENUE
SURFSIDE, FLORIDA 33154

CHAMPLAIN TOWERS
SOUTH - PHASE IIA

Sheet Title:
FIRST FLOOR
(LOBBY LEVEL)
FRAMING PLAN

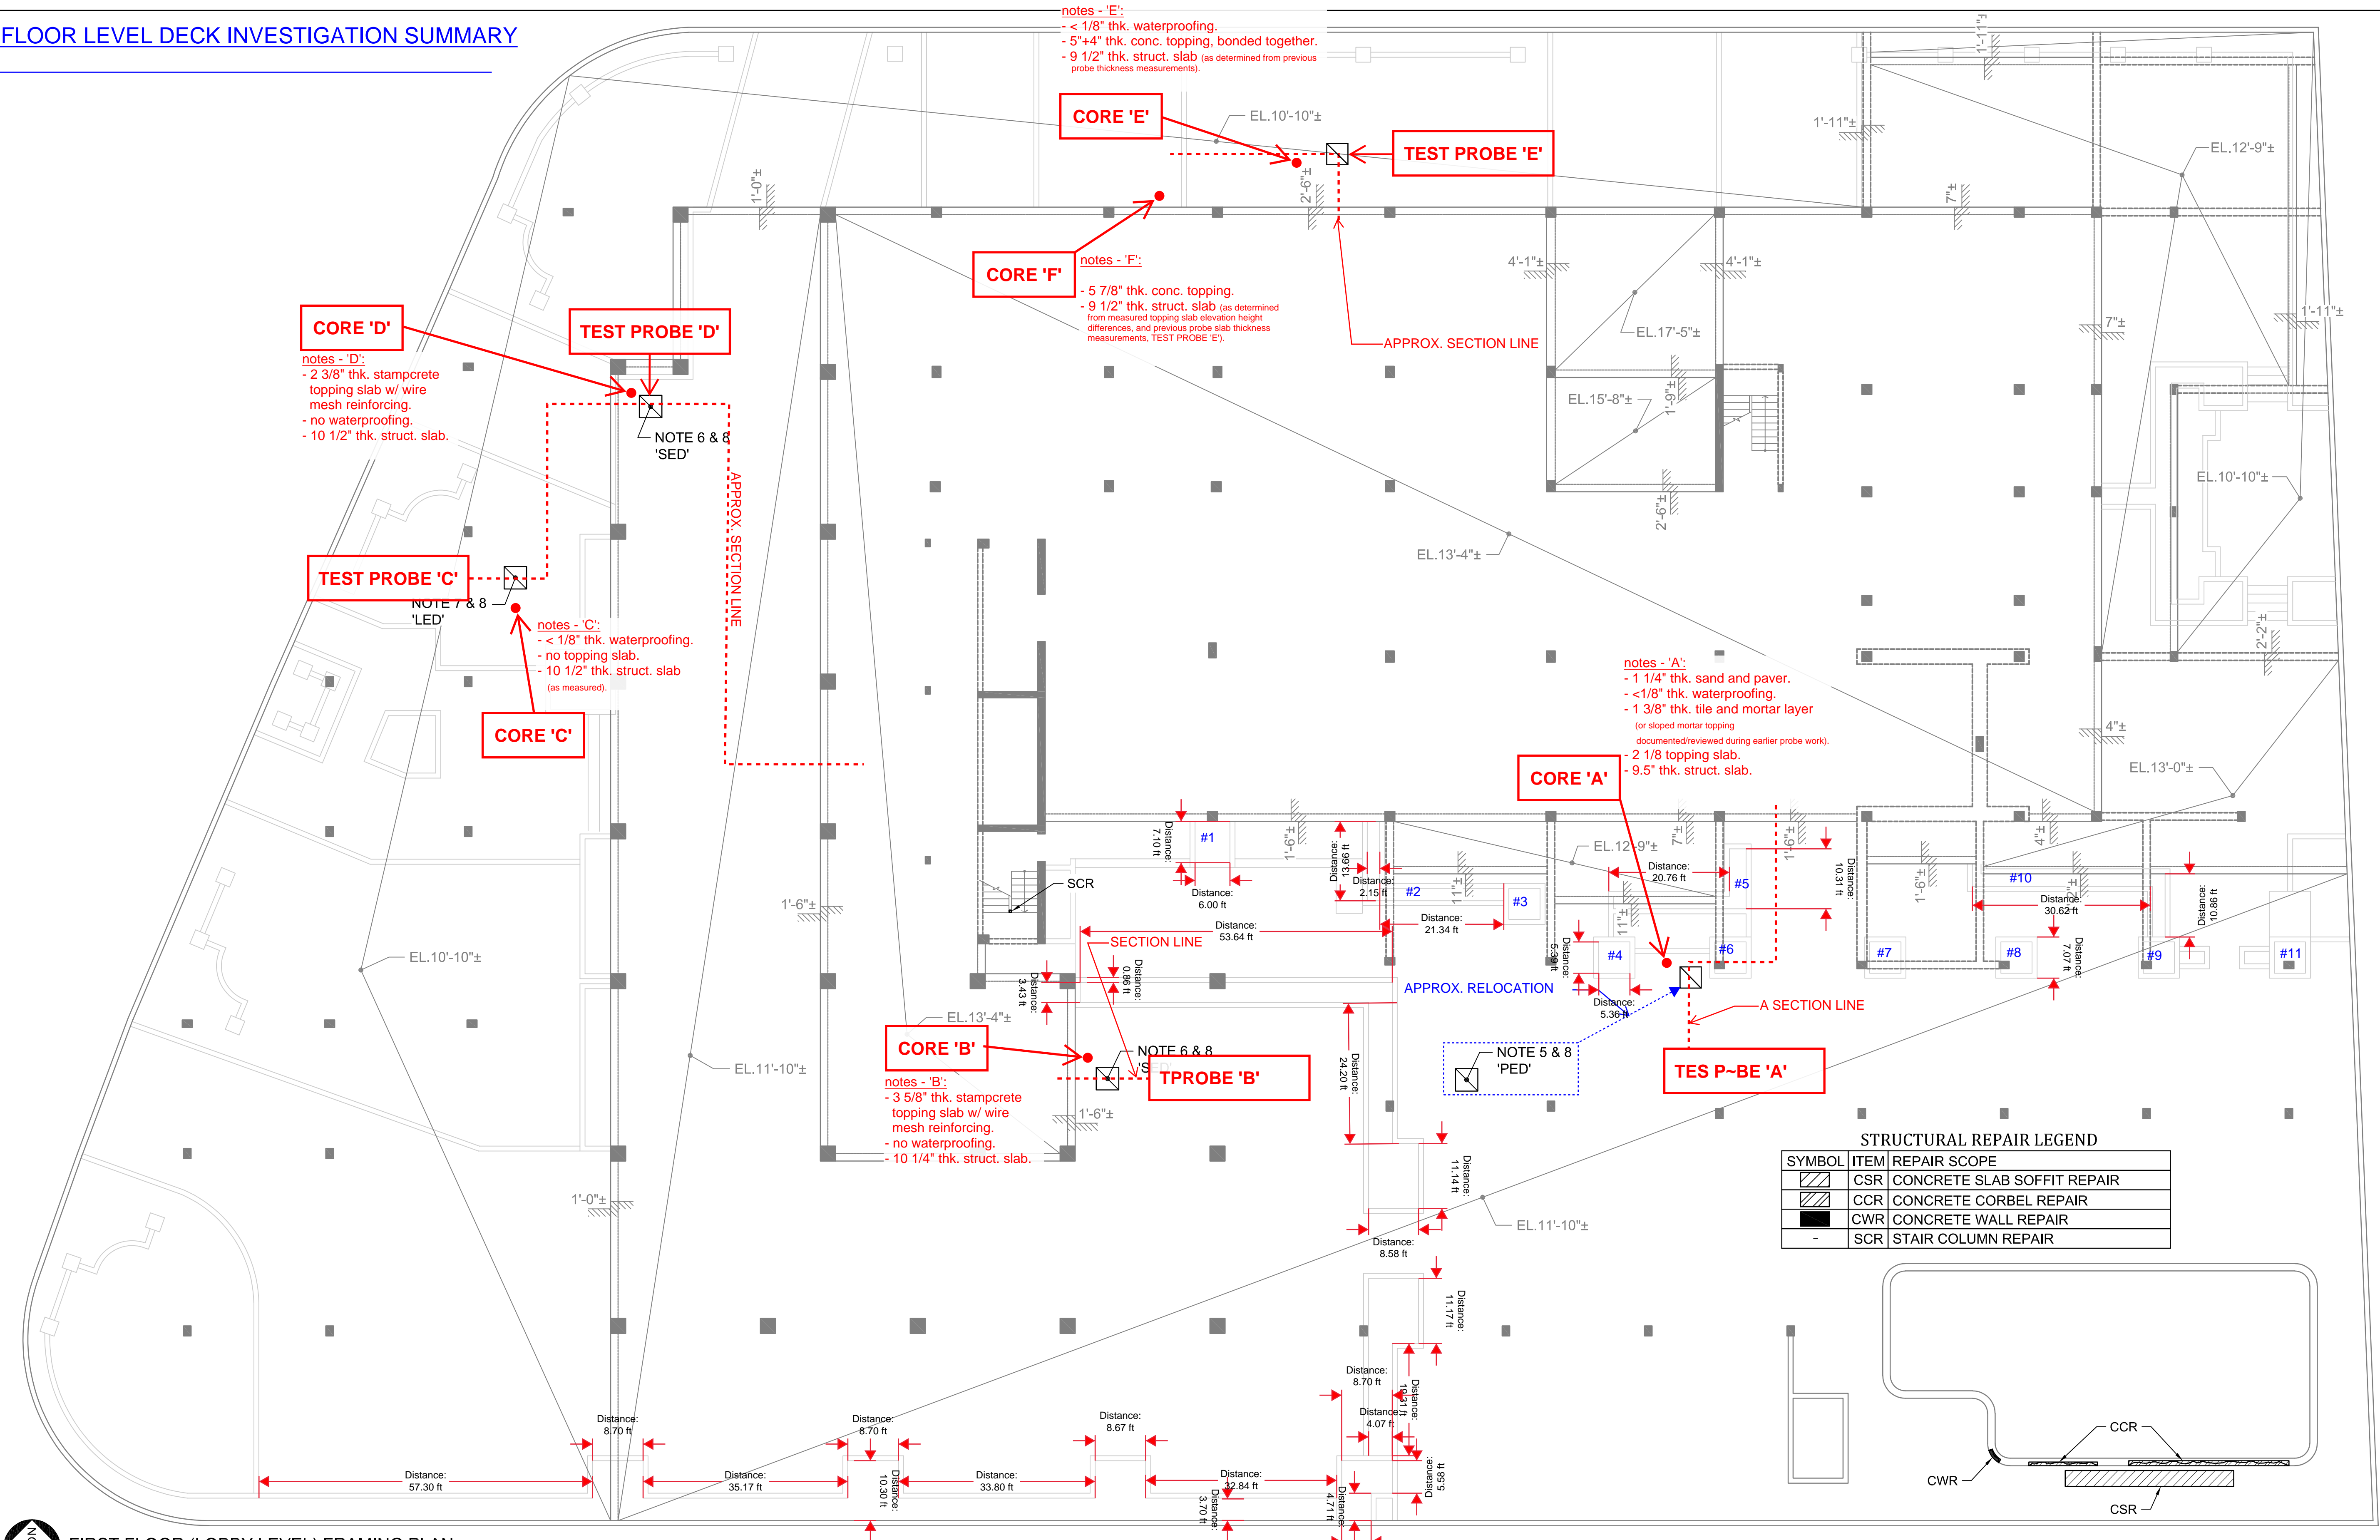
FIRST FLOOR (LOBBY LEVEL) FRAMING PLAN
SCALE: 3/32" = 1'-0"

- EXISTING FIRST FLOOR (LOBBY LEVEL) FRAMING IS A 9 1/2" THICK CAST-IN-PLACE CONCRETE TWO-WAY FLAT PLATE FLOOR SLAB REINFORCED WITH A BOTTOM MAT OF #4 AT 12"o/c AND TOP BARS AS INDICATED ON 'S5' OF THE EXISTING DRAWINGS. THE STRUCTURAL FLOOR SLAB IS STEPPED AS SHOWN ON PLAN WITH 12" WIDE DROP BEAMS AT TRANSITIONS.

- THE CONTRACTOR SHALL COMPLETE CAREFUL EXPLORATORY DEMOLITION OF THE PAVER SYSTEM AT THE POOL DECK TO DOCUMENT THE COMPOSITION OF THE SYSTEM. AN APPROXIMATE 3'-0"x3'-0" AREA SHALL BE DEMOLISHED IN THE LOCATION NOTED ON PLAN. THE PAVER SYSTEM SHALL BE DEMOLISHED DOWN TO THE TOP OF THE EXISTING WATERPROOFING, IF WATERPROOFING IS PLACED DIRECTLY ON TOP OF STRUCTURAL SLAB. THE CONTRACTOR SHALL TAKE PROPER PRECAUTIONS TO AVOID DAMAGING THE EXISTING WATERPROOFING AND FLOOR SLAB. (BID ITEM 'PED')

- THE CONTRACTOR SHALL COMPLETE CAREFUL EXPLORATORY DEMOLITION OF THE STAMPED CONCRETE TOPPING AT THE PARKING AREA AND DRIVE AISLE TO DOCUMENT THE COMPOSITION OF THE SYSTEM. AN APPROXIMATE 3'-0"x3'-0" AREA SHALL BE DEMOLISHED IN THE LOCATION NOTED ON PLAN. THE STAMPED CONCRETE TOPPING SHALL BE DEMOLISHED DOWN TO THE TOP OF THE EXISTING WATERPROOFING, IF WATERPROOFING IS PLACED DIRECTLY ON TOP OF STRUCTURAL SLAB. THE CONTRACTOR SHALL TAKE PROPER PRECAUTIONS TO AVOID DAMAGING THE EXISTING WATERPROOFING AND FLOOR SLAB. (BID ITEM 'SED')

- THE CONTRACTOR SHALL COMPLETE CAREFUL EXPLORATORY EXCAVATION AND DEMOLITION OF THE PLANTER SYSTEM WITHIN THE LANDSCAPING BEDS TO DOCUMENT THE COMPOSITION OF THE SYSTEM. AN APPROXIMATE 3'-0"x3'-0" AREA SHALL EXCAVATED IN THE LOCATION NOTED ON PLAN AND THE SUB PLANTER WATERPROOFING, DRAINAGE BOARD, ETC., SHALL BE DOCUMENTED. THE SUB PLANTER SYSTEMS SHALL BE DEMOLISHED DOWN TO THE TOP OF THE EXISTING WATERPROOFING, IF WATERPROOFING IS PLACED DIRECTLY ON TOP OF STRUCTURAL SLAB. THE CONTRACTOR SHALL TAKE PROPER PRECAUTIONS TO AVOID DAMAGING THE EXISTING WATERPROOFING AND FLOOR SLAB. (BID ITEM 'LED')

- MORABITO CONSULTANTS SHALL BE NOTIFIED TO INSPECT AND DOCUMENT ALL TEST PITS UPON CONTRACTORS COMPLETED DEMOLITION. ONCE THE INSPECTION AND DOCUMENTATION IS COMPLETED, THE CONTRACTOR SHALL RESTORE ALL DEMOLISHED AREAS BACK TO THEIR ORIGINAL CONDITIONS. REPLACE ANY DAMAGED WATERPROOFING PER WATERPROOFING MANUFACTURERS REQUIREMENTS, RE-INSTALL THE PAVER SYSTEM AT THE POOL DECK, REPLACE/REPAIR THE STAMPED CONCRETE AT THE PARKING AREA, AND RESTORE THE PLANTER TO THE ORIGINAL CONDITION.
