The Champlain Towers South condo collapsed in the early morning of Thursday, June 24, in Surfside, Fla.

Flawed Reinforcing Steel

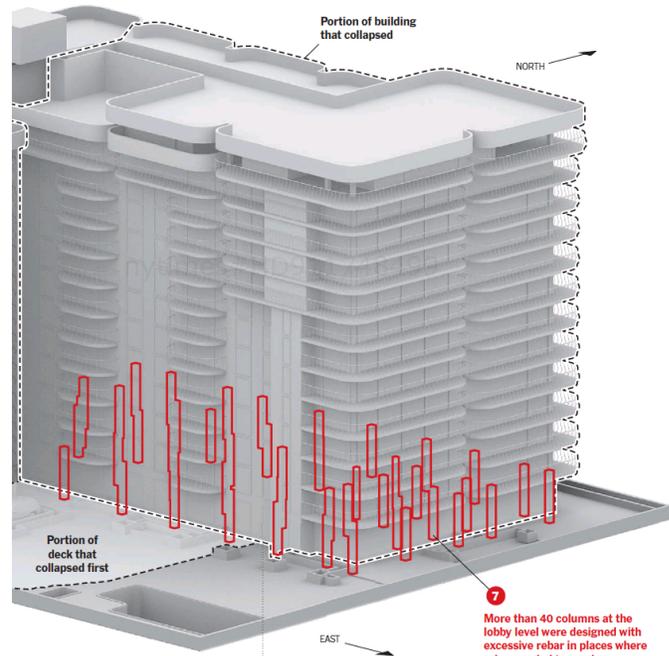
7 More than 40 columns at the lobby level were designed with excessive rebar in places where rebar needed to overlap.

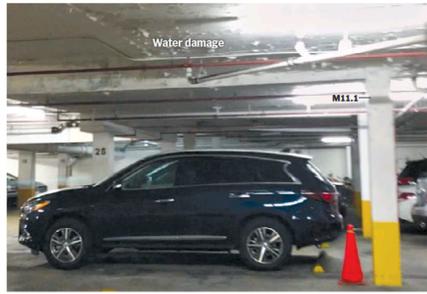
- 9 Water damage near beams** A video of the building in 2020 captured a view of the parking garage, showing the ceiling near the beams. Water damage was visible on the ceiling next to column M11.1, which was below the section of the deck that collapsed first.
