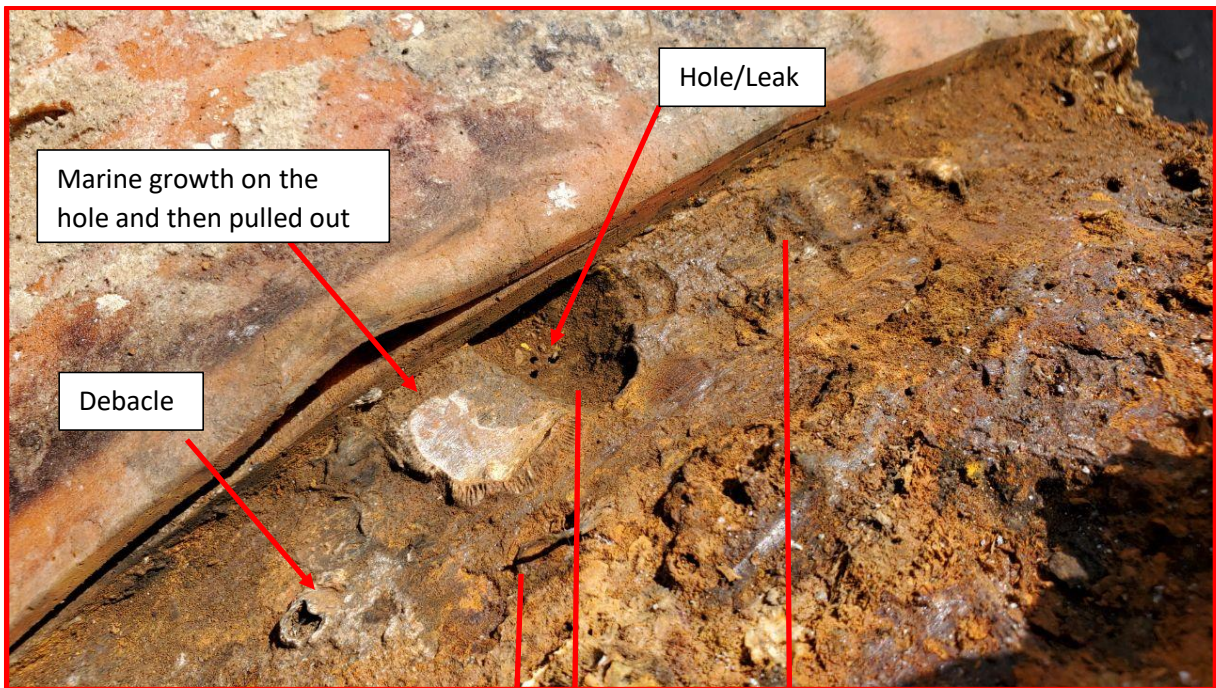
Photo 1: Showing the affected locations before the the polyurethane outer cover and the the deposit on the flange were removed.

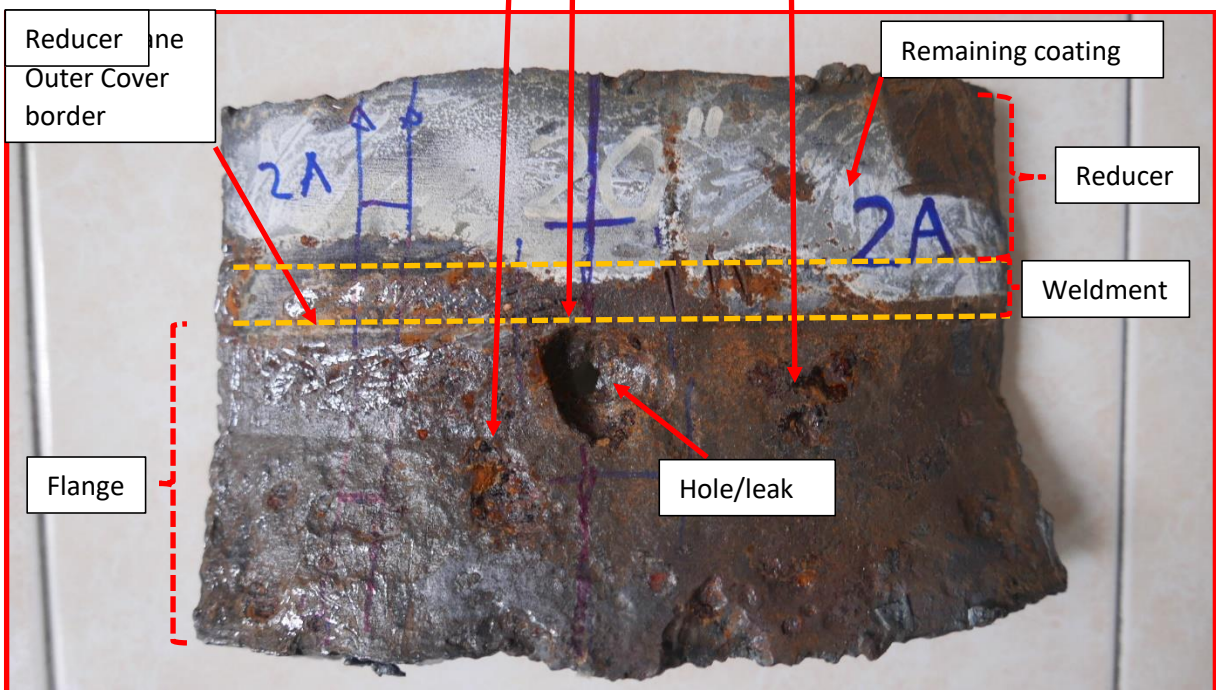
Photo 2: Showing the affected locations after the the polyurethane outer cover and the the deposit on the flange has been removed.
