Bolton Perez & Associates, serving as the CEI for the project performed a visual inspection of main span truss members on 02-06-18 after PT bars tendons No 2 and No 11 were stressed. Cracks were found at moment of the inspection. These have been identified per truss member and a consecutive number within the member. The intent is to monitor these cracks after the bridge is fully tensioned and the main span is at the final location.

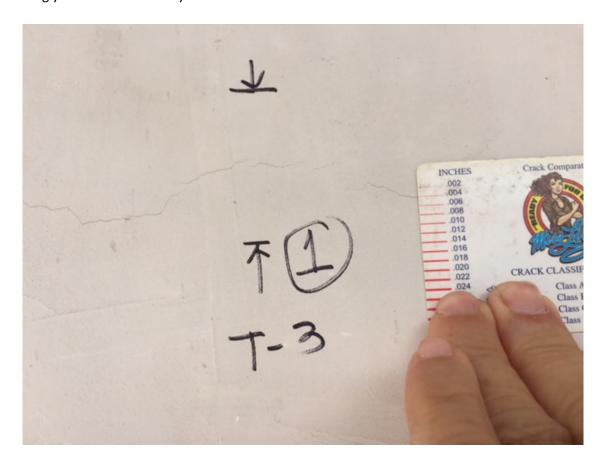
The members showing these small cracks are truss members that share the same blister at the canopy of the already stressed members No 2 (stressed 1/30/18) & No 11 (stressed 1/29/18). We believe, this first stressing operation has temporarily created tension on members No 3 & No 10; thus, creating cross sectional cracks transferring the tension loads to the steel on these members. No other truss members within span 1 show any cracks similar to these shown on members No 3 & No 10.

The intent of the report is to inform Design Build Team of these cracks. It is the Design Build responsibility to assess them and determine if these cracks were expected while tensioning and monitor them accordingly if deemed necessary.

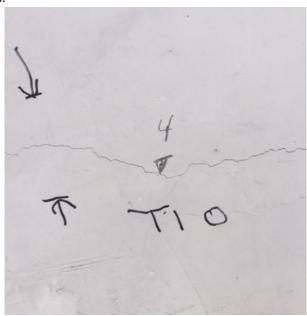
6. Crack T10-4

Location: Truss member No.10, approximately 168 inches measured from the bottom of the member, extended around the cross section.

Classification: Crack type A (<0.007 inches).

Measured: 0.04 inches.
