Subject: Metallurgical Evaluation of Indications on Steel Sample: [REDACTED]

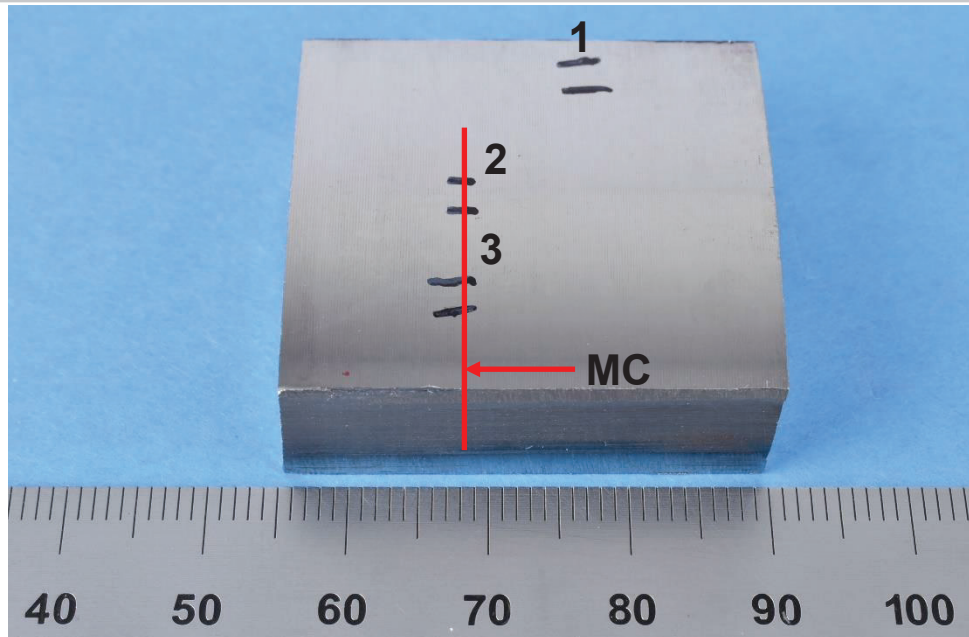
**Fig. 1** Sample C, which was excised by [REDACTED], is shown as received. Between the short, horizontal black ink lines were regions that showed linear indications during magnetic particle inspection, which was performed at a third-party testing laboratory. The red line indicates the plane where the transverse cross-section through Sample C was performed. The scale is in millimeters.

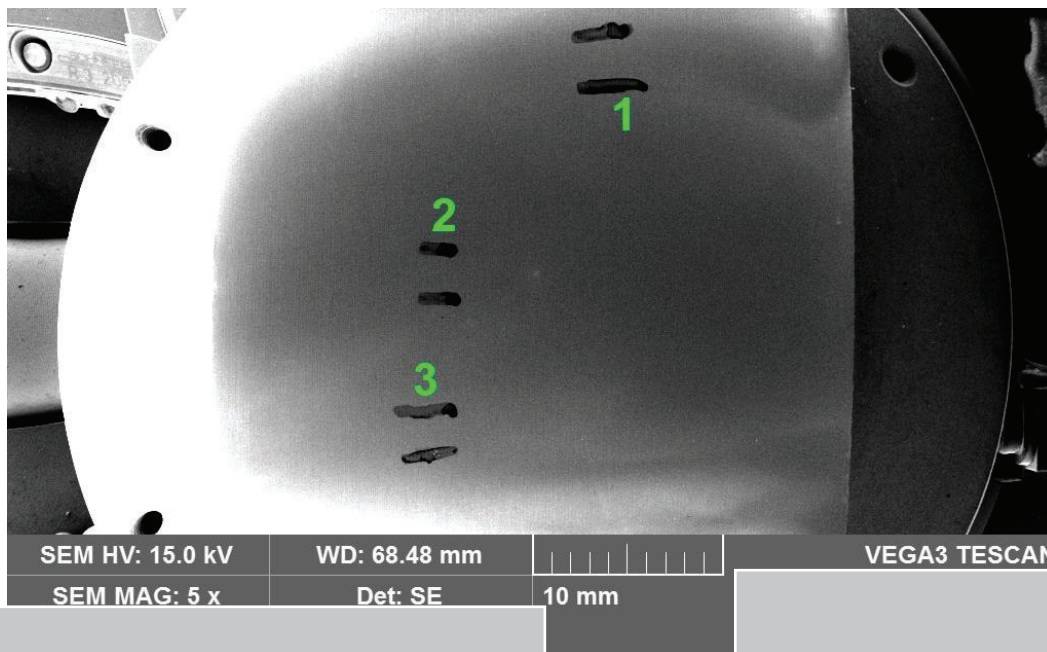
Sample C was rinsed with acetone and marked with black ink the locations of the three indications before EDS elemental line scan analysis, as shown in the scanning electron micrograph presented in Figure 2. Although Indication 2 was faintly visible with an unaided eye, no topographical features were observed when viewed via SEM, as evident in Figure 3. Two line scans, arbitrarily selected at the representative Indication 2, were performed on the surface, perpendicularly crossing Indication 2, to determine changes in relative composition. Initially, a line scan was performed at 75X magnification, but no significant changes in relative composition were observed, as shown in Figures 4 and 5. An additional high-resolution line scan was performed at 200X magnification in the same location, but slightly truncated on either end, as originally shown in Figure 4, as presented in Figure 6. No significant changes in relative composition were observed at the surface through Indication 2. The results of the 200X line scan are presented in Figure 7.

**Fig. 2** A scanning electron micrograph of Sample C is presented. Indications 1 through 3 are identified.

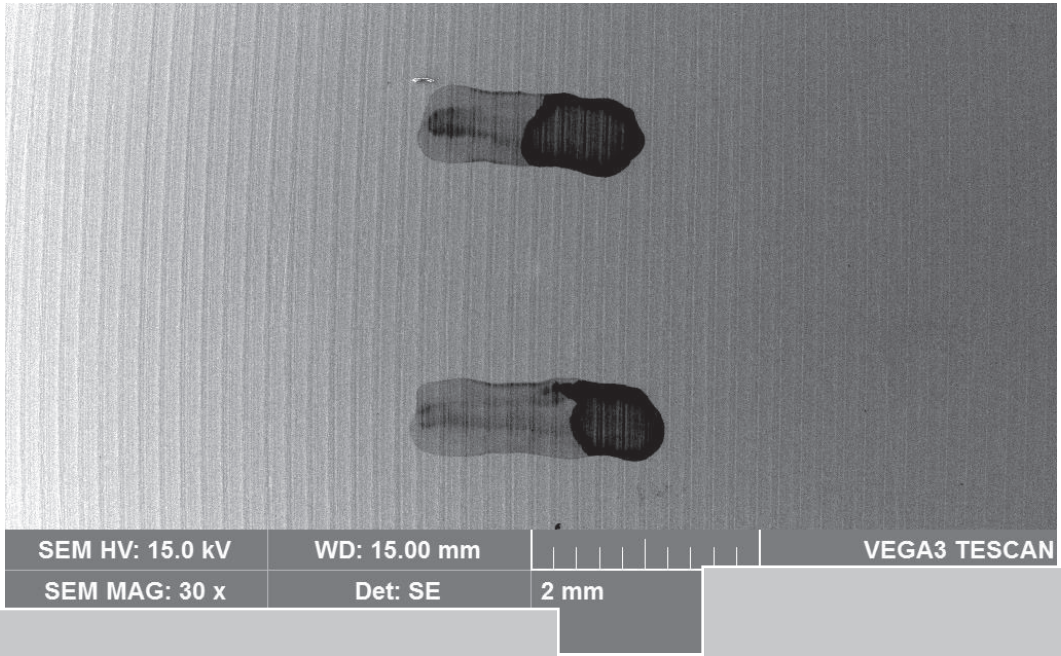
**Fig. 3** A magnified view of Indication 2 from Figure 2 is shown. Machining lines were evident, but no anomalous features were observed.

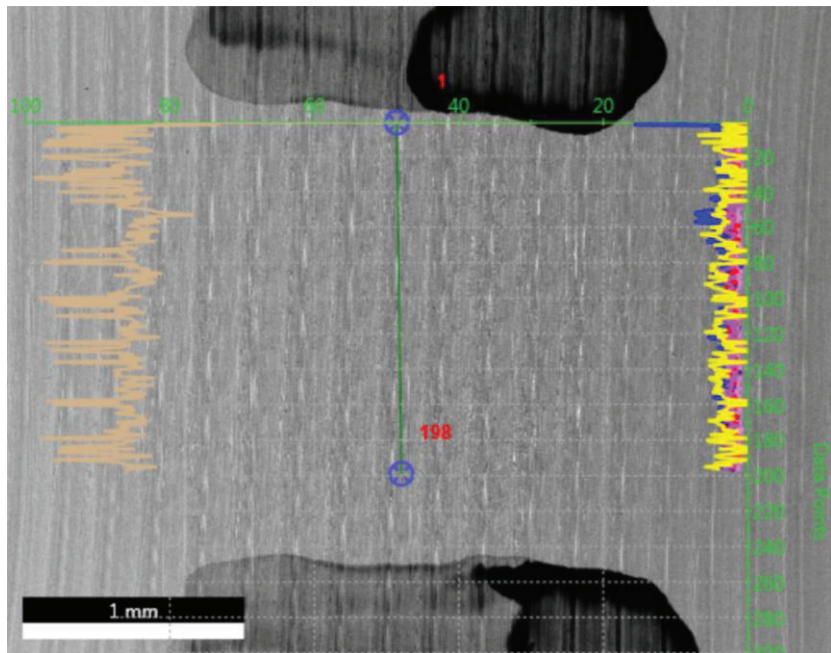
**Fig. 4** A line scan was performed across Indication 2 at a magnification of 75X. A detailed view of the line scan results is shown in Figure 5.

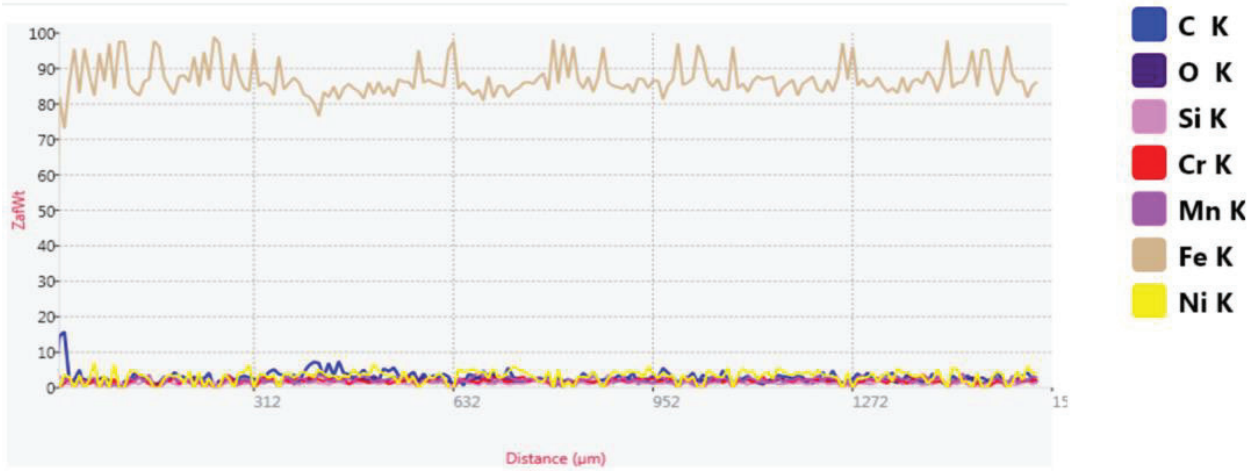
**Fig. 5** The line scan results from Figure 4 are presented. No significant change in relative surface composition was observed.

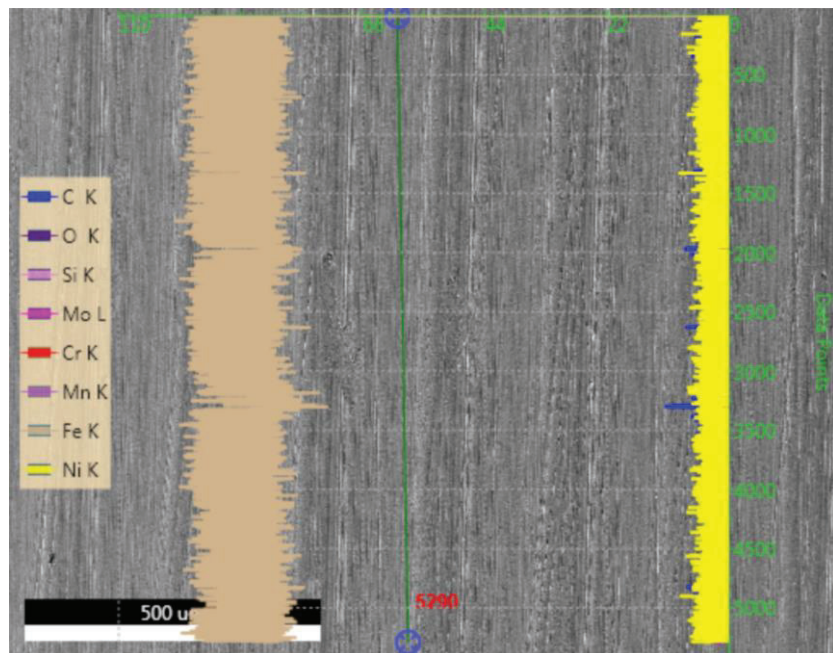
**Fig. 6** The center of Figure 4 is shown at higher magnification, where a high-resolution line scan was performed at 200X magnification. A detailed view of the line scan results is shown in Figure 7.

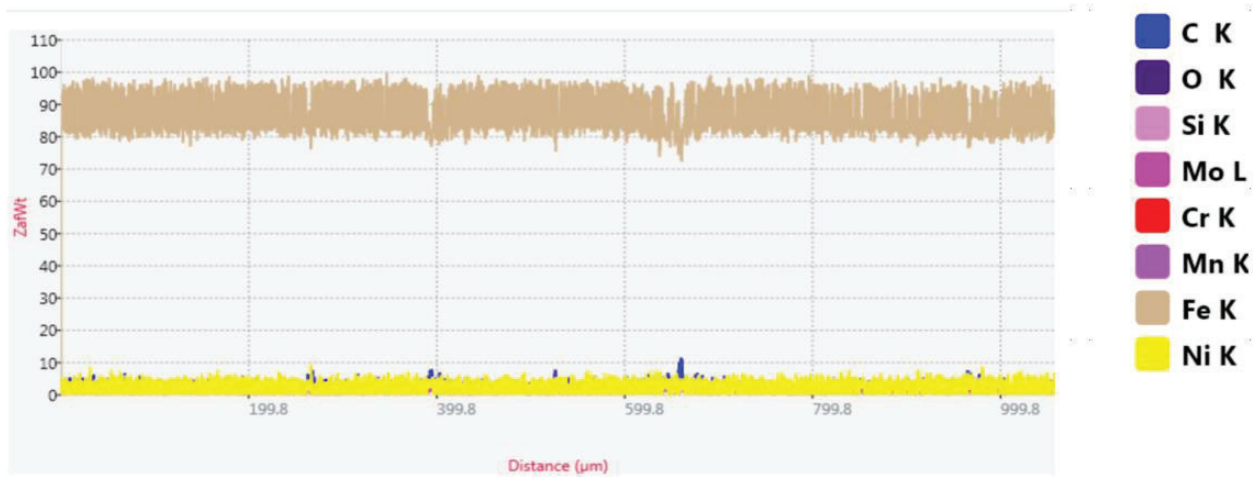
**Fig. 7** The line scan results from Figure 6 are presented. No significant change in relative surface composition was observed.

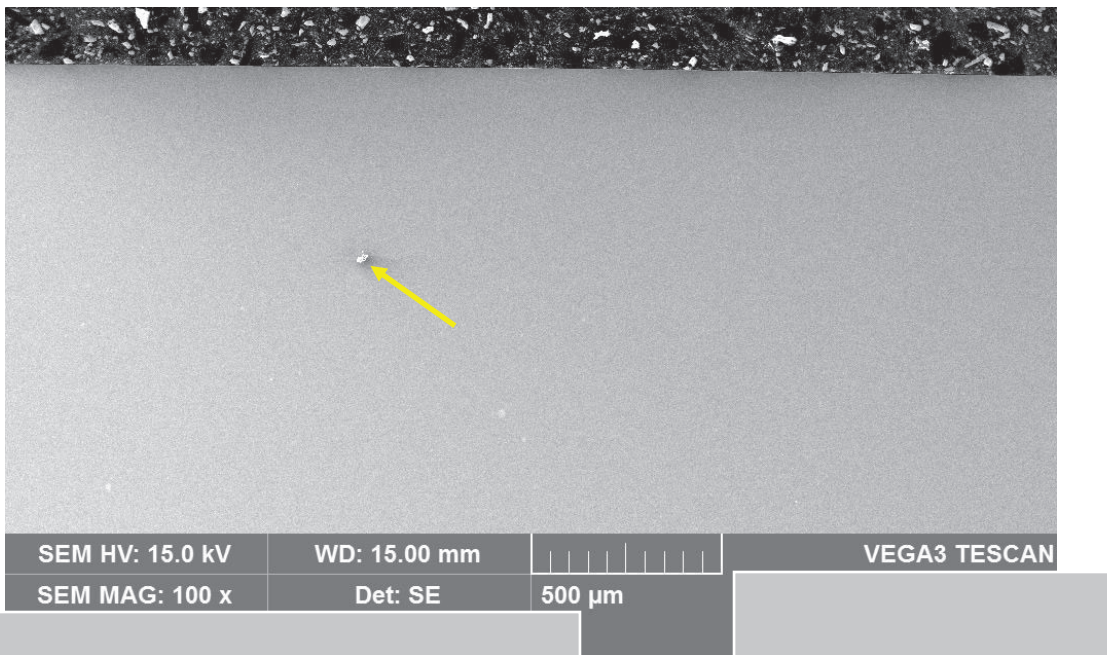
**Fig. 8** A scanning electron micrograph of the cross-section at the location of Indication 2 is presented. An EDS elemental map of the field of view was performed and is shown in Figure 9. The location of the elemental map on an overall view of the cross-section is shown in Figure 16. Dust, which had settled on the polished surface, is indicated with the arrow. As Polished.

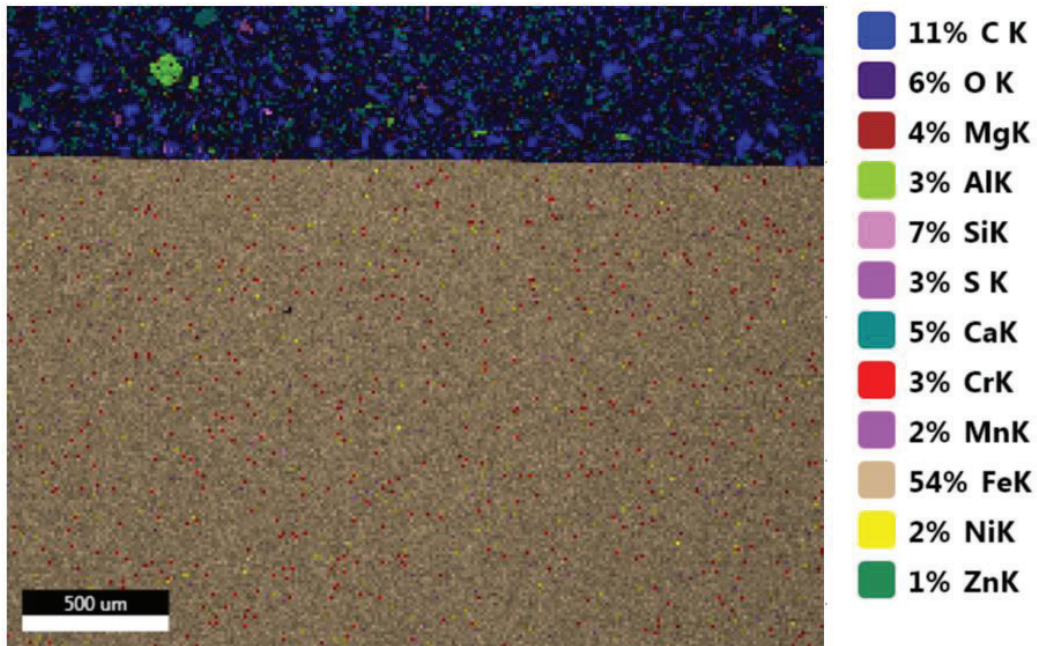
A metallographic cross-section, MC, was excised through the indicated plane in Figure 1. After metallurgical preparation, EDS elemental mapping was performed in the region containing Indication 2, as shown in Figure 8. The EDS elemental map, presented in Figure 9, revealed no large changes in relative composition, suggesting that the magnetic particle indication result for Indication 2 was not due to material inhomogeneity. The individual maps used to construct the initially presented composite elemental map are presented in Figures 10 through 21.

**Fig. 9** The EDS elemental map of Figure 8 is presented. The material did not exhibit large variations of relative composition. As Polished.

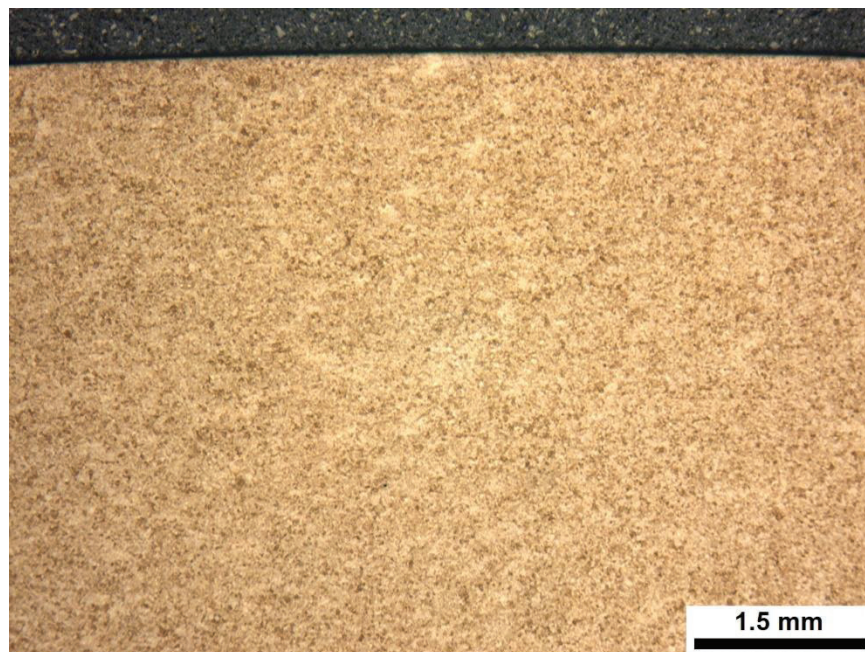
**Fig. 22** An overall view of the cross-section is shown at Indication 3 after etching. The microstructure was uniform and contained no anomalous features. 2% Nital.

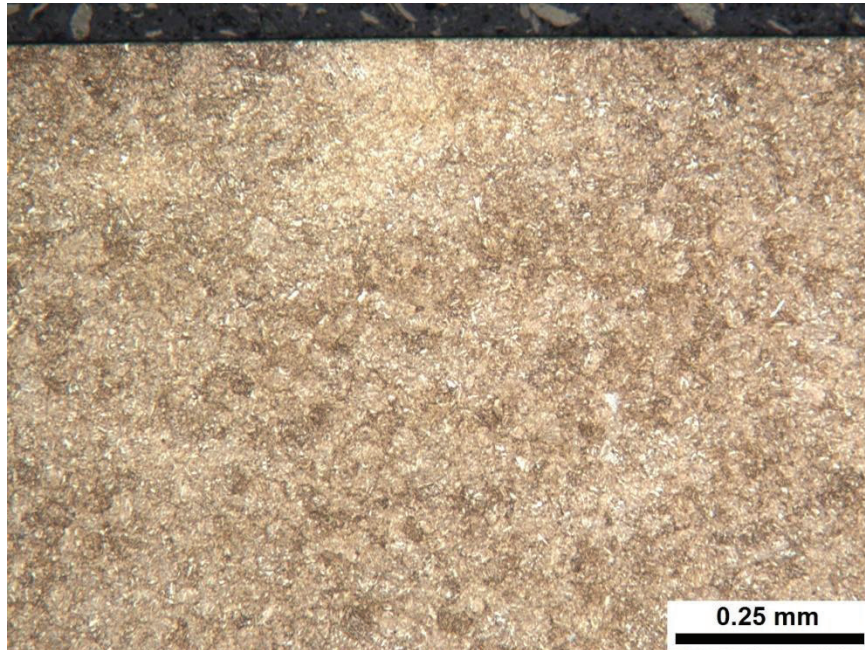
**Fig. 23** The top-center of Figure 22 is shown at higher magnification. No decarburization or cracking was observed. 2% Nital.

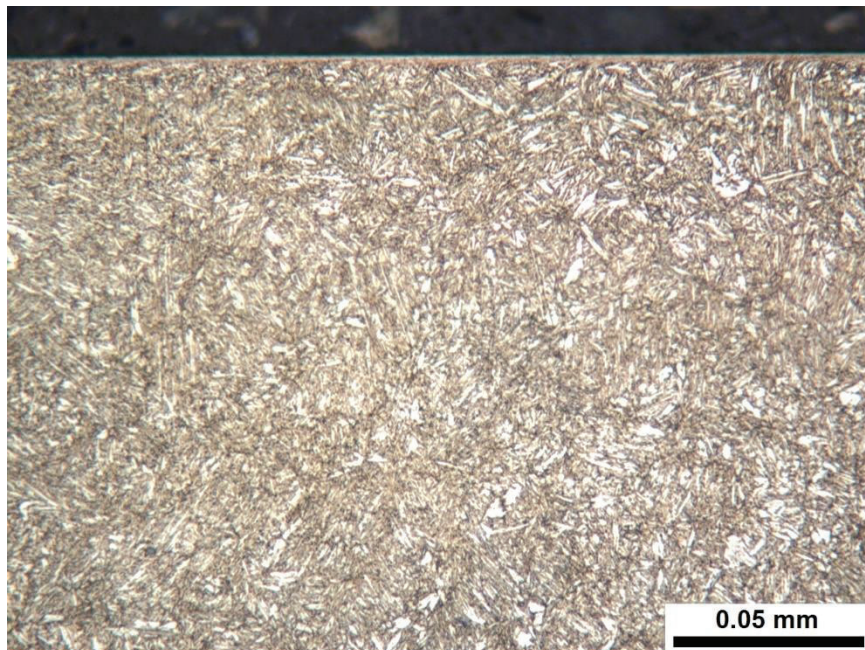
The cross-section was etched with 2% nital to characterize the microstructure. The microstructure was homogenous from surface to core and consisted of tempered martensite. No cracks, laps, folds, or other anomalous features were observed. Photomicrographs of the etched cross-section are presented in Figures 22 through 30.

**Fig. 24** The top-center of Figure 23 is shown at higher magnification. The microstructure was consistent with tempered martensite. The surface was smooth and uniform and was free of surface cracking, laps, or other forging defects. 2% Nital.

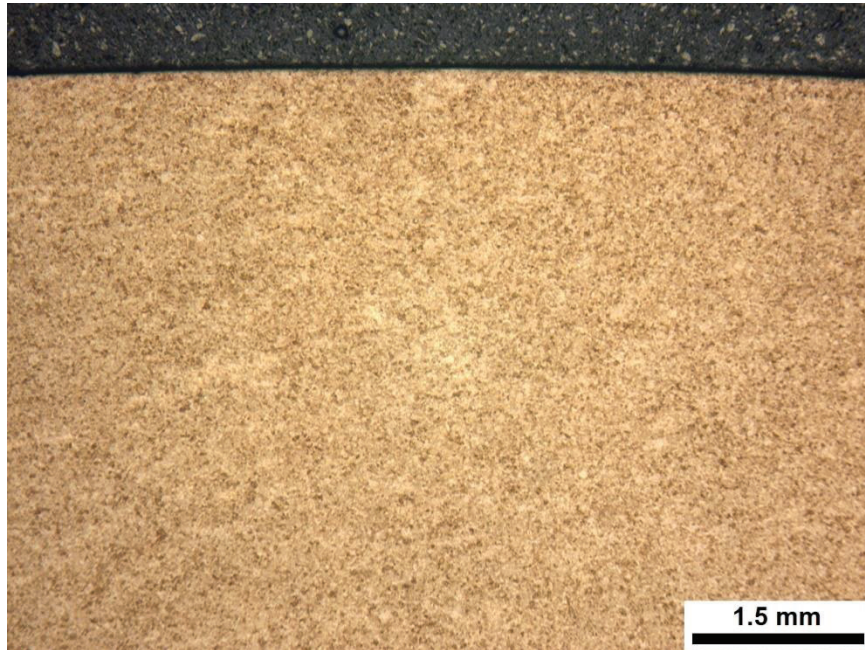
**Fig. 25** An overall view of the cross-section is shown at Indication 2 after etching. The microstructure was uniform and contained no anomalous features. 2% Nital.

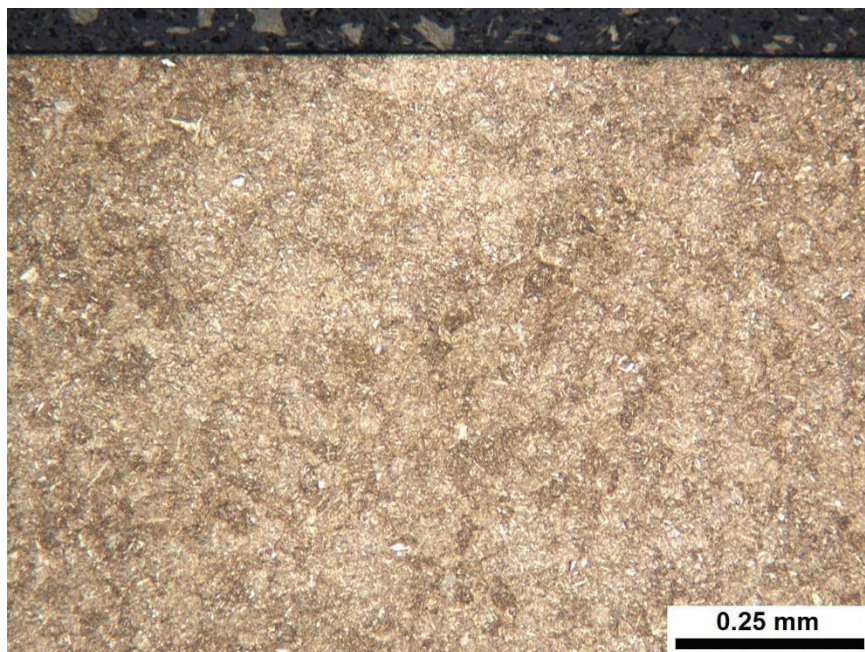
**Fig. 26** The top-center of Figure 25 is shown at higher magnification. No decarburization or cracking was observed. 2% Nital.

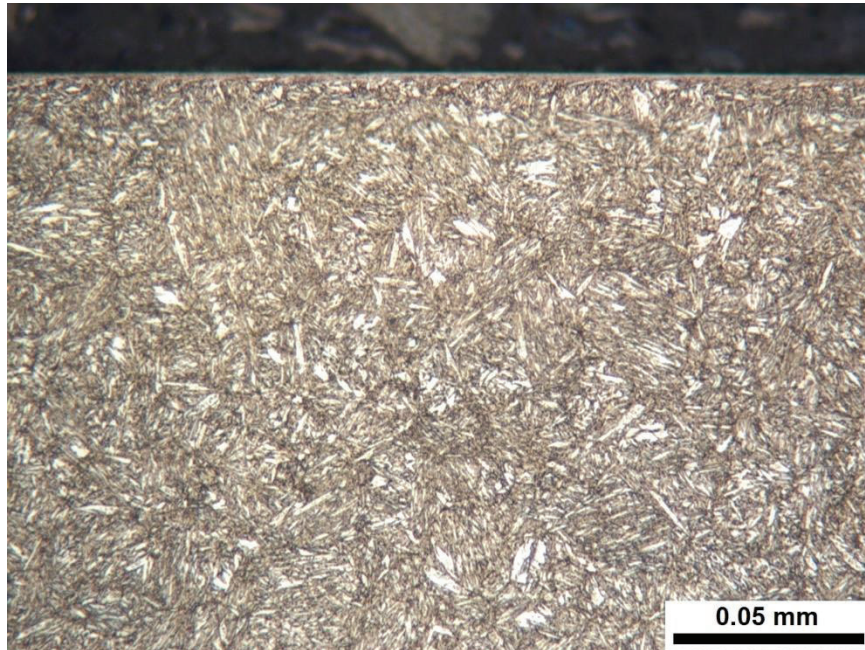
**Fig. 27** The top-center of Figure 26 is shown at higher magnification. The microstructure was consistent with tempered martensite. The surface was smooth and uniform and was free of surface cracking, laps, or other forging defects. 2% Nital.

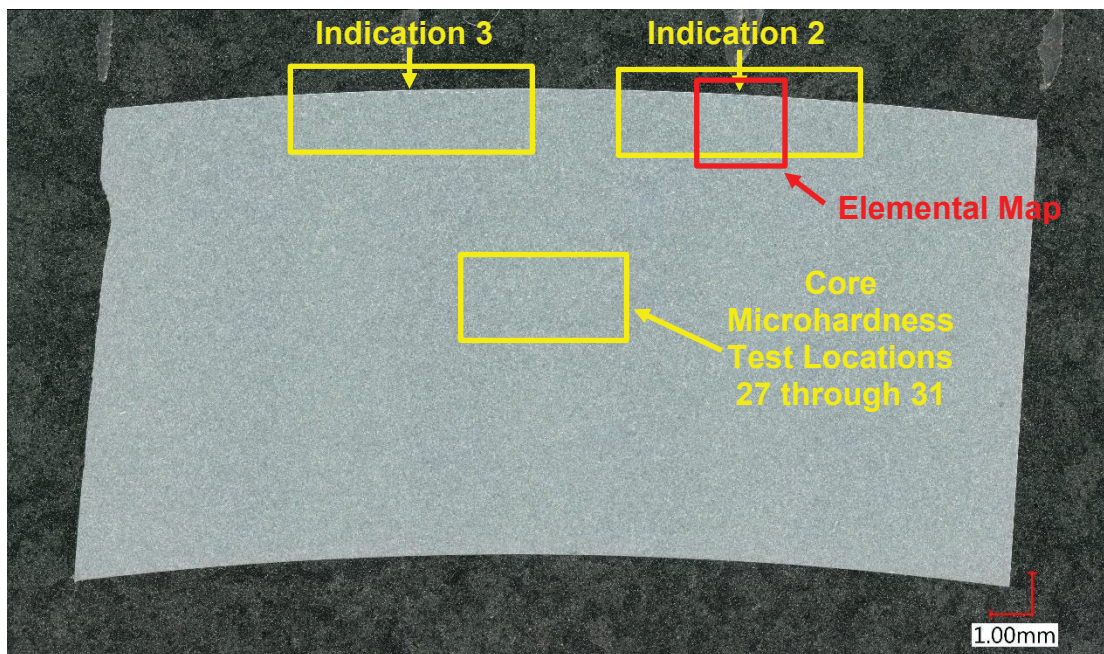
**Fig. 28** An overall view of the etched cross-section is shown after microhardness testing. The regions within the yellow boxes were microhardness tested, whereas the red boxed region shows the location of the elemental map in Figure 9. 2% Nital.

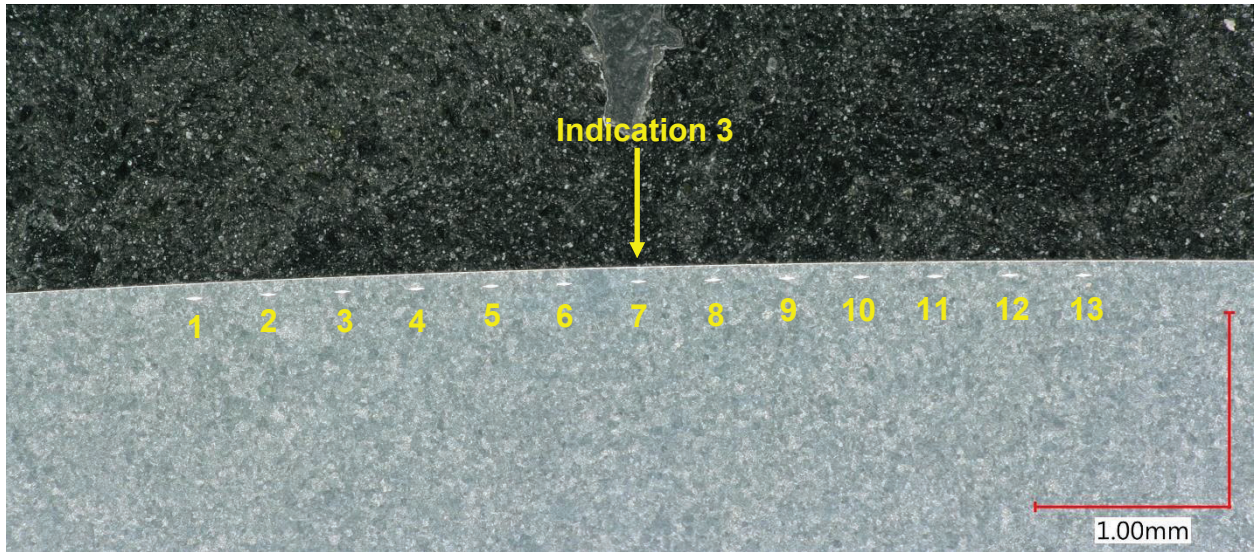
Near surface 200gf Knoop (HK 0.2) microhardness traverses were performed on the cross-section 0.003" from the surface at and adjacent to Indications 2 and 3, with the results presented in Table 1. Exact hardness locations are indicated in Figures 28 through 30. The hardness readings were generally consistent and did not follow a strong pattern surrounding the indication sites. Five microhardness readings were performed at the core with results summarized in Table 2.

**Fig. 29** The boxed region at Indication 3, originally shown in Figure 28, is shown in greater detail. Individual Knoop hardness indentations are visible and numbered, which correlate to their respective hardness results in Table 1. 2% Nital.

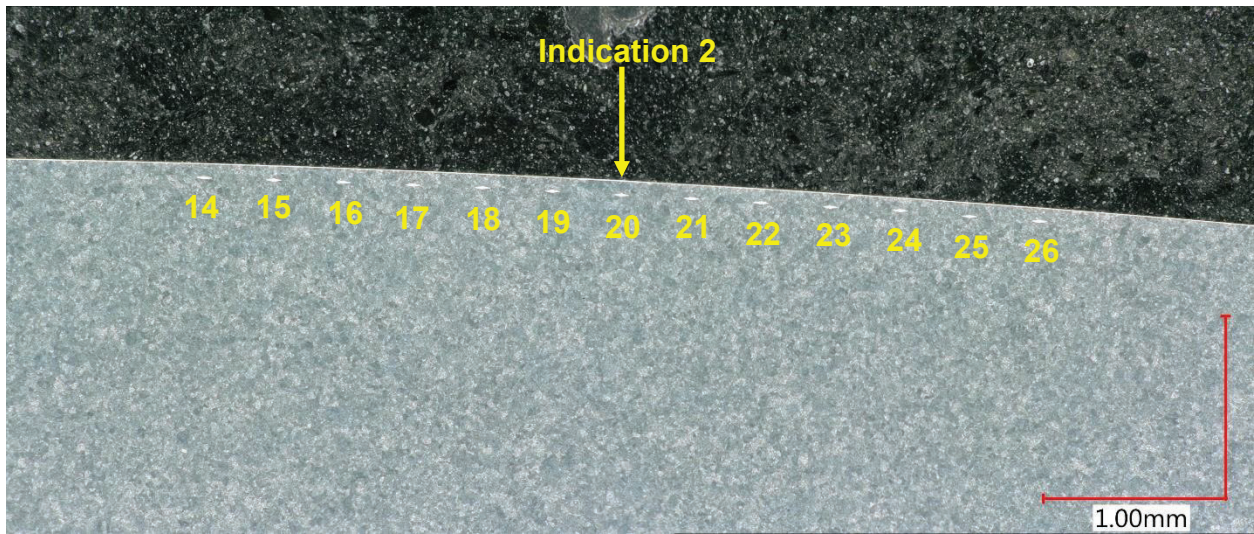
**Fig. 30** The boxed region at Indication 2, originally shown in Figure 28, is shown in greater detail. Individual Knoop hardness indentations are visible and numbered, which correlate to their respective hardness results in Table 1. 2% Nital.
