NBSIR 81-2374

# Investigation of Construction Failure of Harbour Cay Condominium in Cocoa Beach, Florida

September 1981

H. W. Lew  
N. J. Carino  
S. G. Fattal  
M. E. Batts

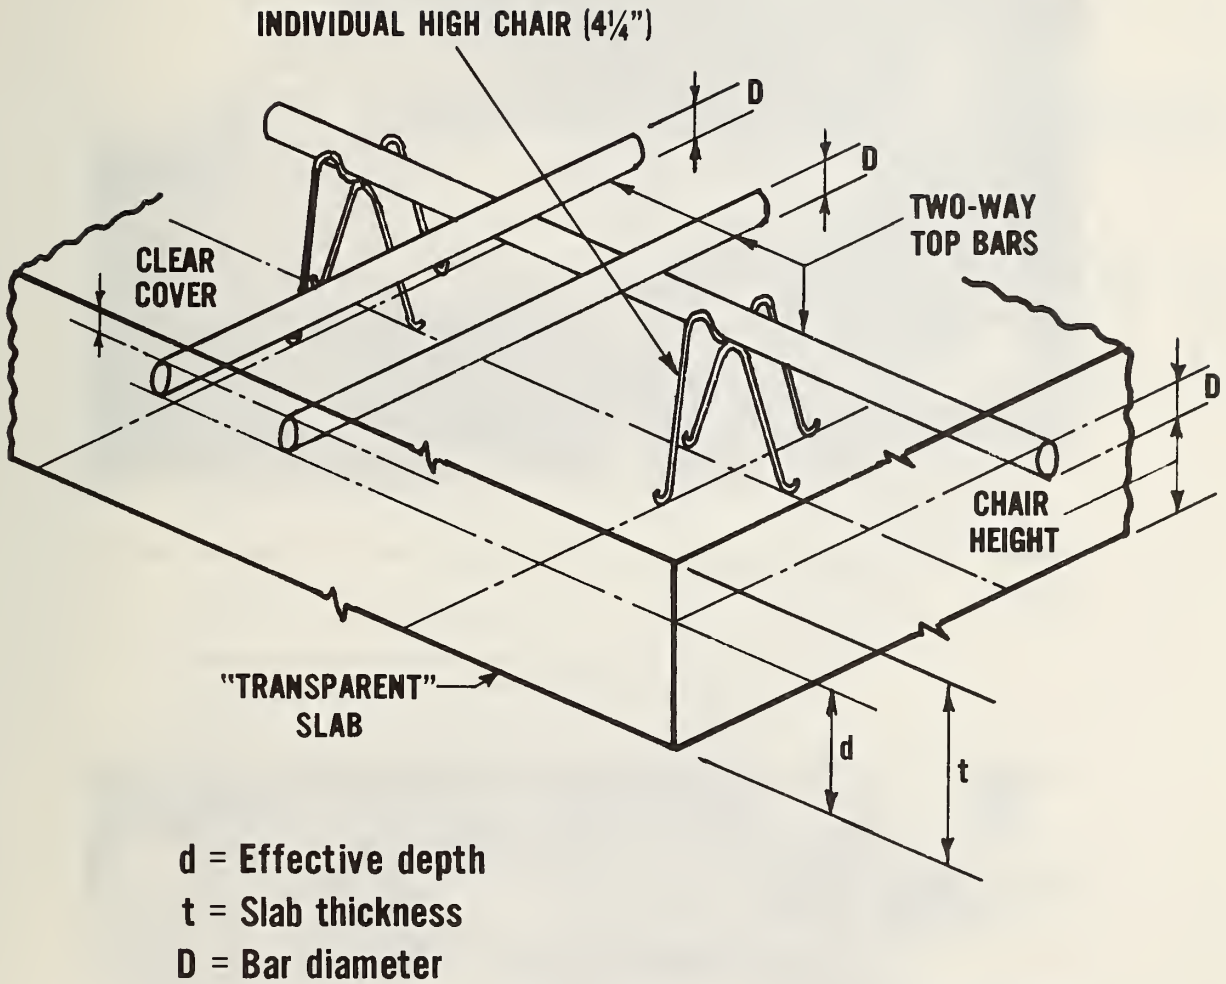
Figure 2.3 Configuration of chairs and top reinforcement in column strip

It is shown that high punching shear stresses resulted from use of reduced height individual high chairs to support the top reinforcing bars in the column strip, thereby reducing the effective depth of the slab. The omission of a check for punching shear capacity in the design calculations resulted in a slab thickness of 8 in (203 mm). The ACI Code would have required a thickness of 11 in (279 mm) to provide adequate safety against punching shear under design loads. It is shown that this design deficiency resulted in a reduction of the margin of safety such that the slab had insufficient reserve strength to accommodate construction errors.

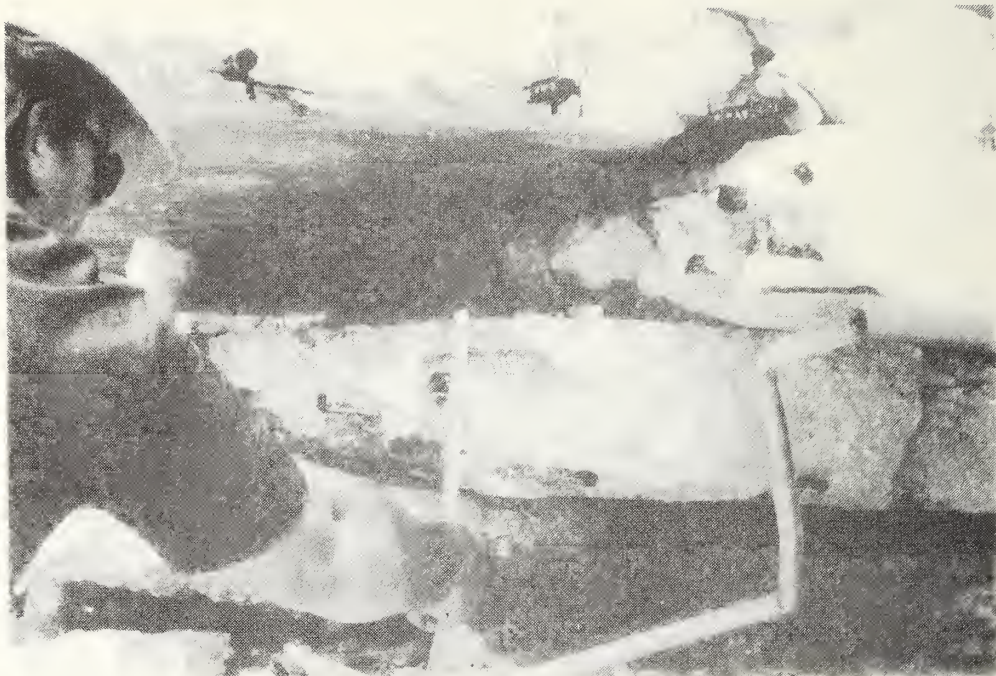
Figure 2.4 Field measurement of top bar cover in column strip

The calculated effective depth at a column where the top reinforcement in the slab consists of #8 and #9 bars is 5.3 in (135 mm). This is obtained by adding to the 4-1/4-in (108-mm) chair height the average diameter of the two bars. If the effective depth is taken to the centroid of the bars, as defined in section 2.1 of the ACI Code [2.1], its value would be 5.28 in (134 mm) or 5.35 in (136 mm) depending on which size bar is assumed to be at the top. Considering all the columns and using both methods of calculation, the effective depth is found to fall in the range of 4.97 to 5.35 in (126 to 136 mm). These figures will be somewhat less along the sides of columns at the edges of balcony and walkway

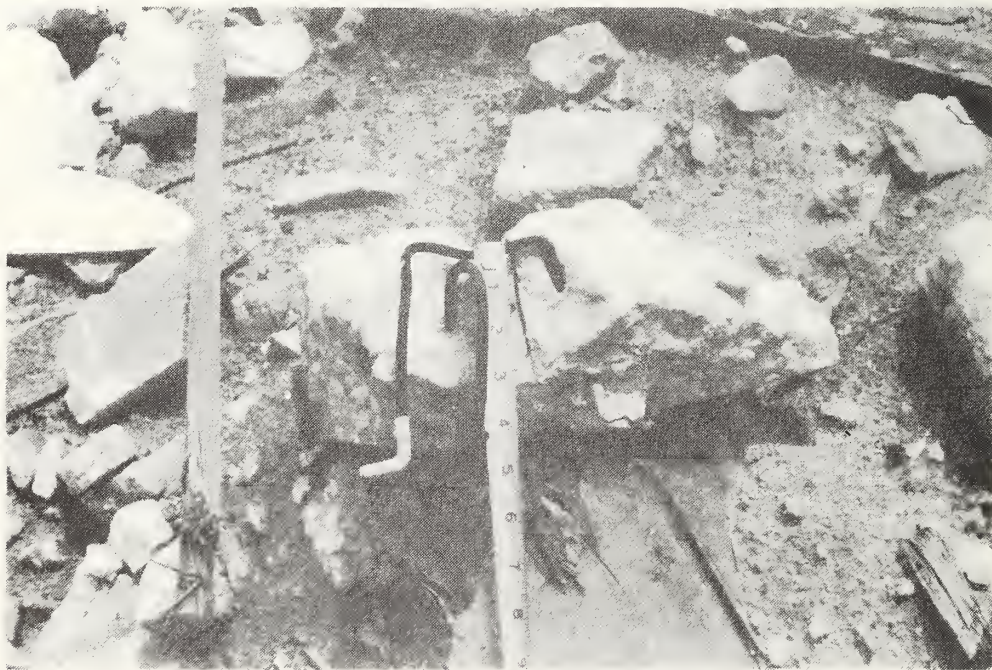
Figure 2.5 Field measurement of chair heights for top bars in column strip

There is, therefore, an inconsistency in the construction documents. The structural drawings indicated a 3/4-in (19-mm) cover for the top slab bars, whereas the chair height indicated on the steel supplier's shop drawings would result in more than 3/4-in cover for the top bars in the column strips of the slabs. The record copies of the shop drawings contained numerous check marks. One of the six pages bore the handwritten words "approved as noted" and the signature of the design engineer of record.

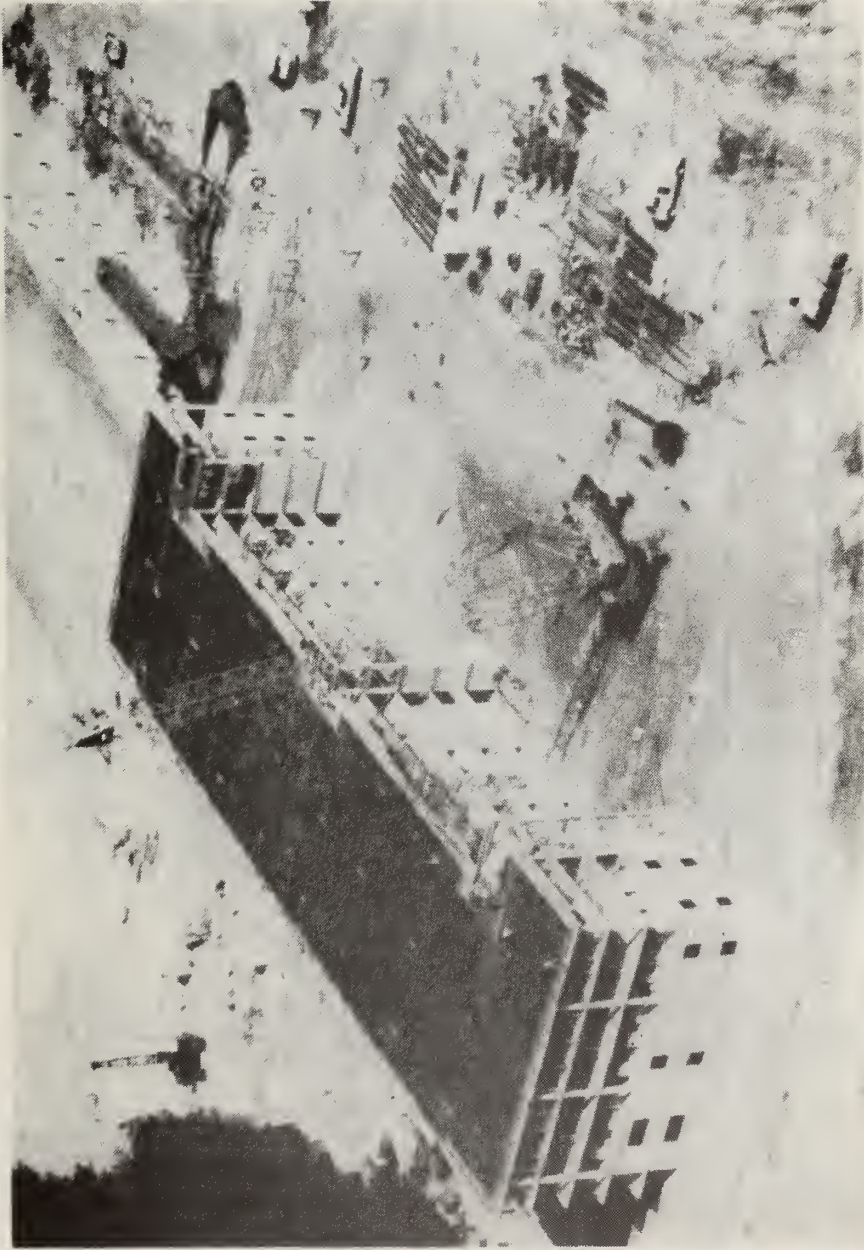
Figure 2.14 Aerial view of building taken from southeast

Figure 2.14 is an aerial photograph of the building viewed from the southeast side. The direction of the shadows and the presence of the steel reinforcement for the roof slab indicate the photograph to have been taken on the morning of March 26, or the day before the collapse. The steep angle of the photograph conceals the view of interior reshores in the fourth story and below. It is noted that at the south end only one exterior reshore is in place in each bay of the fourth story while no reshores are in place at the same location in the third story. This contradicts the reshoring plans supplied by the general contractor where two reshores are shown in each bay along the exterior edges of the slabs. It is possible that some of the original reshores were removed to place masonry units in the third floor, as indicated by worker statements.

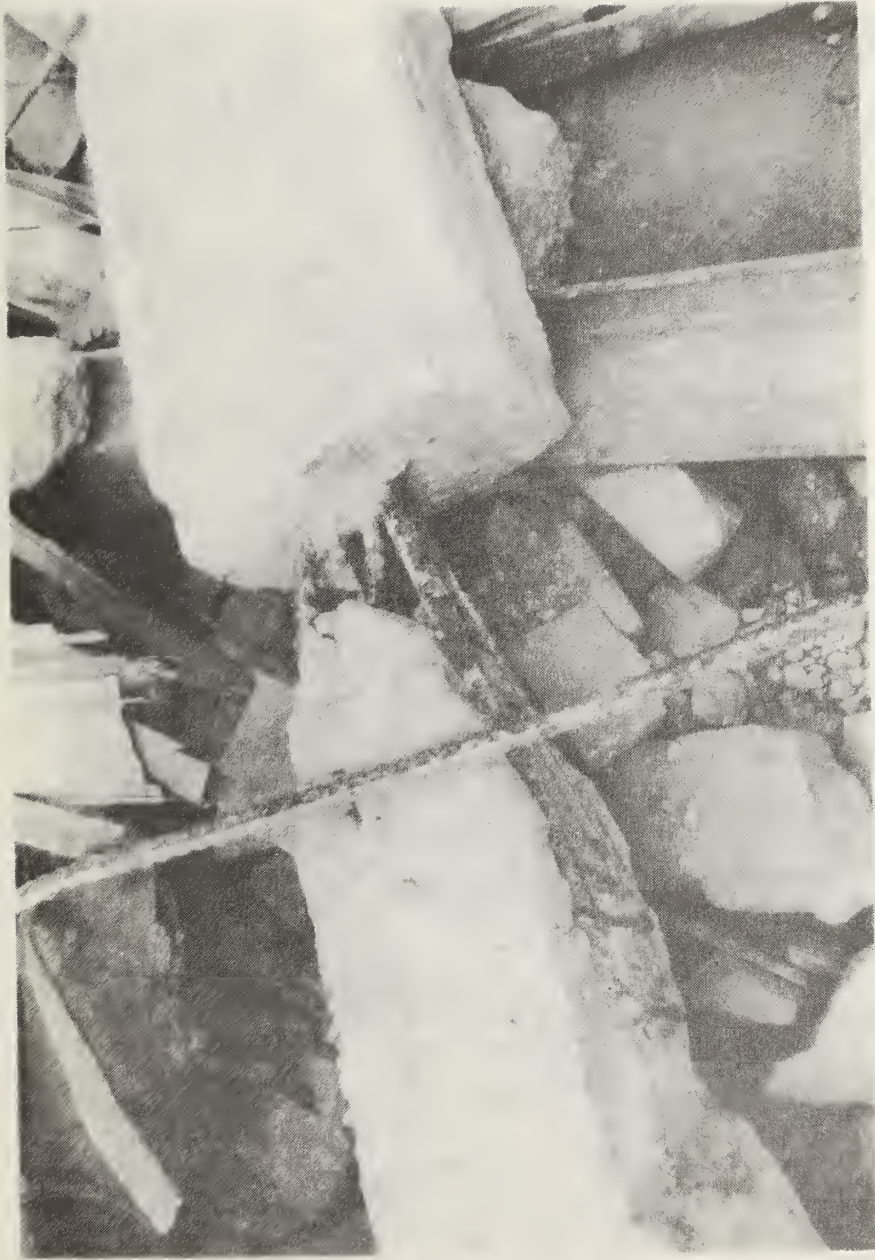
Figure 3.2 Severely bent column reinforcement

1. The slabs broke away from the columns at the slab-column interface (figure 3.2).
2. One or two bottom slab bars were placed through some columns. In many other columns no such evidence was noted.
3. In some cases, the vertical reinforcement above the floor level was bent severely during fabrication (figure 3.2).
4. Column size measurements agreed with the structural drawings.

Three workers (#40, #45, #73) mentioned that the construction joints at the middle of the building were not of good quality. They were described as "ragged", "cracked", and "honeycombed". Two workers (#45, #14) mentioned that they saw rebars showing on the faces of some columns. The incomplete filling of the column forms was probably due to congestion of steel (see figure 3.3), which, according to a supervisor (#72) was so severe in some of the second and third floor columns that the top reinforcing steel in the slabs could not pass through. In order to pass slab bars through some columns, the protruding column reinforcement was "bunched together" and the slab bars were placed alongside the column bars (figure 3.2).

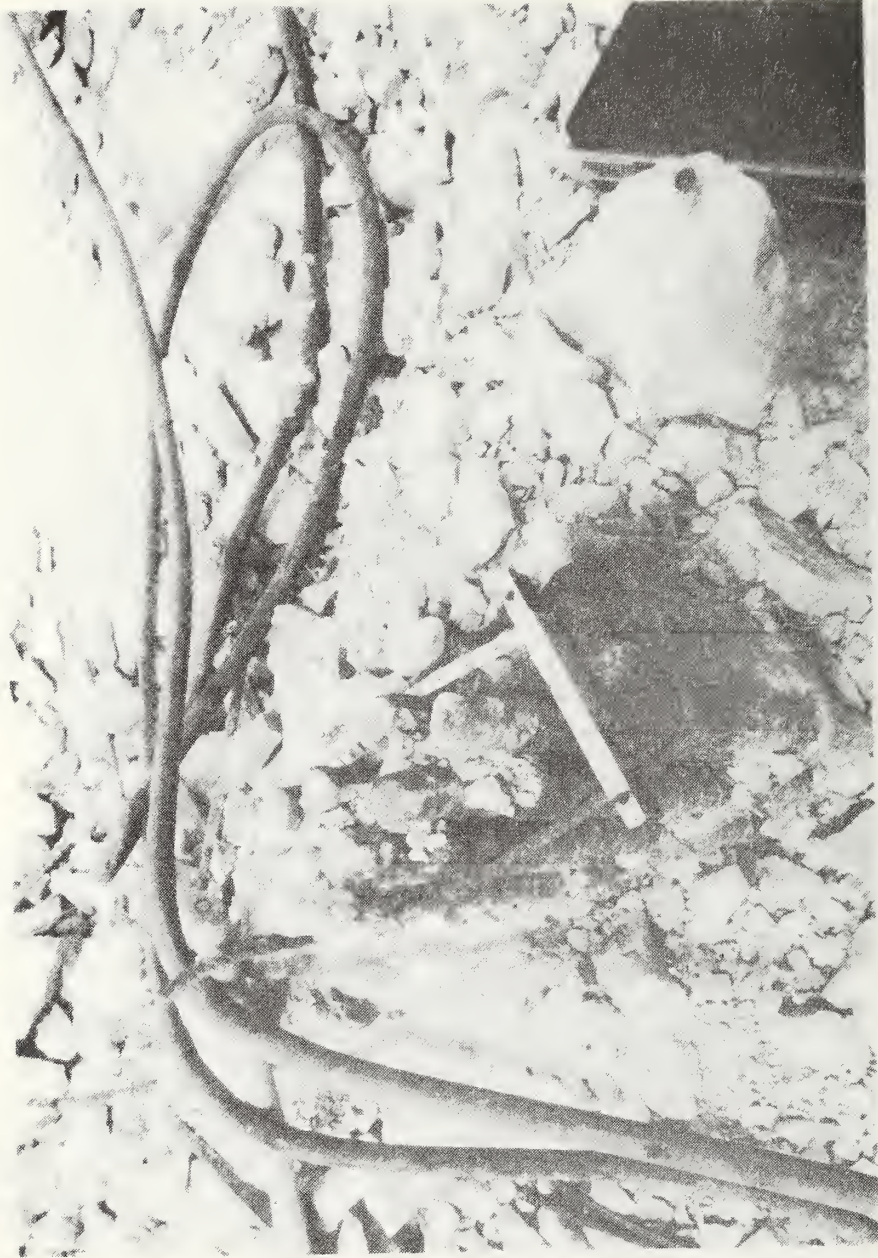
Figure 3.3 Congested reinforcement in a first-story column

It was also noted from the first-story column sections still standing on the ground level that where 8- # 10 or 8- # 11 bars were lapped, in a 10 x 18 in (250 x 460 cm) column section, the total steel area exceeded considerably the maximum limit of four percent of the gross area of the concrete allowed by the

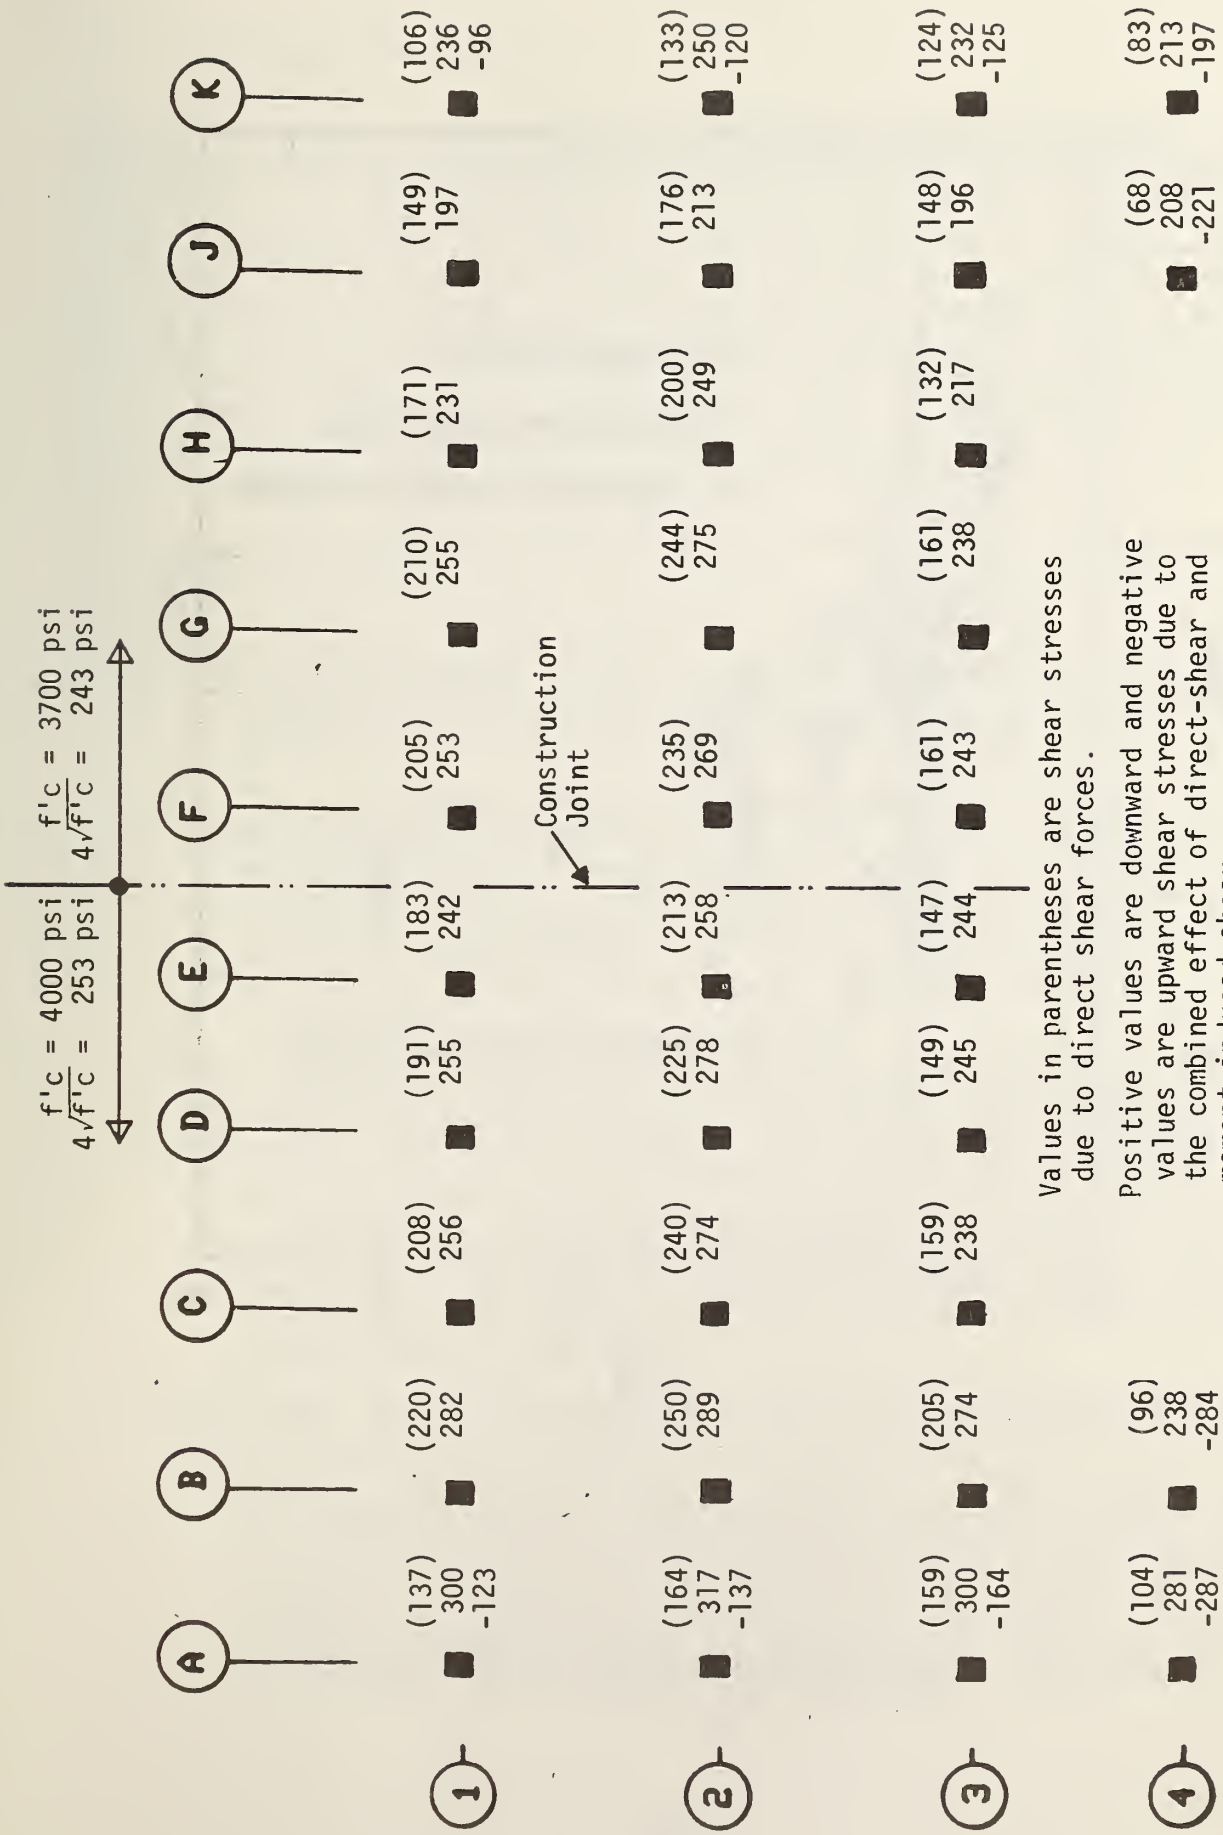
Figure 6.4 Punching shear stresses in fifth floor slab

It is concluded that the most probable cause of the failure was the lack of adequate punching shear capacity in the fifth-floor slab at several of the columns to resist the applied construction loads. This deficiency was brought about by the design inadequacy which resulted in the slab thickness of 8 in instead of 11-in and by the placement of the top reinforcement at the column strips with significantly greater cover than that which would have met the cover requirement specified by the structural drawings. This resulted in an insufficient effective depth of the fifth floor slab to resist punching shear under construction loads.
