Problem Statement: At 0421 on 11/17/2022 pump PUMP2A tripped on time overcurrent. The trip was preceded (within 2 minutes prior to trip) by increasing gearbox acceleration, decreasing speed, increasing motor winding temperature, and small drops in pump flow and discharge pressure.

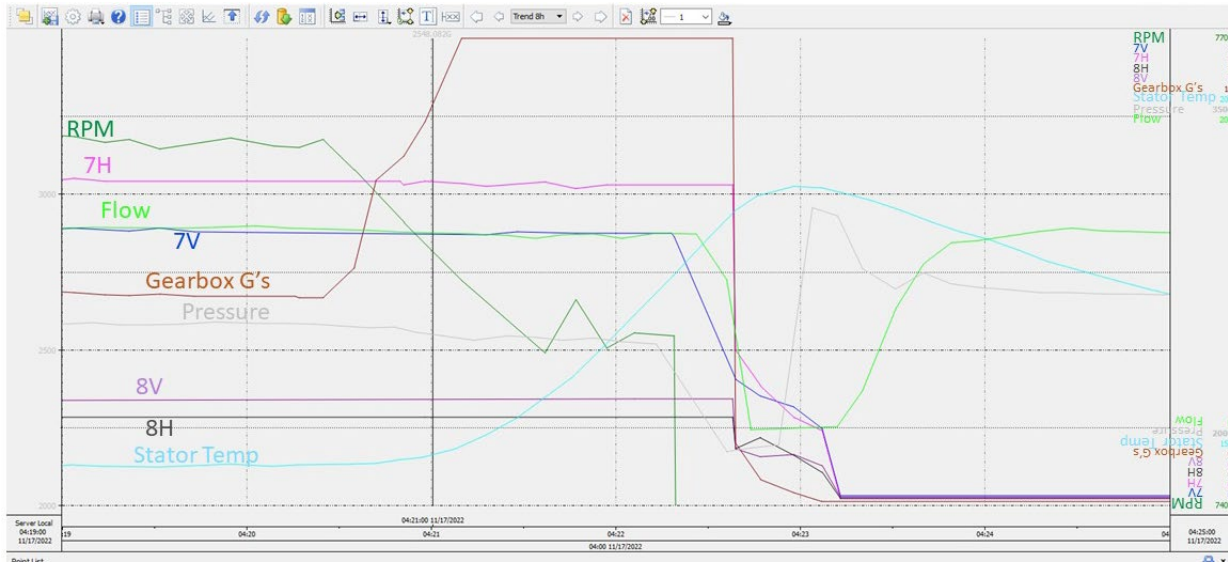
A summary of the parameter changes is below (the scales for each parameter are color coded on the right side of the plot). Note that pump vibration did not change until the pump tripped.

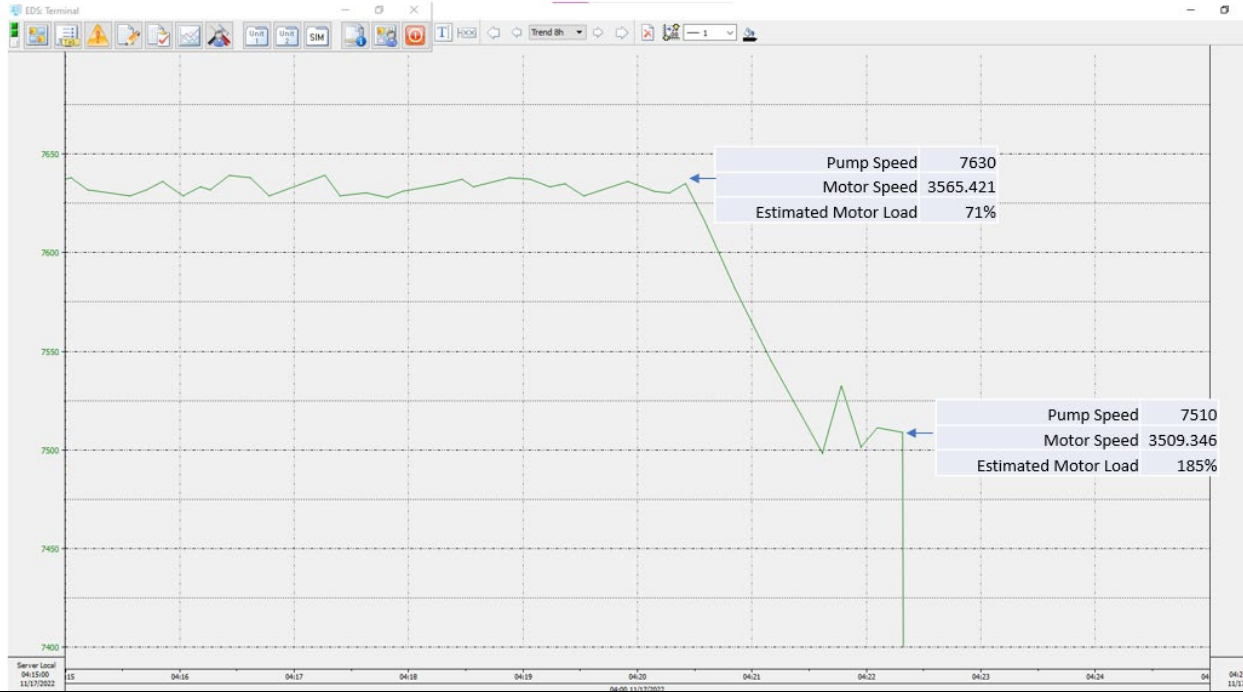
- Under the scenario of increased mechanical load, the measured pump speed can be correlated to the estimated motor load using the gearbox ratio and the motor nameplate speed. The results suggest the motor was initially at 70% load and increased to 185% load for 30 seconds (if it was an actual overload rather than torque speed characteristic degradation). Figure below

2.140 gear ratio. 3551 motor nameplate speed.
