MC 1st FLOOR LEVEL DECK INVESTIGATION SUMMARY
AND DOCUMENTATION OF EXISTING CONDITIONS

CHAMPLAIN TOWERS
SOUTH
8777 COLLINS AVENUE
SURFSIDE, FLORIDA 33154

CHAMPLAIN TOWERS
SOUTH - PHASE IIA

MC SOFFIT INVESTIGATION SUMMARY AND RECOMENDED REPAIR WORK

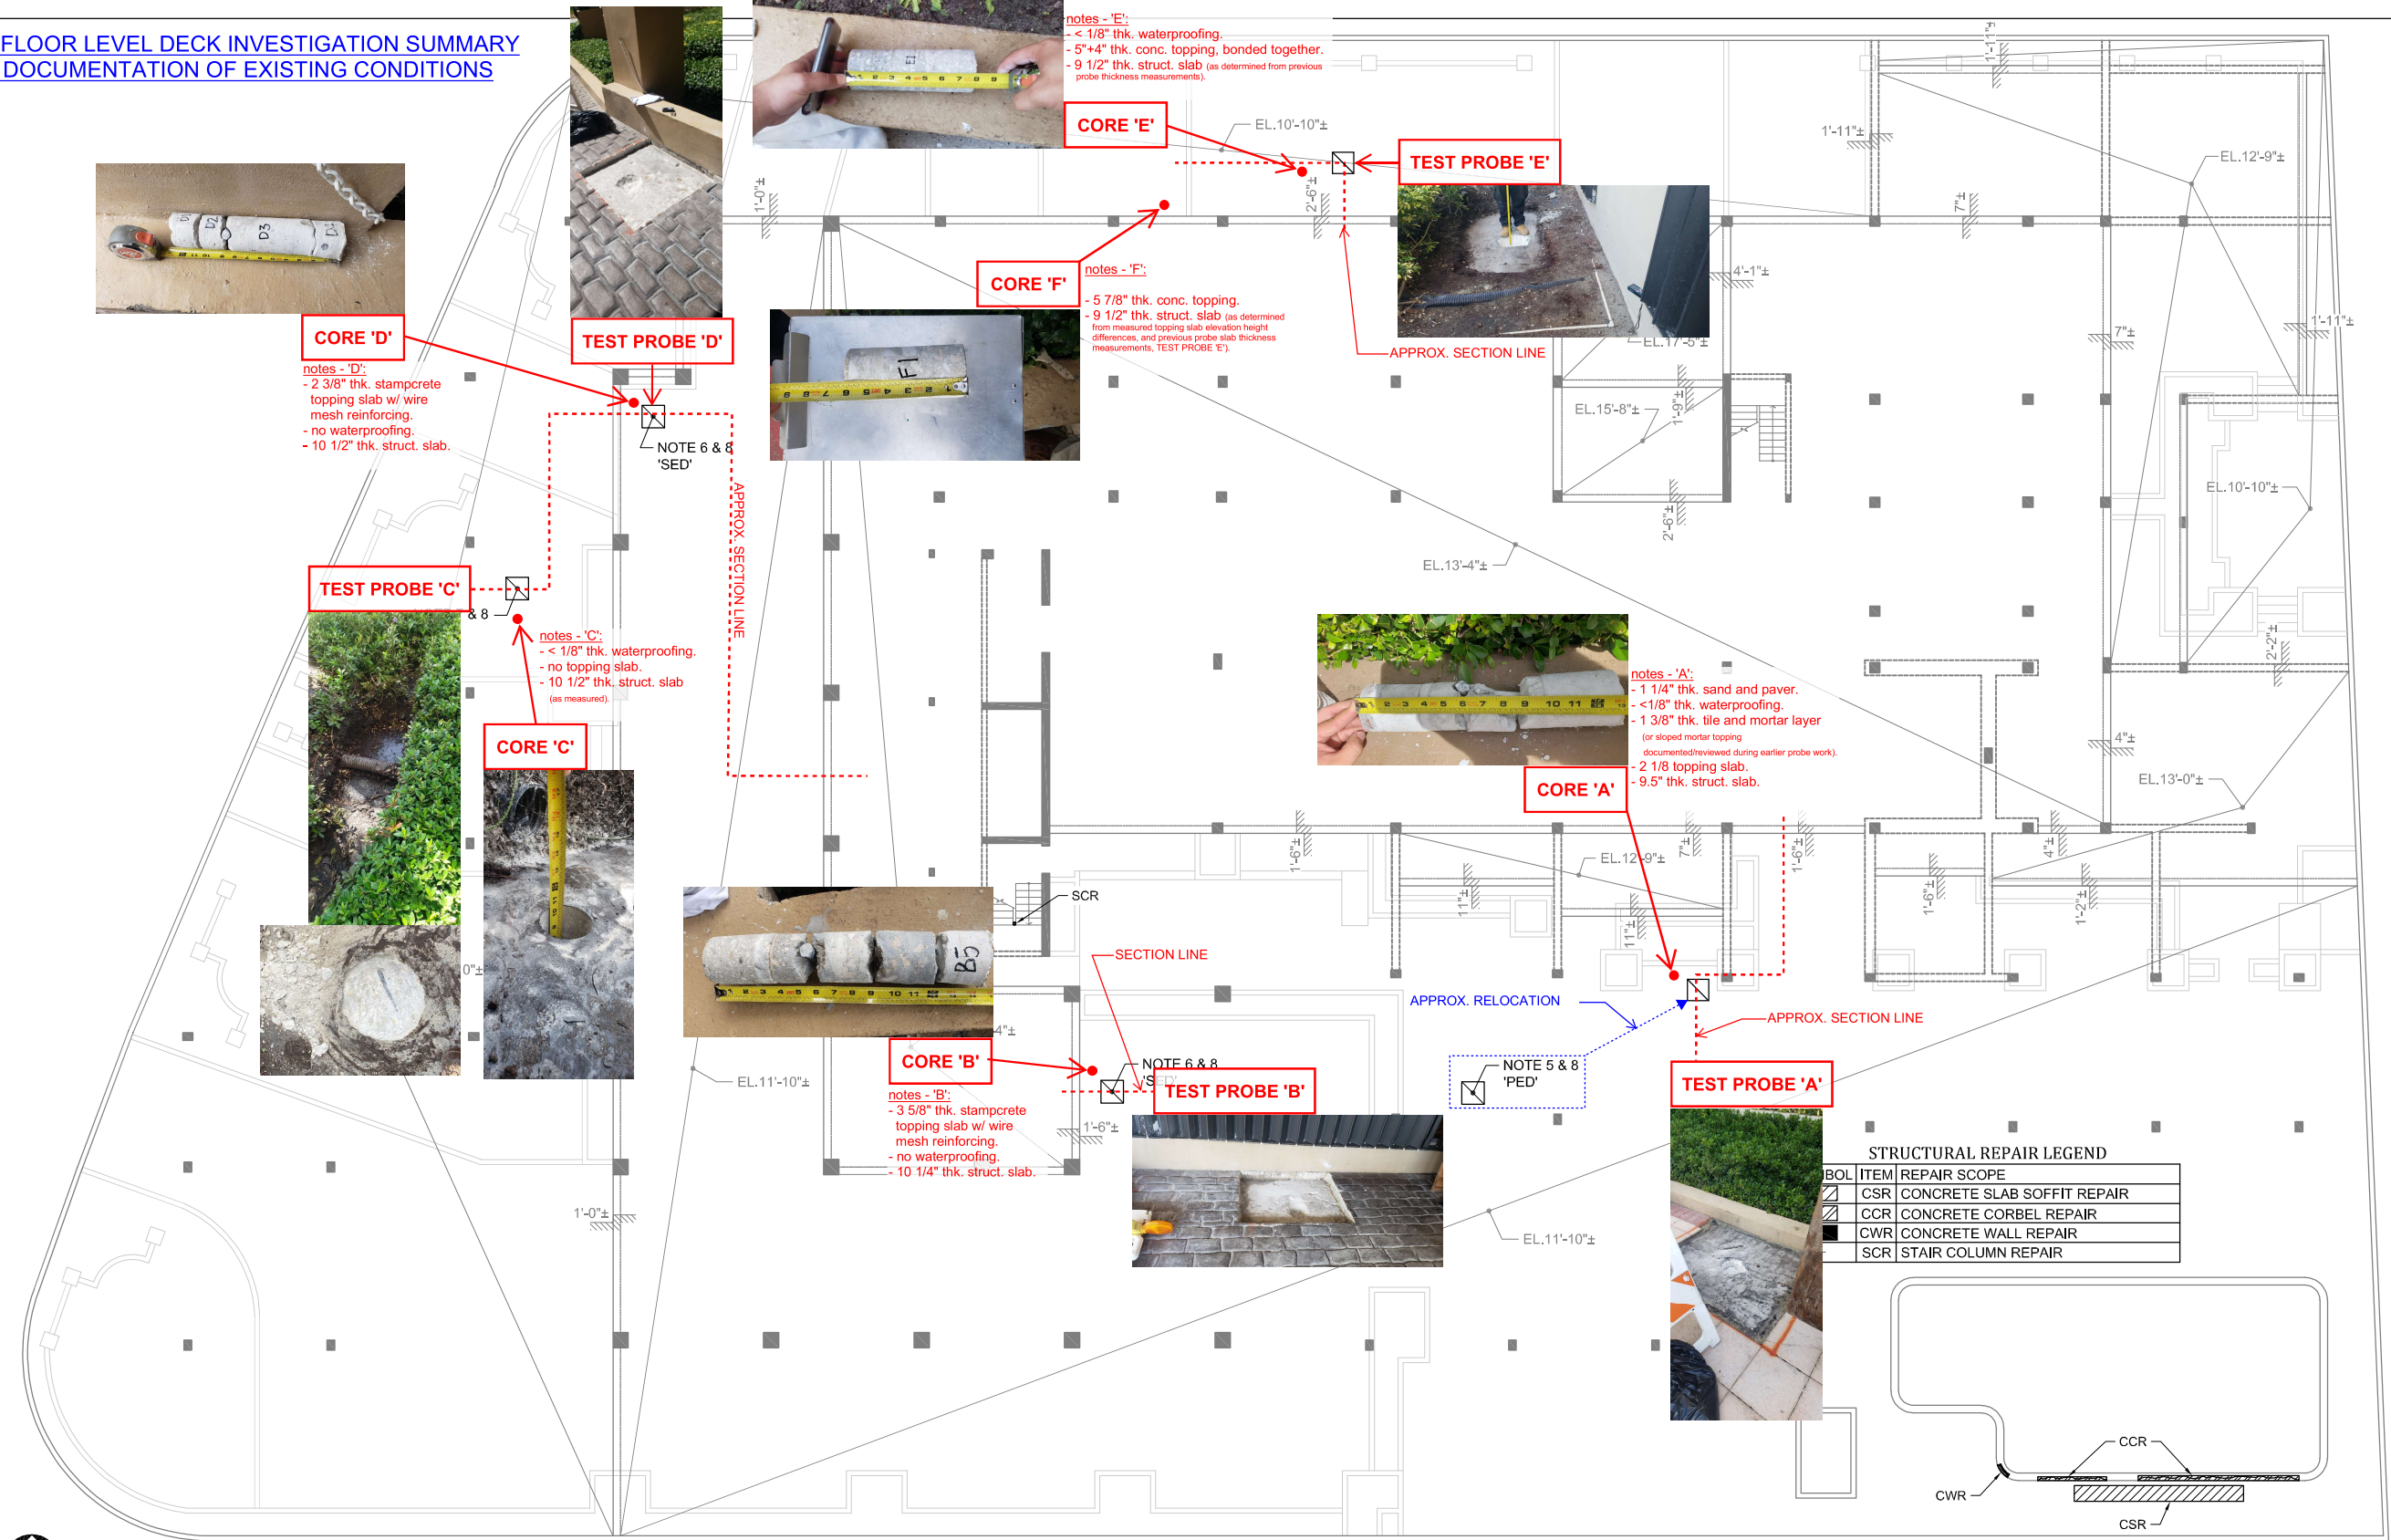
S2A-1.1

- EXISTING FIRST FLOOR (LOBBY LEVEL) FRAMING IS A 9 1/2" THICK CAST-IN-PLACE CONCRETE TWO-WAY FLAT PLATE FLOOR SLAB REINFORCED WITH A BOTTOM MAT OF #4 AT 12"o/c AND TOP BARS AS INDICATED ON 'S5' OF THE EXISTING DRAWINGS. THE STRUCTURAL FLOOR SLAB IS STEPPED AS SHOWN ON PLAN WITH 12" WIDE DROP BEAMS AT TRANSITIONS.

- THE CONTRACTOR SHALL COMPLETE CAREFUL EXPLORATORY DEMOLITION OF THE PAVER SYSTEM AT THE POOL DECK TO DOCUMENT THE COMPOSITION OF THE SYSTEM. AN APPROXIMATE 3'-0"x3'-0" AREA SHALL BE DEMOLISHED IN THE LOCATION NOTED ON PLAN. THE PAVER SYSTEM SHALL BE DEMOLISHED DOWN TO THE TOP OF THE EXISTING WATERPROOFING, IF WATERPROOFING IS PLACED DIRECTLY ON TOP OF STRUCTURAL SLAB. THE CONTRACTOR SHALL TAKE PROPER PRECAUTIONS TO AVOID DAMAGING THE EXISTING WATERPROOFING AND FLOOR SLAB. (BID ITEM 'PED')

- THE CONTRACTOR SHALL COMPLETE CAREFUL EXPLORATORY DEMOLITION OF THE STAMPED CONCRETE TOPPING AT THE PARKING AREA AND DRIVE AISLE TO DOCUMENT THE COMPOSITION OF THE SYSTEM. AN APPROXIMATE 3'-0"x3'-0" AREA SHALL BE DEMOLISHED IN THE LOCATION NOTED ON PLAN. THE STAMPED CONCRETE TOPPING SHALL BE DEMOLISHED DOWN TO THE TOP OF THE EXISTING WATERPROOFING, IF WATERPROOFING IS PLACED DIRECTLY ON TOP OF STRUCTURAL SLAB. THE CONTRACTOR SHALL TAKE PROPER PRECAUTIONS TO AVOID DAMAGING THE EXISTING WATERPROOFING AND FLOOR SLAB. (BID ITEM 'SED')

- THE CONTRACTOR SHALL COMPLETE CAREFUL EXPLORATORY EXCAVATION AND DEMOLITION OF THE PLANTER SYSTEM WITHIN THE LANDSCAPING BEDS TO DOCUMENT THE COMPOSITION OF THE SYSTEM. AN APPROXIMATE 3'-0"x3'-0" AREA SHALL EXCAVATED IN THE LOCATION NOTED ON PLAN AND THE SUB PLANTER WATERPROOFING, DRAINAGE BOARD, ETC.. SHALL BE DOCUMENTED. THE SUB PLANTER SYSTEMS SHALL BE DEMOLISHED DOWN TO THE TOP OF THE EXISTING WATERPROOFING, IF WATERPROOFING IS PLACED DIRECTLY ON TOP OF STRUCTURAL SLAB. THE CONTRACTOR SHALL TAKE PROPER PRECAUTIONS TO AVOID DAMAGING THE EXISTING WATERPROOFING AND FLOOR SLAB. (BID ITEM 'LED')

- MORABITO CONSULTANTS SHALL BE NOTIFIED TO INSPECT AND DOCUMENT ALL TEST PITS UPON CONTRACTORS COMPLETED DEMOLITION. ONCE THE INSPECTION AND DOCUMENTATION IS COMPLETED, THE CONTRACTOR SHALL RESTORE ALL DEMOLISHED AREAS BACK TO THEIR ORIGINAL CONDITIONS. REPLACE ANY DAMAGED WATERPROOFING PER WATERPROOFING MANUFACTURERS REQUIREMENTS, RE-INSTALL THE PAVER SYSTEM AT THE POOL DECK, REPLACE/REPAIR THE STAMPED CONCRETE AT THE PARKING AREA, AND RESTORE THE PLANTER TO THE ORIGINAL CONDITION.

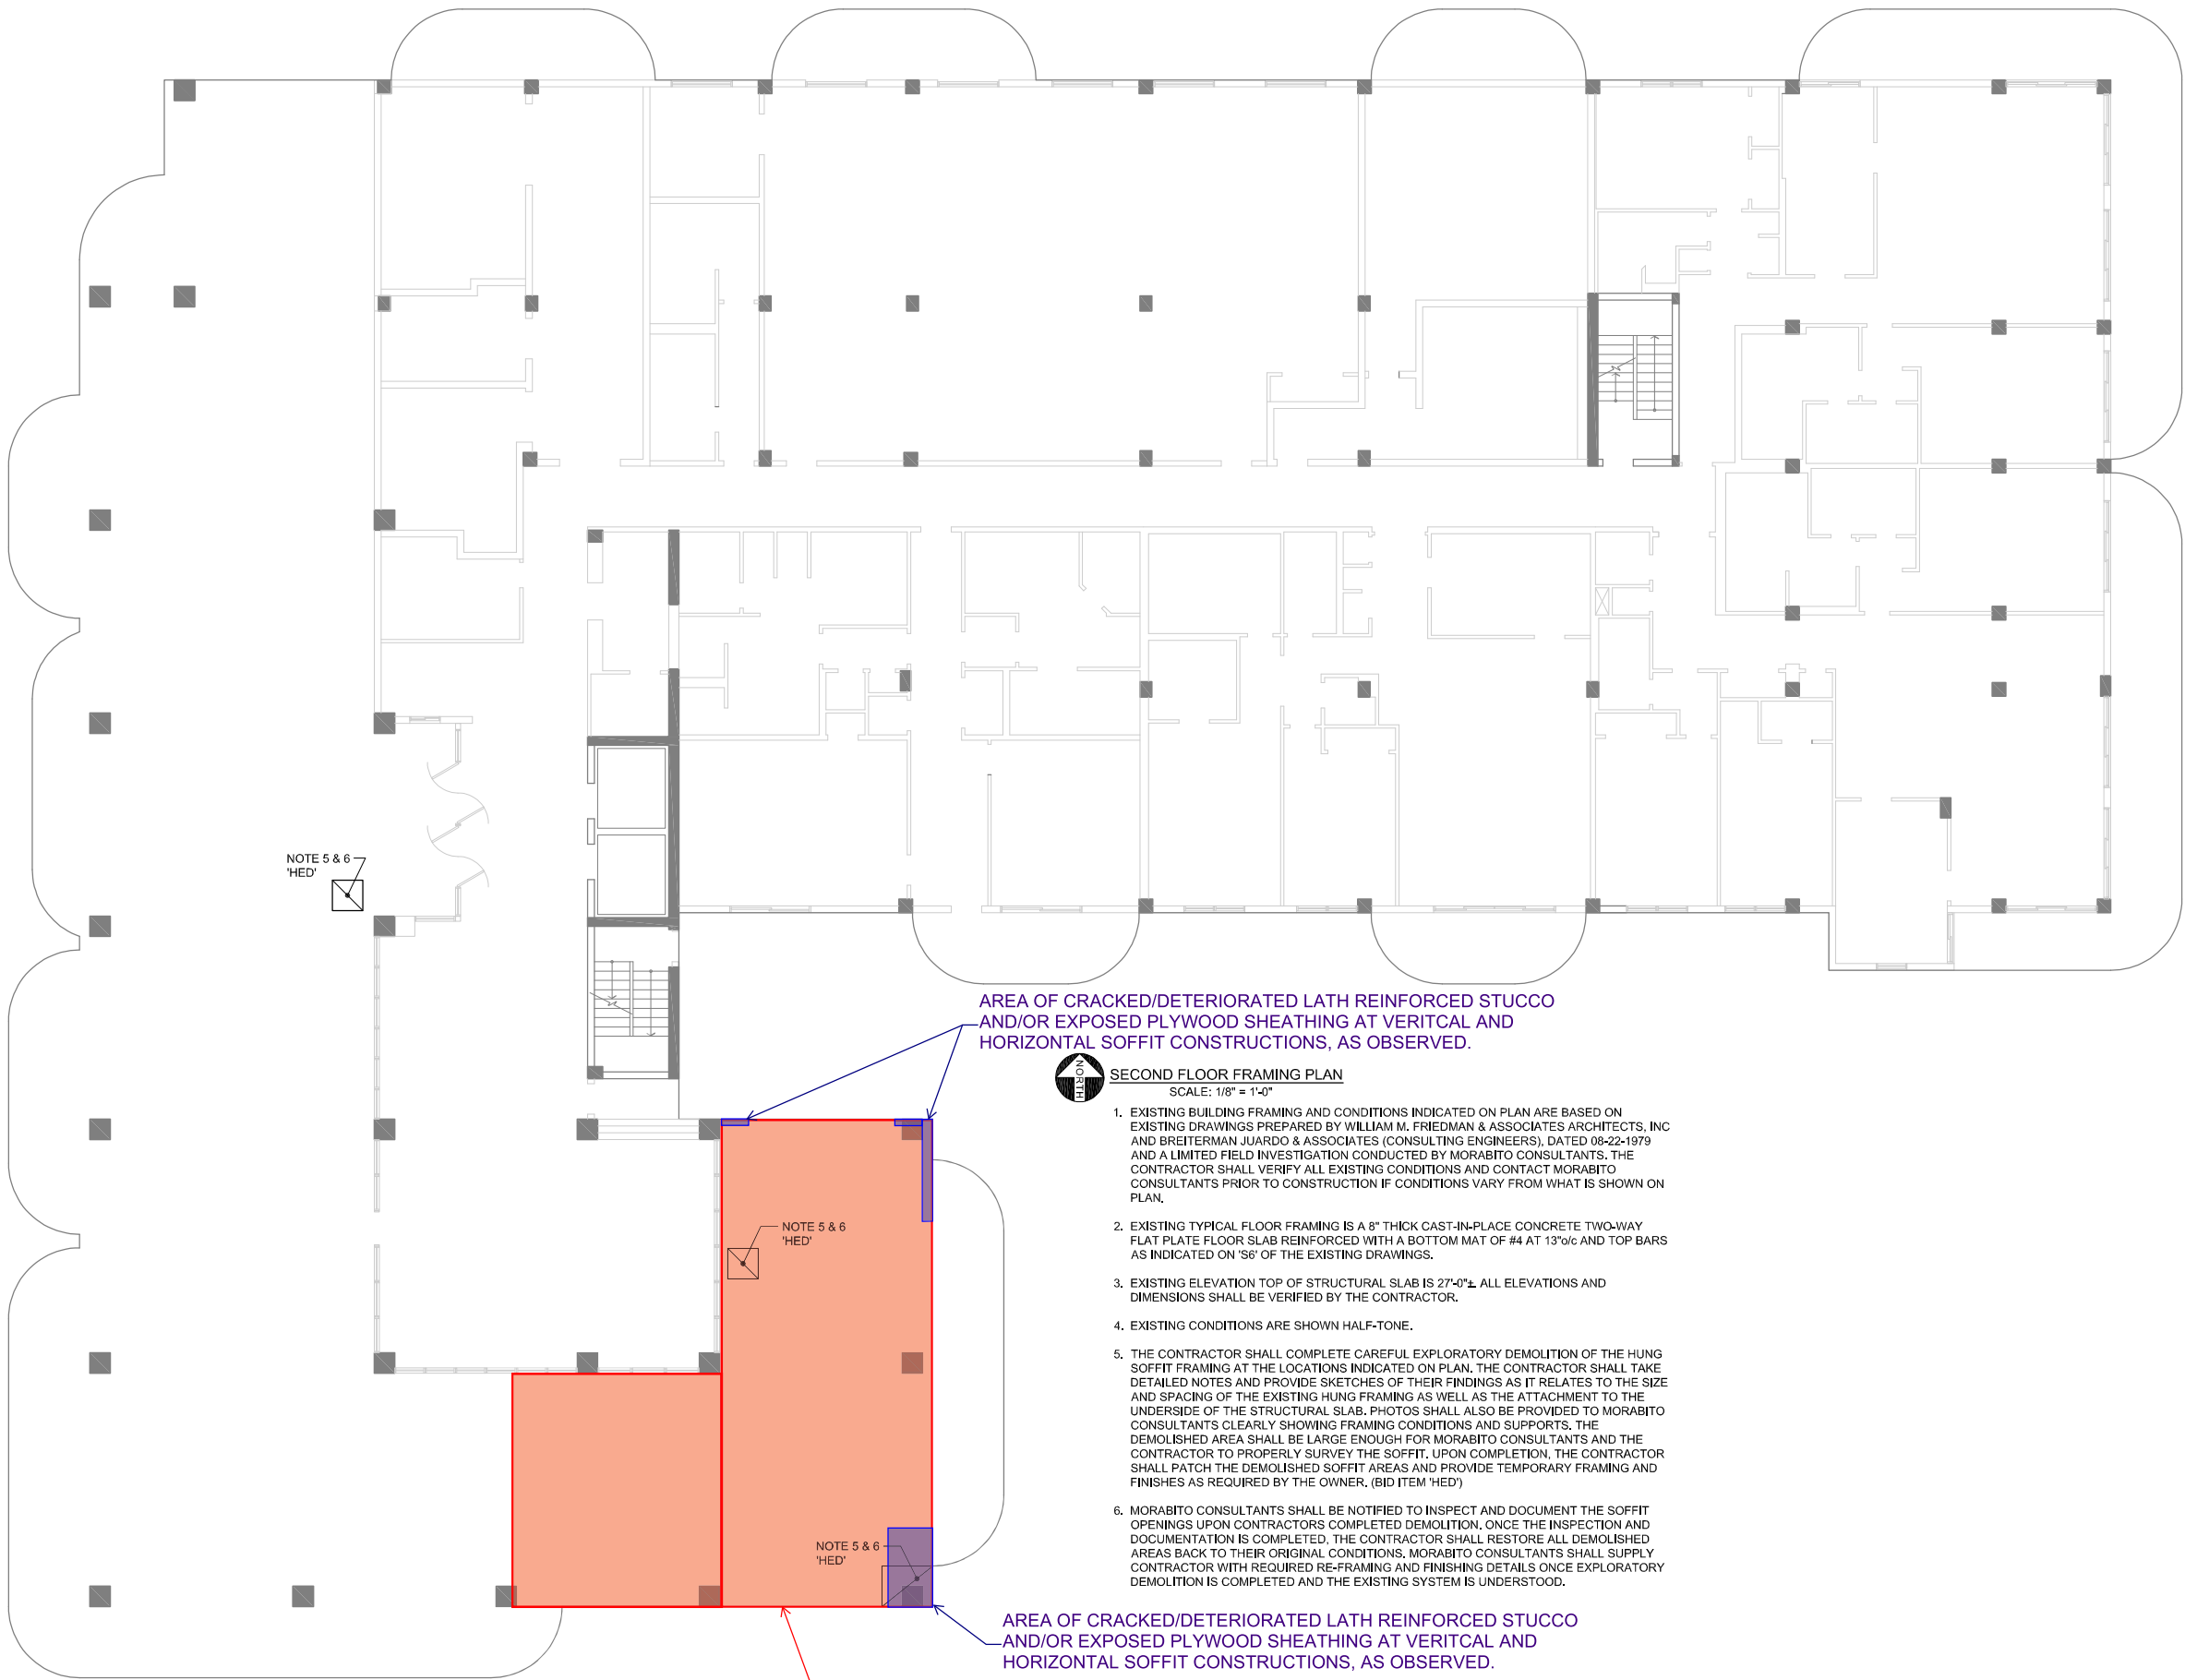
S2A-1.2

AREA OF CRACKED/DETERIORATED LATH REINFORCED STUCCO AND/OR EXPOSED PLYWOOD SHEATHING AT VERITCAL AND HORIZONTAL SOFFIT CONSTRUCTIONS, AS OBSERVED.

AREA CONTANING SAGGING /CRACKED SOFFIT CONDITIONS, AS OBSERVED.
MC (ESTIMATED) RECOMMENDED AREA OF REMOVAL/REPAIR WORK

• Soffit is metal stud framed (2x4's), 3/8-inch plywood, and ½-inch thk. lath reinforced stucco.

5. THE CONTRACTOR SHALL COMPLETE CAREFUL EXPLORATORY DEMOLITION OF THE HUNG SOFFIT FRAMING AT THE LOCATIONS INDICATED ON PLAN. THE CONTRACTOR SHALL TAKE DETAILED NOTES AND PROVIDE SKETCHES OF THEIR FINDINGS AS IT RELATES TO THE SIZE AND SPACING OF THE EXISTING HUNG FRAMING AS WELL AS THE ATTACHMENT TO THE UNDERSIDE OF THE STRUCTURAL SLAB. PHOTOS SHALL ALSO BE PROVIDED TO MORABITO CONSULTANTS CLEARLY SHOWING FRAMING CONDITIONS AND SUPPORTS. THE DEMOLISHED AREA SHALL BE LARGE ENOUGH FOR MORABITO CONSULTANTS AND THE CONTRACTOR TO PROPERLY SURVEY THE SOFFIT. UPON COMPLETION, THE CONTRACTOR SHALL PATCH THE DEMOLISHED SOFFIT AREAS AND PROVIDE TEMPORARY FRAMING AND FINISHES AS REQUIRED BY THE OWNER. (BID ITEM 'HED')

6. MORABITO CONSULTANTS SHALL BE NOTIFIED TO INSPECT AND DOCUMENT THE SOFFIT OPENINGS UPON CONTRACTORS COMPLETED DEMOLITION. ONCE THE INSPECTION AND DOCUMENTATION IS COMPLETED, THE CONTRACTOR SHALL RESTORE ALL DEMOLISHED AREAS BACK TO THEIR ORIGINAL CONDITIONS. MORABITO CONSULTANTS SHALL SUPPLY CONTRACTOR WITH REQUIRED RE-FRAMING AND FINISHING DETAILS ONCE EXPLORATORY DEMOLITION IS COMPLETED AND THE EXISTING SYSTEM IS UNDERSTOOD.
