## Another Look at Hartford Civic Center Coliseum Collapse

Martin, R., and Delatte, N. (2001). "Another Look at Hartford Civic Center Coliseum Collapse." *J.Perform.Constr.Facil.*, 15(1), 31-36.

# ANOTHER LOOK AT HARTFORD CIVIC CENTER COLISEUM COLLAPSE

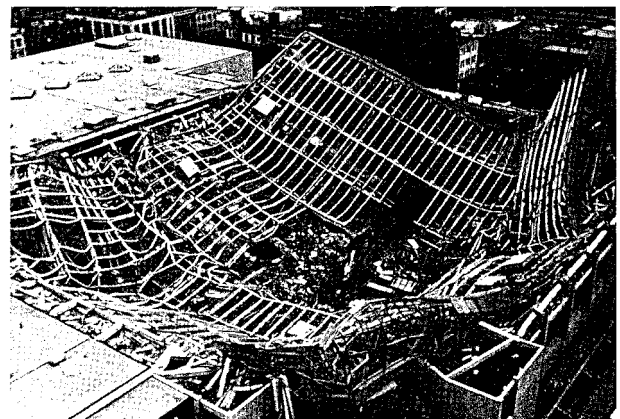
No one was killed or injured when the huge space truss roof of the empty Hartford Civil Center Coliseum collapsed under a heavy snowfall at 4:19 a.m. on January 18, 1978 (Fig. 1). Had the failure occurred just a few hours before, however, the death toll might have been hundreds, or even thousands. The dramatic roof, designed with the aid of computers, had shown evidence of distress during construction, but the warnings had not been heeded. The building had been in service for five years when it collapsed (Levy and Salvadori 1992).

FIG. 1. Hartford Civic Center Coliseum Roof Collapse, 1978 (Construction Failure, Feld and Carper, © 1997. Reprinted by Permission of John Wiley & Sons, Inc.)

On January 18, 1978, the Hartford Arena experienced the largest snowstorm of its five-year life. At 4:19 a.m., the center of the arena’s roof plummeted 25.3 m (83 ft) to the floor of the arena, throwing the corners into the air. Just hours earlier the arena had been packed. Luckily, it was empty by the time of the collapse (Ross 1984).

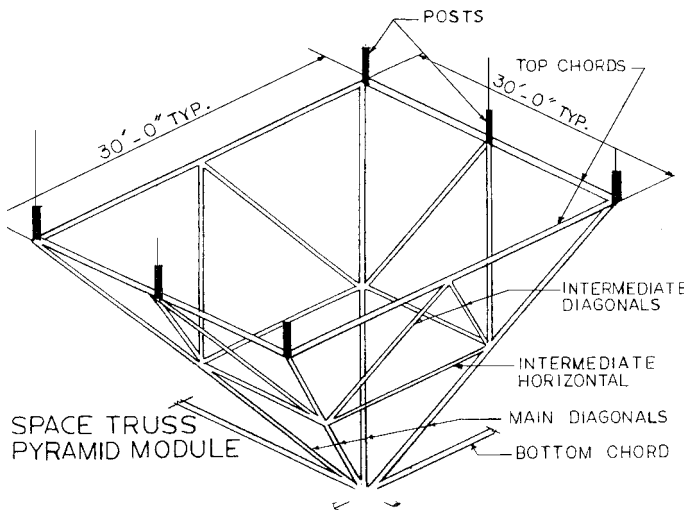
m (83 ft) over the arena. The proposed roof consisted of two main layers arranged in  $9.14 \times 9.14$  m (30 by 30 ft) grids composed of horizontal steel bars 6.4 m (21 ft) apart. Diagonal members 9.14 m (30 ft) long connected the nodes of the upper and lower layers and, in turn, were braced by an intermediate layer of horizontal members. The 9.14 m (30 ft) members in the top layer were also braced at their midpoint by intermediate diagonal members (Figs. 2 and 3).

FIG. 3. Section of Space Frame Roof (Figure Courtesy of LZA Technology, from Lev Zetlin Associates, 1978, Reprinted by Permission)

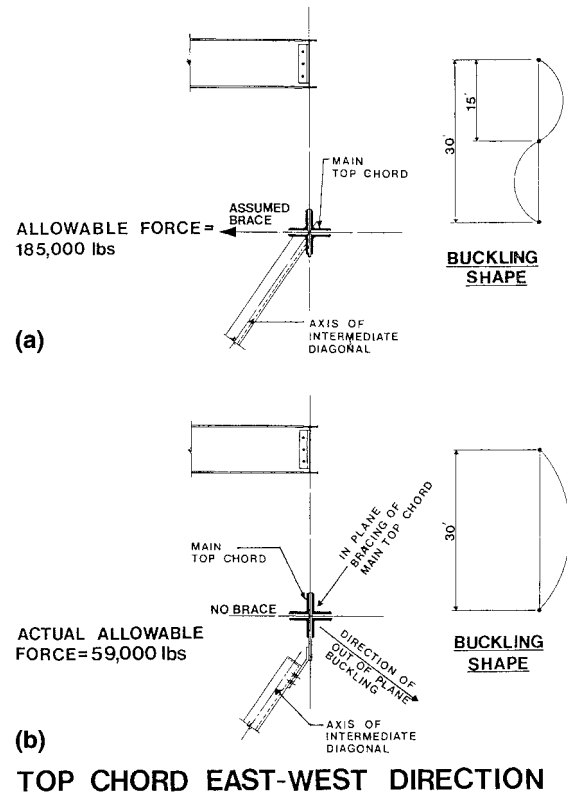
In addition to these errors in the original design, LZA discovered that no midpoint braces were provided for the members in the top layer. The exterior members were only braced every 9.14 m (30 ft), rather than the 4.57 m (15 ft) intervals specified, and the interior members were only partially and insufficiently braced at their midpoints. The two members attached to the midpoint of the top chord were both in the same plane as the long axis of the chord, so they only provided bracing in one direction. The perpendicular direction was effectively unbraced for the full 9.14 m (30 ft) length. This significantly reduced the load that the roof could safely carry. In addition, certain perimeter top chord members with a post landing at midpoint were subjected to bending stress from the roof load applied through the post. Since the members were not designed for bending, this led to a considerable overstress (Lev Zetlin Associates 1978).

Fig. 5 and Table 1 compare some of original details to actual designs used in the building, demonstrating the reduction in strength that these changes caused. Connection A was typically used on the east-west edges of the roof, while connection B was used on the north-south edges. Most of the interior members used connection C, while a few used connection D. The key difference between the original and the as-built details may be seen in Fig. 5 and also by comparing the top and bottom rows of the table. The diagonal members were attached some distance below the horizontal members. Thus, the flexibility of the connection reduced the effectiveness of the bracing by introducing a “spring brace” instead of the hard brace that had been assumed.

**FIG. 5. Comparison of Actual and Assumed Bracing (Figure Courtesy of LZA Technology, from Lev Zetlin Associates, 1978, Reprinted by Permission): (a) Original Design Assumption; (b) Actual Design Condition**
