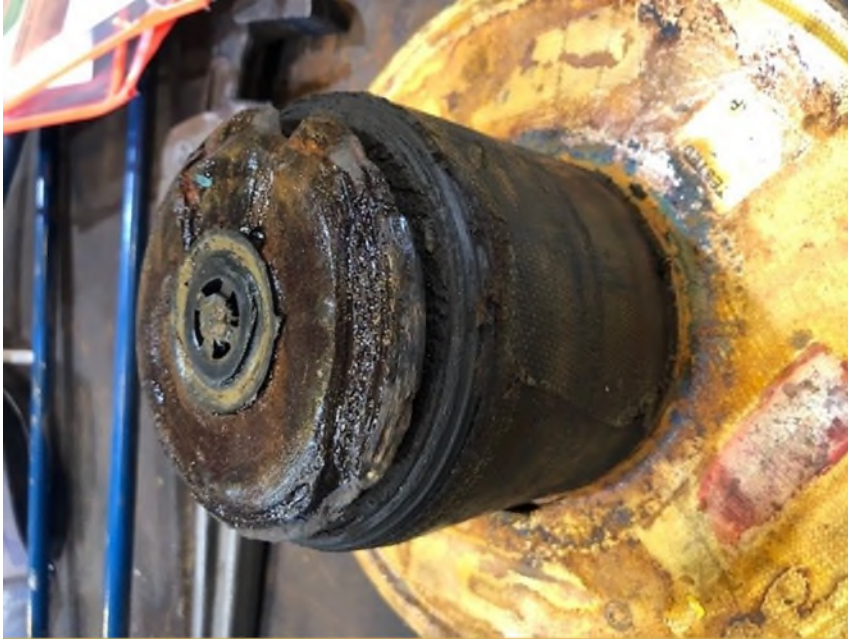
Figure 1: Containment Shell Damage

Figure 1 shows the damage to the containment shell. The four holes at the top of the shell are in the plastic shroud that holds the carbon silica pump shaft in place. The pump shaft as seen in Figure 2, has a hole bored in the center, which allowed the nitric acid from the suction side of the pump to flow straight through the containment shell.

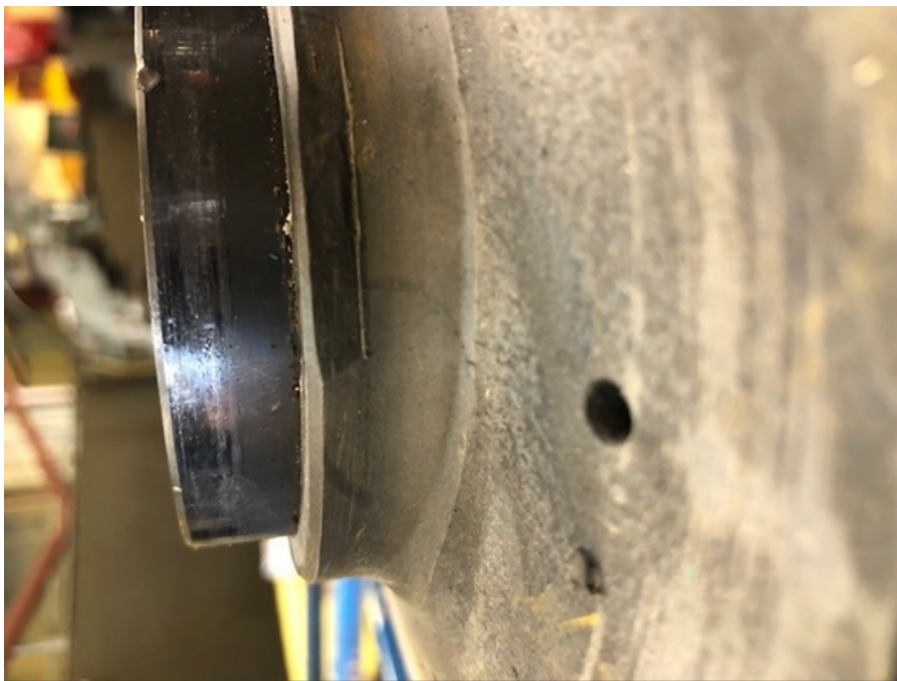
Figure 4: Impeller wear ring showing signs of dry running according to manufacturer
