Here Are 11 Serious Flaws Discovered In the Surfside Tower

The collapse of the Champlain Towers South condo on the morning of June 24 in Surfside, Fla., left 98 people dead and prompted investigations that could last years. Such a catastrophic failure almost certainly had many contributing factors, engineers said. The New York Times created a 3-D model of the tower based on the original design drawings. That model, as well as a review of documents and interviews with structural experts, reveals how design errors, last-minute changes, dubious construction practices and years of deteriorating conditions could all have contributed to the collapse.

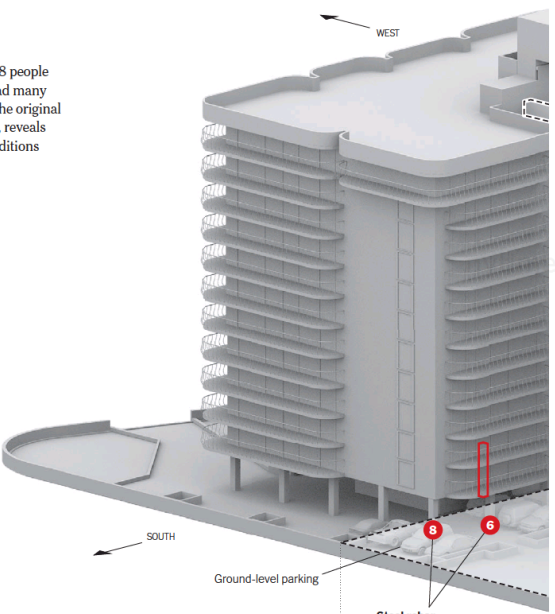
5 Overstressed columns beneath the pool deck Two structural engineers who have been studying the collapse independently concluded that parts of the deck were designed with inadequate support. In one area, where columns were spaced relatively far apart — with about 28 feet between them — one engineer's analysis found that the deck was "overstressed" even before additional weight was placed on it. The collapse of the deck could have destabilized columns at the base of the structure, compromising the eastern half of the tower, which fell soon after.
