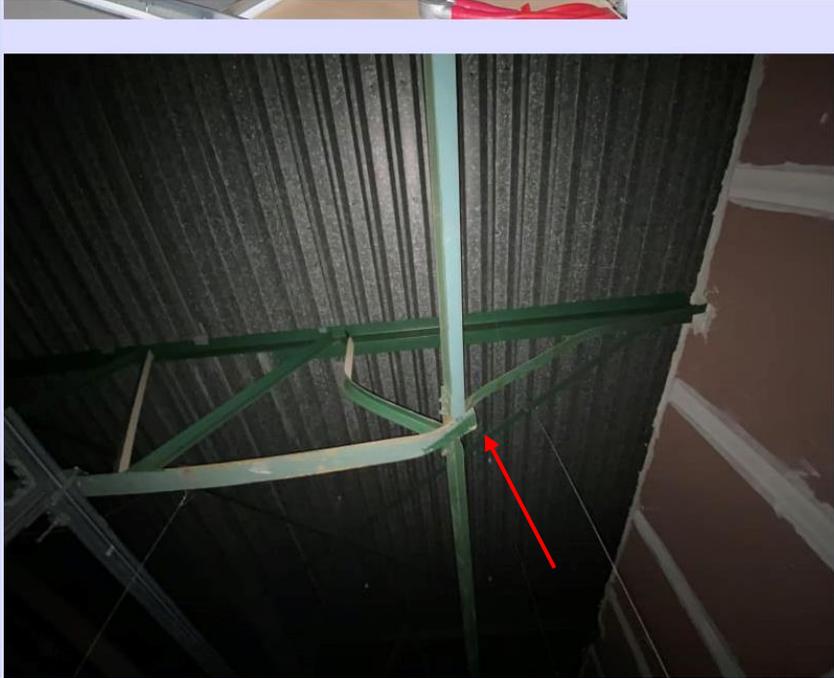
Ron247 (Structural) 16 Aug 20 23:09
Seems like a lot of buckling and disfiguring in an isolated area with adjacent members undamaged. I wonder is someone bent the compression diagonal during construction or after so that it did not take much to make it fail. Is there a heavy point load above it that is new?

MIStructE_IRE (Structural) (OP) 16 Aug 20 23:14
That one truss supports significant copper bar services, which the other trusses do not. No point loads above. You could be right Ron about just enough damage during construction to cause disproportionate buckling.

retired13 (Civil/Environmental) 16 Aug 20 23:49
The truss bottom chord is in tension with hinging weight (ceiling?). Both top and bottom chords seem straight in good shape, and the end support does not seem distressed, there is no good reason for the diagonal to buckle that much. Did the owner mention anything suspicious?
