"Full" Reserve Study

Champlain Towers South Condominium Association, Inc. Surfside, FL

Report #: 38941-0
For Period Beginning: January 1, 2021
Expires: December 31, 2021

Date Prepared: March 20, 2020

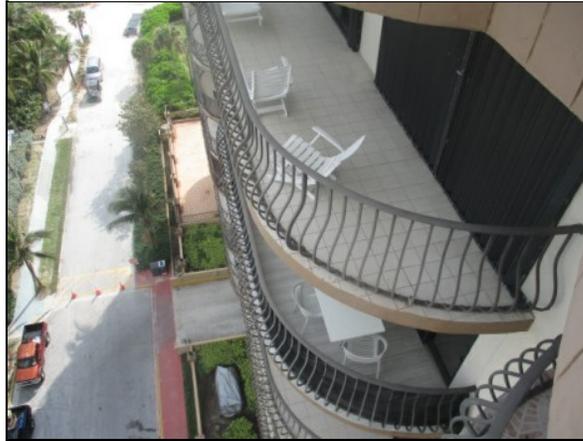
Comp #: 2315 Balcony Decks - Repair/Re-coat

Useful Life:
5 years

Remaining Life:
5 years
