Faulty Rotor TIR Map

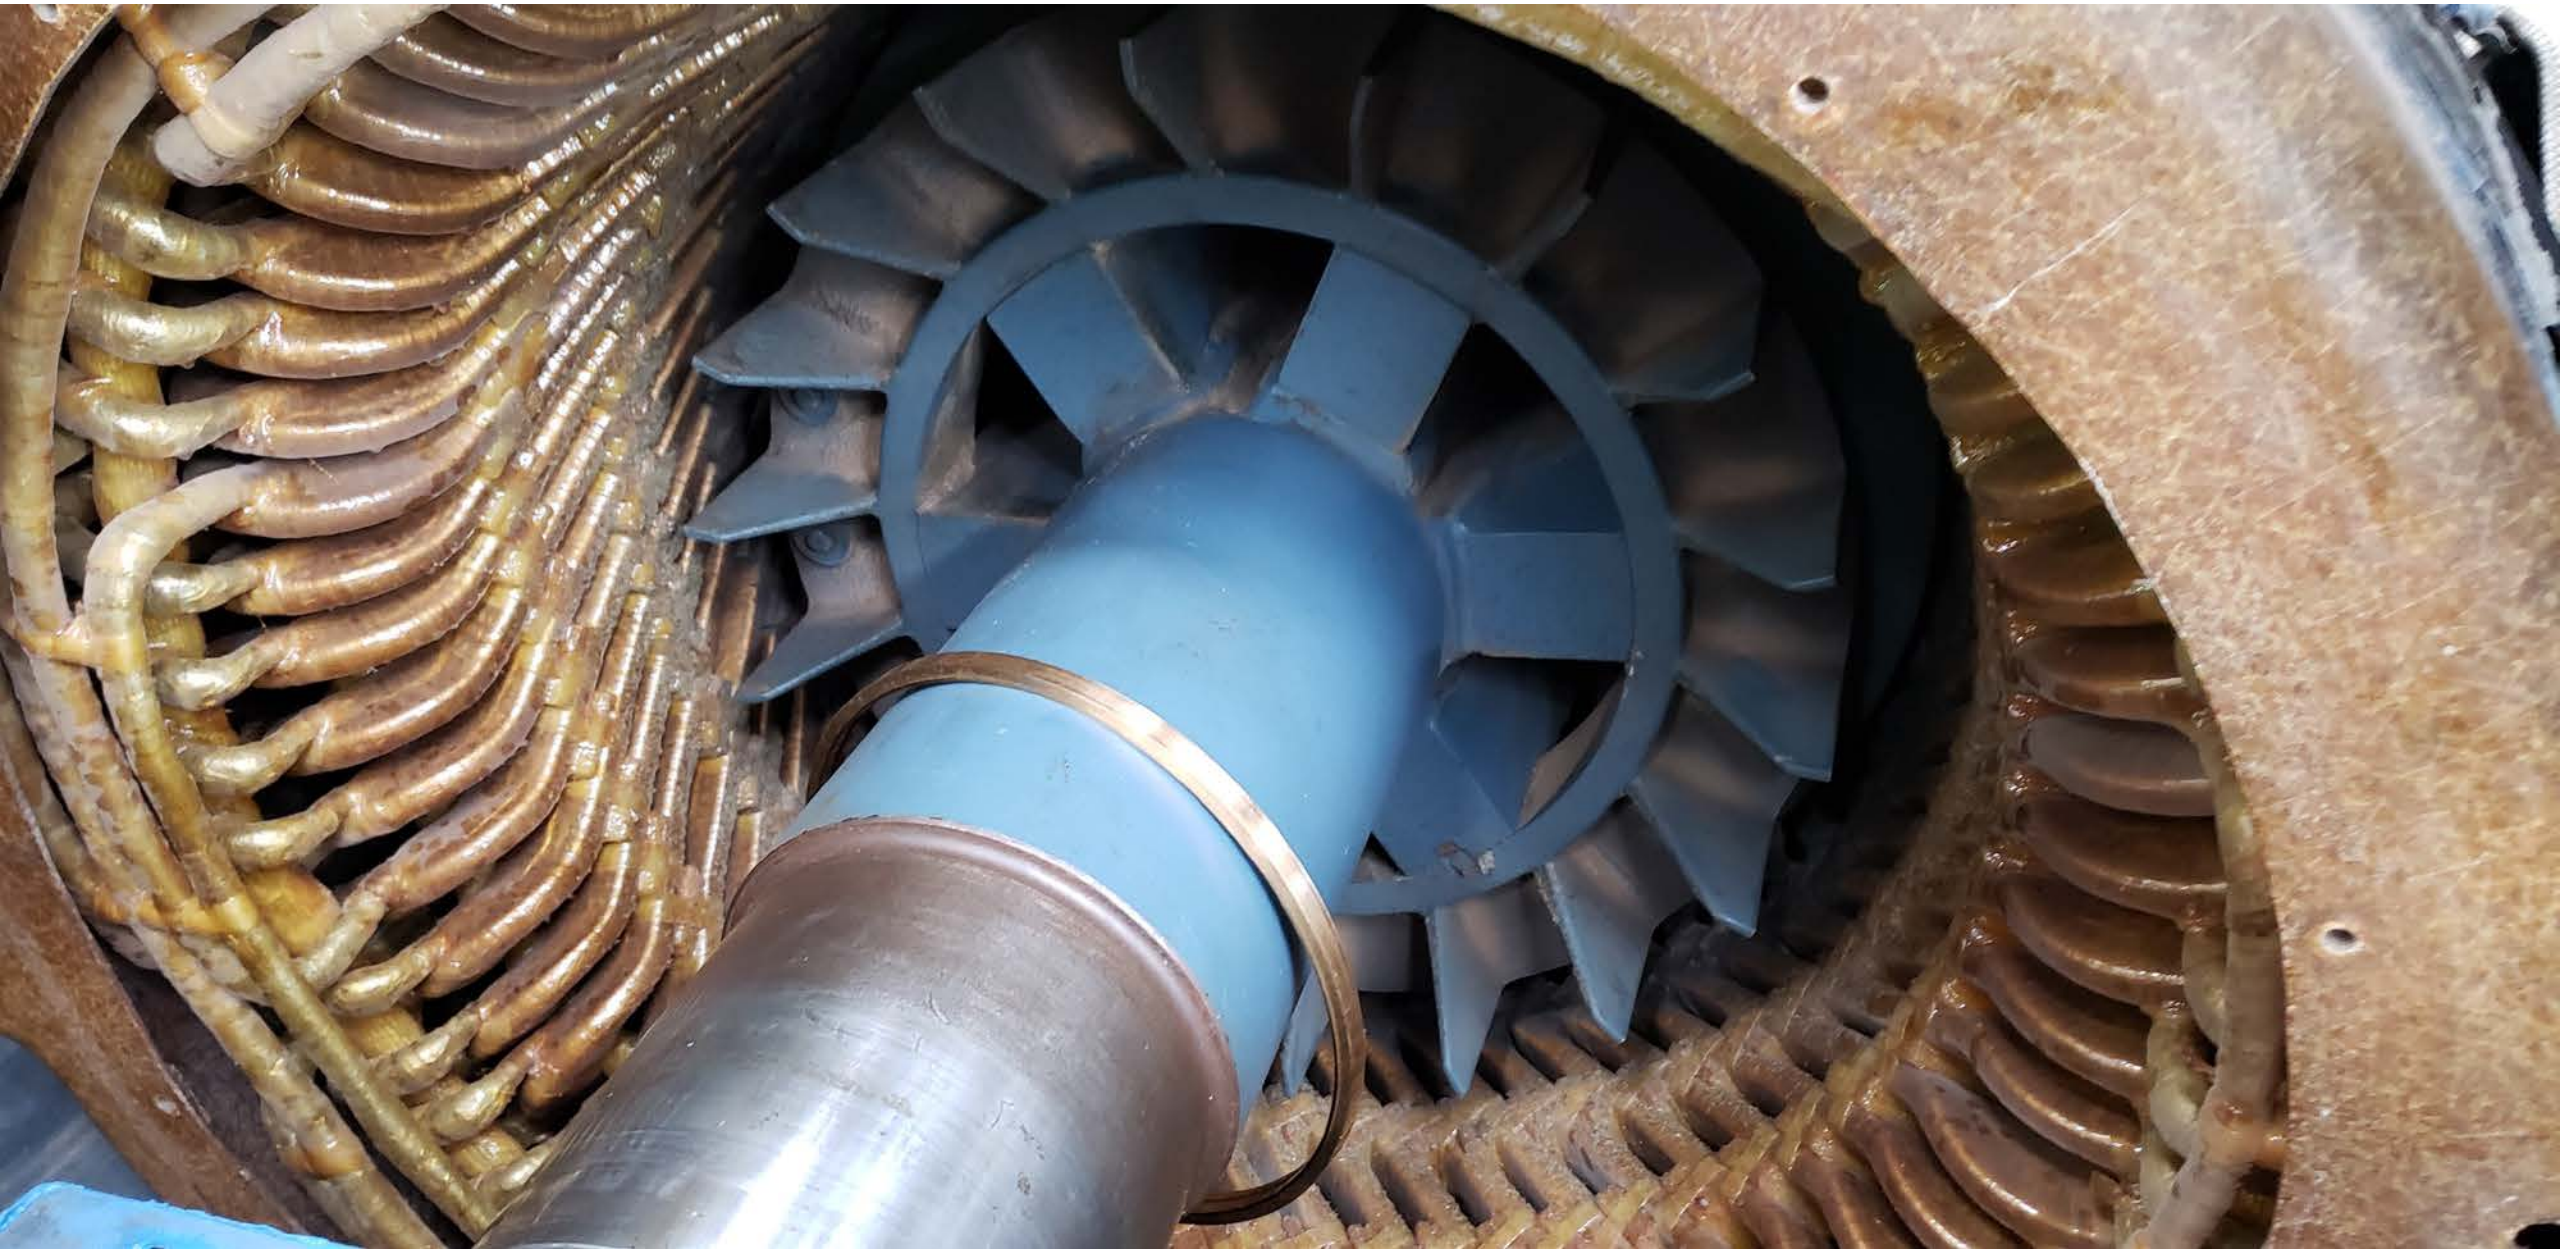
Faulty Rotor

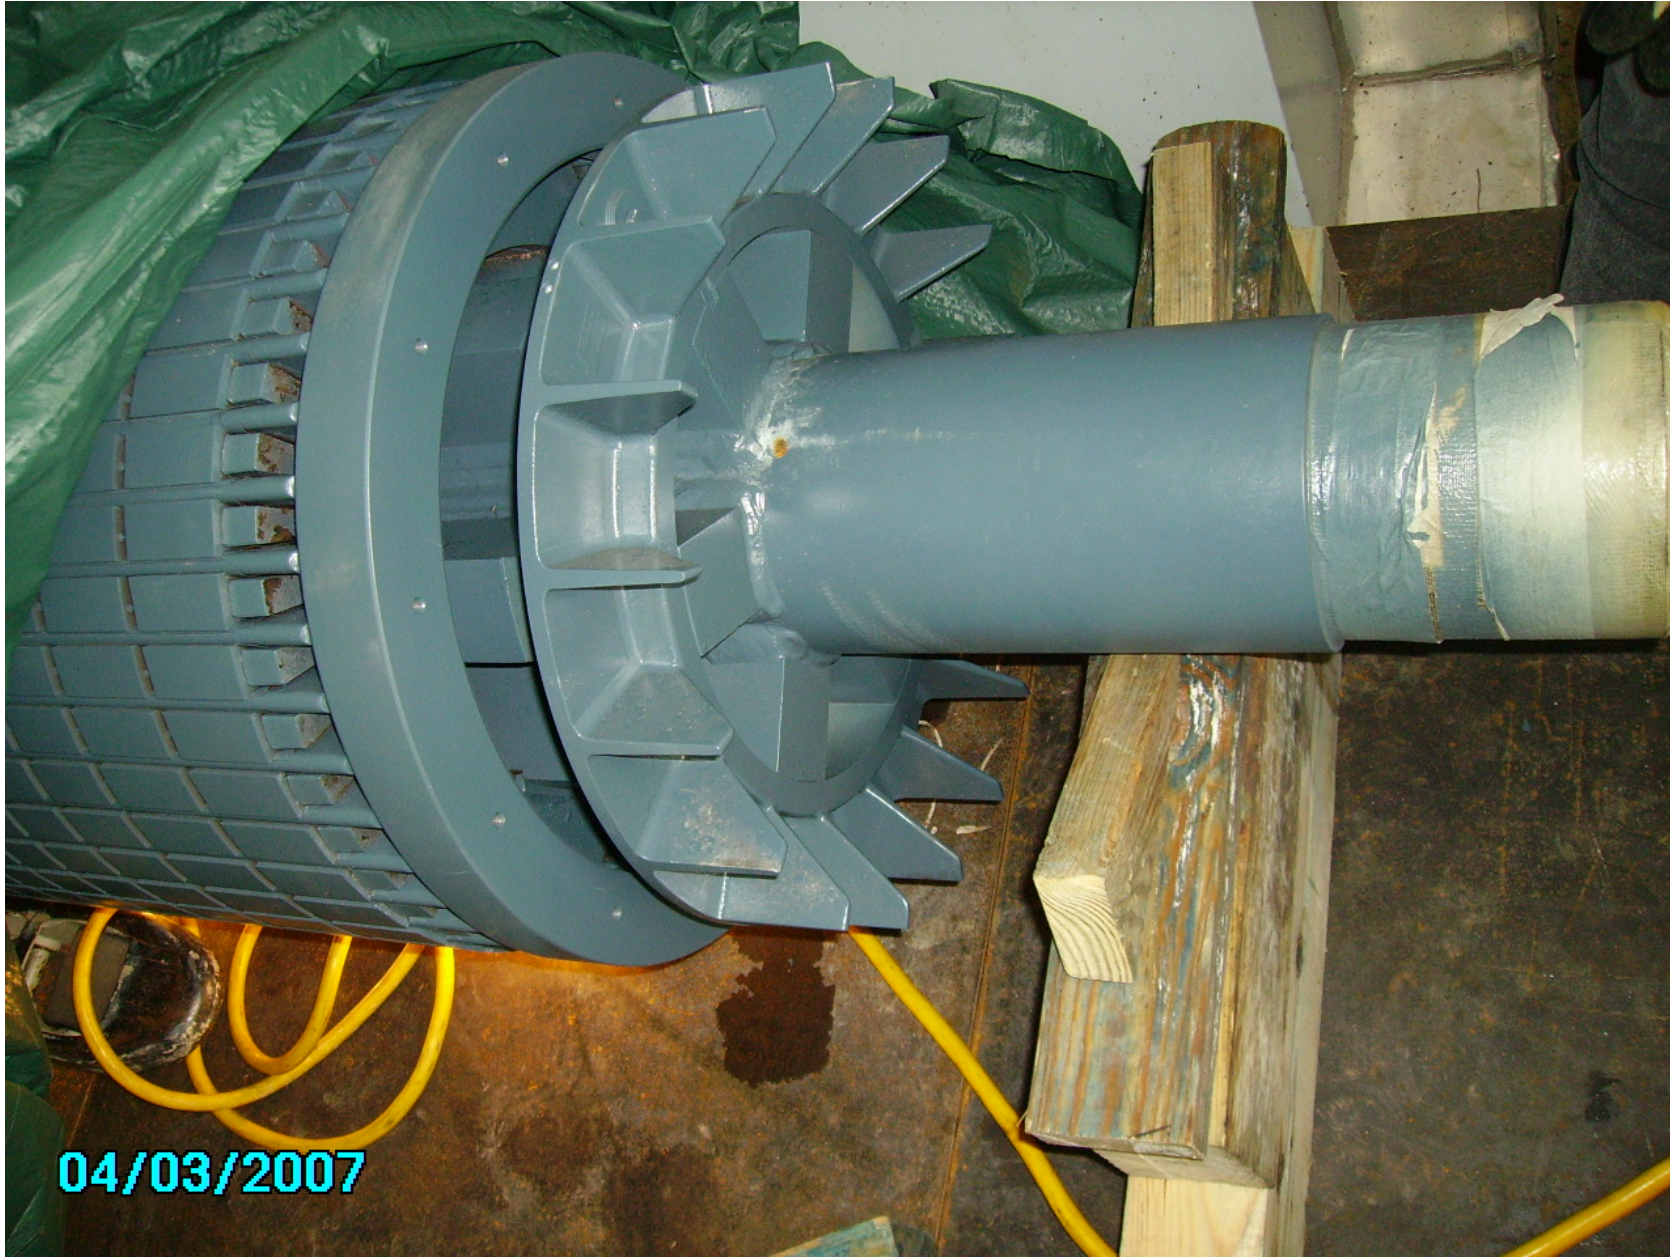
Another view of sister rotor, identical design

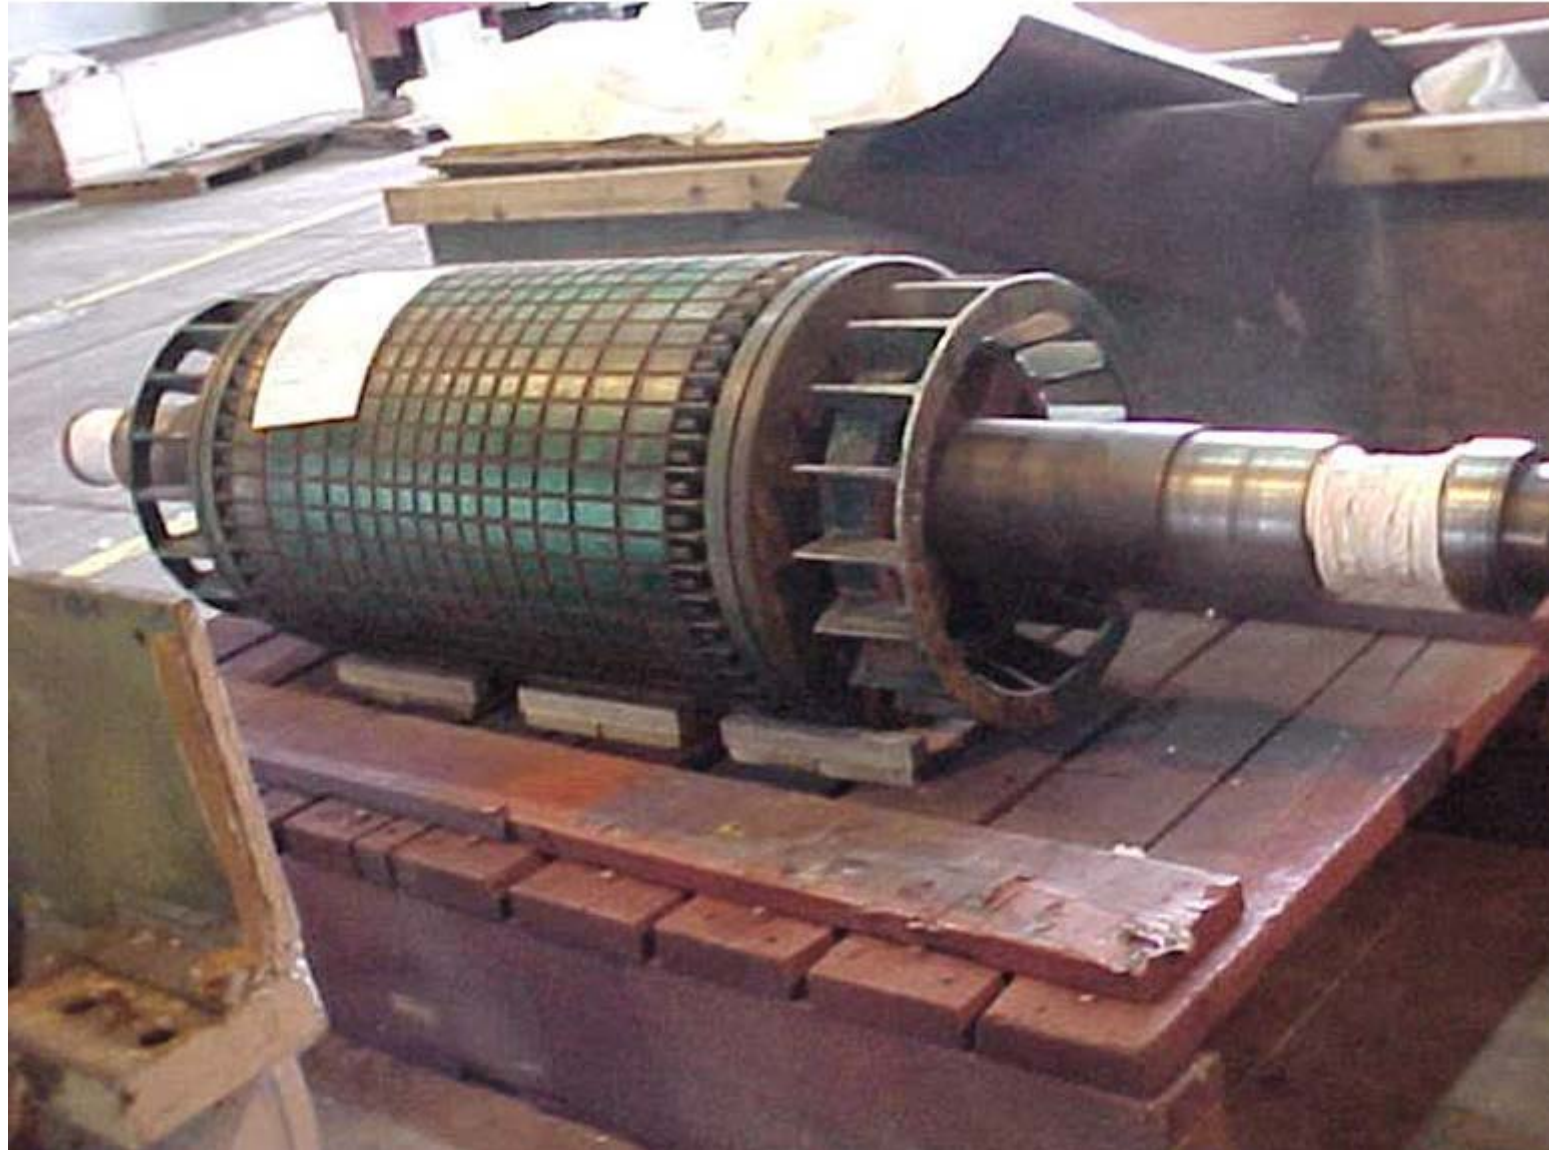
Sister rotor, non-identical design (used with the same stator / frame, but OEM redesigned the rotor – this is a different generation)

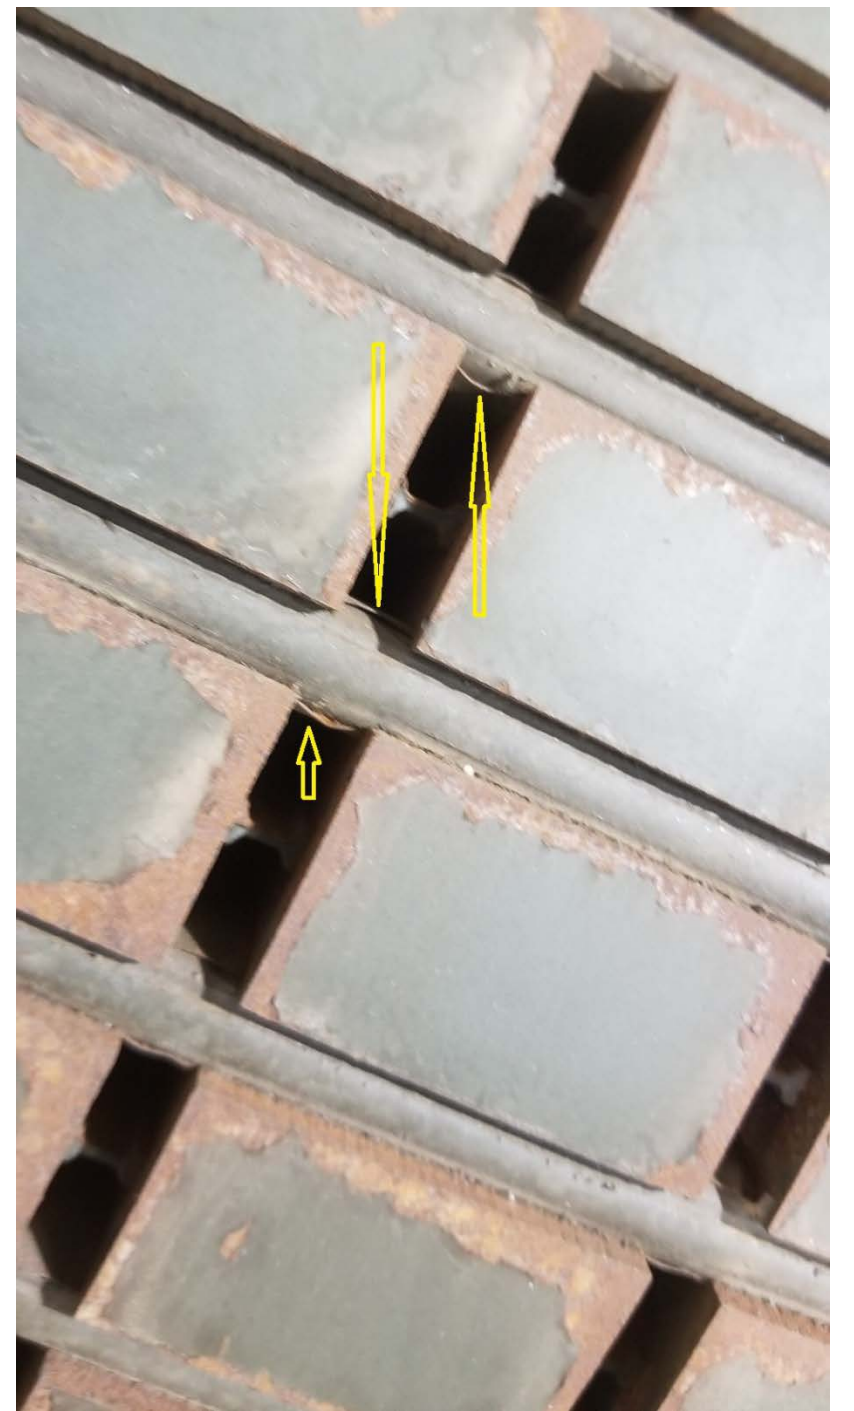
Copper Liner around bars in slots.
