| <b>FIELD REPORT NO. 07</b> | | <br><b>SIMPSON GUMPERTZ &amp; HEGER</b><br>Engineering of Structures<br>and Building Enclosures |
| <b>Project No.:</b> 147041.10 | <b>Keyword:</b> 301S | <b>Purpose:</b> Observe basement walls and mat foundation |
| <b>Project Name:</b> 301 Mission Street Perimeter Pile Upgrade | | |

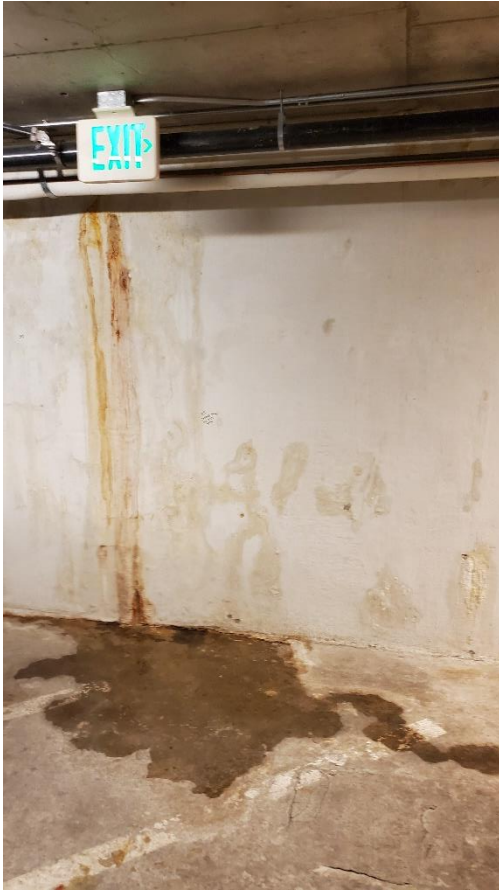
We observed leaks and cracks in the podium basement walls. Various locations are shown on Photos 1-15. The most significant leakage occurs in the western basement wall adjacent to the tower foundation. Leaks were repaired using epoxy injection in most areas. Photos 9 and 10 show the basement wall in the northwest corner of the podium at level B1 where we observed the most severe leakage. Cracks in the podium basement walls appeared identical to the conditions we observed in June 2019. The interior podium ramp shear wall (Photo 18) appears to be uncracked suggesting little structural deformation in the podium substructure.

**Photo 1**  
Podium west basement wall  
at level B5

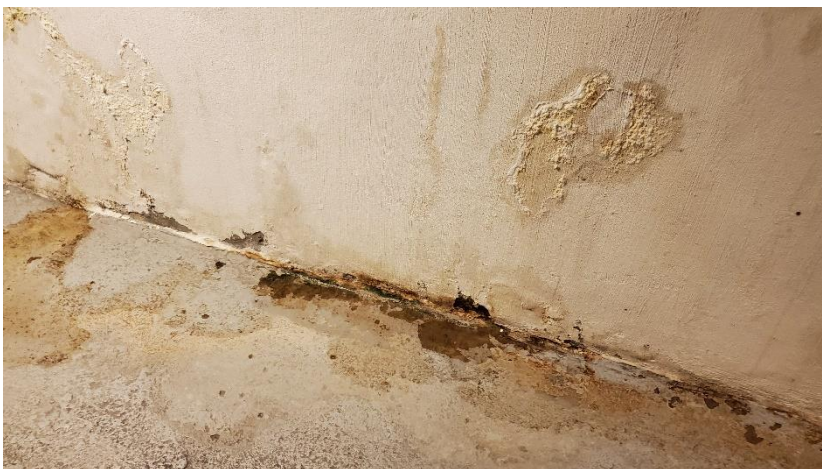
**Photo 2**  
Podium west basement wall  
at level B5

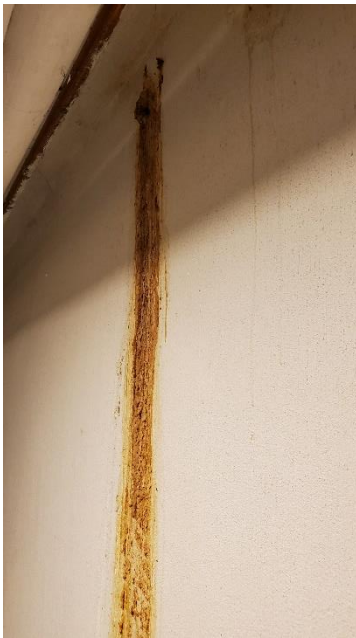
**Photo 3**  
Podium west basement wall  
at level B5

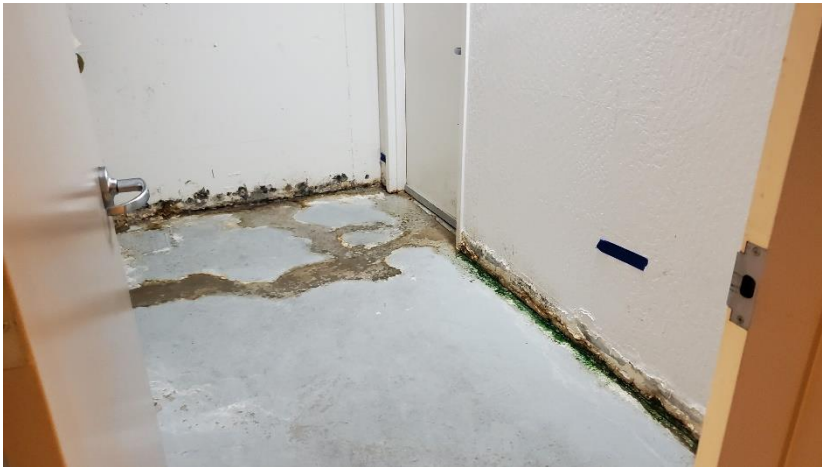
**Photo 4**  
Signs of prior leakage in the  
podium at level B5

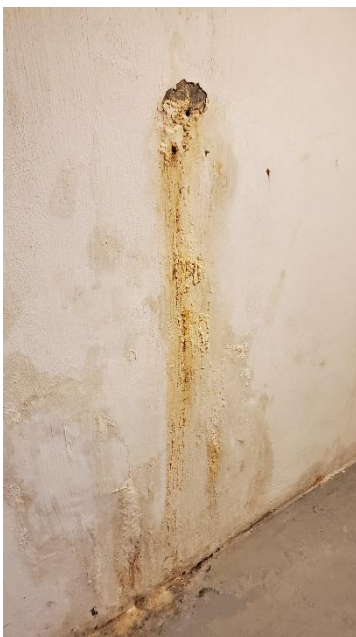
**Photo 5**  
Podium west basement wall  
at level B1

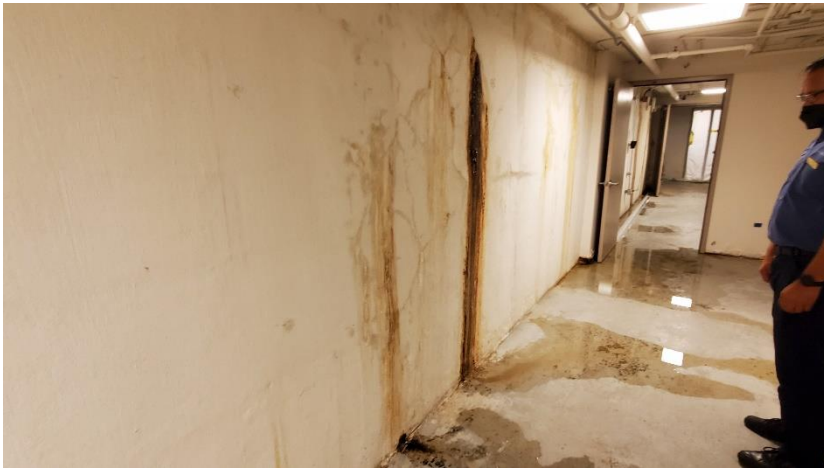
**Photo 6**  
Podium west basement wall  
at level B1

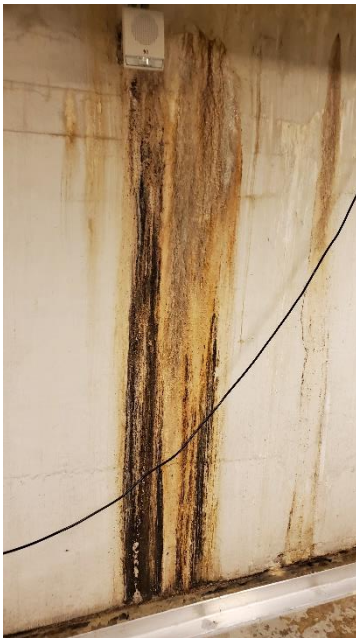
**Photo 7**  
Podium west basement wall  
at level B1

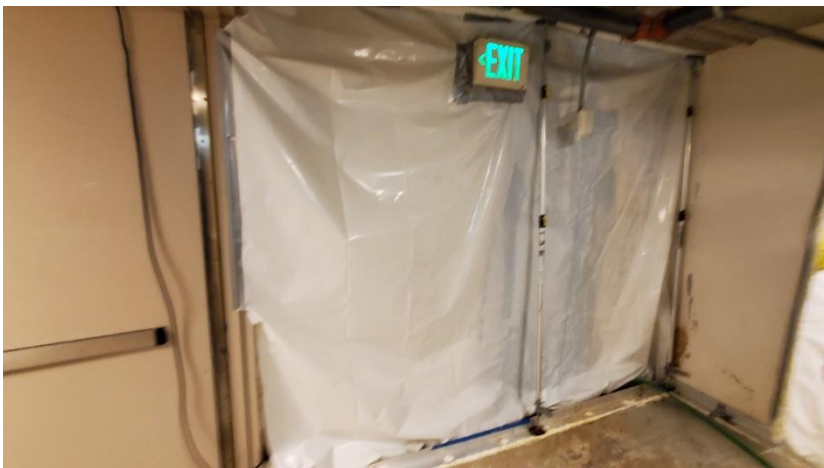
**Photo 8**  
Podium west basement wall  
at level B1

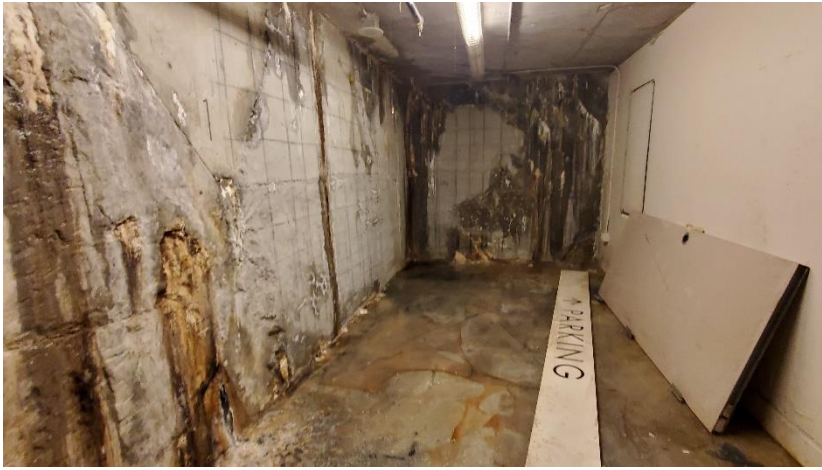
**Photo 9**  
Podium west basement wall  
at level B1

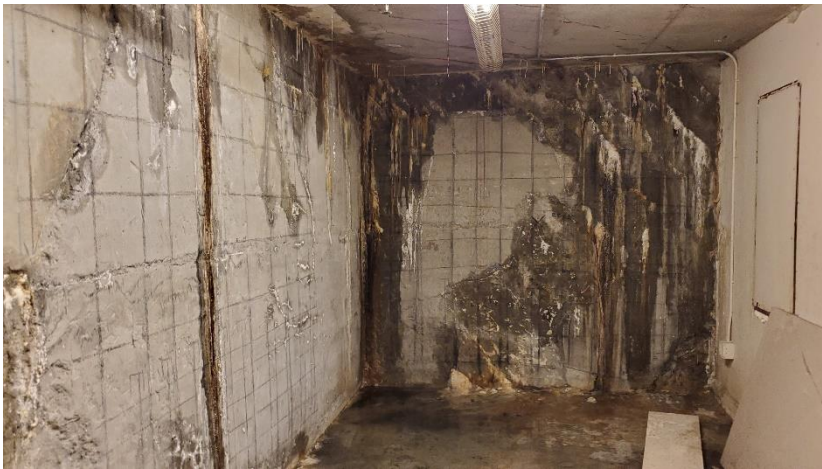
**Photo 10**  
Podium west basement wall  
at level B1

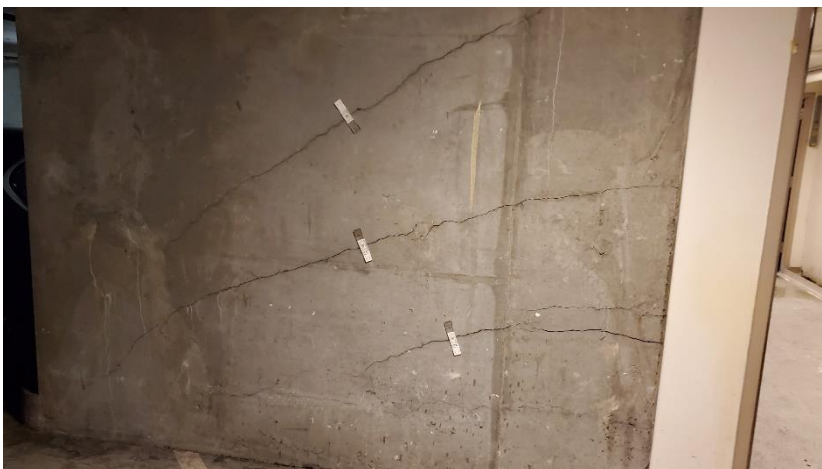
**Photo 11**  
Podium shear wall at level  
B1

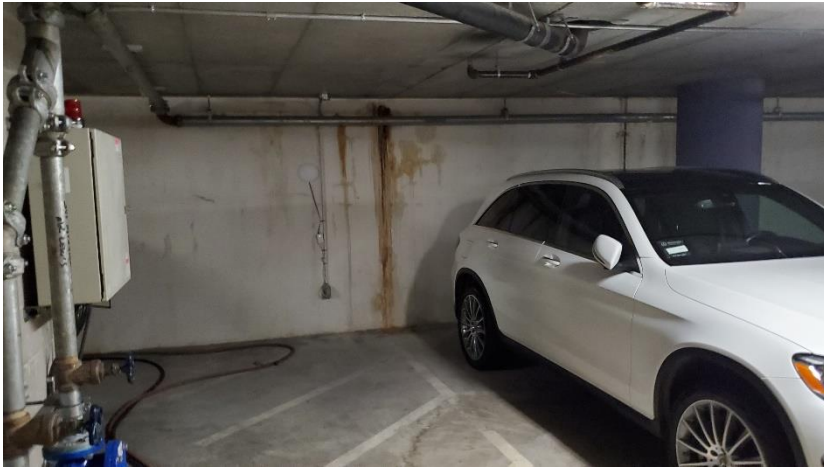
**Photo 12**  
Podium north basement wall  
at level B1

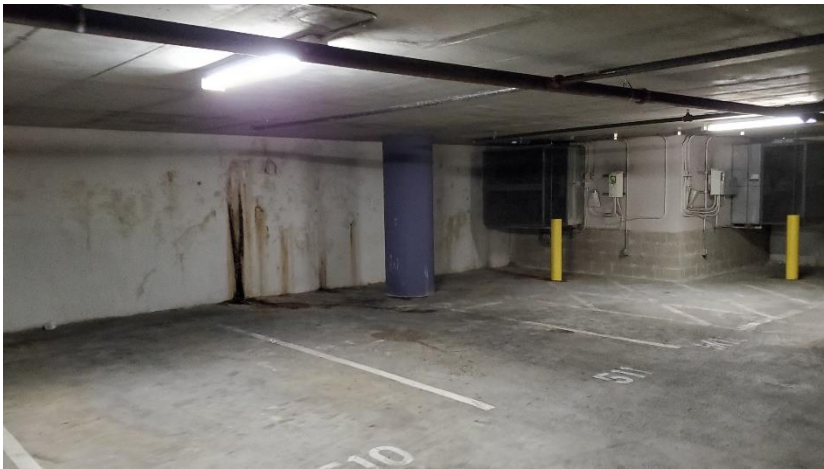
**Photo 13**  
Podium north basement wall  
at level B1

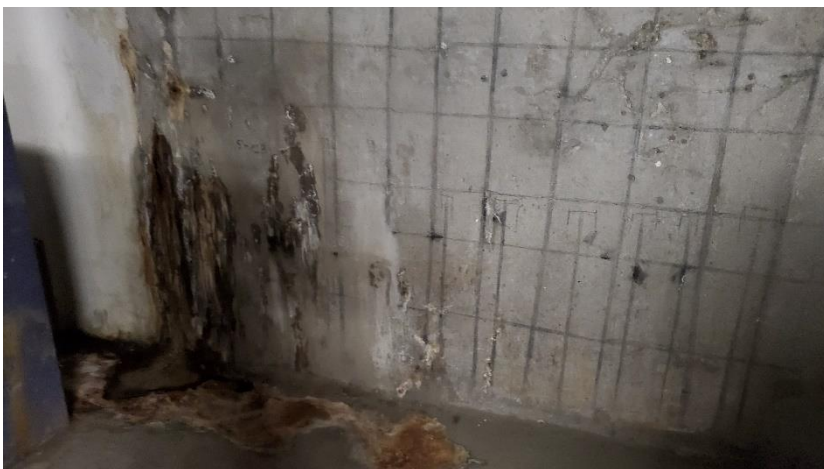
**Photo 14**  
Podium east basement wall  
at level B1

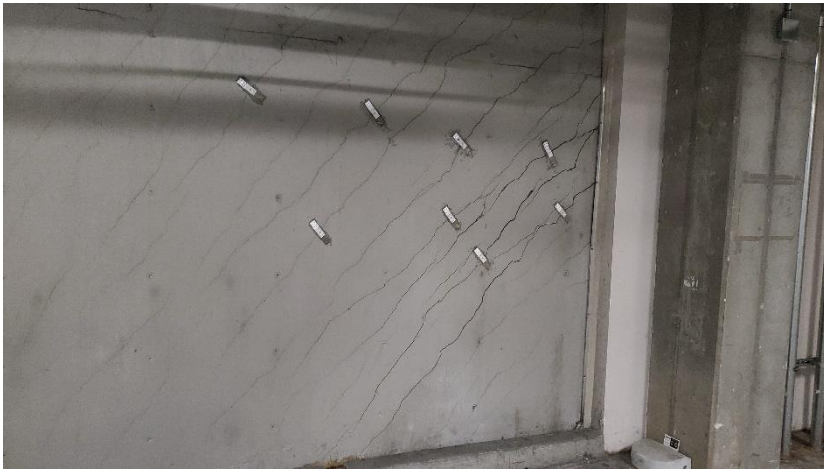
**Photo 15**  
Podium east basement wall  
at level B1

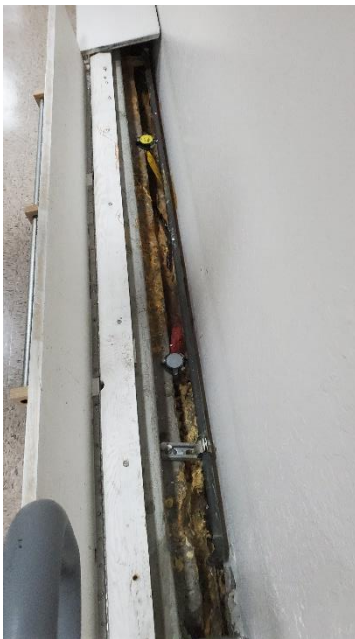
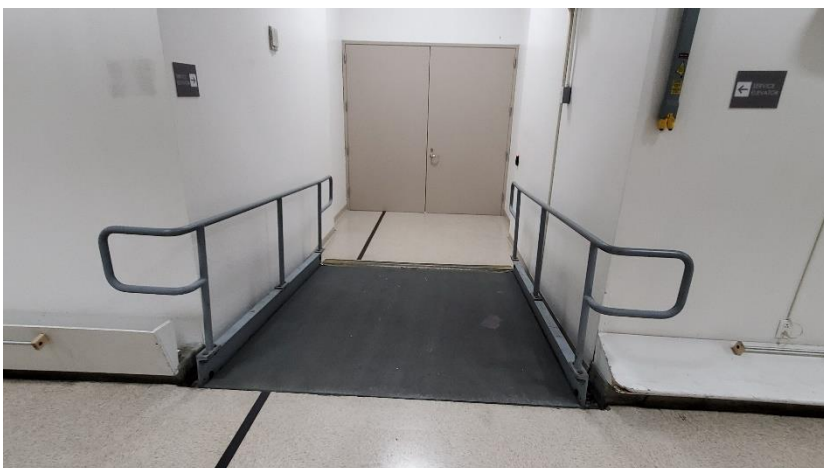
Photos 16 and 17 show the vertical movement joint between the tower and the podium substructures. Floor finishes in the area have been repaired and a ramp was added to provide an accessible walking surface across the joint.

**Photo 16**  
Separation joint between the  
tower and the podium

**Photo 17**  
Separation joint between the  
tower and the podium

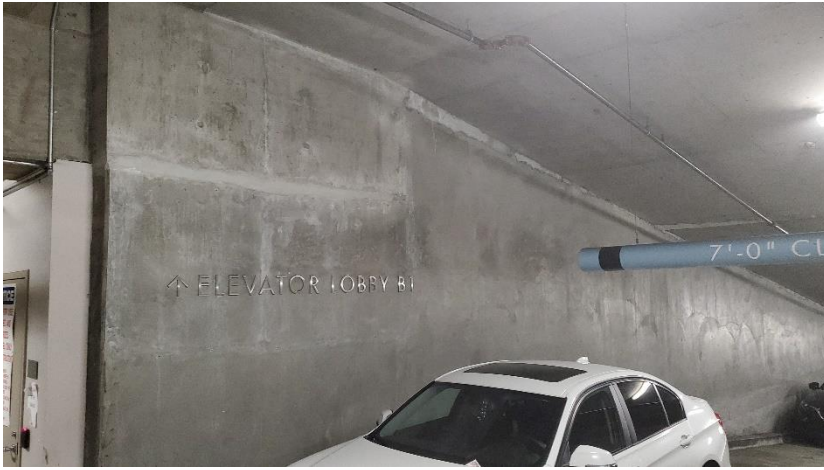
**Photo 18**  
Interior podium ramp shear  
wall at B1

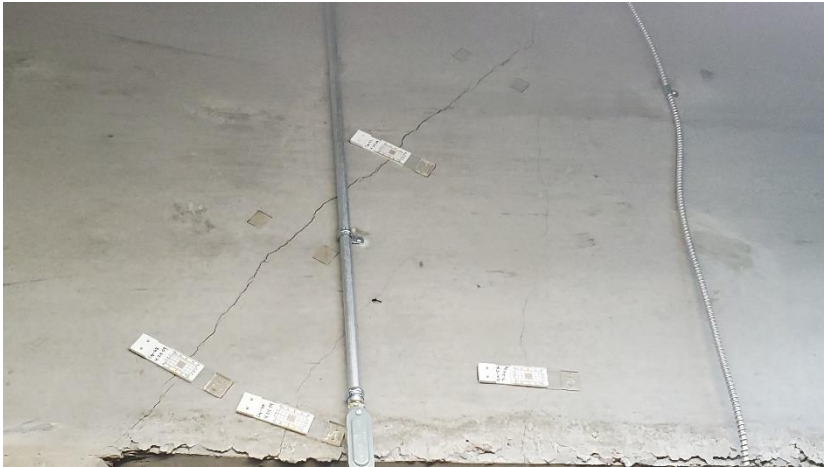
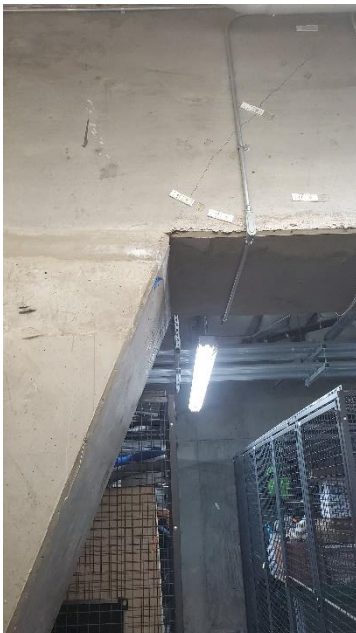
Photos 19 and 20 show the condition of the preexisting cracks in column H-11 in the southeast basement storage room. Photo 21 shows the cracks at the concrete shear wall adjacent to this column. These cracks appeared visually identical to the conditions we observed in June 2019.

**Photo 19**  
Preexisting cracks in tower  
column H-11 at B1

**Photo 20**  
Preexisting cracks in tower  
column H-11 at B1

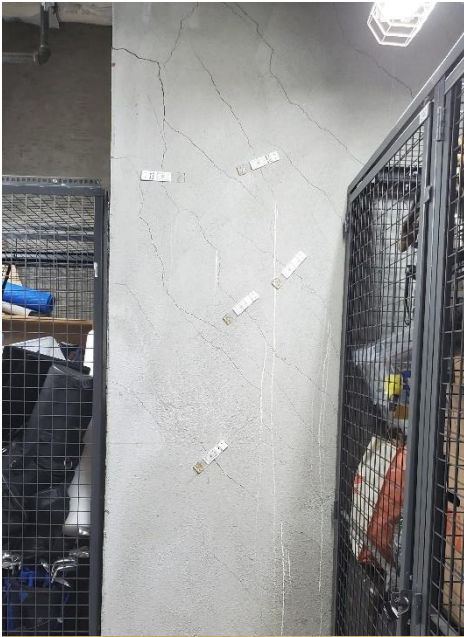
**Photo 21**  
Basement wall cracks  
in tower storage  
room at B1

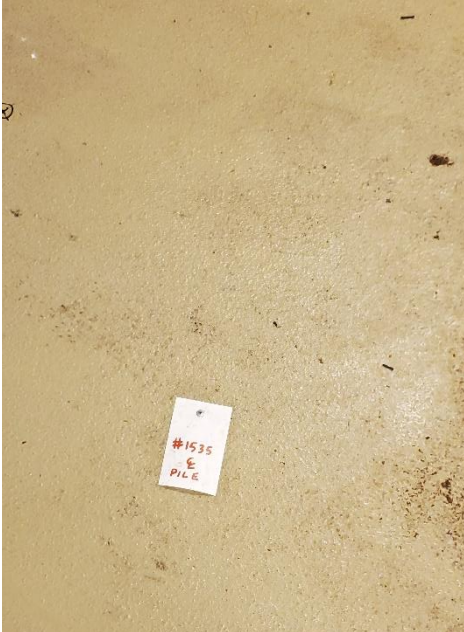
Photos 22 through 30 show various tower basement wall and top of mat foundation locations. The north and south tower basement walls appeared in good condition. We observed leakage at the tower western walls. In some areas the leaks were repaired using epoxy grout injection. The building engineer, Gary Pera, reported that during drilling operations the rate of water inflow through the basement wall cracks increases. The top of the tower mat was uncracked.

**Photo 22**  
Top of tower mat  
foundation in Fire  
Pump room

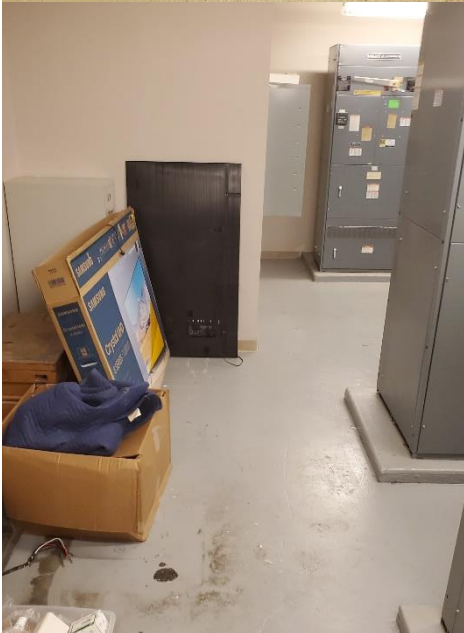
**Photo 23**  
Top of tower mat  
foundation in  
Switchboard room

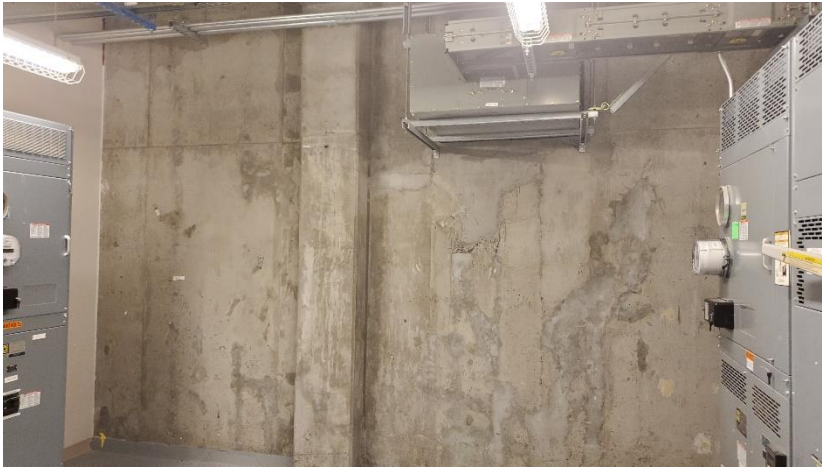
**Photo 24**  
South tower basement  
wall at Switchboard  
room

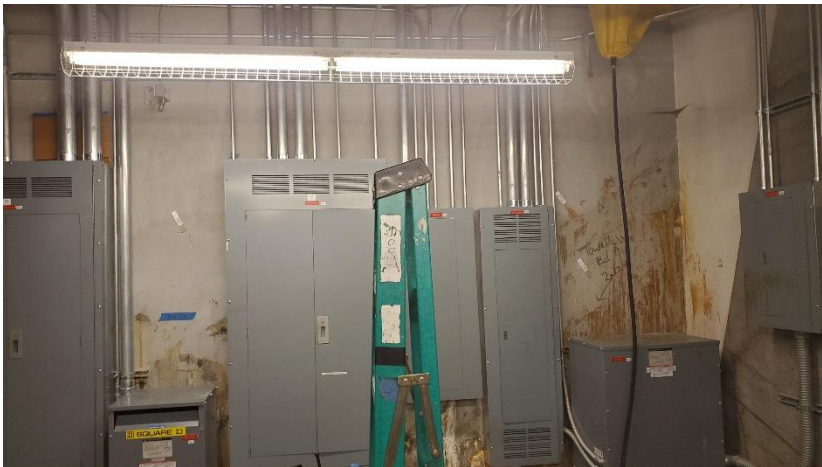
**Photo 25**  
West tower basement  
wall at Emergency  
Switchboard room

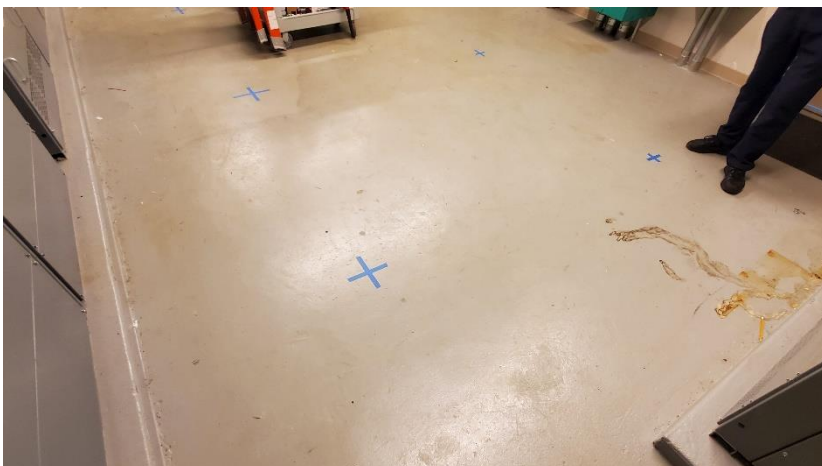
**Photo 26**  
Top of tower mat  
foundation at  
Emergency  
Switchboard room

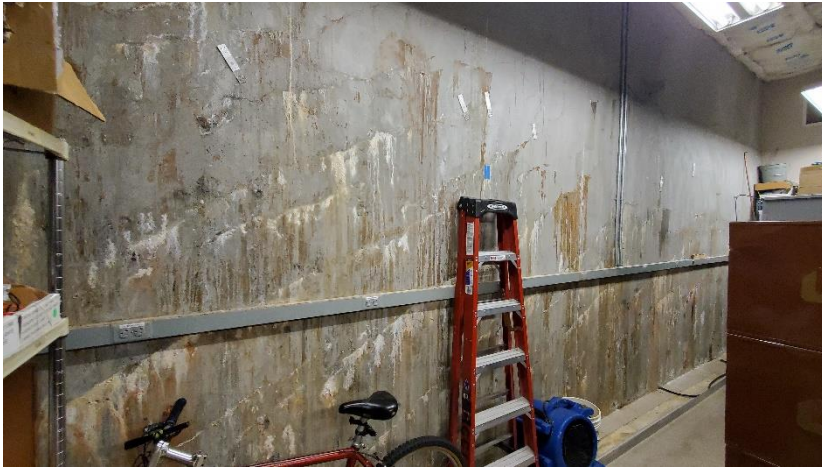
**Photo 27**  
West tower basement  
wall

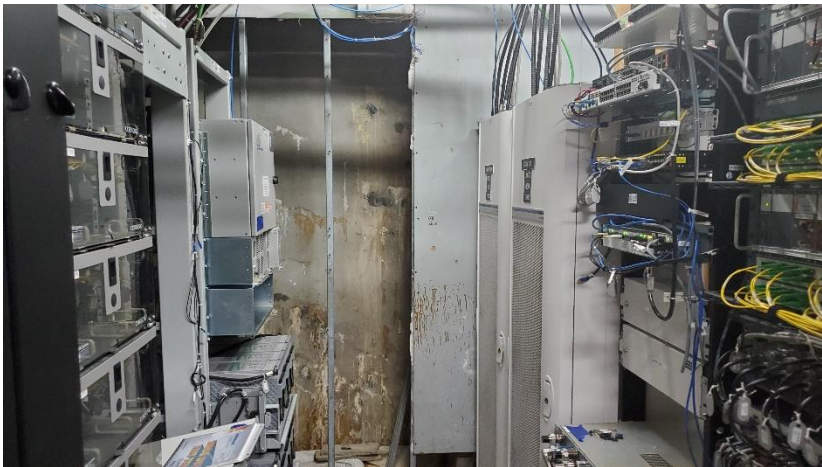
**Photo 28**  
West tower basement  
wall at telephone  
security room.

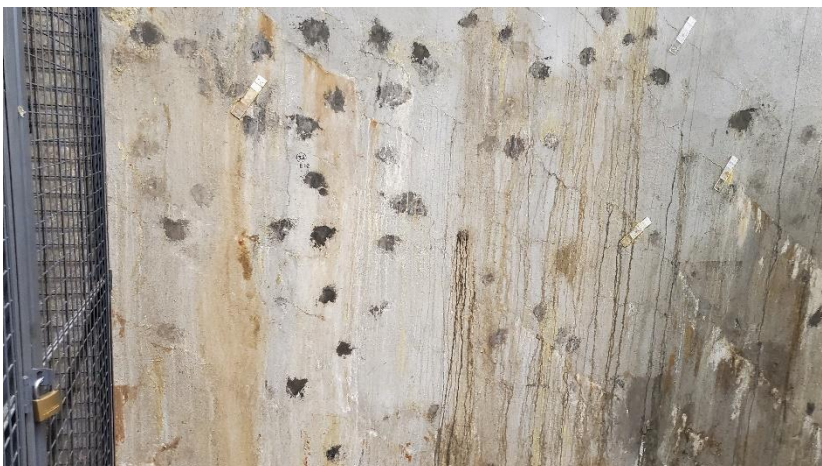
**Photo 29**  
West tower basement  
wall epoxy  
injection repairs at  
storage B1-F

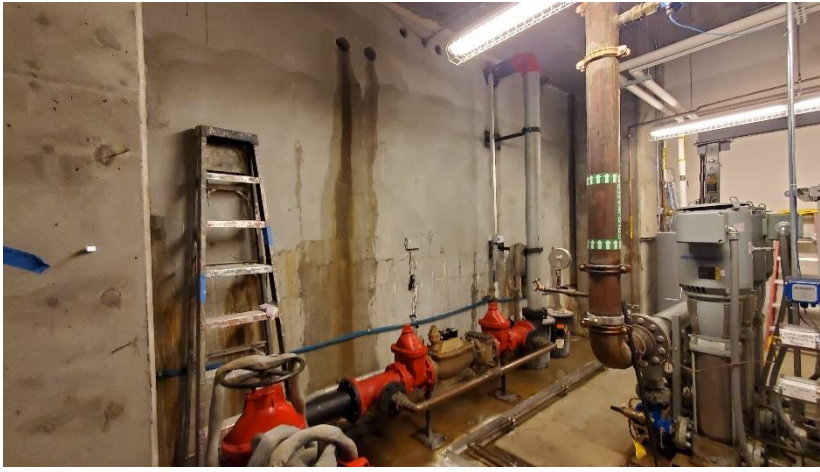
**Photo 30**  
North tower basement  
wall at Fire Water  
room

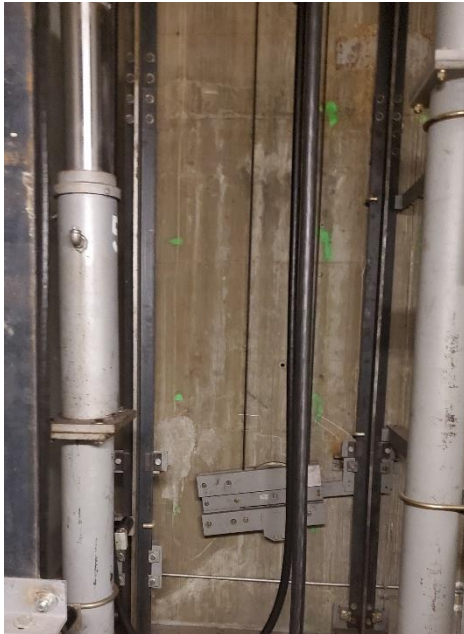
Photos 31 and 32 show the condition of the shear walls and mat foundation at two elevator cores. We did not observe any cracks or other indications of structural damage in these areas.

**Photo 31**  
Elevator C-5 pit shear  
walls

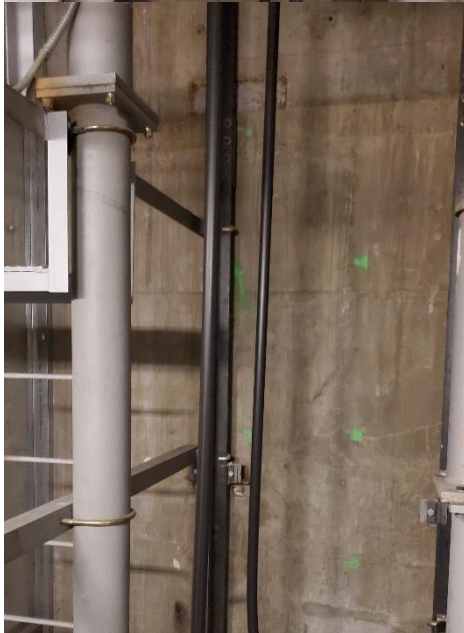
**Photo 32**  
Elevator C-1 & C-2 pit  
shear walls

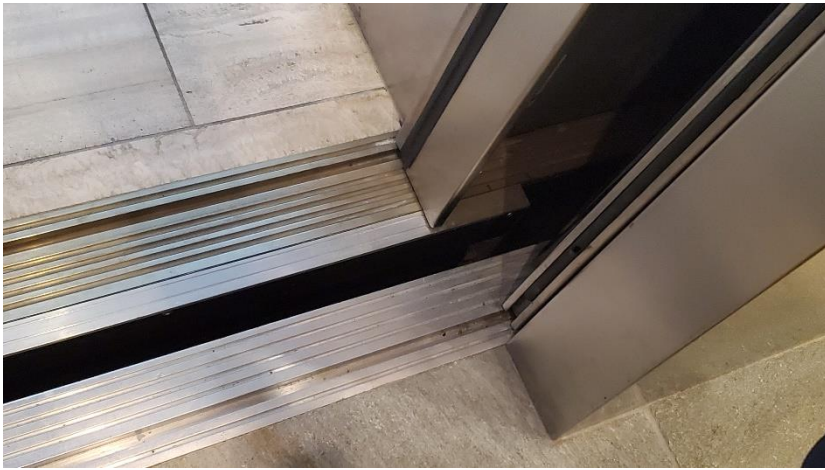
Photo 33 shows the elevator threshold repair performed at level 1. Tower tilt increased the gap between the elevator car located in the podium building and the slab part of the tower. The repair consists of the addition of an aluminum plate to the tower floor to reduce the size of the gap.

**Photo 33**  
Elevator threshold  
repair at L1.
