3.6. Plant Inspection Findings

Damaged Mechanical Seals

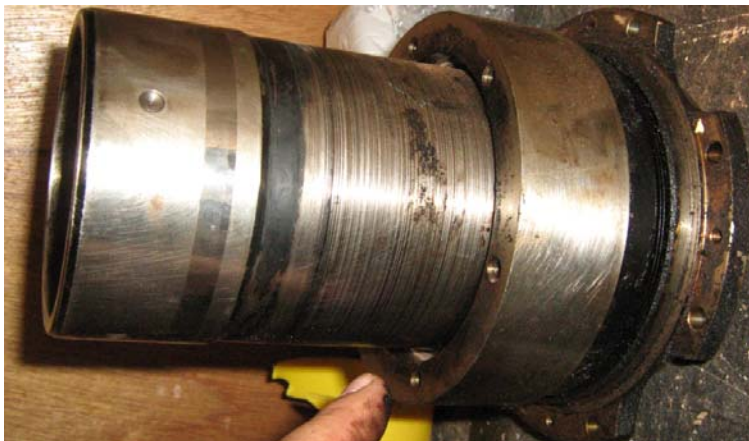
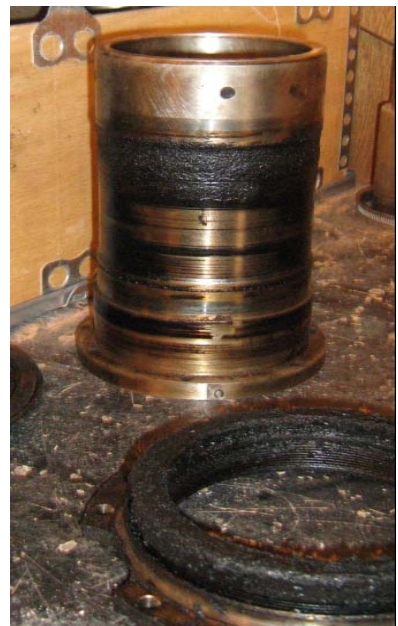
Inspection of the seals showed that there was extensive debris (black tar like deposits with solids) accumulation inside the bellows of the primary and secondary containment seals and guide sleeves of all seals (pictures included in **Appendix D**). The shaft sleeves were found heavily marked and scratched shown as follows:

Physical damage to the bellows and seal faces was not visible, however this does not conclude that there is no damage present. The deposits were dry at the time of inspection it is not known if at the time of removal from the pump the deposits were actually sticky. There may be implications on seal integrity and life if this is found to be the case. Further inspection by John Crane is required to fully assess the condition of the mechanical seal components.

Detailed examination by John Crane specialists is required to assess the true extent of any damage in the seals and also review the current seal auxiliaries set-up for correct quench gas flows.
