NUREG-1275  
Vol. 11

# Operating Experience Feedback Report—Turbine-Generator Overspeed Protection Systems

Commercial Power Reactors *~*

**U.S. Nuclear Regulatory Commission**

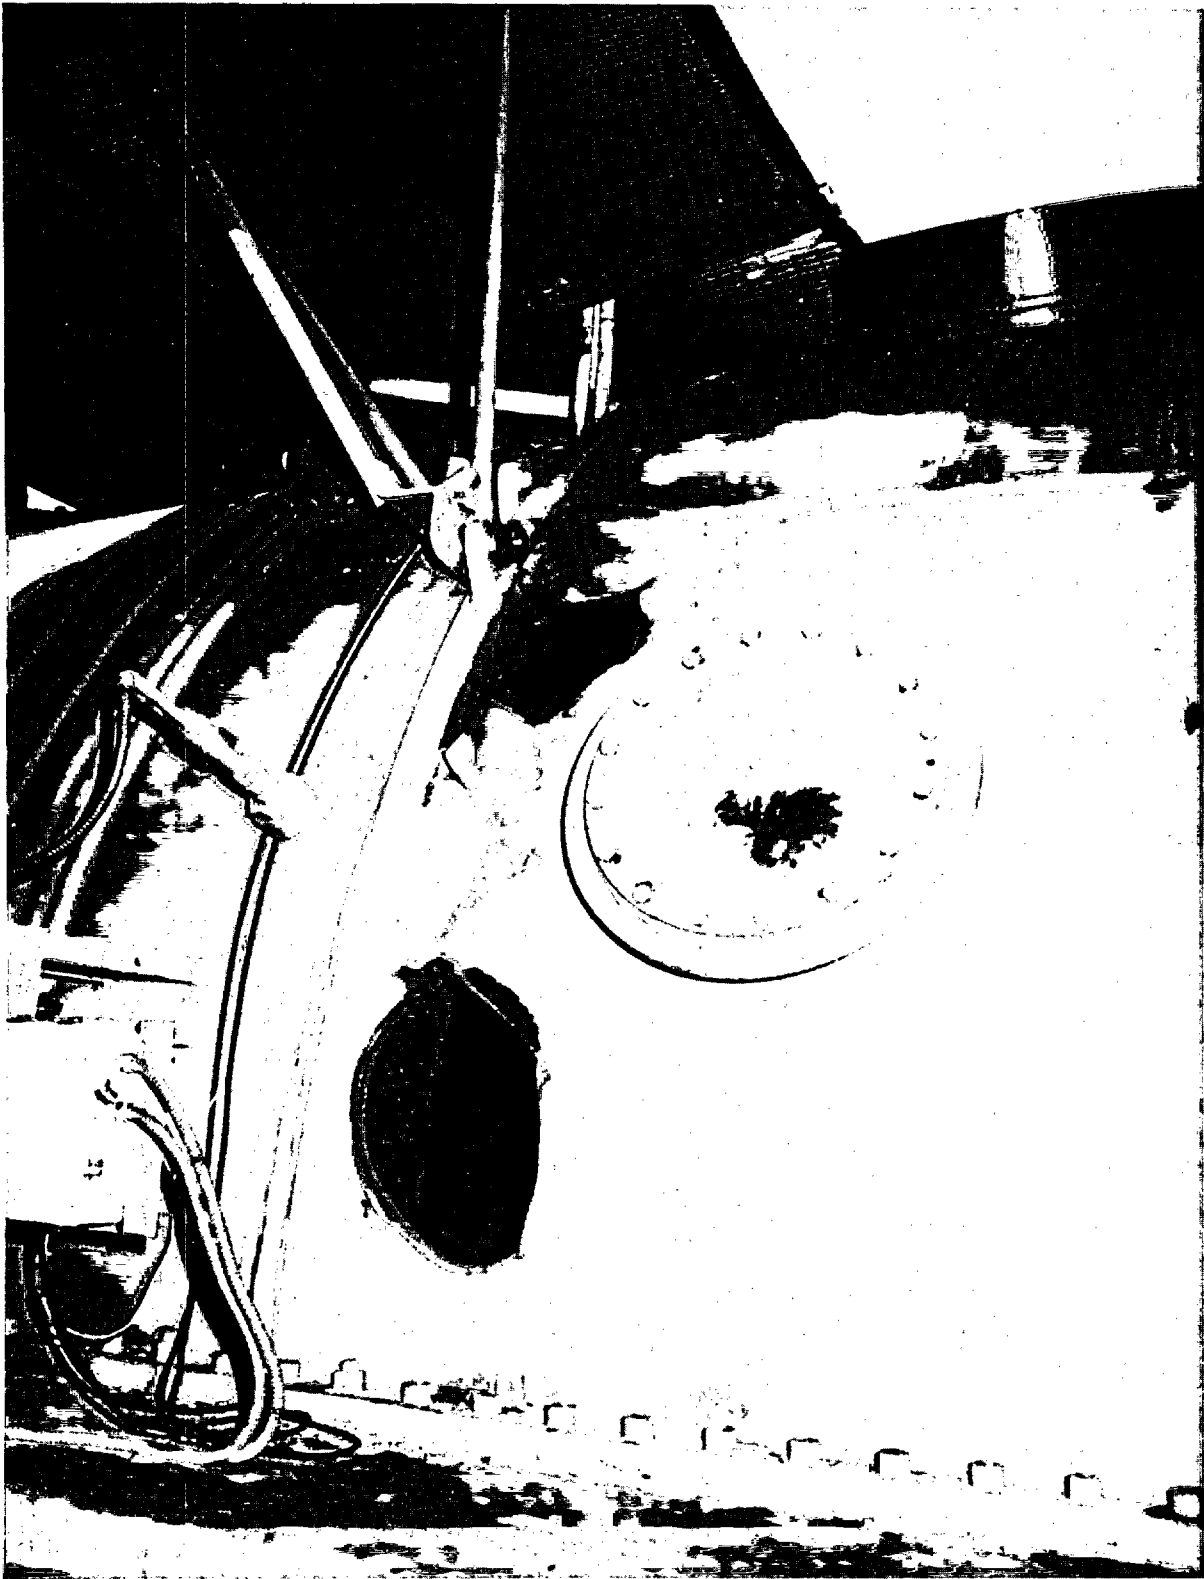
**Figure 4 Photograph: Salem Unit 2, showing holes in turbine casing**

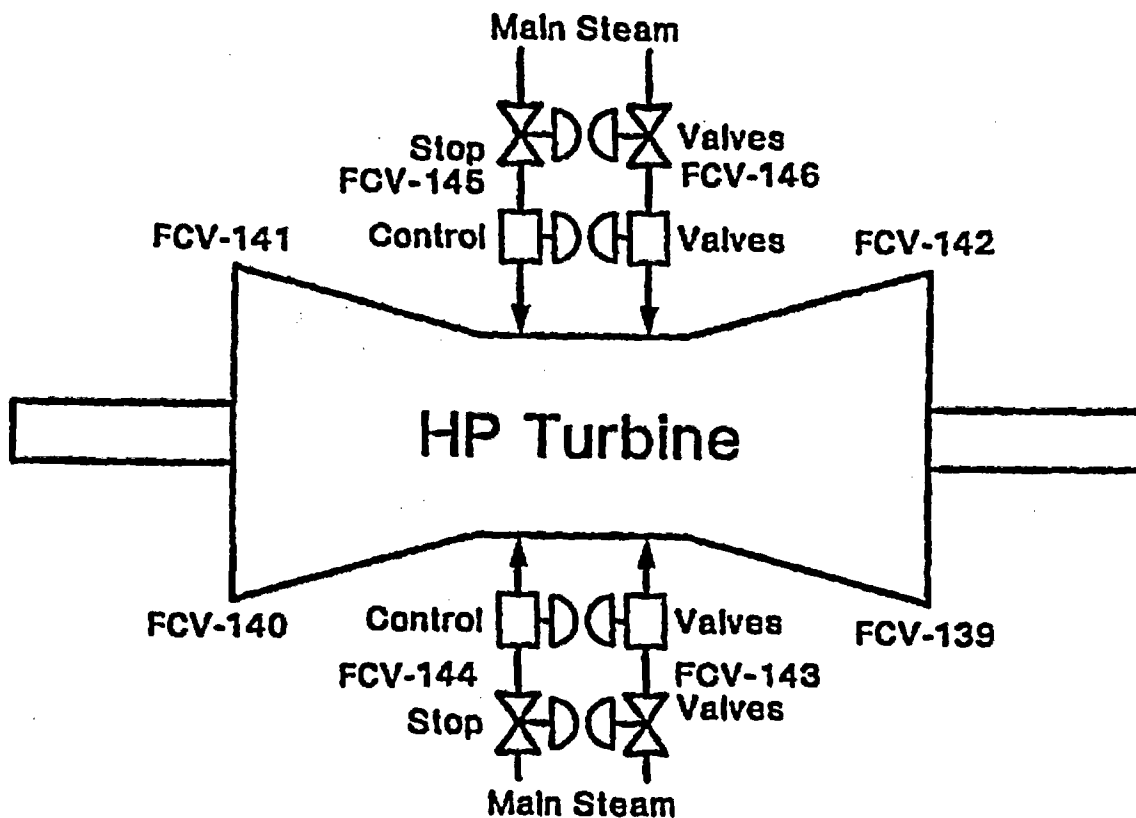
Figure 9 Diablo Canyon turbine steam admission valves

It is interesting to note that 6 months earlier on March 22, 1992, the licensee shut down Unit 2 because of an inoperable high-pressure TSV, MS-2-FCV-144 (Westinghouse Electric Corporation—Model #723-J-119). The TSV failure was reported in LER 50-323/92-003 (Ref. 11). The valve disc separated from its swing-arm. In the March 10, 1993, revision of the LER, 50-323/92-003, Rev. 1 (Ref. 12), the licensee noted that the root cause of the TSV failure had not yet been determined. This failure is viewed as a precursor to widespread common-mode failures. There had been similar failures at other plants. In February 1990, W alerted their turbine owners to this

type of problem (Operations & Maintenance Memo 108, which is reprinted in Appendix F of this report, courtesy of W Power Generation Business Unit). This issue is an extremely important one because, as the licensee noted in the LER, "FCV-144 protects the HP turbine (SB) (TRB) from overspeed if the associated turbine governor valve (SB) (FCV) downstream of FCV-144 should fail to close when the overspeed trip or the normal trip mechanism operates." The licensee noted that, during the spring 1993 outage, the licensee's inspection found other main steam stop valves which appeared to have signs of degradation in areas where FCV-144 had failed previously.<sup>11</sup>

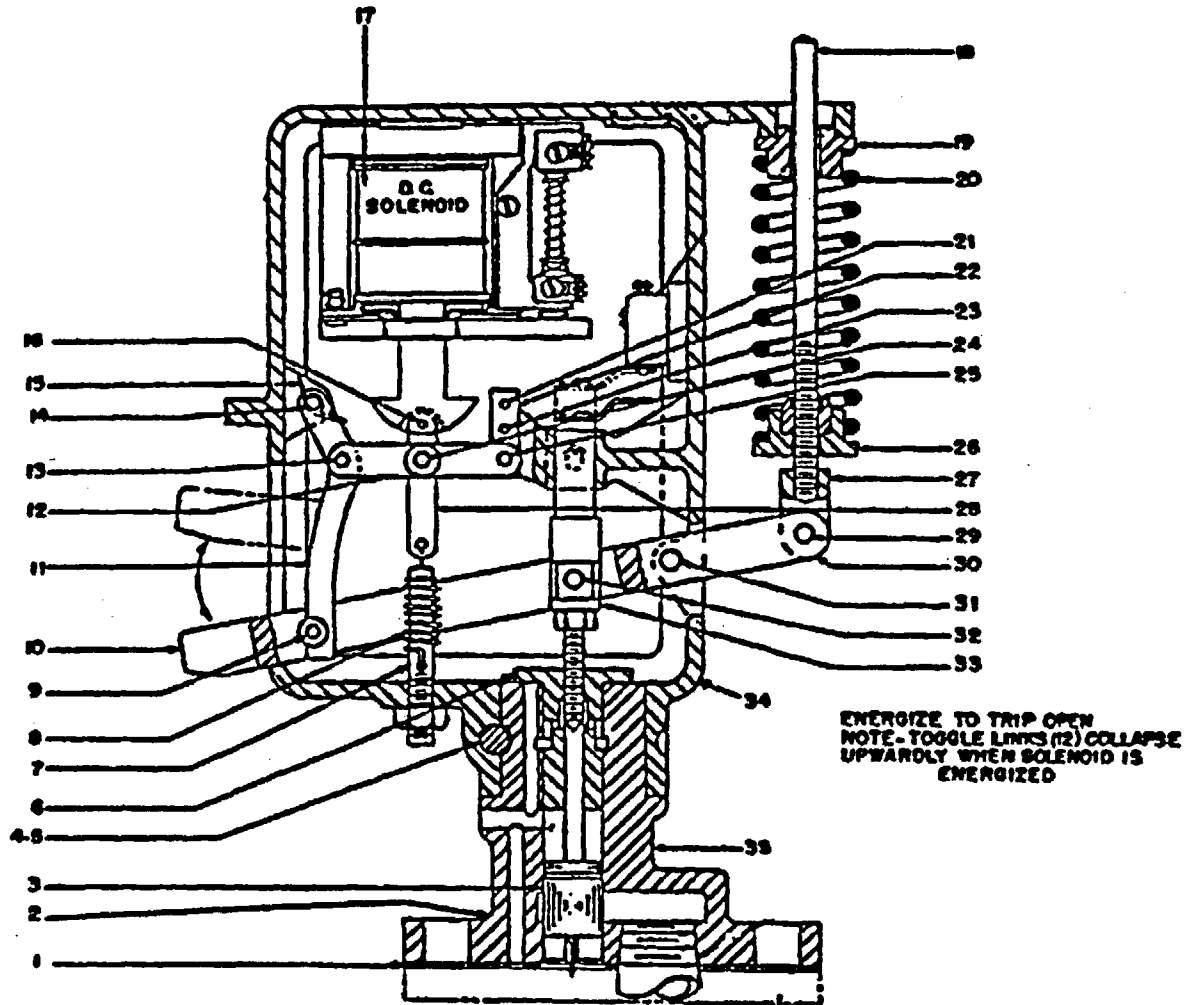
Figure 12 Big Rock Point—Original hand-trip solenoid valve

actions. For the short term, depending on the schedule, the licensee would either replace the HTS with a refurbished one or replace the HTS with another valve of a simpler type before power ascension (see Figure 13). For the long term, the licensee considered modifying the manifold block that housed the HTS to allow another valve to be added in parallel to the HTS. The extra valve would preclude another HTS failure from tripping the turbine.
