Construction Problems with an Earth and Rockfill Dam

Hasan Hejazi

Tennessee Technological University, Cookeville, Tennessee

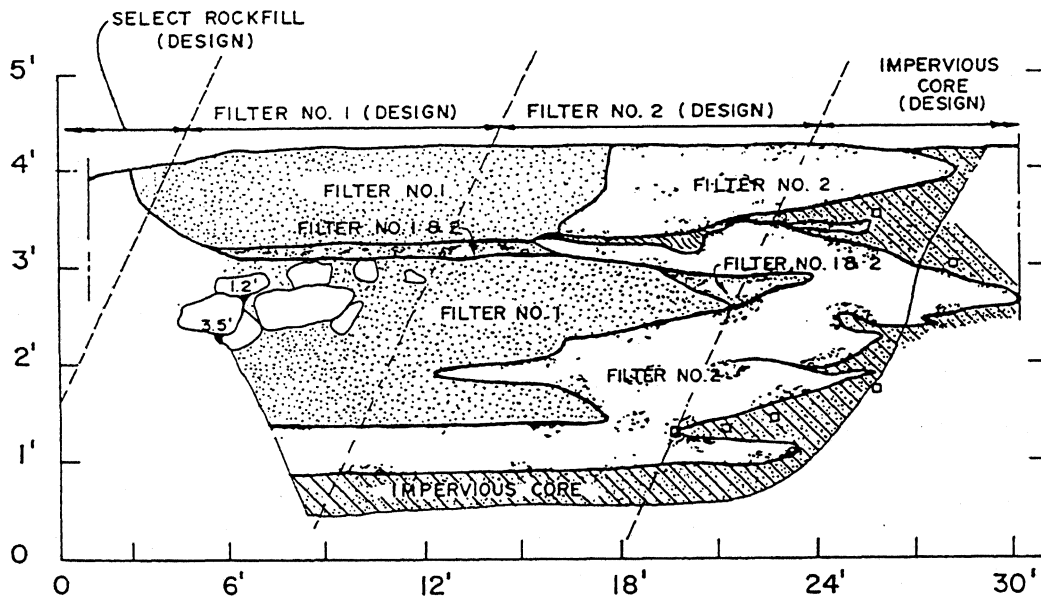
Further discussions led to questions concerning the integrity of the embankment. In order to determine the extent of the problem, work was stopped to conduct the investigations. Test pit excavations were made, at randomly selected locations at the shell and coarse filter contact. Excavations extended from the surface of the in-place embankment fill down to the top of the drainage blanket. Trenches were then extended from some of the pits, through the two filters, into the impervious core. Results of the test pit excavations revealed the following:

- a. The filter zones were not constructed to specified lines and grades.
- b. The shell rockfill was badly segregated and it contained up to 12% of oversize (+16 inch) rock.
- c. The select rockfill was not as dense as would be expected for rockfill placed as specified.
- d. The filter zones and the core were intermingled and overlapping, as shown in Figures 5 and 6.

Figure 5. Overlapping Zones on Upstream Side of Embankment.

The findings of the investigations rendered portions of the embankment in place unacceptable. The contractor was directed to proceed with the remedial work. He removed the unacceptable portions and replaced them according to specifications under rigid control. For the continued construction, the zones were constructed as near level as possible. Continuous monitoring of the proper location for the zones was maintained.

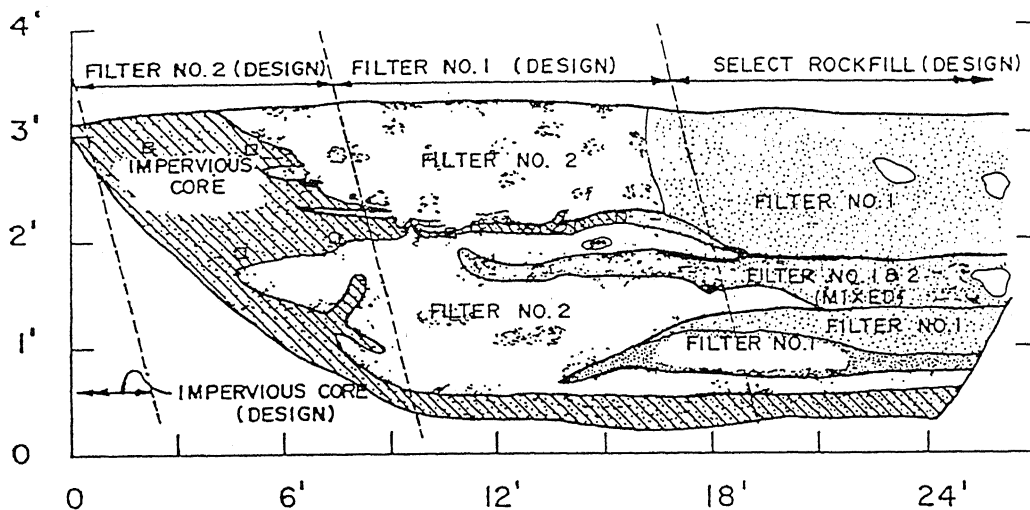
Figure 6. Overlapping Zones on Downstream Side of Embankment.
