### Failure at Delhi Metro An Analysis

15<sup>th</sup> Jul' 2009

### FAILURE ANALYSIS OF MISHAP AT DMRC SITE ON 12TH JULY, 2009 - A REPORT

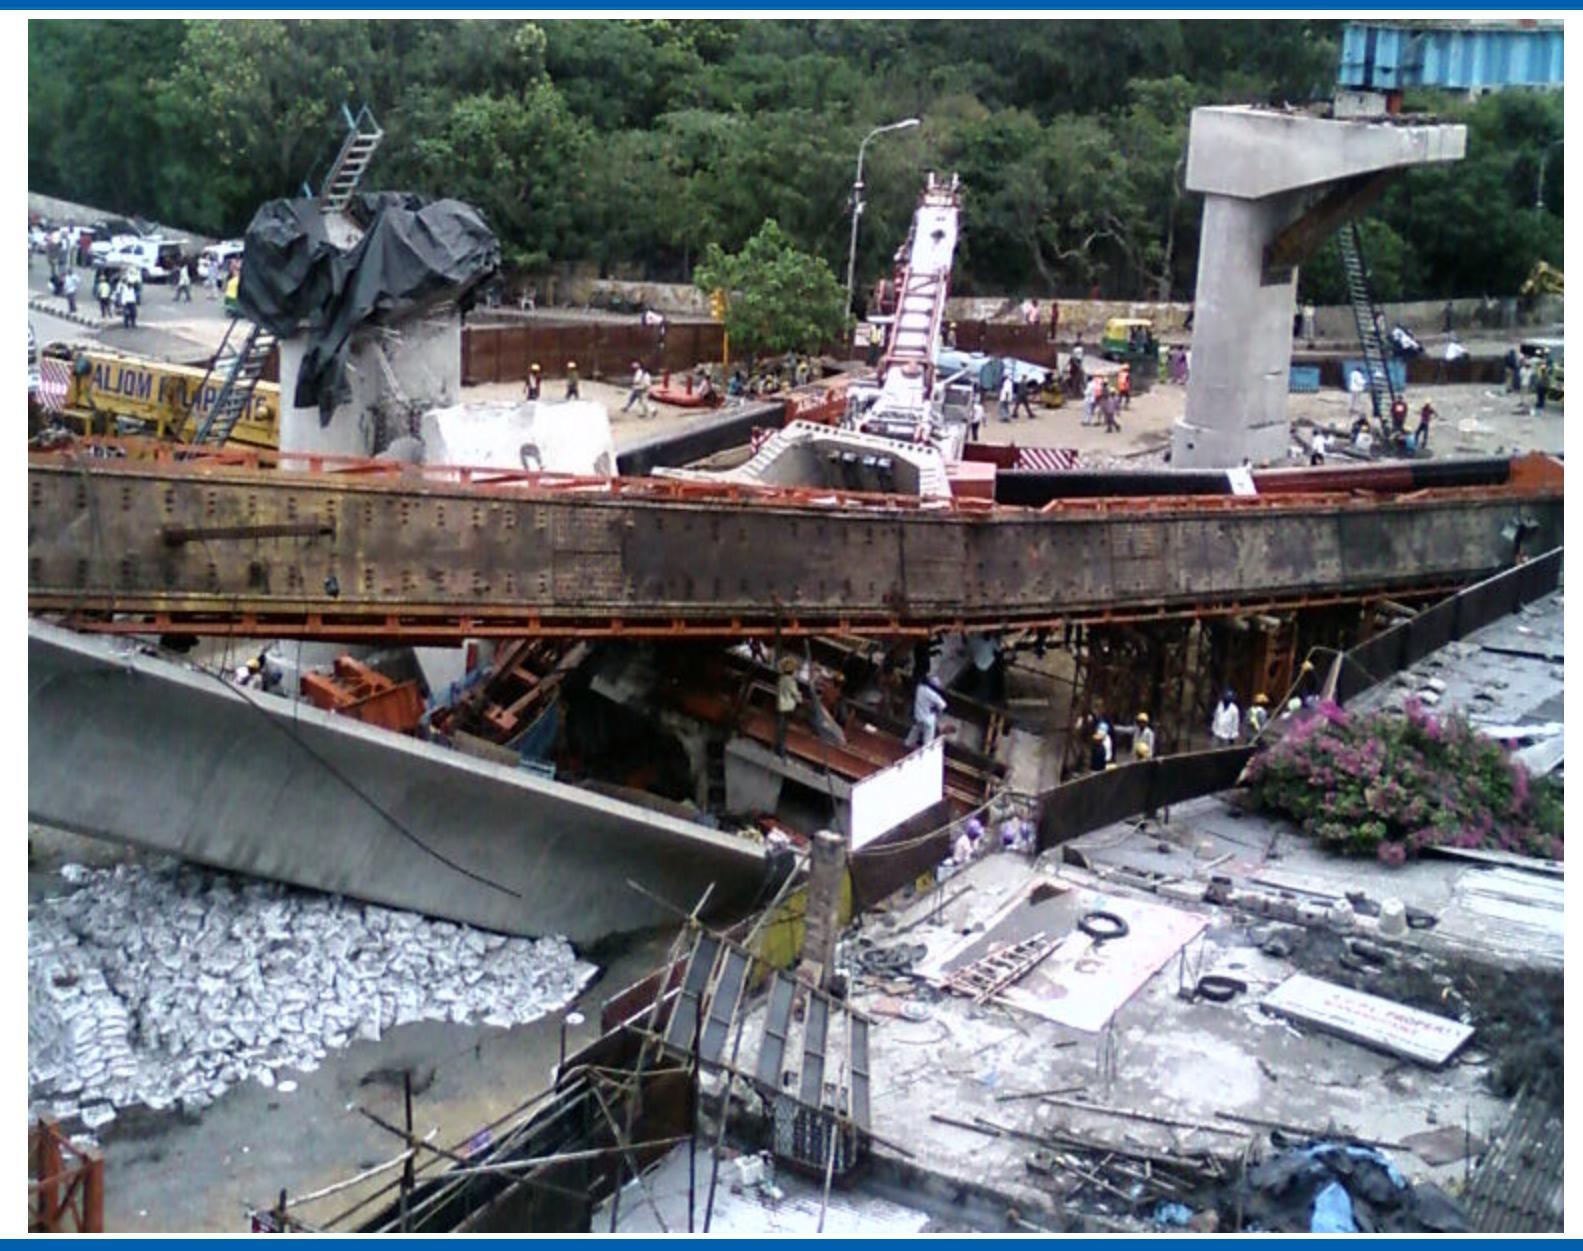
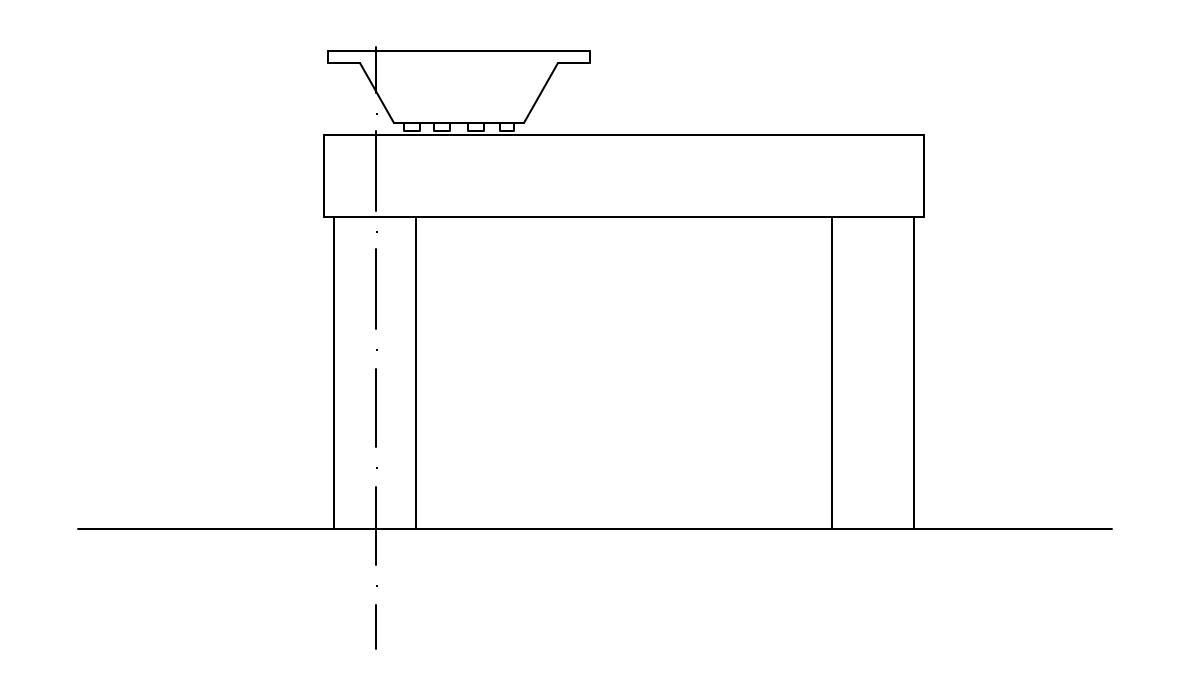
### **PICS OF FAILURE**

The rail track alignment takes a turn here. The top deck can not be placed at the centre of the pier. 4 nos piers (66-69) were initially proposed to be portals.

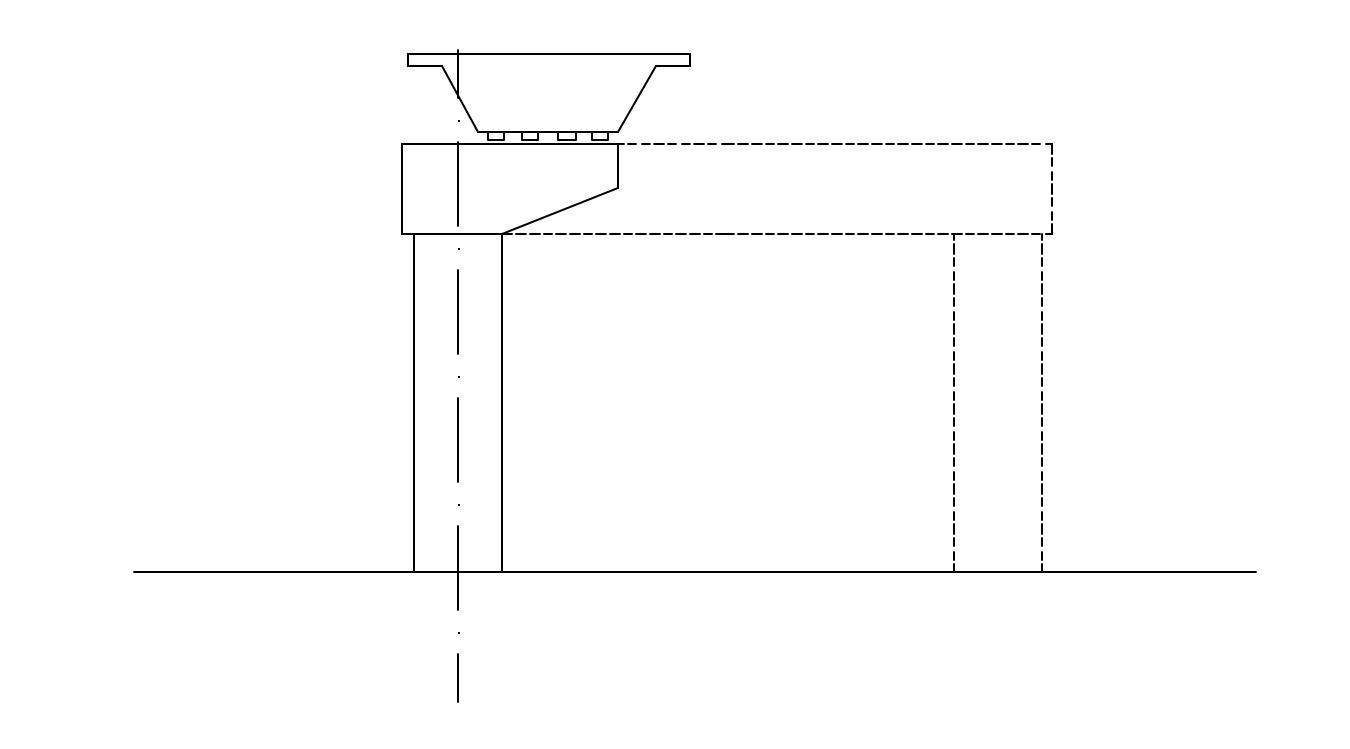
This being a congested area, the 2<sup>nd</sup> pier was coming pretty close to the adjoining shops. Due to resistance from the shopkeepers, these portals were converted into cantilevers supported on single pier.

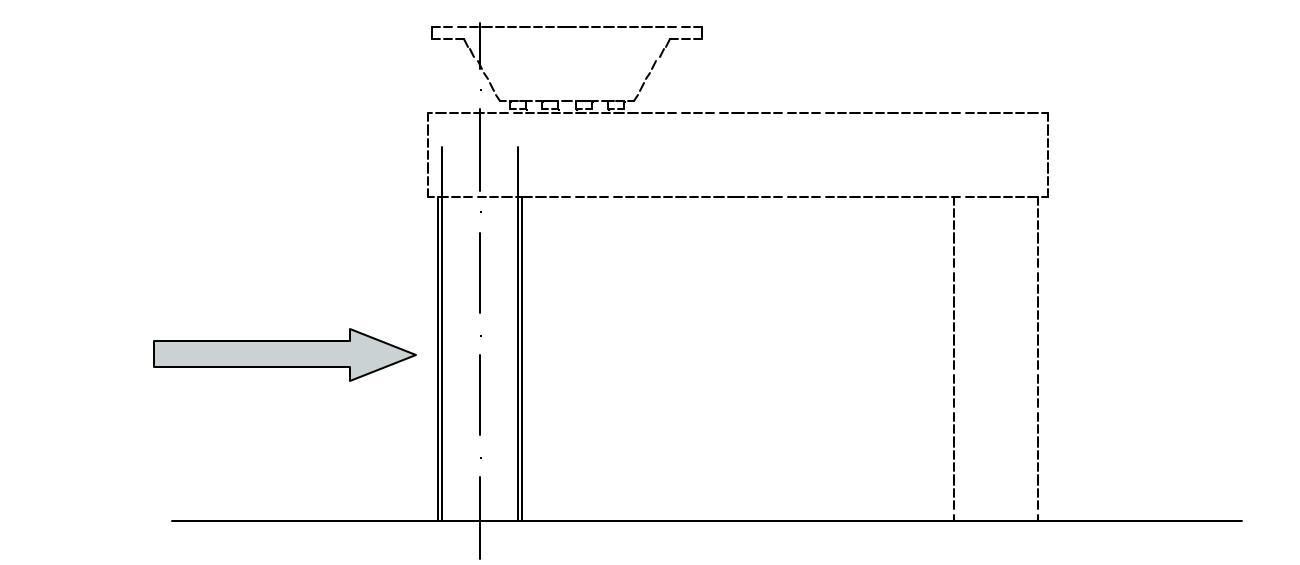
The pier already constructed with dowels as per old design.

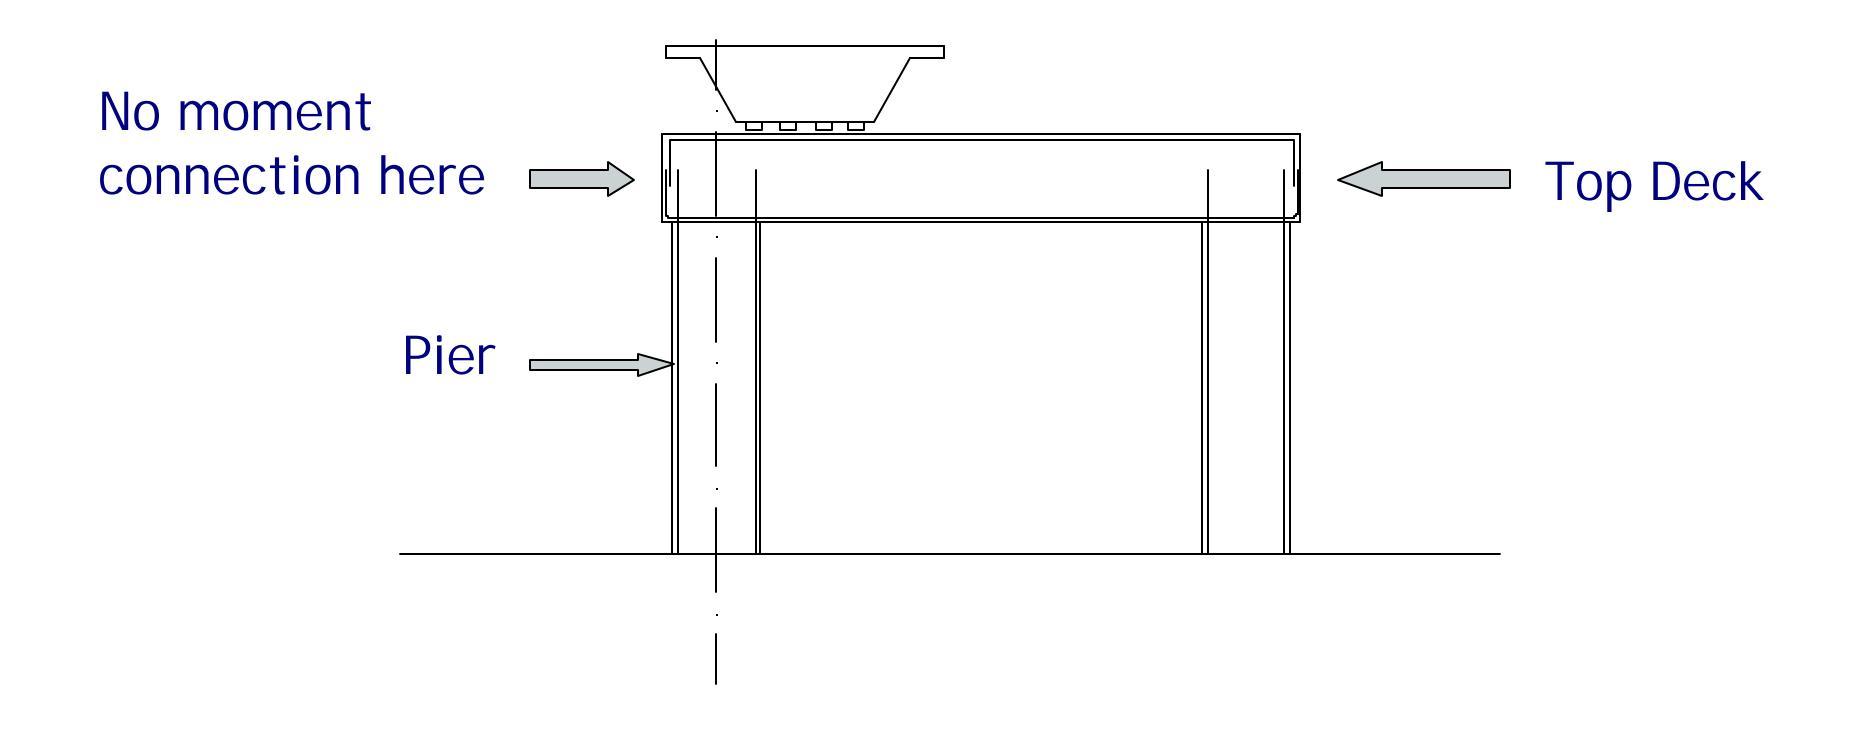
The top deck was probably designed as simply supported on piers

# The portal is converted into long cantilever approx 4.5 m

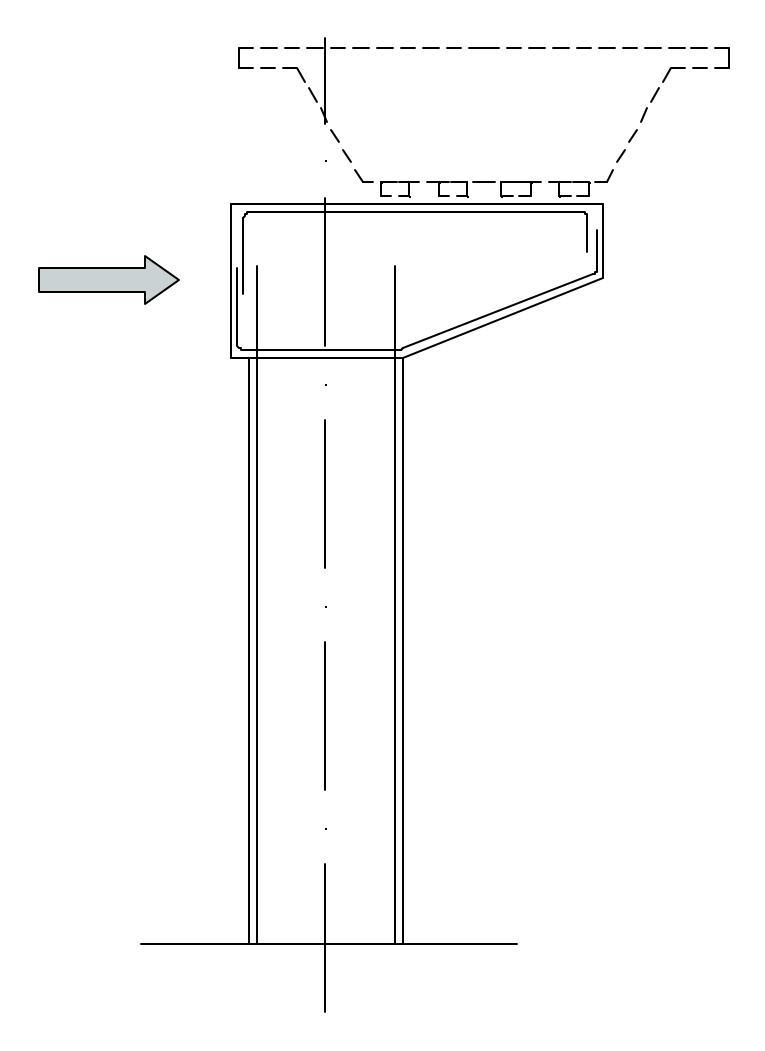
Probable Cause – insufficient lap of deck top tension rebars with pier's projected rebars. The cantilevered deck shows signs of failure as crack.

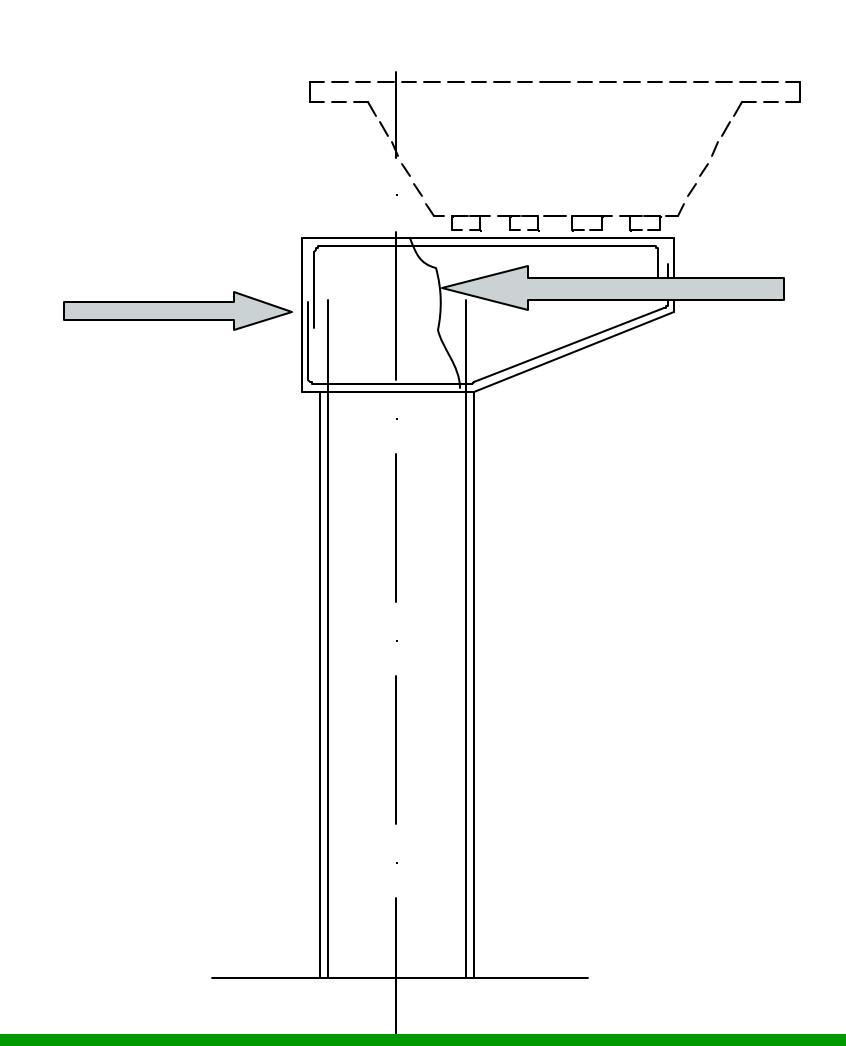
Top deck develops crack while erecting segments of previous stretch i.e. between pier 66 - 67

The work is stopped for almost 2 months for deciding rectification measure

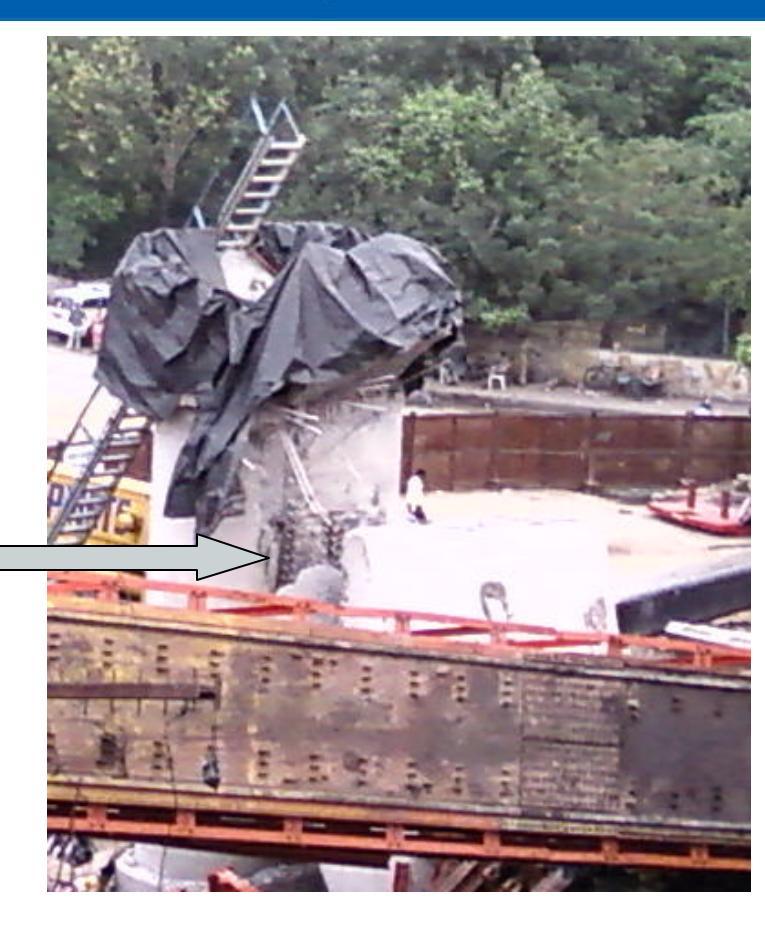
Steel bracket's weld with end plate fails keeping the bracket plate and anchor fastners intact.

The top deck again acts as cantilever and fails in moment due to In-sufficient lapping of bars

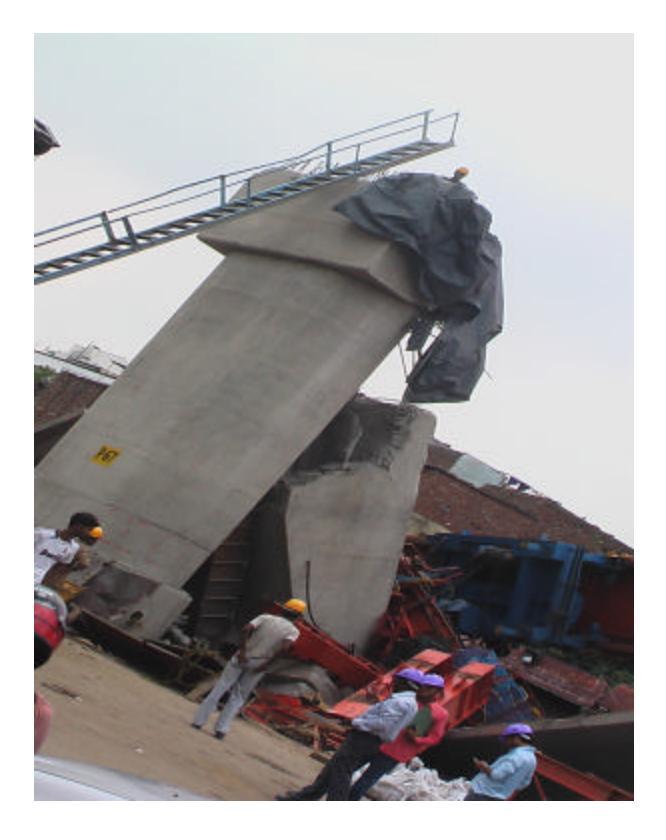
#### A. Observation – 1

The pier cap of affected pier (P-67) has sheared from the connection point of the pier and pier cap. It is a cantilever pier cap.

It was informed by the contractor and DMRC representatives that the support system for viaduct was initially designed as portal pier till the casting of the pier was over. The shop owners put up

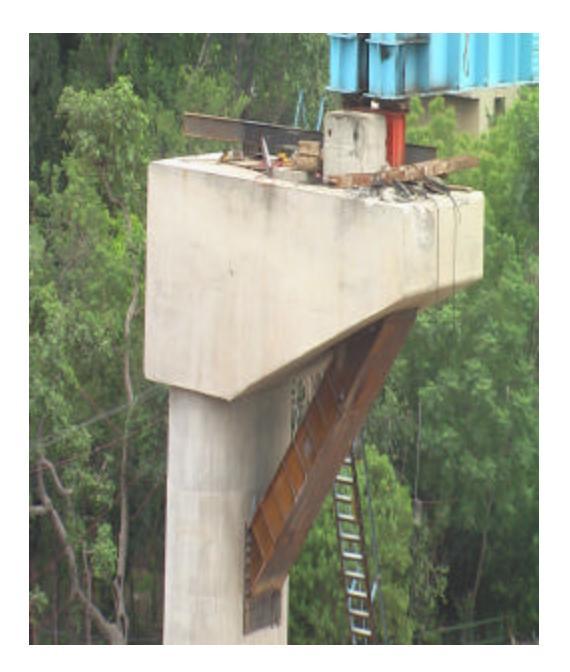
resistance against casting of the other leg of the portal and it was subsequently decided by DMRC that this would be changed to a cantilever pier, similar to P-68 which is still standing at site (shown below).

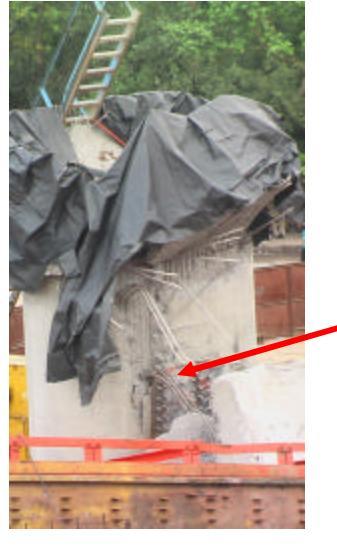
### B. Observation - 2

It was noticed that the prop support of the cantilever has failed from its connection to the pier.

The prop support has sheared from here

- x. The sequence of failure is as follows:
  - a. The support of the prop / jacket got sheared from its connection due to inadequate section / welding.

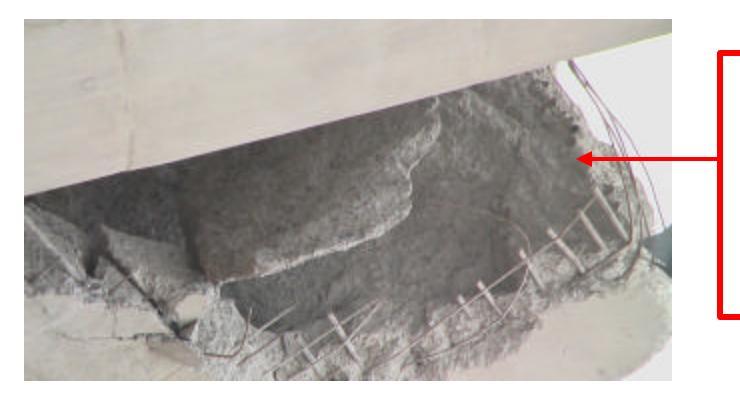
#### C. Observation - 3

The top reinforcement of the cantilever beam does not have any development length into pier concrete. As learned from the sources, the top reinforcement of the cantilever beam had an "L" bend of 500 mm only.

Top reinforcement does not have development length

There is very nominal (or no trace) of shear reinforcement at the juncture.

- v. The top reinforcement of pier cap was 36 mm in diameter and had a development length of 500 mm. only as an "L" from the top. There was insufficient bond length for the structure to behave like a cantilever beam.

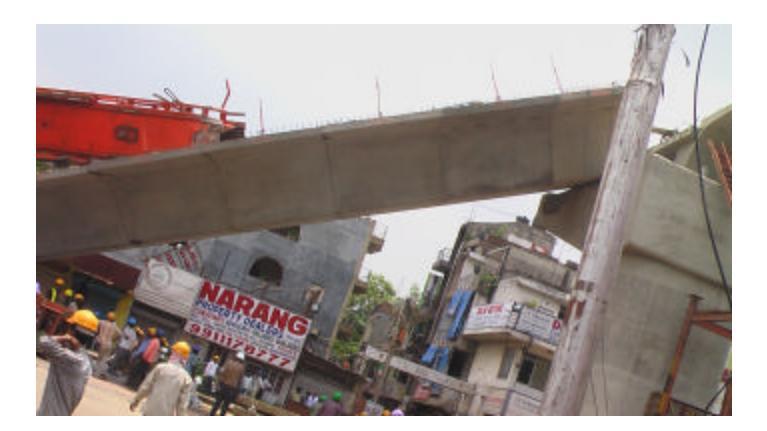
### D. Observation - 4

The launching girder has fallen below with the failure of pier cap. Also, the span between P-67 and P-68 has fallen inclined, supported by the ground at one end and pier cap (P-68) on the other.

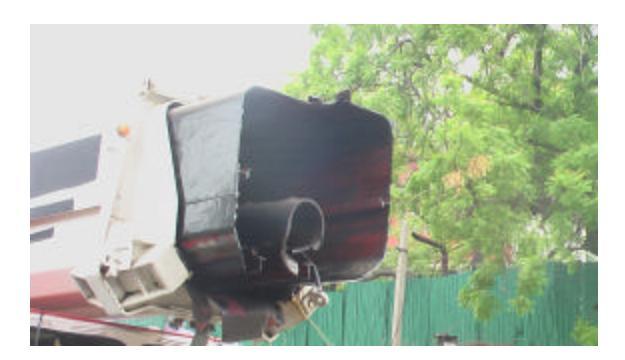
### E. Observation - 5

The boom of the crane, used for lifting the launching girder on 13 July, 2009, has failed in bending and shows clear sign of overloading.

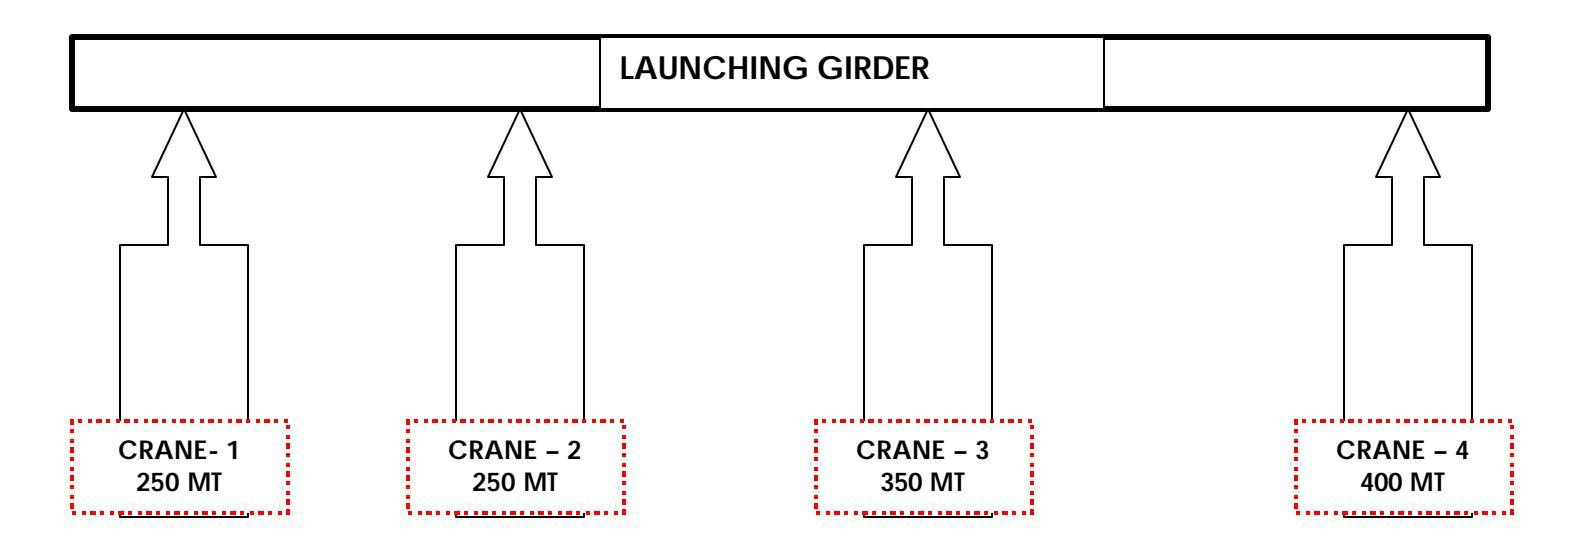
There were four cranes operating simultaneously as shown in the sketch

The launching girder was lifted by the cranes. However, it needed to be pushed little forward for unloading it on the ground. So, all the cranes were asked to stretch there booms by some length. During this operation, the 250 MT capacity crane on extreme left exceeded it's capacity and the boom failed and broke down. Since, there were unequal loading on the 250 MT crane by it's side, that also failed and broke down. The crane of 350 MT capacity didn't broke but it toppled with it's base. The 400 MT crane remained intact.
