## HS2000 Trouble 1

## HS2000 Trouble 2

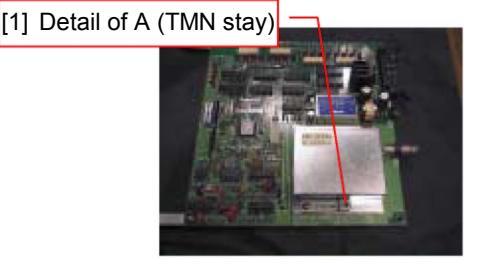
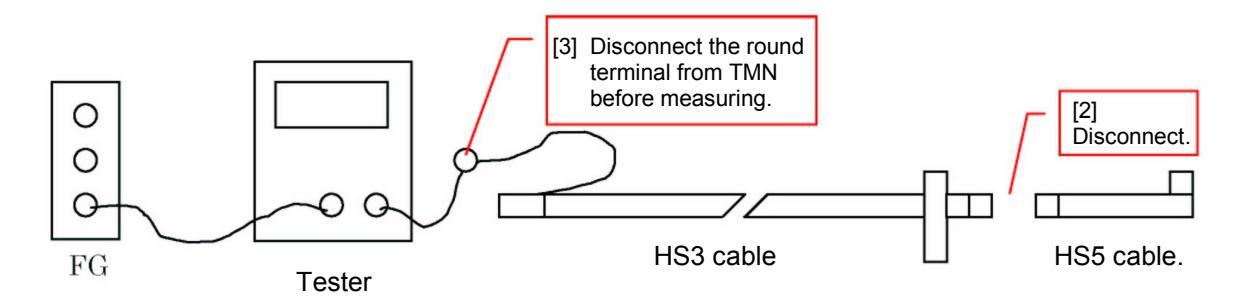
HS2000 board

• One likely cause is short-circuit caused by a broken shield of the HS3 cable.

- [1] Remove the shielded cable connected to A (TMN).
- [2] Disconnect the HS3 cable from the HS5 cable (to free the head end of the HS3 cable).
- [3] Using a tester, measure the resistance between the FG terminal block in the NC operation panel and the shielded cable.

[4] Move the sensor head over the full strokes of respective axes (X, Y, Z) and check if the resistance value changes.

If the resistance is infinitely large, the cable is normal (since the other end is free). If the resistance is several kilo-ohms to several tens of kilo-ohms, the cable is abnormal (shorted at some point).

If the cable is found abnormal, broken cable cover and other problems are considered.

- Change the wiring destination of the HS3 shielded cable from TMN to FG.
  - Note) Note that HS-WACS (cooling cut) can no longer be used on the FO/ $\theta$  due to conflict of certain characteristics such as cable length. (This doesn't apply to  $\alpha$ ,  $\beta$  or APE.)
