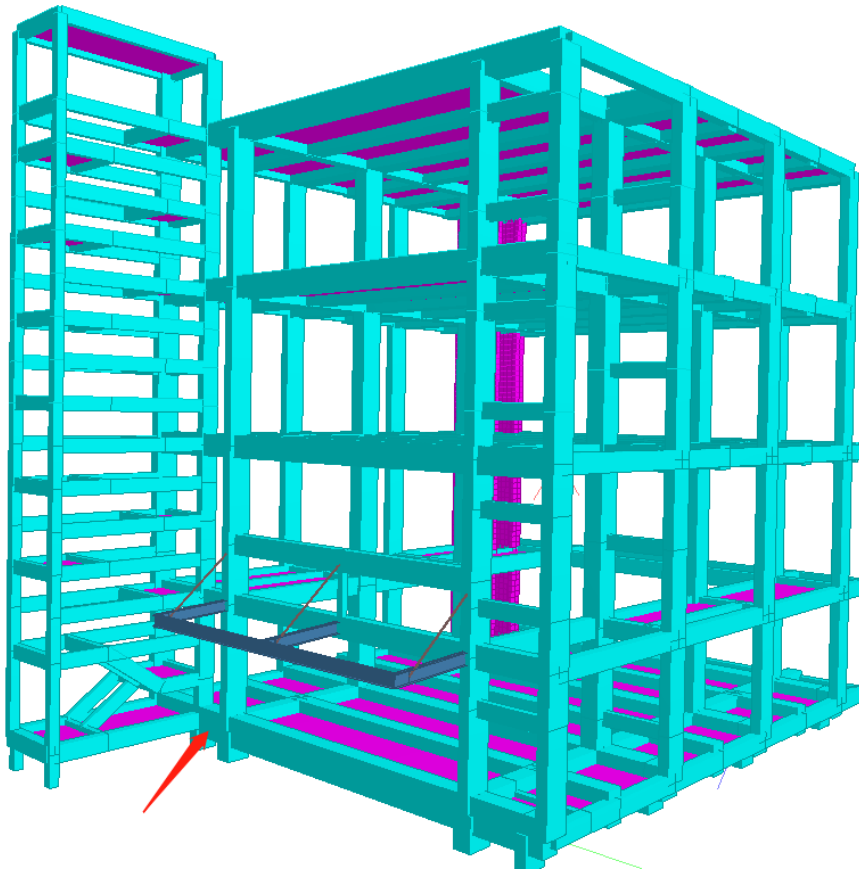
The arrowed beam got torsion and it failed in shear design by staad.
