Surfside tower was flawed from day one. Designs violated the code, likely worsened collapse

UPDATED AUGUST 08, 2021 10:40 AM

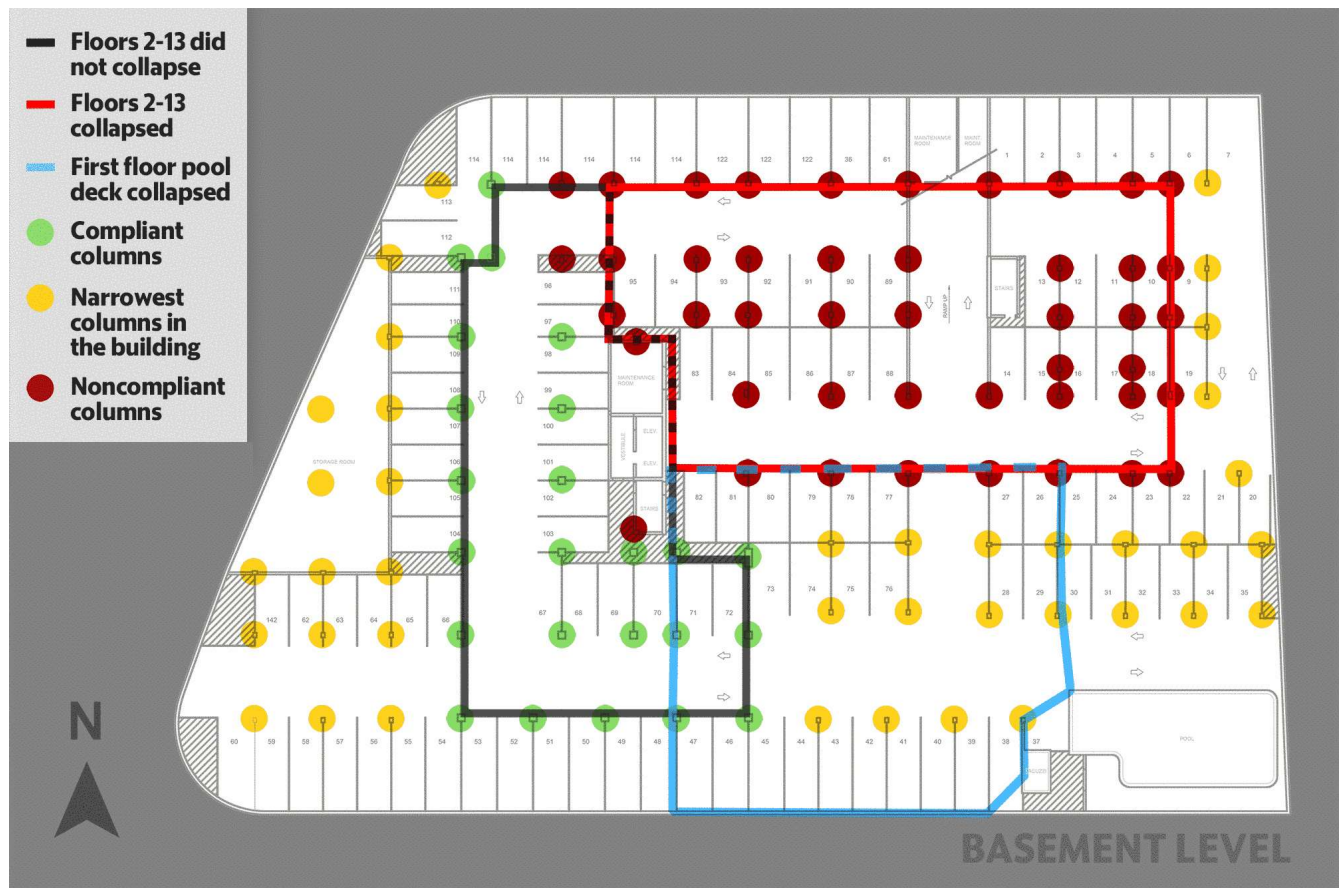
Collapsed portion of building wasn't designed to code

The Champlain Towers South design violated building codes at the time of original construction. On the northern side, under the portion of the tower that collapsed, the columns were too narrow to accommodate all of the vertical and horizontal rebar called for in the plans while maintaining clearance

required by the code. The pool deck had narrow columns and inadequate load bearing capacity, engineers consulted by the Herald found. Only columns beneath the surviving structure were fully compliant with the code at the time.

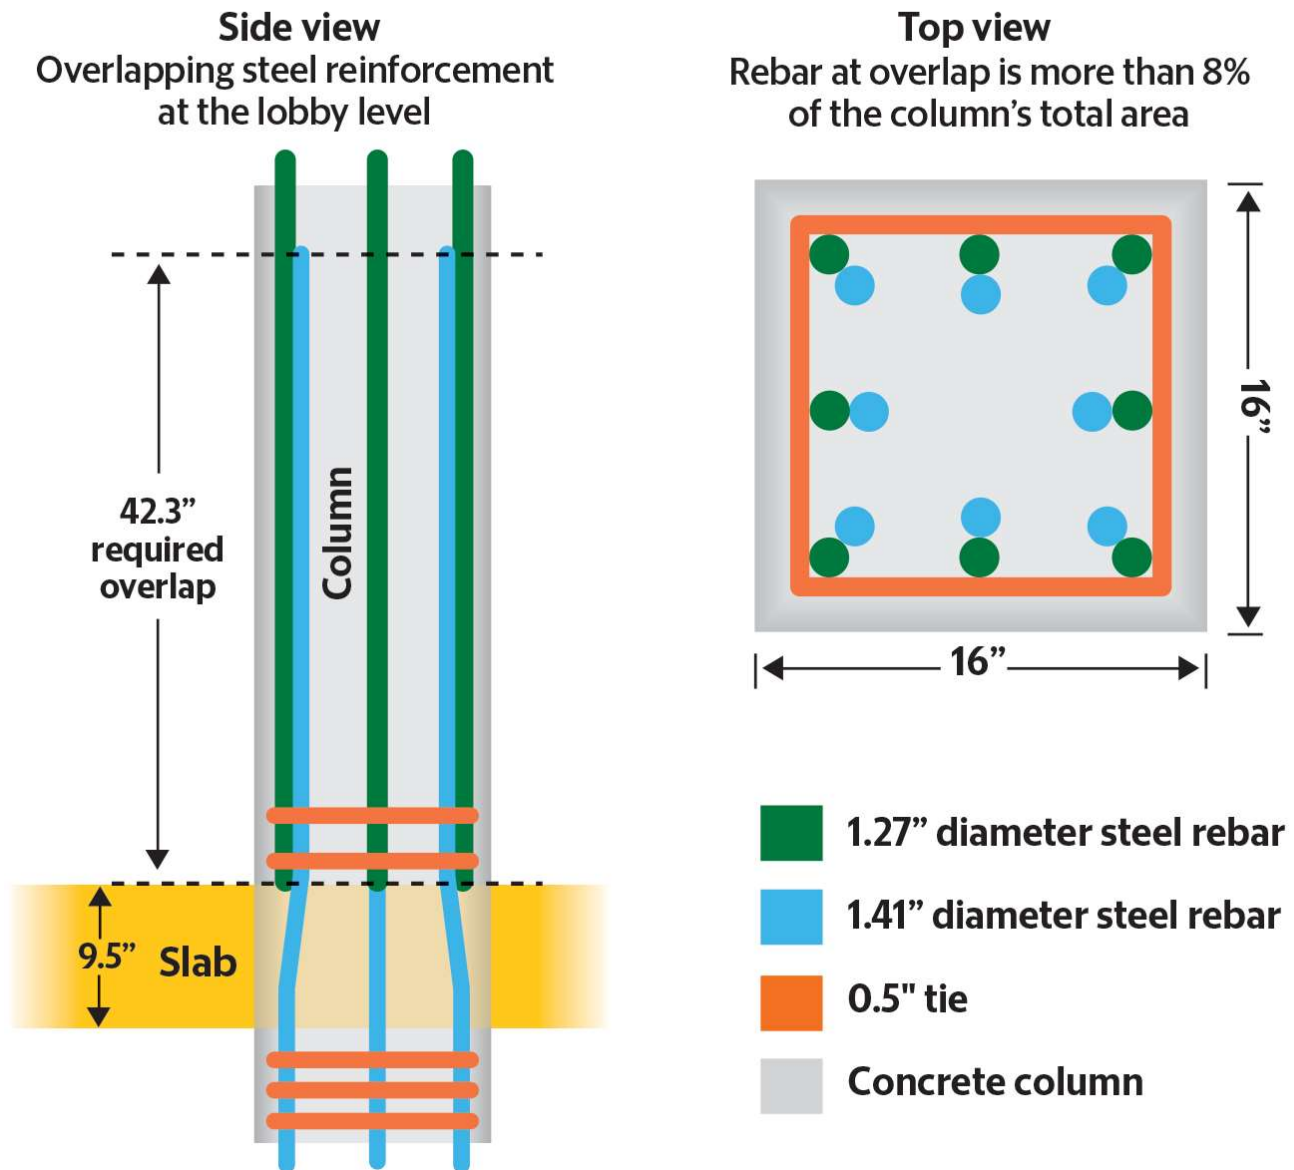
## Common Champlain column design

The American Concrete Institute’s 1977 code required a rebar-to-concrete ratio of no more than 8% to prevent overcrowding, which can make the column difficult to properly construct and reduce its overall strength. All but two column types in the Champlain Towers South plans were noncompliant where rebar overlaps in the basement and lobby levels. The overcrowded columns were clustered under the north portion of the condo that collapsed on June 24, 2021.

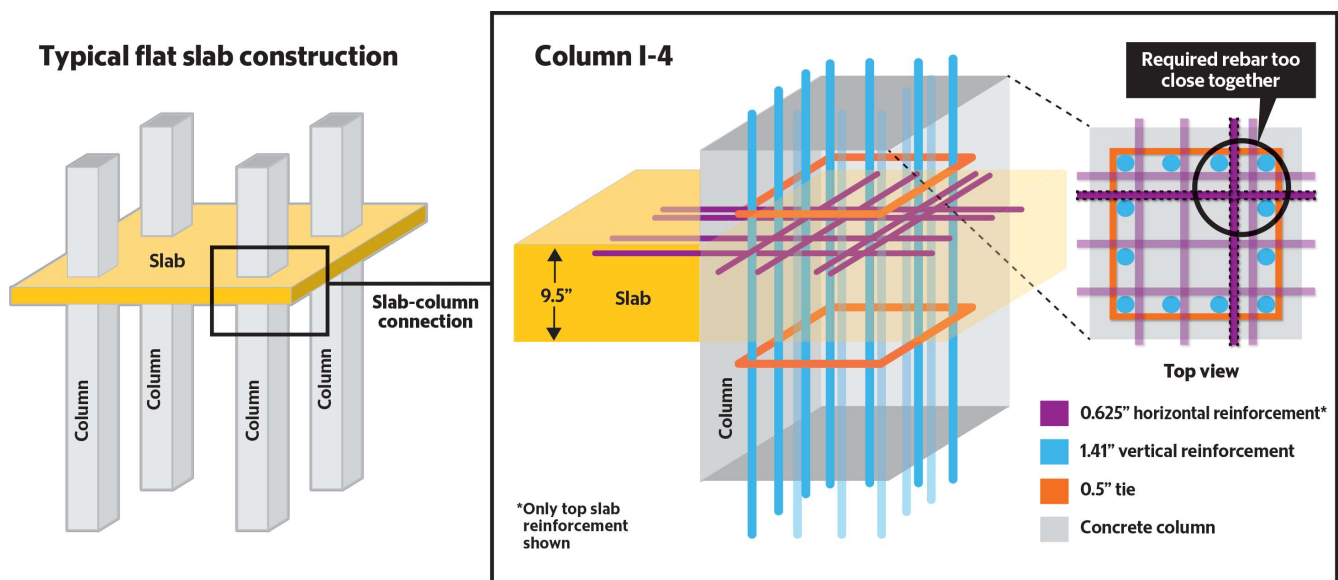
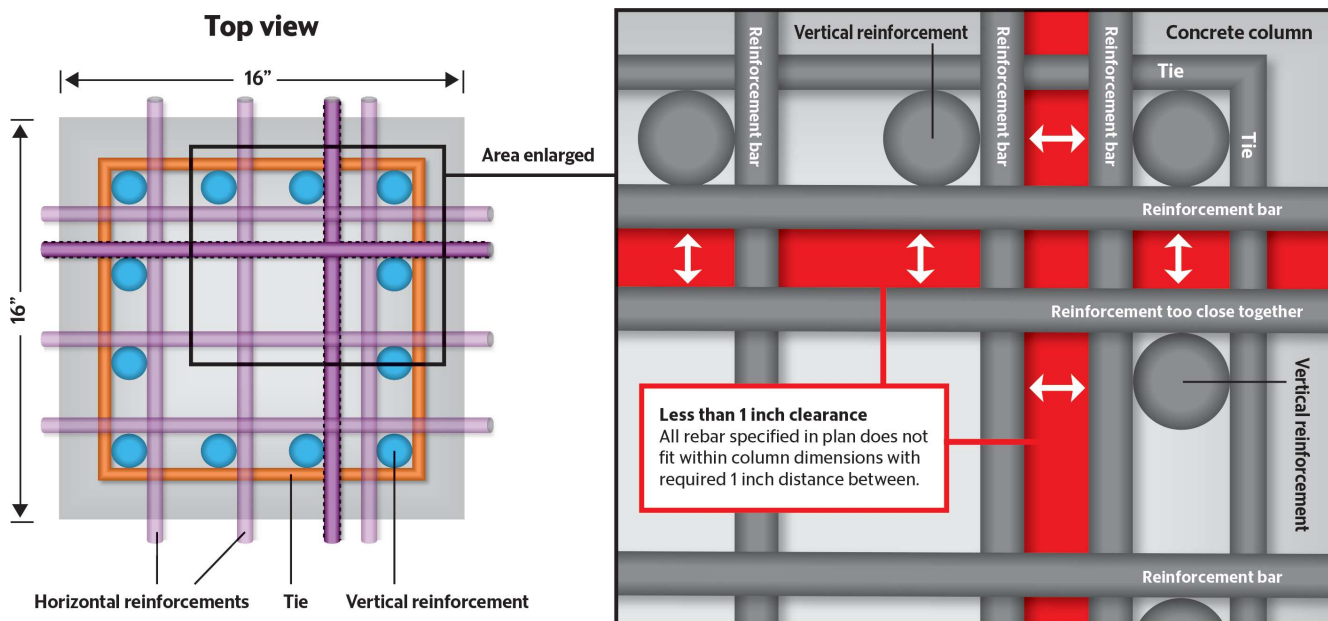
Design violated minimum spacing requirements for connecting steel

Some structural elements in the collapsed portion of Champlain Towers South did not meet minimum spacing requirements for reinforcing steel set by the American Concrete Institute at the time the condo was designed. For example, at Column I-4 between the basement and first floor, building plans required four pieces of horizontal rebar through the column in both directions to connect it to the slab. If built to plan, the column was too narrow to fit all of the rebar with the required spacing.

Section 7.6.1 of the ACI 318-77 code required a minimum of 1 inch clearance between parallel

reinforcement. In the example of Column I-4, two pieces of horizontal rebar in each direction would have been less than 1 inch apart, making the column-slab connection difficult to properly construct and potentially reducing its overall strength.

“That would have been an occasion for a request for a change [by the contractor],” Aghayere said. “Maybe those columns needed to get bigger.”

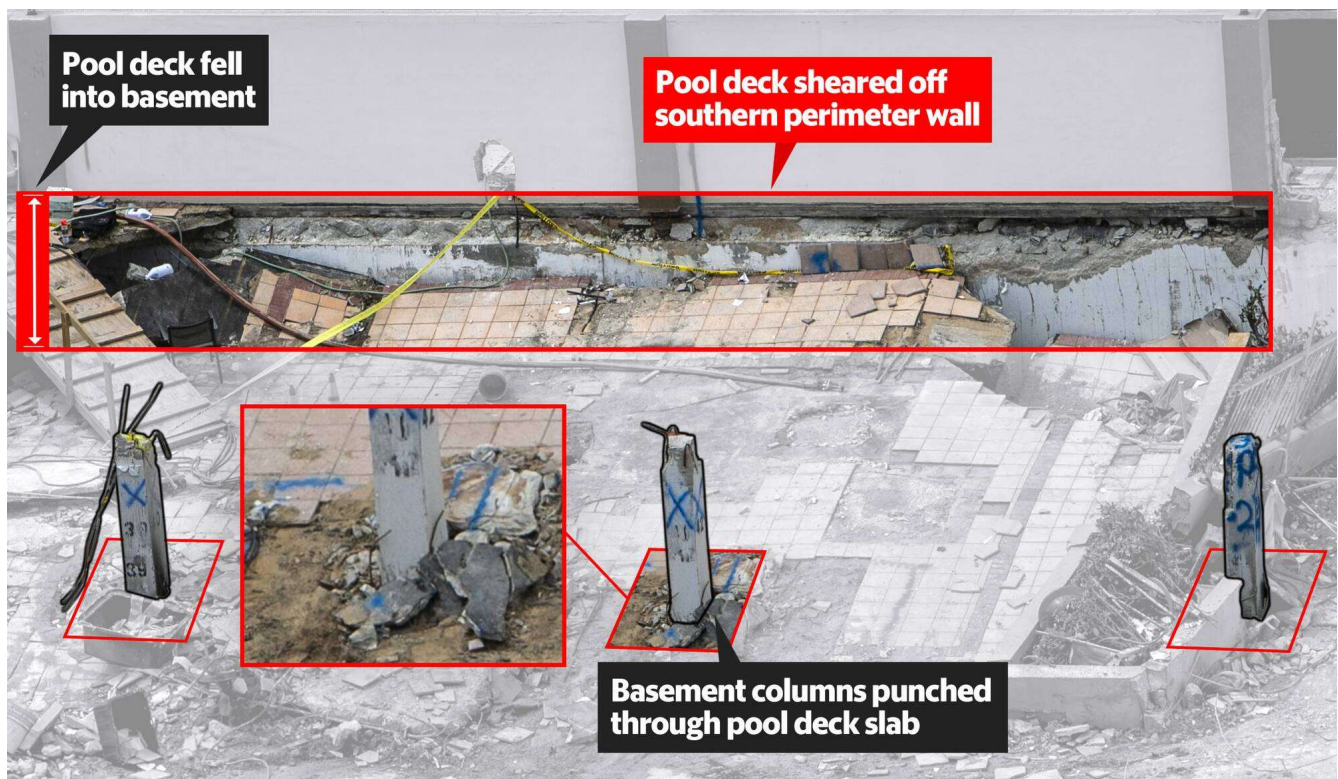
Pool deck falls into the garage in "punching shear" failure

Between 5 and 10 minutes before the north side of the condo pancaked down, eyewitnesses and a cellphone video suggest the pool deck began to sag. The spindly columns supporting it poked through the slab — a failure called “punching shear.”

Eyewitnesses saw the pool deck collapse, shearing off completely from the southern perimeter wall of Champlain Towers South minutes before the tower came crashing down. Photos from the collapse site show that narrow columns from the parking garage below poked through the pool deck as the slab sagged — a dangerous type of failure called "punching shear" which experts say is known to cause sudden collapse.

“My calculations show that the capacity was lower than the load that was imposed at these pool deck columns,” said Aghayere, the engineer from Drexel University. “So I would have added drop panels to increase the shear strength.”

“[Drop panels are] not mandated, but it is what you can use to reduce the punching shear demand so that you meet the punching shear requirement,” Aghayere said. There is no indication of drop panels in the original building plans, he said.

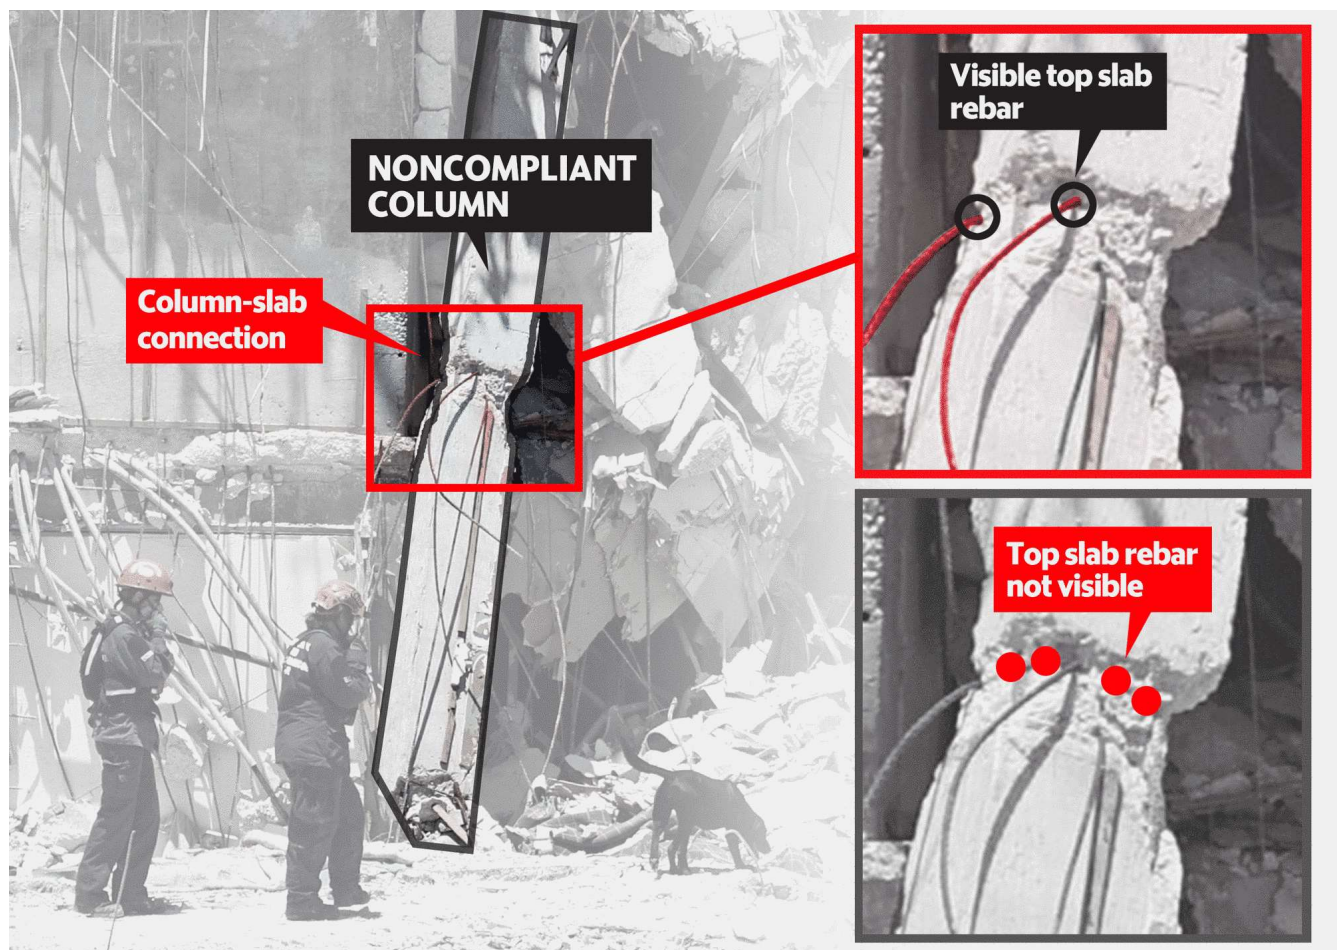
Expected rebar appears missing from column-slab connections

Engineers who compared the Champlain Towers South plans to photos of the post-collapse debris saw examples in various parts of the structure where rebar designed to connect the column to the slab appeared to have been left out during construction. For example, in this column from the north side of the tower, plans called for at least three pieces of horizontal rebar in both directions to connect the column and the slab at the joint pictured below — six pieces of horizontal rebar total. Only two of the expected six are visible in the debris.

Exposed connections in damaged columns in the pool deck, as well as in both sides of the high-rise structure, appeared to have fewer pieces of horizontal rebar than called for in the plans, said the engineers, who reviewed hundreds of photos of the debris and compared the visible columns to building plans.

“It is possible that the rebar broke off and that’s why we don’t see it,” said Lehman, the University of Washington engineer. But the debris photos, especially those from the pool deck, suggest a construction error, she said.

“It’s pretty clear to me that the required slab reinforcement did not go through that [pool deck] column given the way it should be spaced,” she said.
