MATERIAL Titanium 6AL-4V		TOLERANCES: 0.XX = ± 0.010" 0.XXX = ± 0.005" FRACTIONS = ± 1/64" ANGLES = ± 1/2'	DESIGNED BY: MJC	DRAWN BY: MJC	APPROVED BY:	DATE: 8/23/2011	SCALE:
FINISH - DEBURR, BREAK ALL EDGES, SURFACE FINISH RMS 32 UNLESS SPECIFIED					Carbon Socket -91 Size		
A-SIZE	Any designs or drawings produced by Navtec Inc. and transmitted to a second party are the property of Navtec Inc. and are to be considered confidential and are to be used only for the purpose for which they were transmitted.				R531-06-09148	REVISION	SHEET 1 OF 1

-91 TITANIUM SOCKET - TEST

R531-06-09148 Test

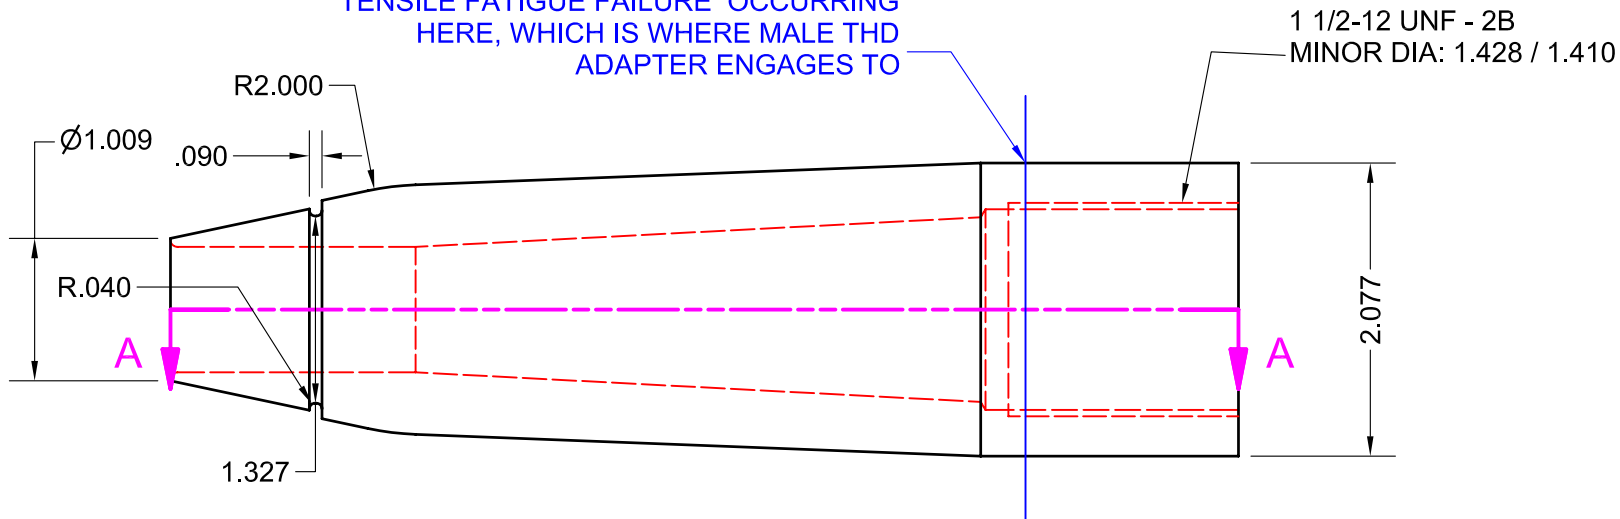
TENSILE FATIGUE FAILURE OCCURRING
HERE, WHICH IS WHERE MALE THD
ADAPTER ENGAGES TO

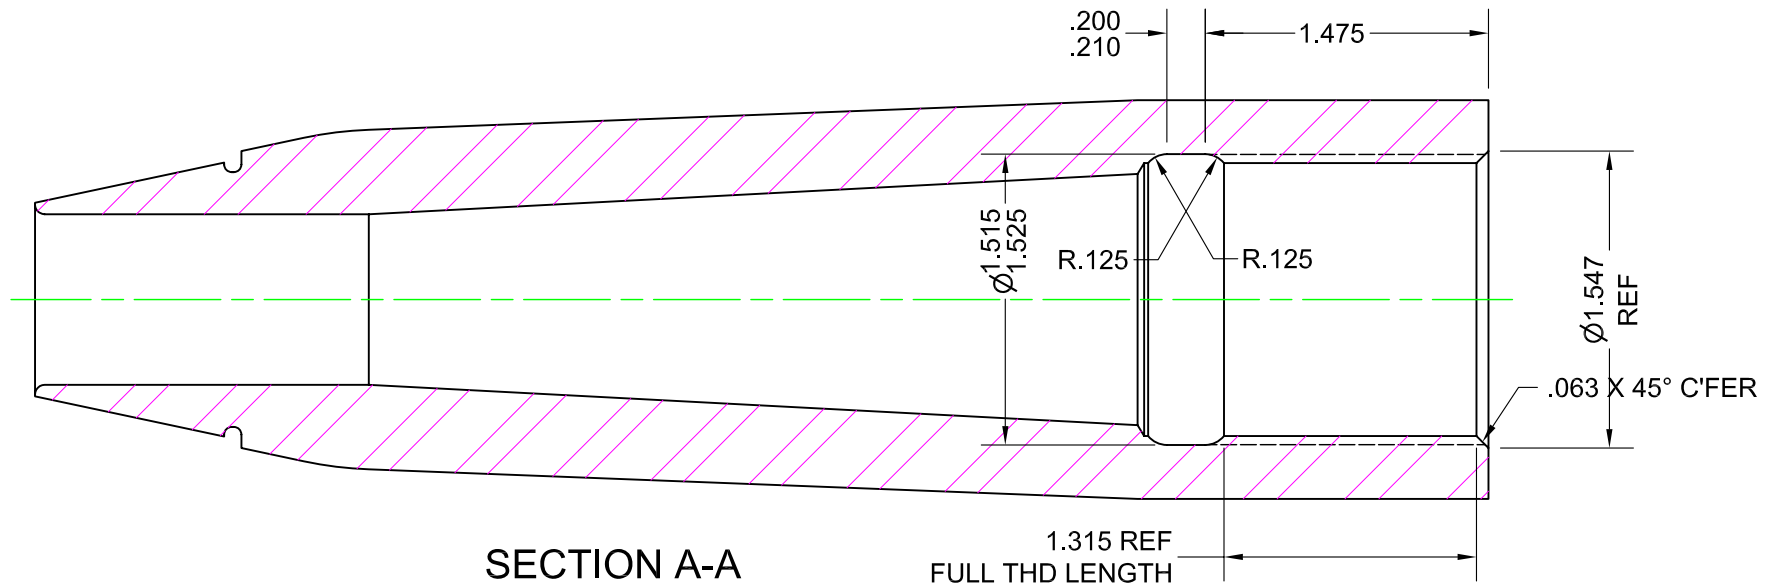
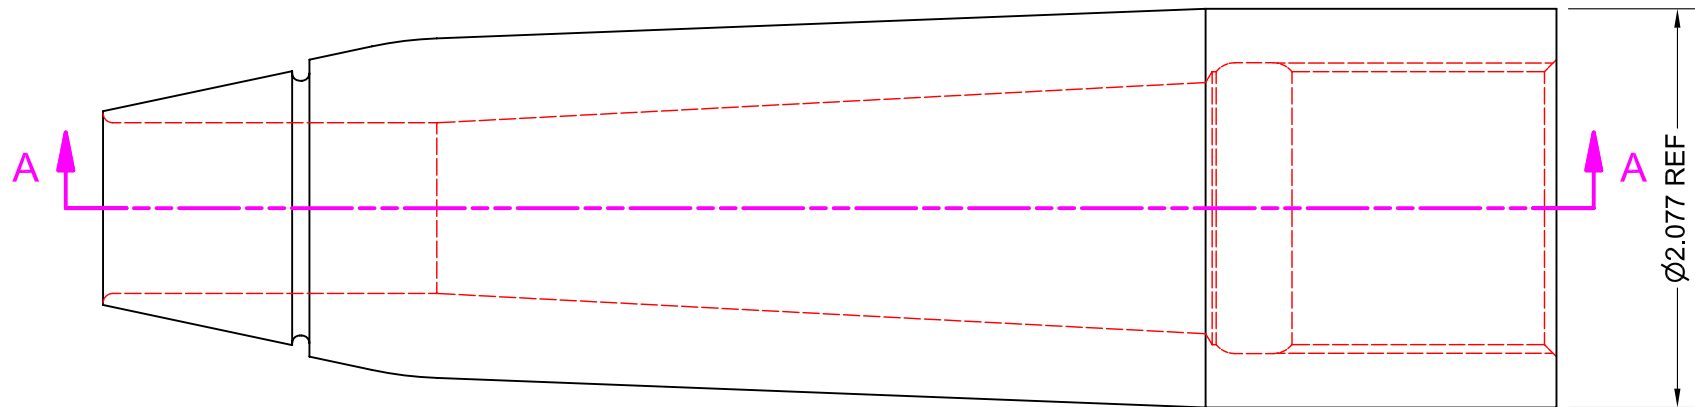
MAKE FROM R531-06-09148 SOCKETS
ADD FEMAL THREAD RELIEF AND CHAMFER TO EXISTING SOCKETS

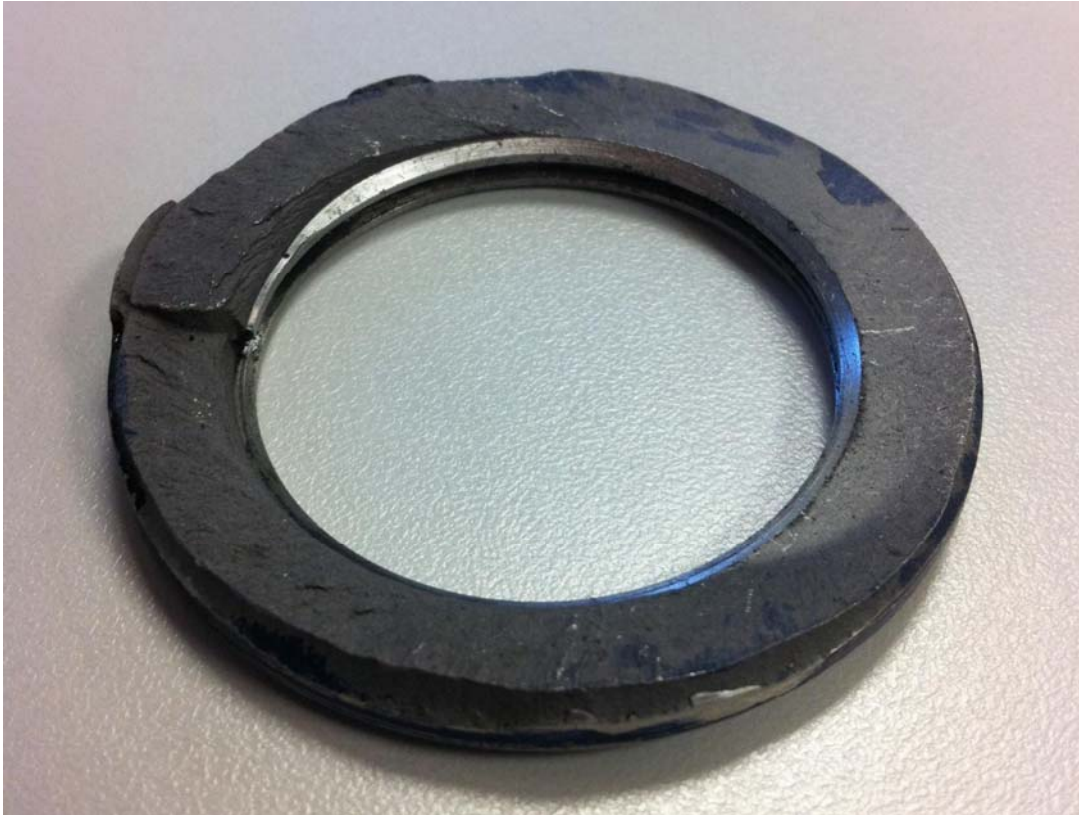
Ring of failure point on -91 titanium socket (Test #1), failed at 104k cycles

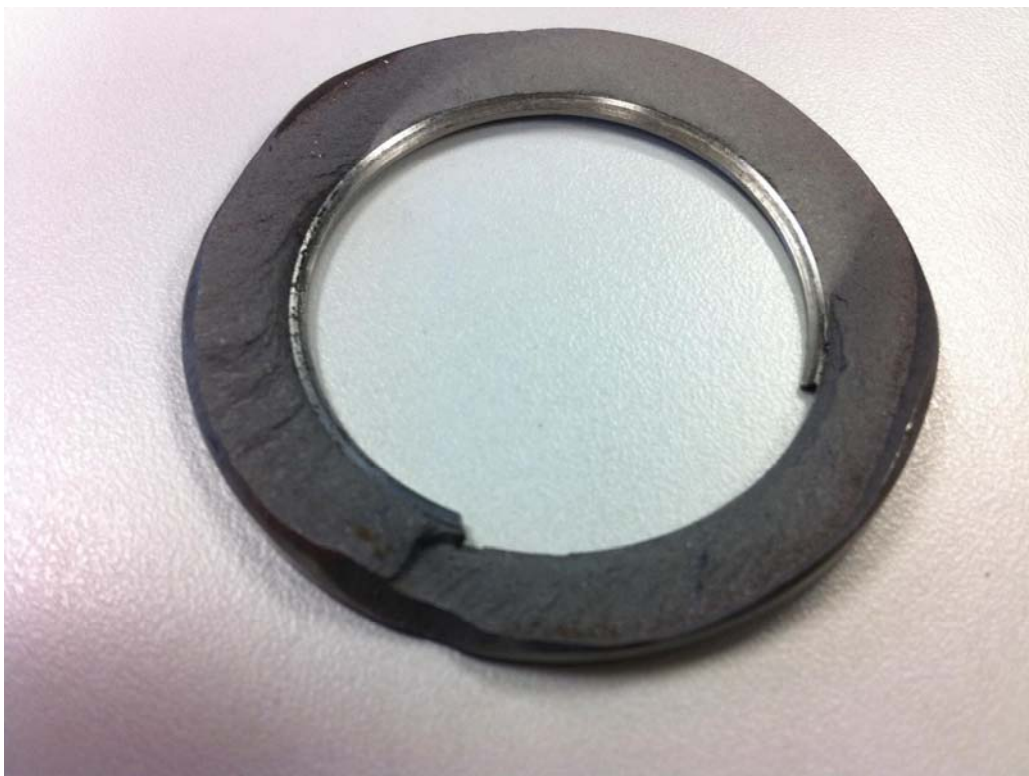
Ring of failure point on -91 titanium socket (Test #1), failed at 104k cycles

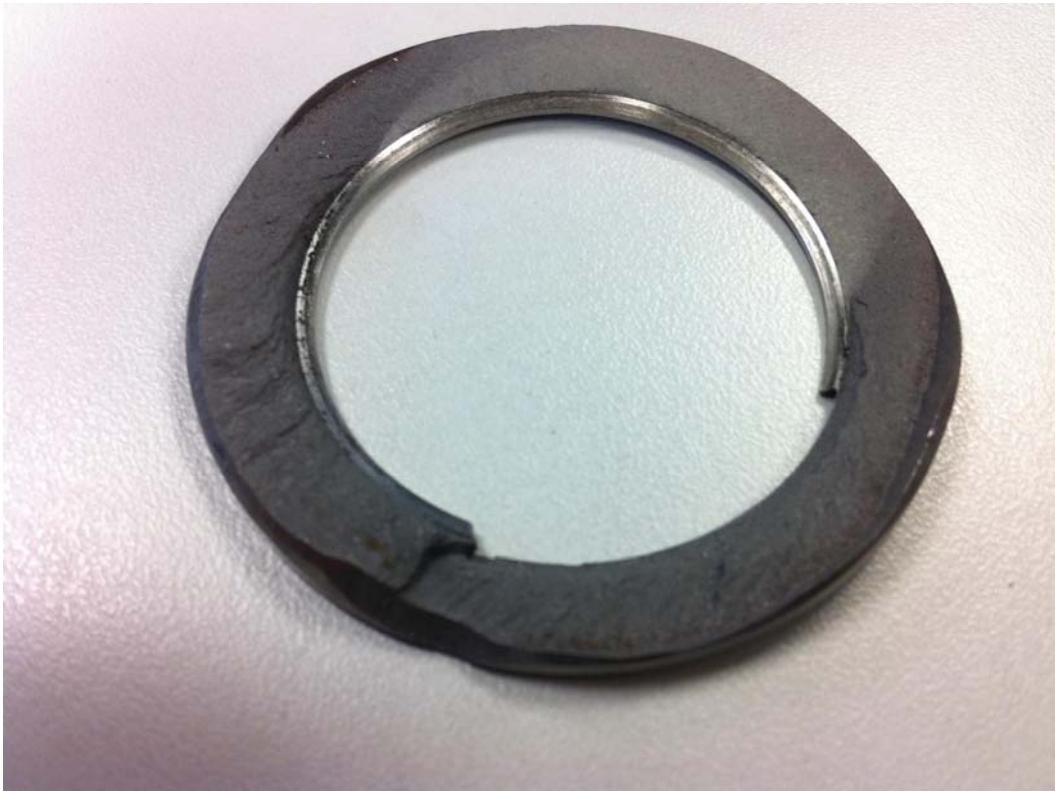
Ring of failure point on -91 titanium socket (Test #2), failed at 96k cycles

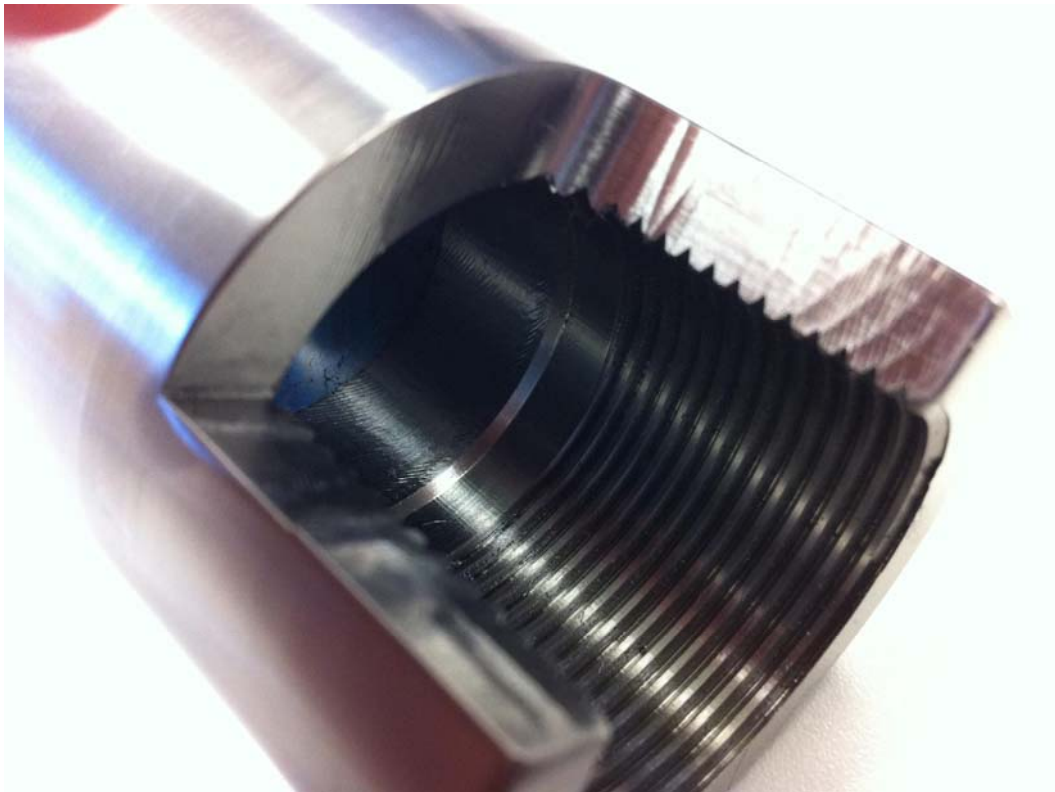
Photo of inside intact socket from opposite end of Test #2 sample, went 96k cycles
