**GE Industrial
& Power Systems**

Broken Bar Detector For Squirrel Cage Induction Motors

G.B. Kliman and A.V. Mohan Rao
GE Company
Schenectady, New York

GER-3609 6/89 (500)

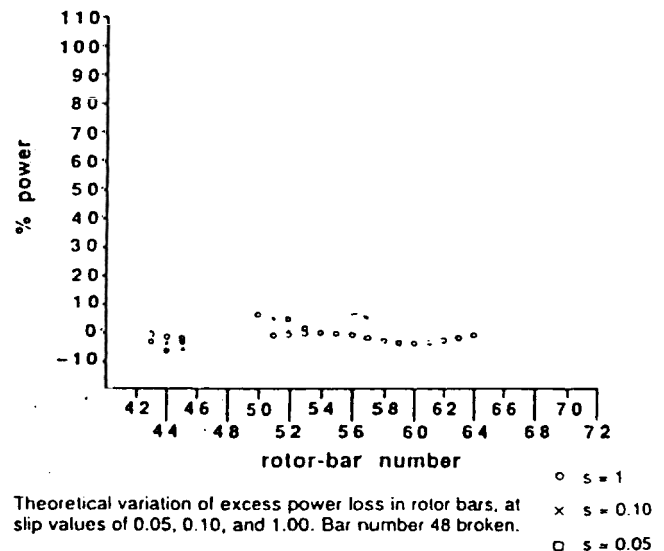
Fig. 5 Prediction of power loss in bars adjacent to break.

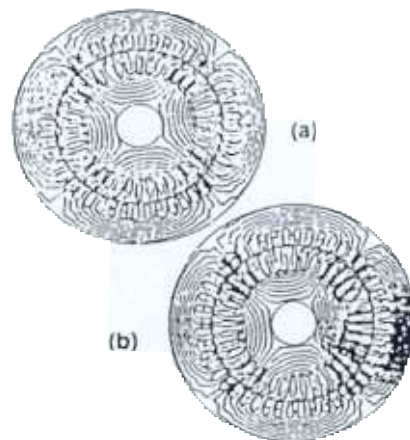
Fig. 6 - The field distribution at full load (1760 rpm). (a) no broken bars (b) five broken bars

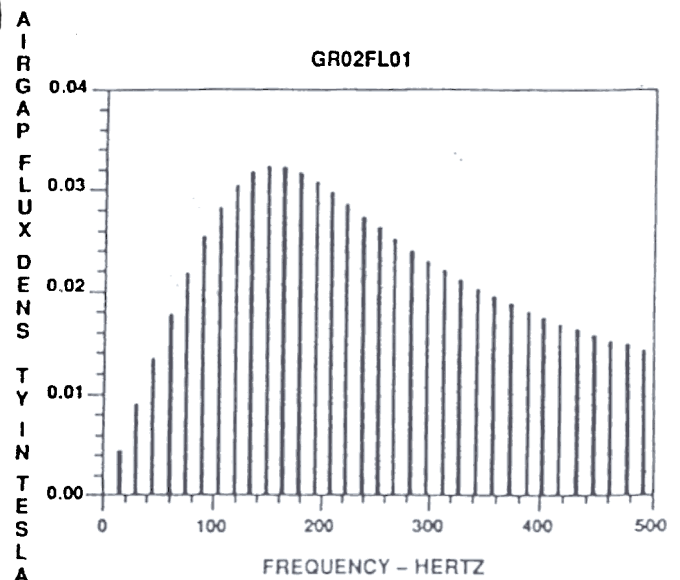
Fig. 9 Air-gap flux spectrum as seen from the stator of an 8-pole gas recirculation fan with one broken bar.

When the counter-rotating waves are transformed to the stationary frame the space harmonics become time harmonics. Fig. 9 shows the spectrum of the air-gap flux density at one point in the stationary frame for a typical 2500 HP, 900 RPH gas recirculation fan motor with one broken bar. Note that each line is actually two lines separated by twice the slip frequency (60s) but not resolved on the printer at this scale. The actual frequencies are given by

All of these frequencies will be present in the air-gap flux. The spectrum shape shown in Fig. 9 is controlled by the rotor parameters combined into the "cage magnetic Reynolds number" or "motor goodness factor". The shape does not vary a great deal for most large power plant motors. When the winding pitch and distribution factors are applied and the line current calculated the spectrum of Fig. 10 is obtained. The pole pitch of the winding must also be taken into account which removes all but the checked lines i.e., the "normal" harmonics except that the "broken bar" lines appear at displaced frequencies given by equation (1). Due to manufacturing tolerances other frequencies may not exactly cancel out and may be measurable but of unpredictable amplitude. The major harmonics will be predictable and reproducible and form the basis of the motor "personality" used in the instrument. The magnitude of the fundamental component for a single broken bar will, typically, be about 35 to 45 db below the 60 Hz power component of current compared to residual magnitudes typically 60 db below the 60 Hz component for good motors.

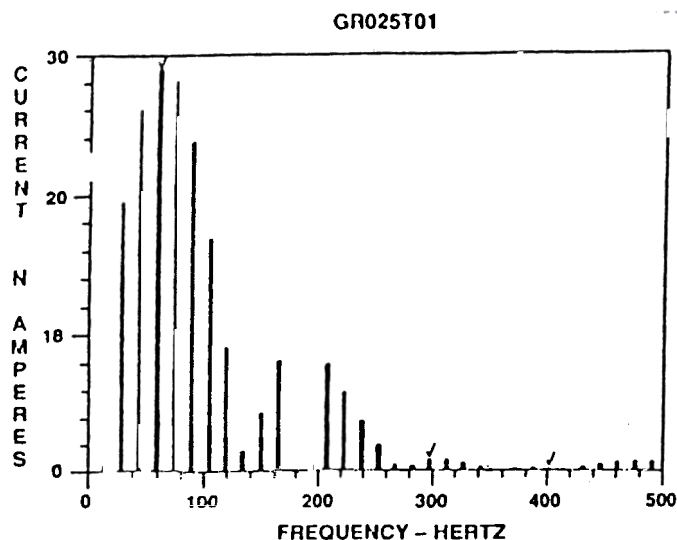
Fig. 10 Predicted line current for a single broken bar (based on Fig. 8) with pitch and distribution factors and inductance applied. Only the checked harmonics are predicted to be present.

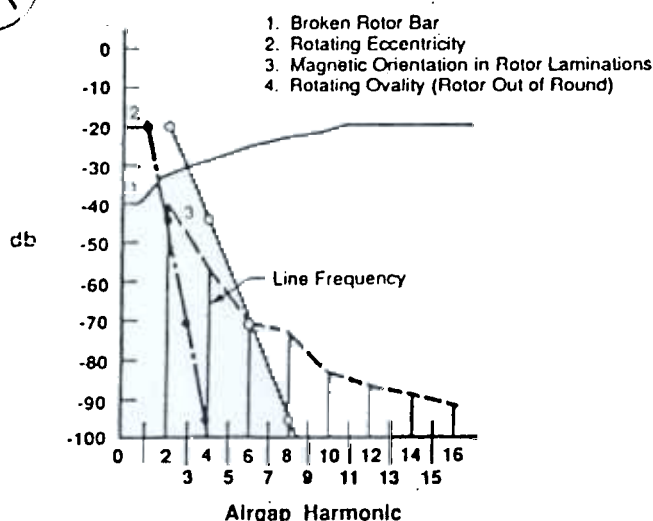
Fig 11 Comparison of air-gap flux spectra for a single broken bar with various asymmetries in a typical 4 pole motor.

As previously mentioned, when the sensitivity is high enough to detect the presence of a single broken bar other rotor asymmetries may cause confusion and false alarms. A brief study [7] was carried out to estimate the magnitude of the likely interfering effects. A comparison of the first few air-gap harmonics for these effects with those for a single broken bar in a typical motor is shown in Fig. 11. Note that there is a real possibility of mistaking the effects of a rotating eccentricity (bearing whirl) or an out of round rotor for a broken bar especially for two pole machines. The case of magnetic anisotropy shown is for an extreme situation which is unlikely to be seen in practice. Fig. 11 also suggests the way in which such ambiguity may be resolved. It is easily seen that the harmonics of a broken bar are much greater than

for an asymmetry and this property is used to differentiate the cases. In situations where there is more than one bar broken this feature will rarely be needed due to the unmistakable size of the signal.

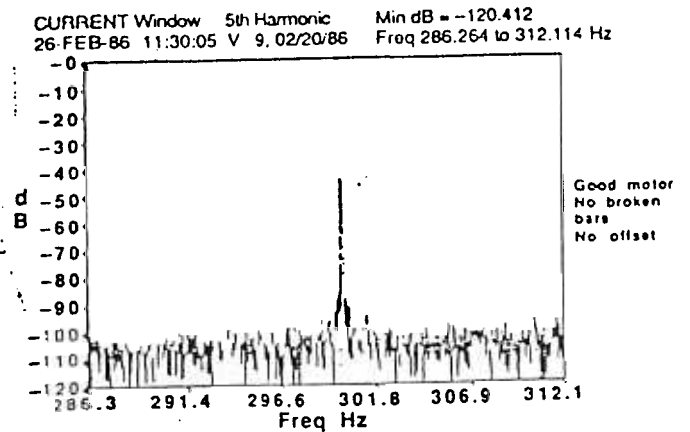
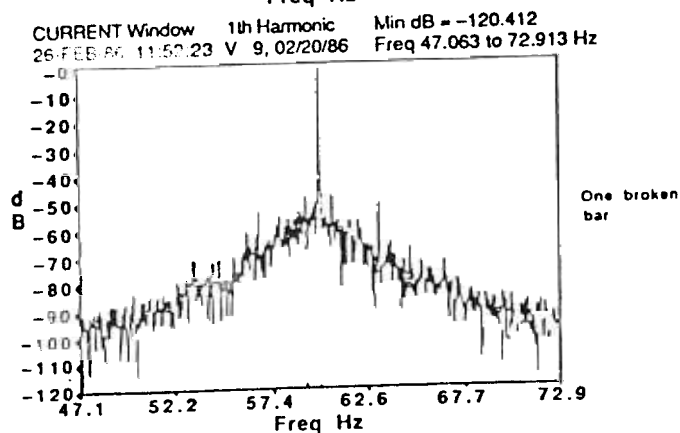
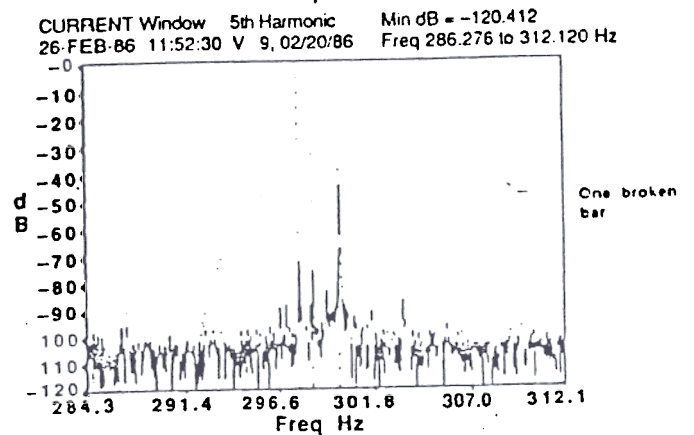
Fig. 14 Current spectra in the vicinity of the fundamental (60 Hz) for several increasingly severe rotor faults.

A functional block diagram of the instrument is shown in Fig. 13. The software is designed so that the spectra, from which the motor personalities are derived, may be viewed at the option of the operator. Fig. 14 is a set of such spectra in the vicinity of 60 Hz for zero, one two and three broken bars. The predicted position of the broken bar spectral line is indicated by a dashed line placed by the software. The characteristic frequencies are 60 Hz and $60(1-2s)$. The 60 Hz component is swallowed up in the power component. The component visible at $60(1+2s)$ is due to the speed oscillation induced by the low inertia test stand. Note also that the general noise level rises as bars are broken, thereby partially masking some of the increase in signal. Notice that other side bands appear especially for the case of three broken bars. Additional sidebands separated by multiples of $2s60$ Hz will sometimes

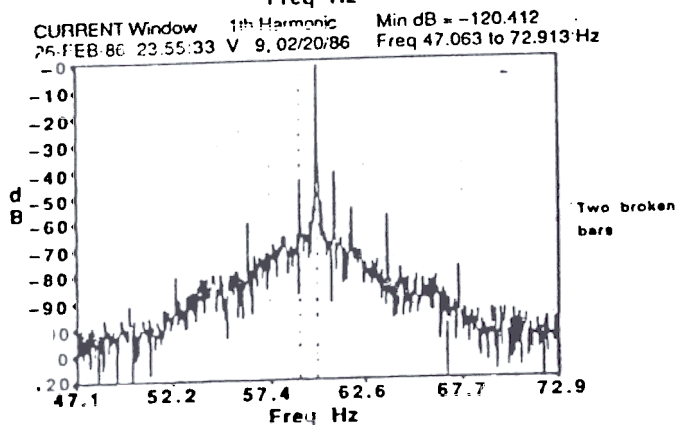
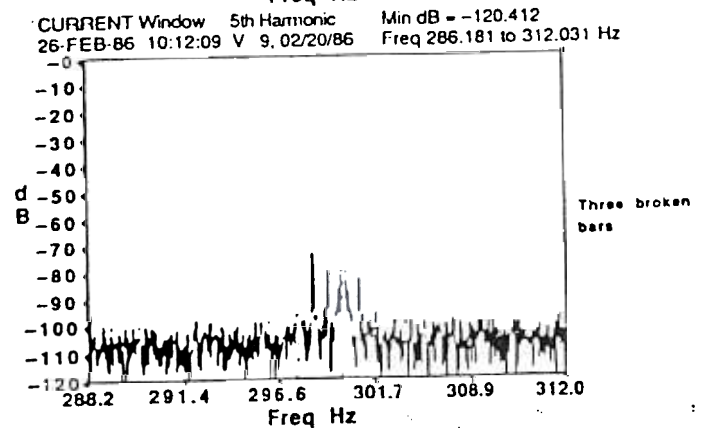
Fig. 15 - Current spectra in the vicinity of the 5th harmonic for the conditions of Fig. 14.

appear due to harmonic currents flowing in the windings, from slots, phase belts and broken bars interacting with the rotor fault [13]. In this case the sidebands were not at such a frequency and were ultimately traced to a faulty coupling in the motor-generator set driving the test motor dynamometer loop. Fig. 15 shows an example of harmonic sidebands for the same conditions as Fig. 14.

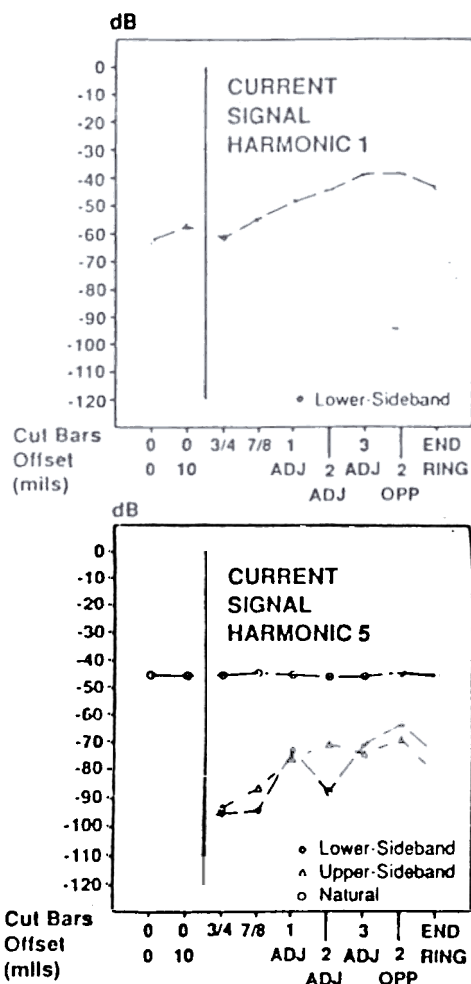
Fig. 16 - Summary of 1st and 5th current harmonics.

Fig. 16 summarizes the results of the inside-out motor tests for the first and fifth harmonics. The variation of the harmonics with severity of break is much as predicted by theory except for one point in one of the 5th harmonic sidebands. This point was repeatable and is, at present, not explained as were some other minor variations. Again, as predicted, the natural or usual 5th harmonic was unaffected by the presence of faults and this pattern carried through the remaining harmonics.

The first round of field tests was carried out by R & D personnel in and around the GE plant in Schenectady and at a nearby facility of the Niagara Mohawk Power Corp. using the laboratory "breadboard" instrument. The results of these tests, for the 1st and 5th harmonics are shown in Fig. 16. All of the motors were, evidently, in good condition without broken bars and represented a variety of sizes, poles, windings and applications. It is remarkable and useful that the range of signals from them was, none the less, quite restricted (in db below the 60 Hz component) and provides the basis for "single look" decision making. All of the motors (ranging from 400 HP to 1200 HP) were running on the 60 Hz power line except 271 #1 which was powered by a square wave inverter. Points from the inside-out motor tests were included for comparison. It should be noted that the inverter 5th harmonic may have influenced the results to some extent but not more than the normal variation between motors.

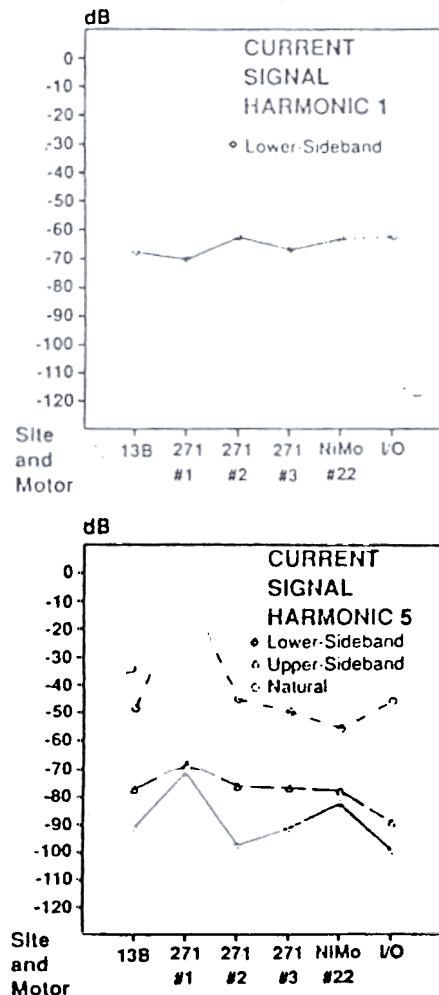
Fig. 17 - Summary of first round field test data for the 1st and 5th harmonics.

EPRI accompanied the instrument nor were power plant personnel taken to Schenectady for training. After several months of field testing and evaluation, the instrument's software was rehosted to a "PC" compatible computer, Fig. 12. Results for the lower side band for the complete sample are shown in Fig. 17. Summary of the total field test data of the fundamental component is summarized in Figure 18.
