ORNL-TM-14

N. S. SAVANNAH  
Nuclear Merchant Ship

INVESTIGATION OF THE EFFECTS OF WET,  
CHLORIDE-BEARING, THERMAL INSULATION  
ON AUSTENITIC STEEL PIPE

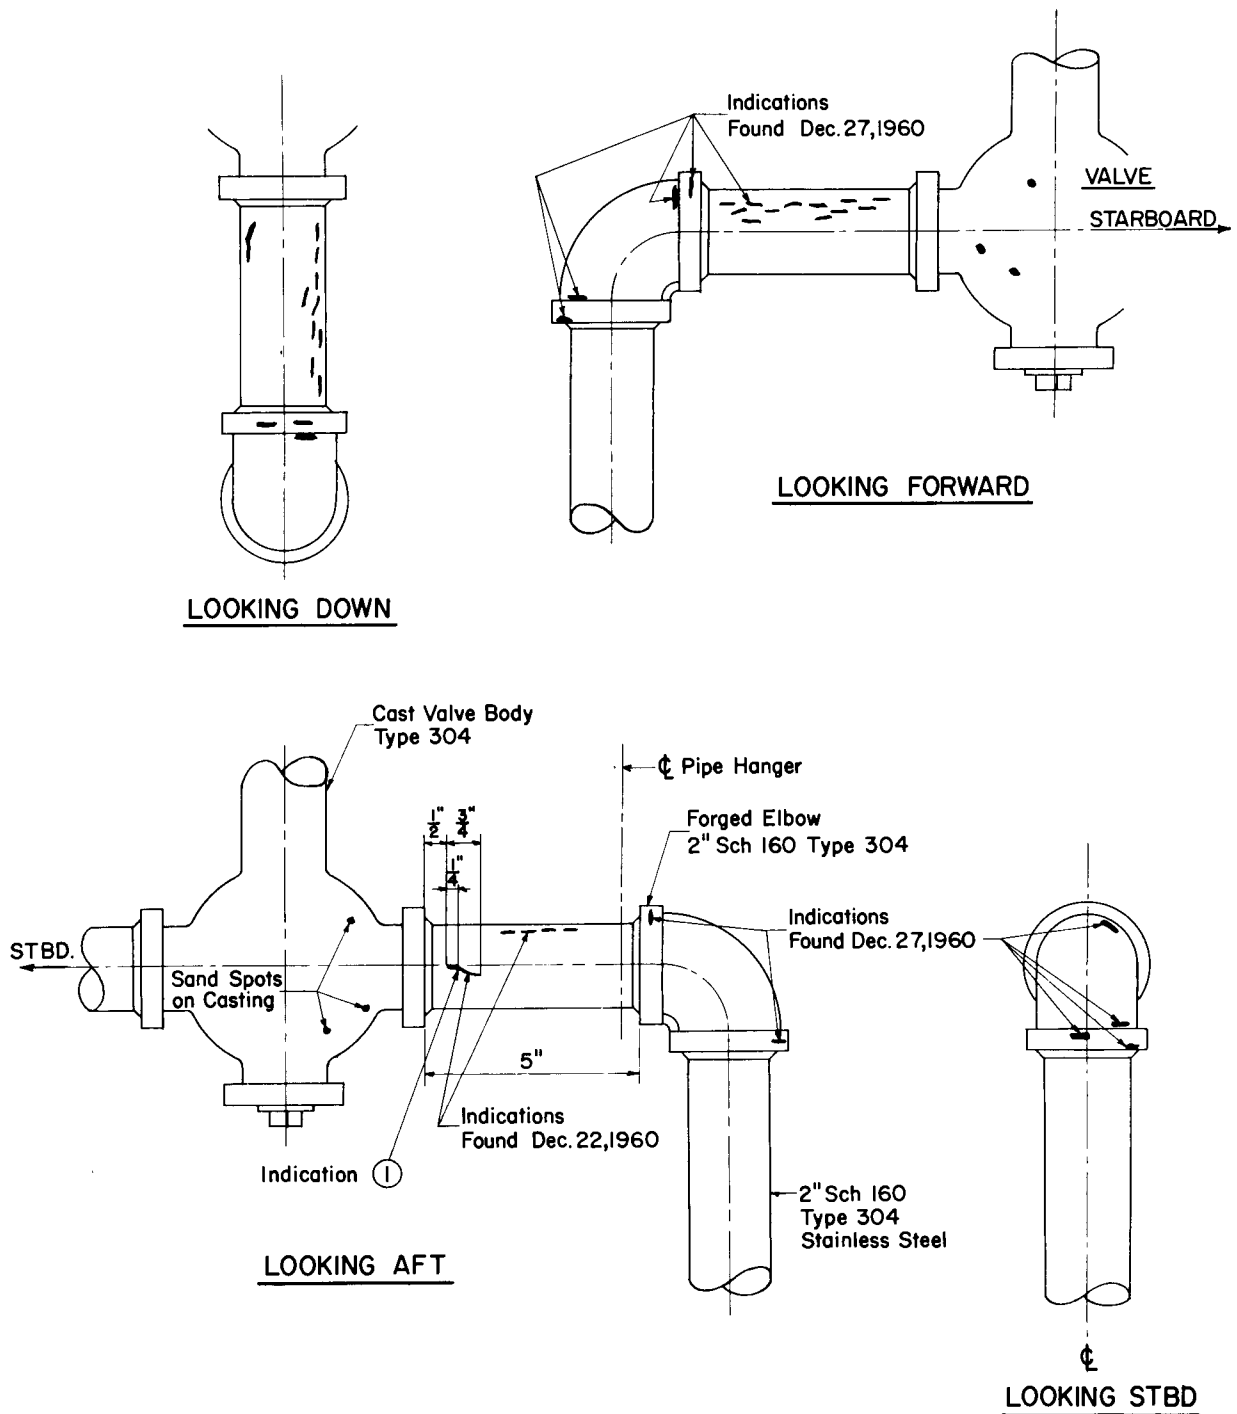
ORNL-LR-DWG. 56235  
UNCLASSIFIED

One indication (indication 1, Fig. 1) when first observed was only  $1/4$  in. long. The indication was abraded with 80-grit emery paper four times for 5 min each time. After each abrading operation, the indication grew in length in a jagged pattern (as observed under the fluorescent penetrant) until it reached a length of  $3/4$  in. Unfortunately, during the cutting of the pipe on December 29, 1960, indication 1 was completely obliterated by the grinding. The area in which indication 1 was located was ground to a depth of greater than  $3/32$  in. during the removal operation. Thus, it cannot be established if this indication was removed at the  $3/32$ -in. depth or at a depth considerably less than  $3/32$  in.

Fig. 1. Indications Found December 22, and 27, 1960, in PP-1V Line preceding Letdown Coolers.

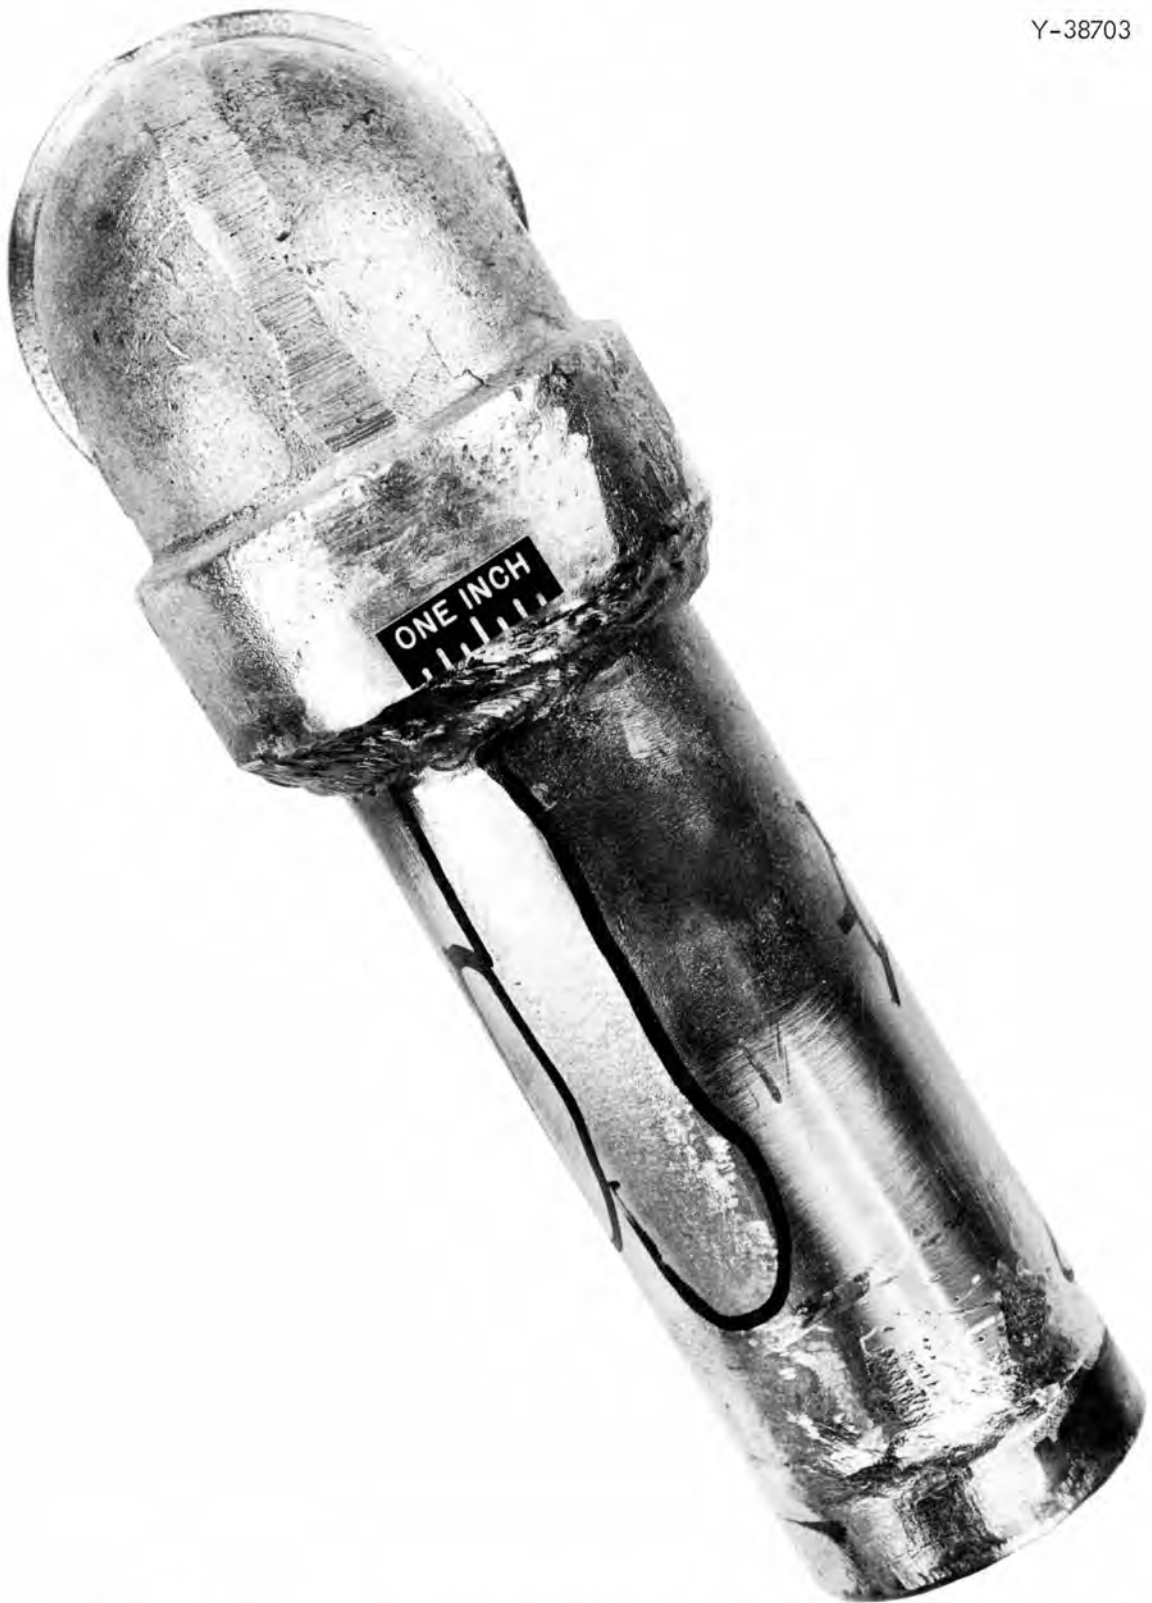
Fig. 2. In-Place Section of PP-1V Line after Cleaning at ORNL.

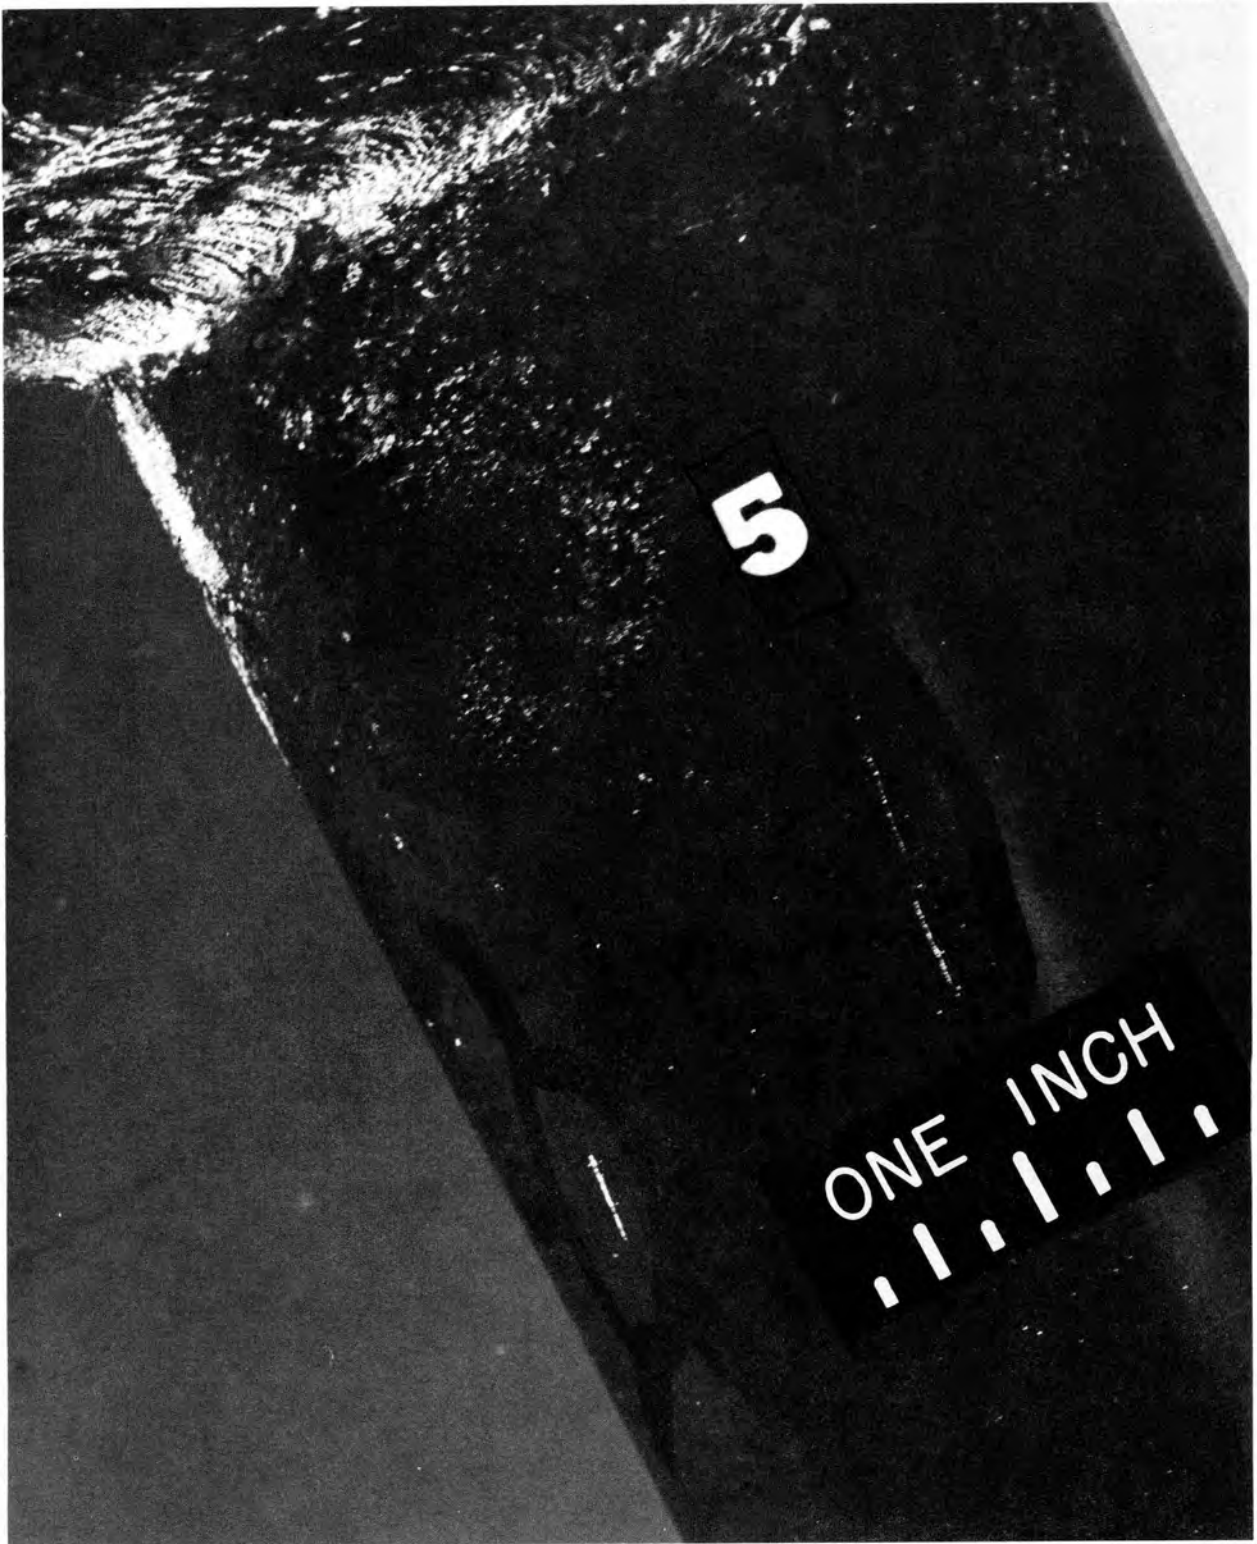
Fig. 6. Indications Revealed by Ultraviolet Light Inspection--Section 5.

indications seen on the pipe. Metallographic specimens were taken through section 5, Fig. 6; the "v"-shaped indication, Fig. 7; and section 6, Fig. 8.

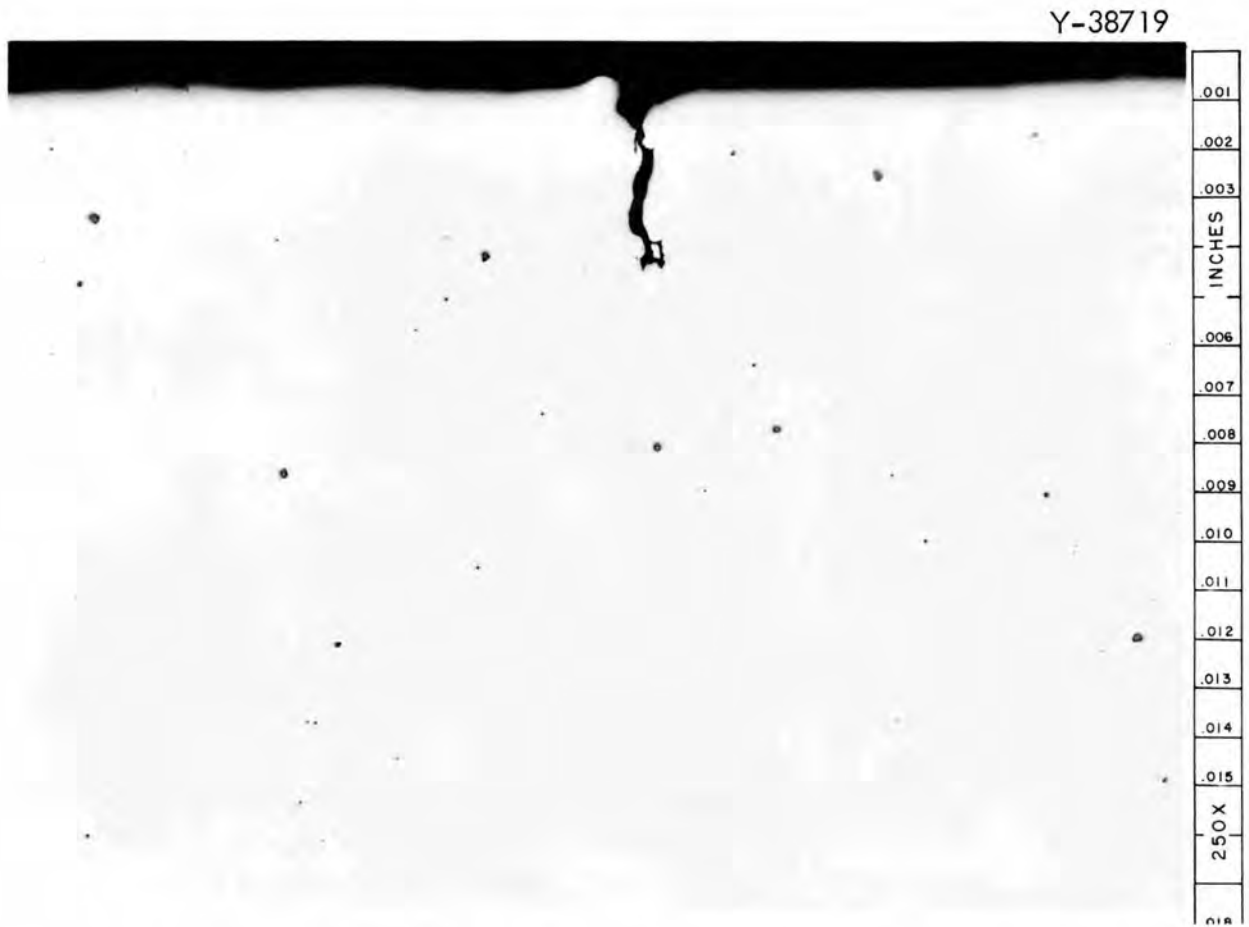
Fig. 9. Photomicrograph of Section 5, Fig. 6, Showing Penetration Normal to Surface, as Polished, X-250.

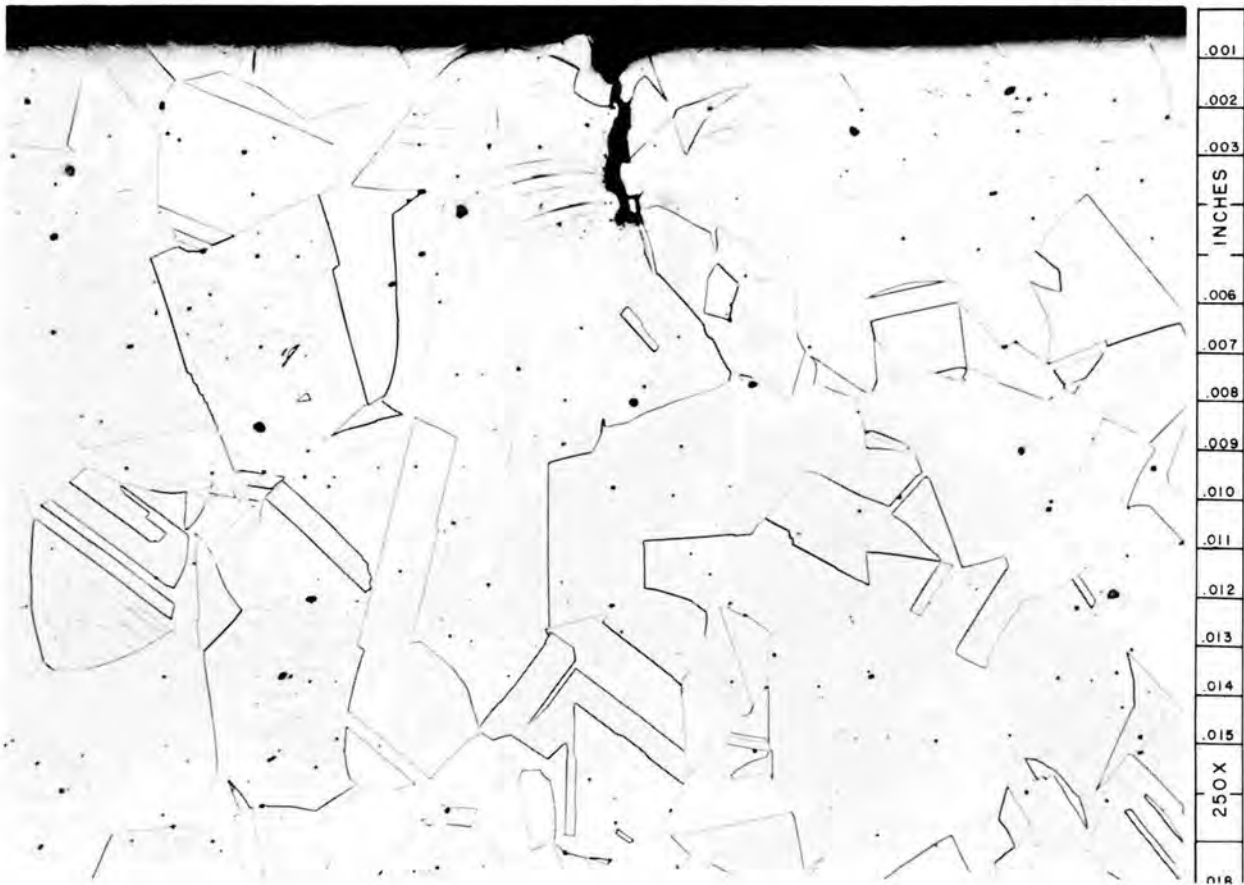
Y-38718

Fig. 10. Photomicrograph of Section 5, Fig. 6, Showing Penetration Normal to Surface, Etched with Modified Aqua Regia, X-250.

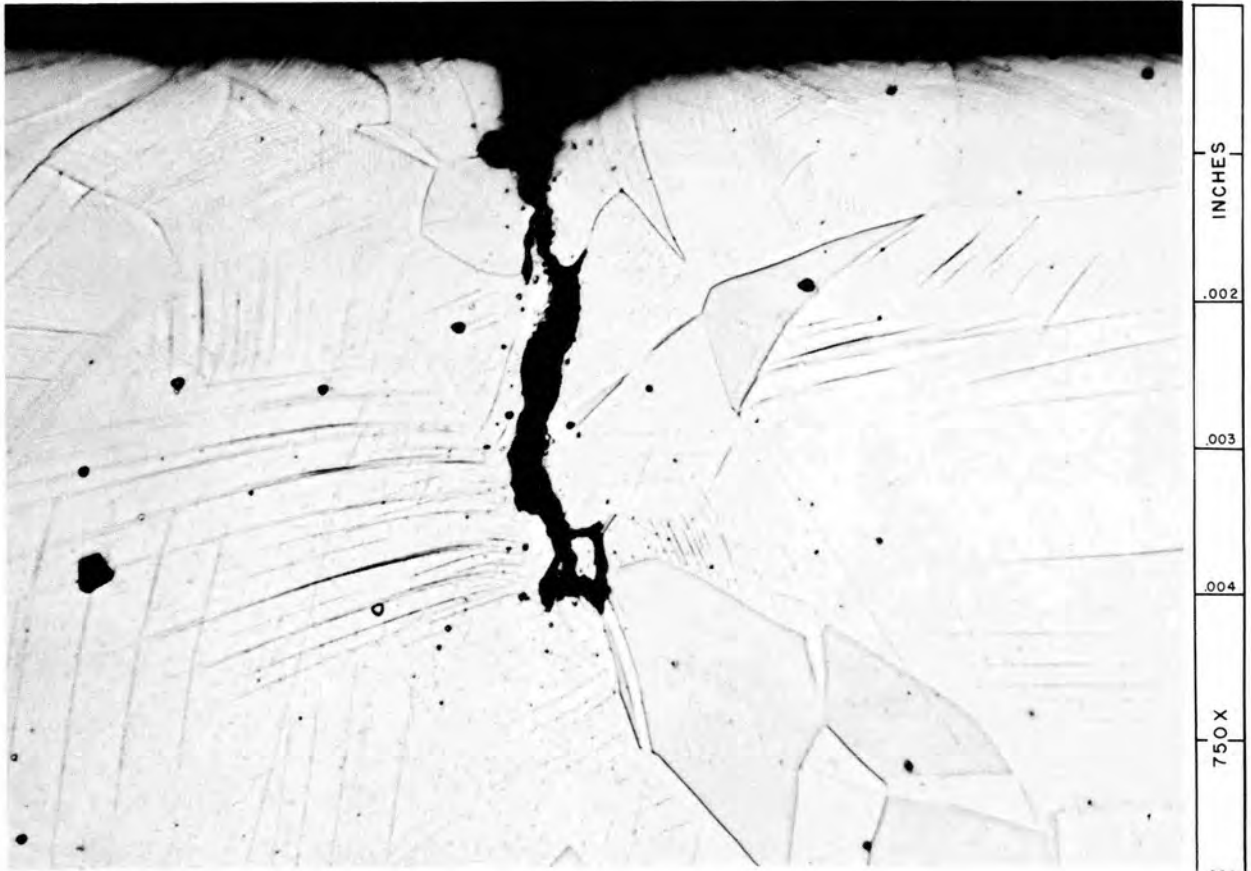
Y-39217

2. The penetrations shown in Figs 11 and 14 are believed to be chloride stress-corrosion cracks in the incipient state. The conditions under which the piping operated during the testing program support this view.

Fig. 11. Photomicrograph of Section 5, Fig. 6, Showing Penetration Normal to Surface, as Polished, X-750.

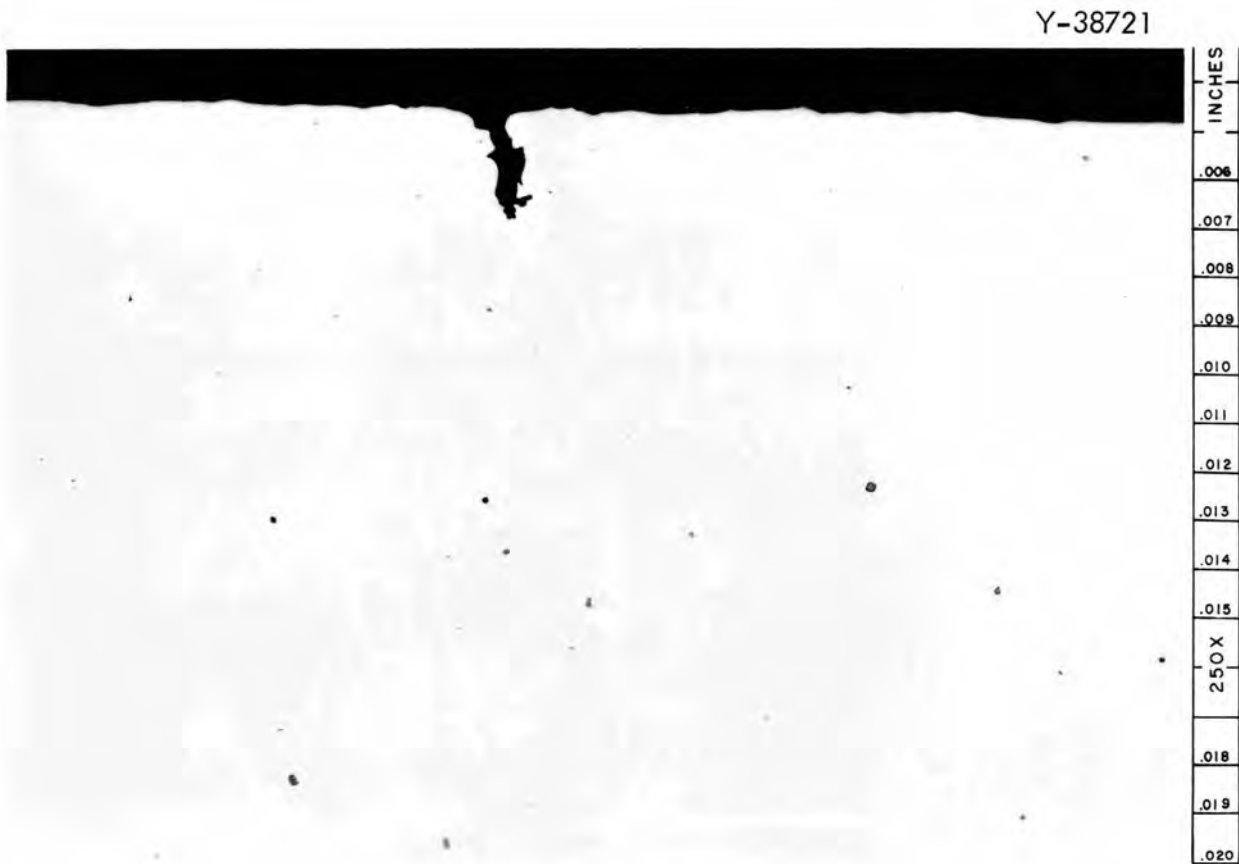
Fig. 12. Photomicrograph of Section 6, Fig. 8, Showing Penetration Normal to Surface, as Polished, X-250.

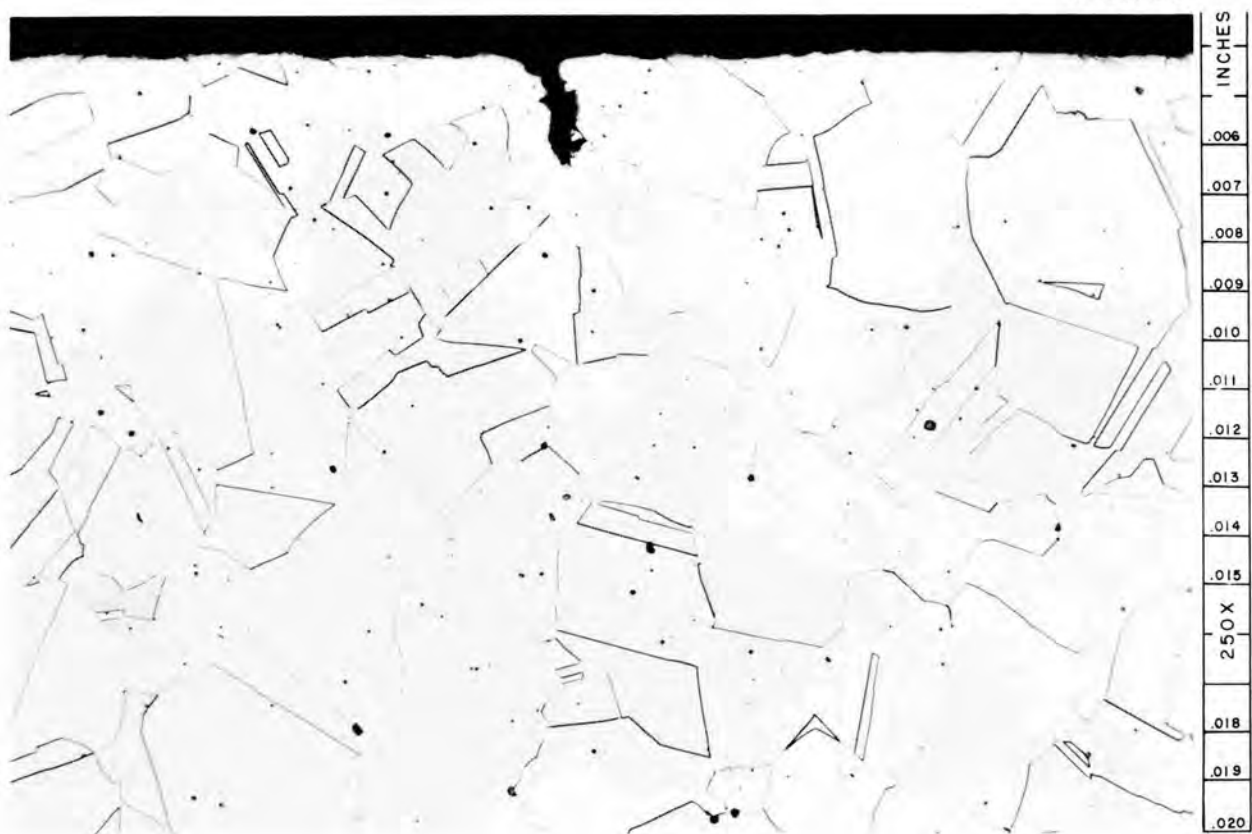
Y-38720

Fig. 13. Photomicrograph of Section 4, Fig. 8, Showing Penetration Normal to Surface, Etched with Modified Aqua Regia, X-250.

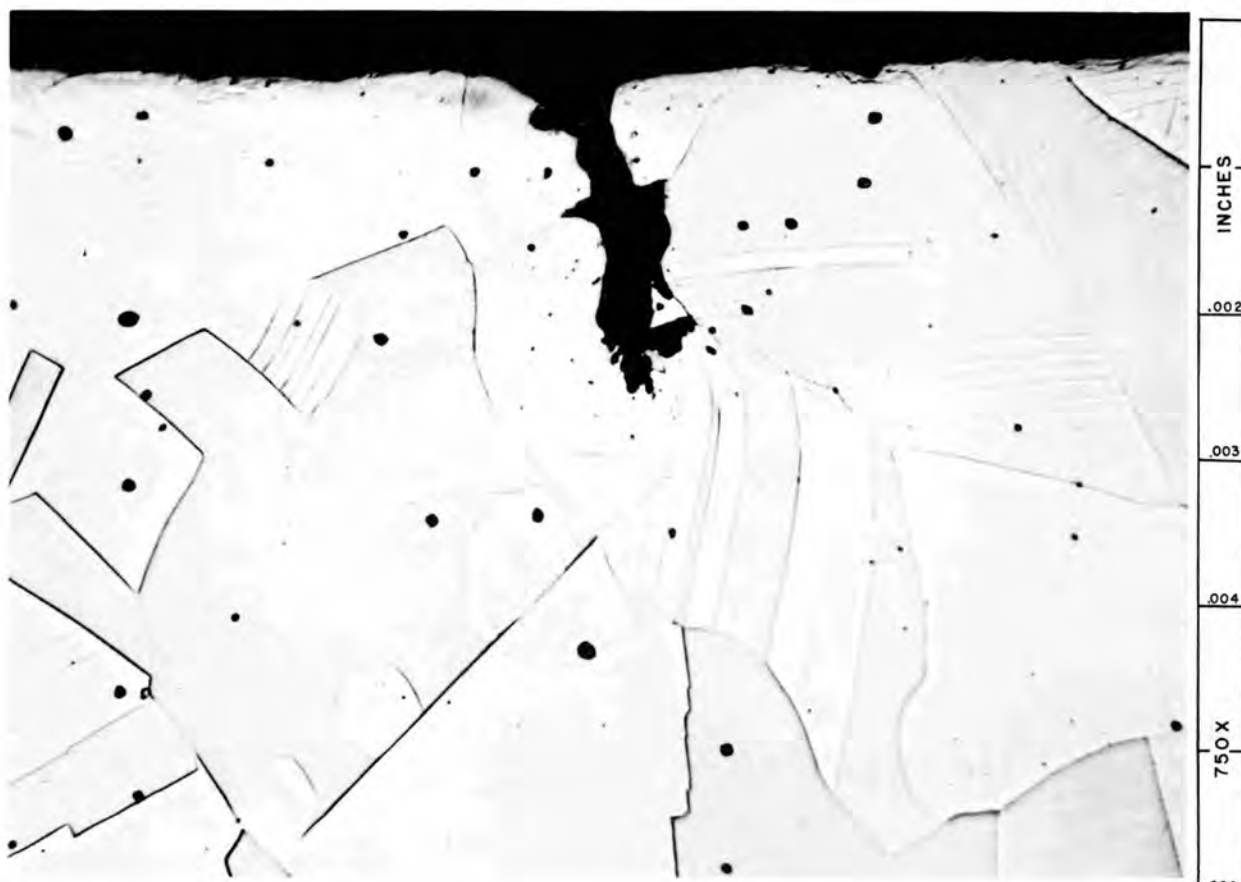
Y-39216

Fig. 14. Photomicrograph of Section 6, Fig. 8, Showing Penetration Normal to Surface, Etched with Modified Aqua Regia, X-750.

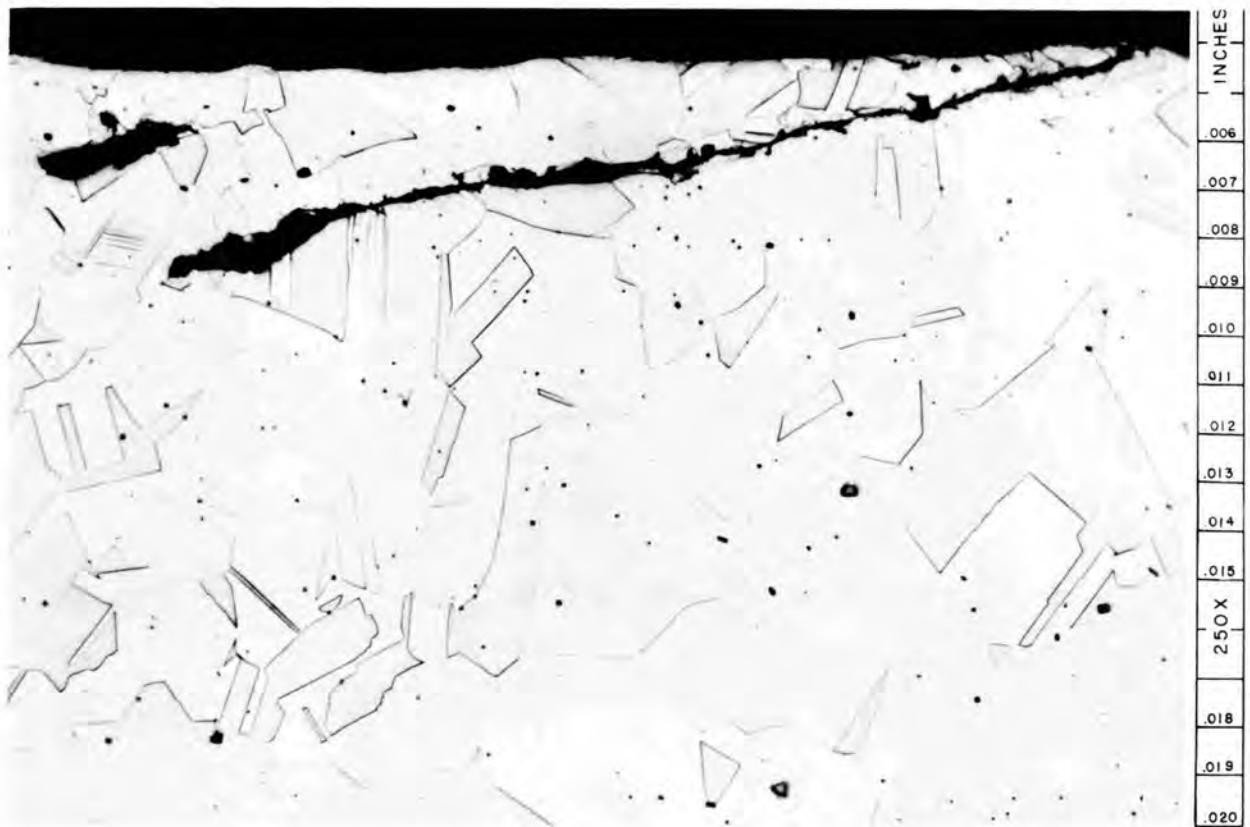
Y-38722

Fig. 15. Section through "v"-Shaped Indication, Fig. 7, Etched with Modified Aqua Regia, X-250.

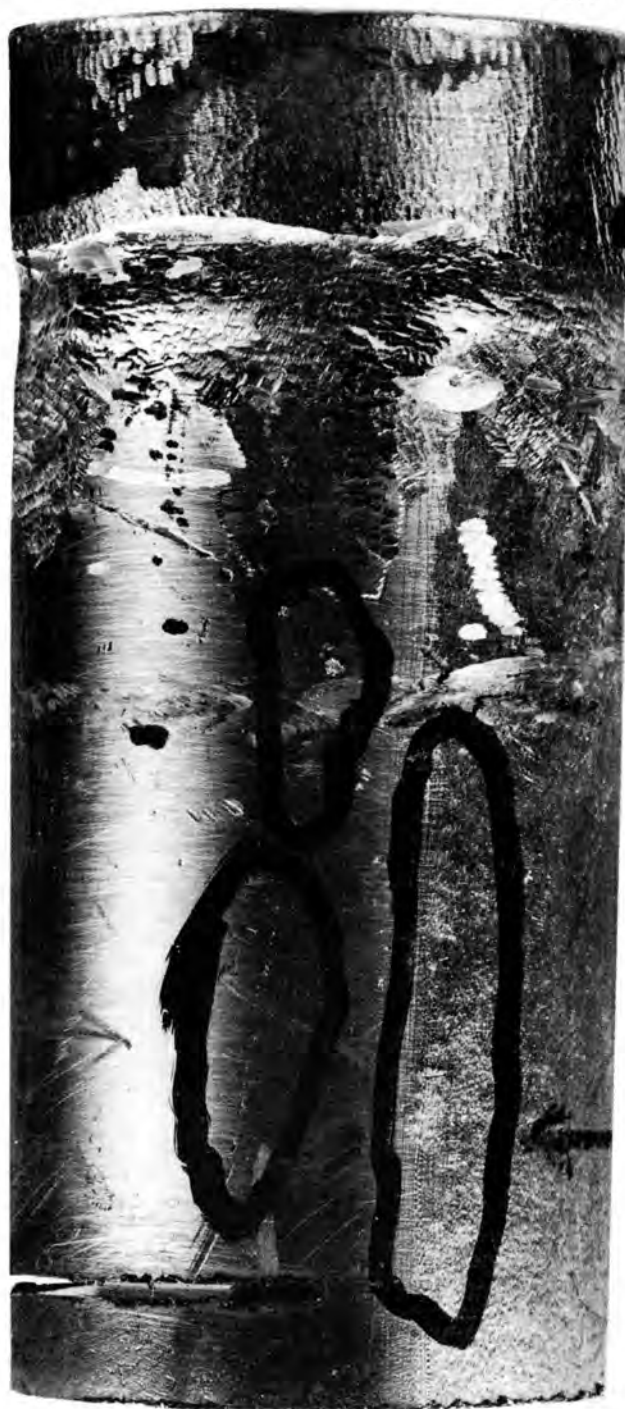
Y-38711

Fig. 16. Another View of Sample Cut from PP-1V.

Metallographic specimens taken at other indications of the in-place pipe section (see Figs. 16 and 17) showed only shallow grooves (these grooves appear as surface pits on photomicrographs) and folds in the surface. Figures 18 through 20 are typical of these indications. None of these grooves exhibited the character of those in Figs. 9 through 15.

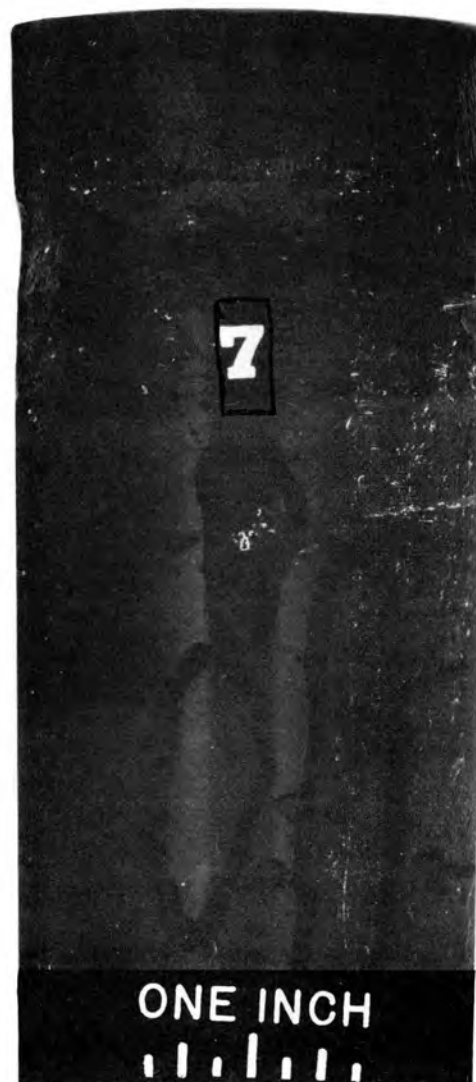
Y-38712

Fig. 17. Indications Revealed by Ultraviolet Light Inspection from Fig. 16.

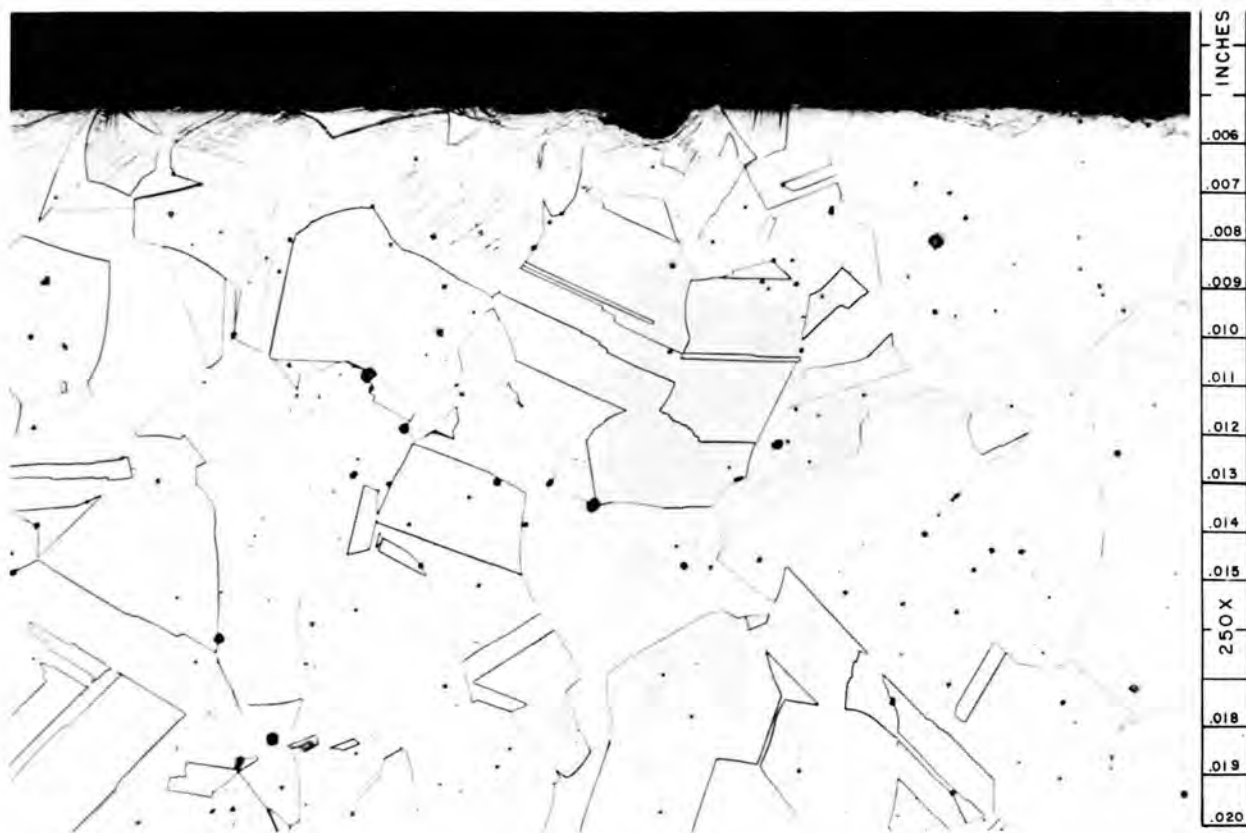
Y-38731

Fig. 18. Typical Defect Area Shown on Figs. 16 and 17, Modified Aqua Regia Etch, X-250.

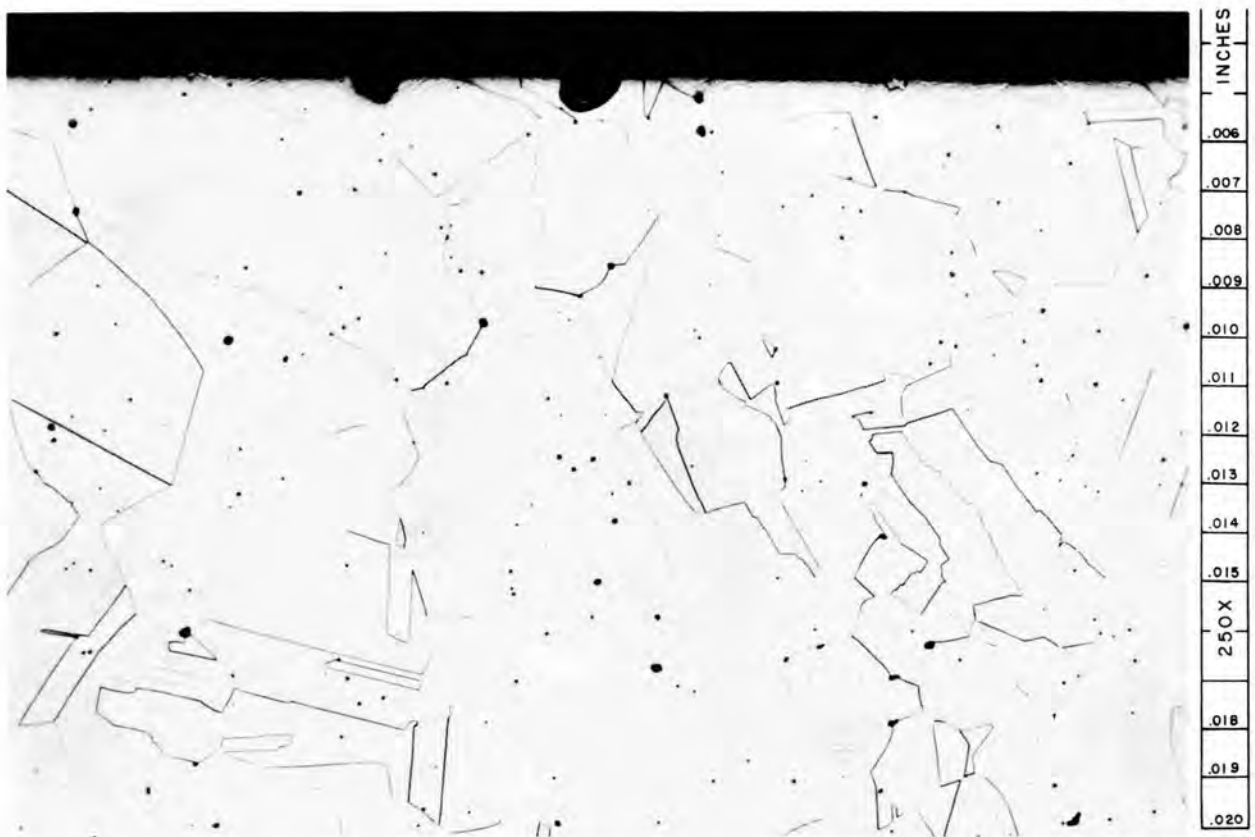
Y-38732

Fig. 19. Typical Defect Area Shown on Figs. 16 and 17 (Different from Fig. 18), Modified Aqua Regia Etch, X-250.

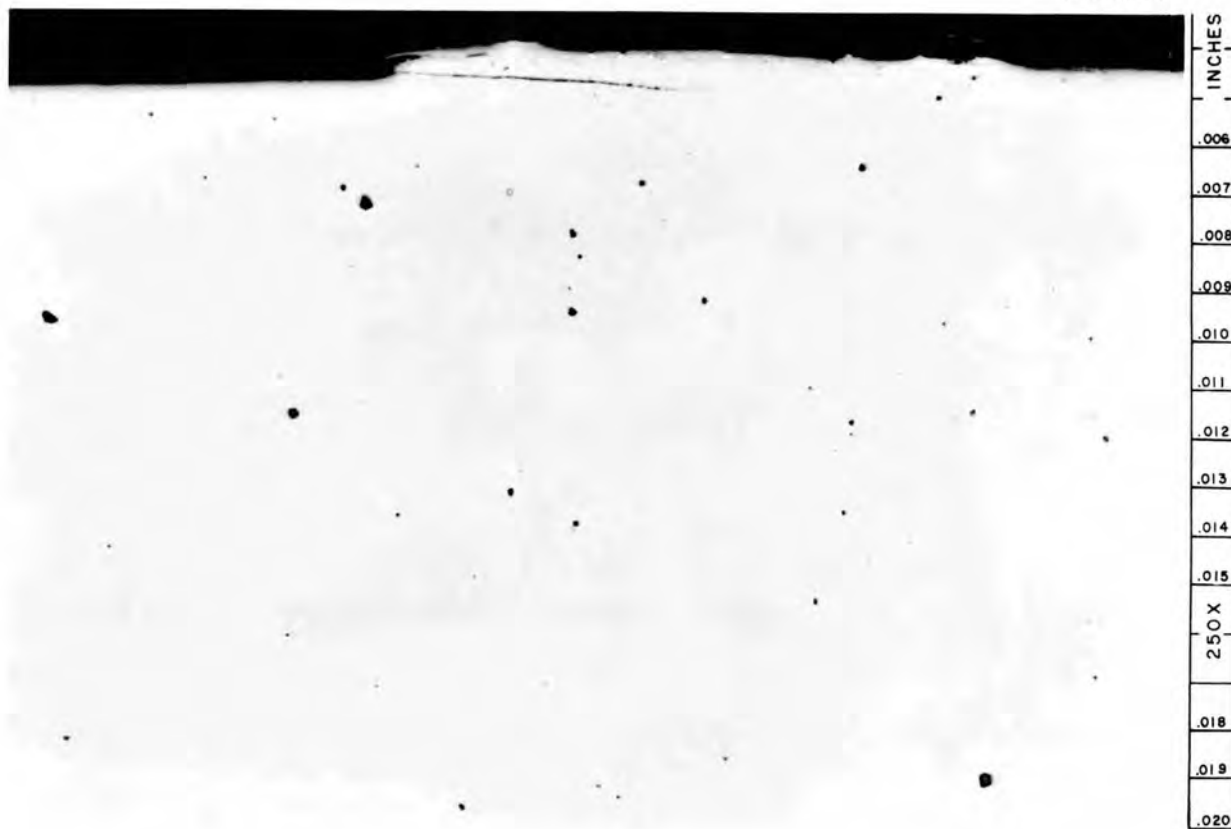
Y-38730

Fig. 20. Lap in Surface from Area Shown in Figs. 16 and 17, as Polished, X-250.

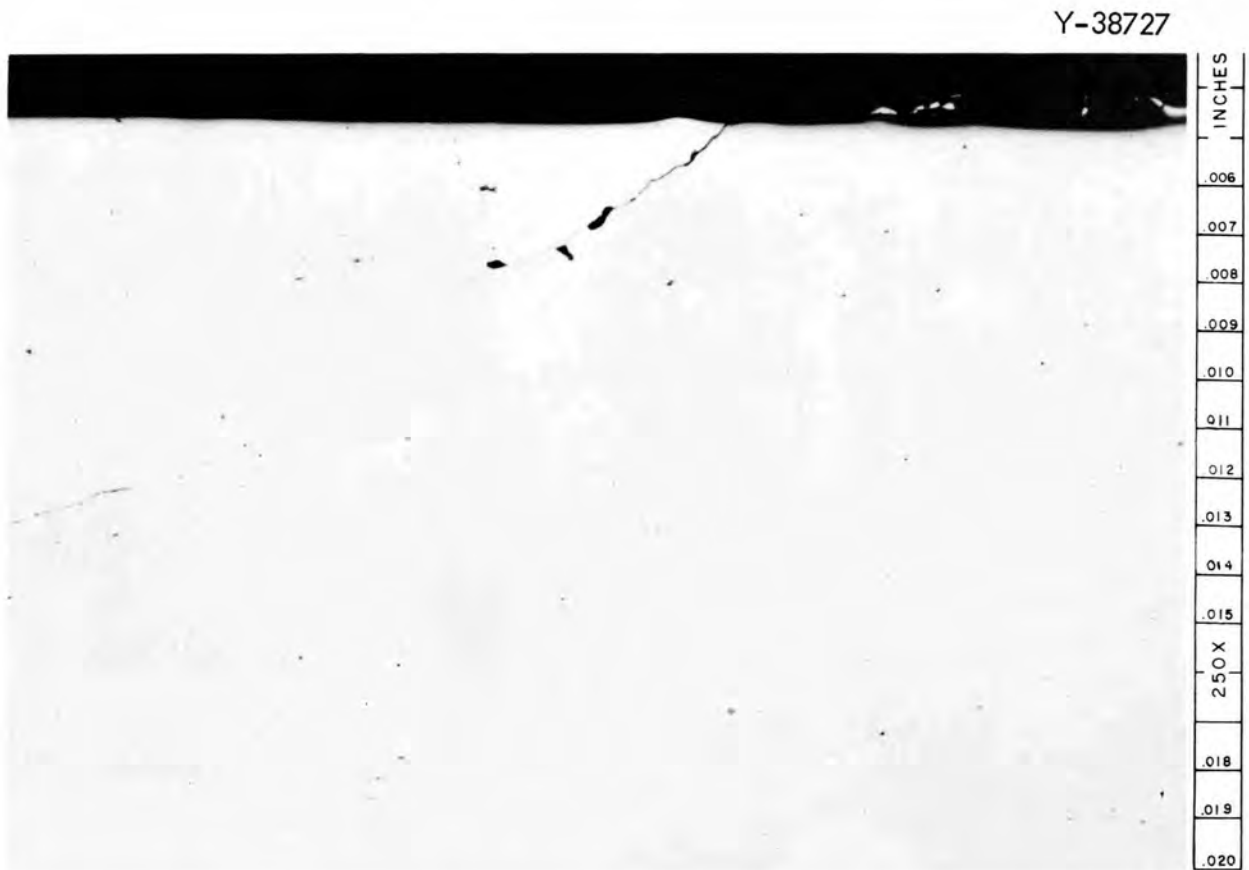
Fig. 22. Crack or Slag Inclusion in as-Received Pipe, as Polished, X-250.

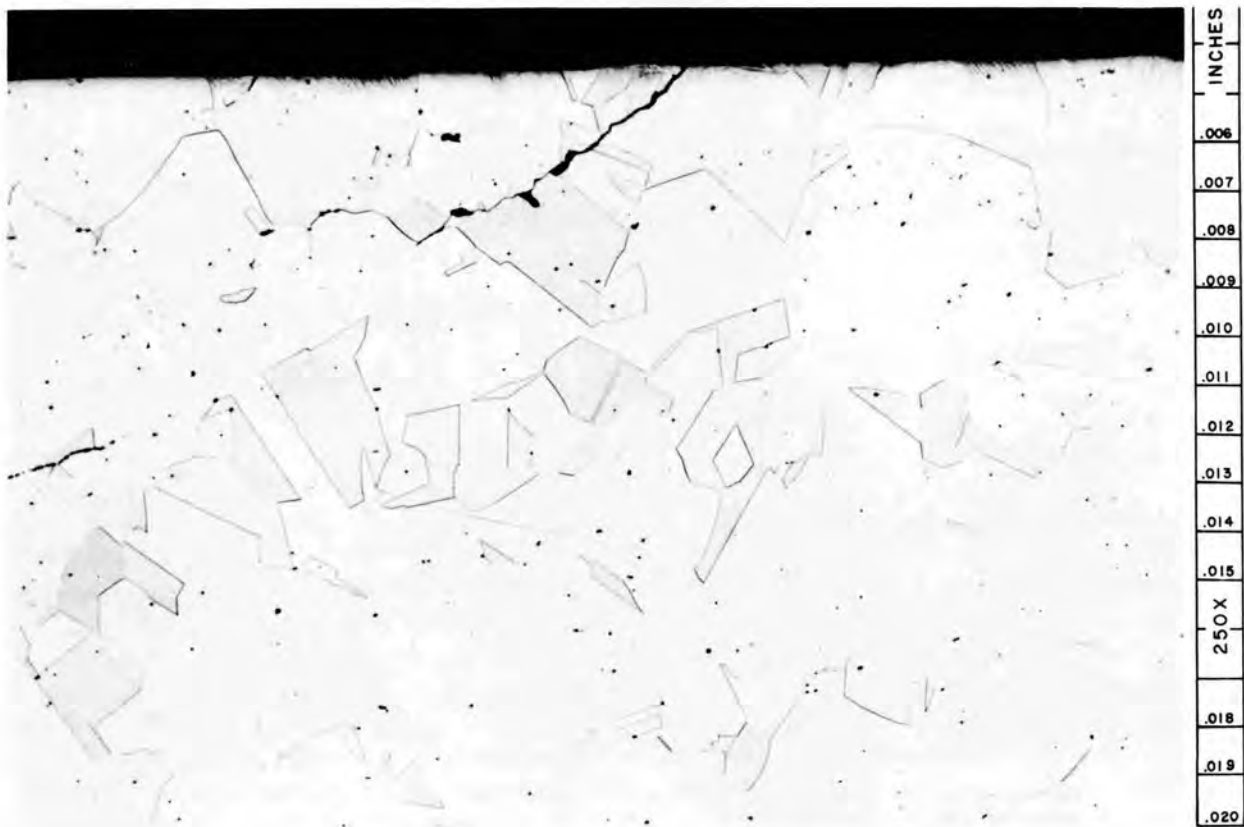
Y-38726

Fig. 23. Crack or Slag Inclusion in as-Received Pipe, Modified Aqua Regia Etch, X-250.

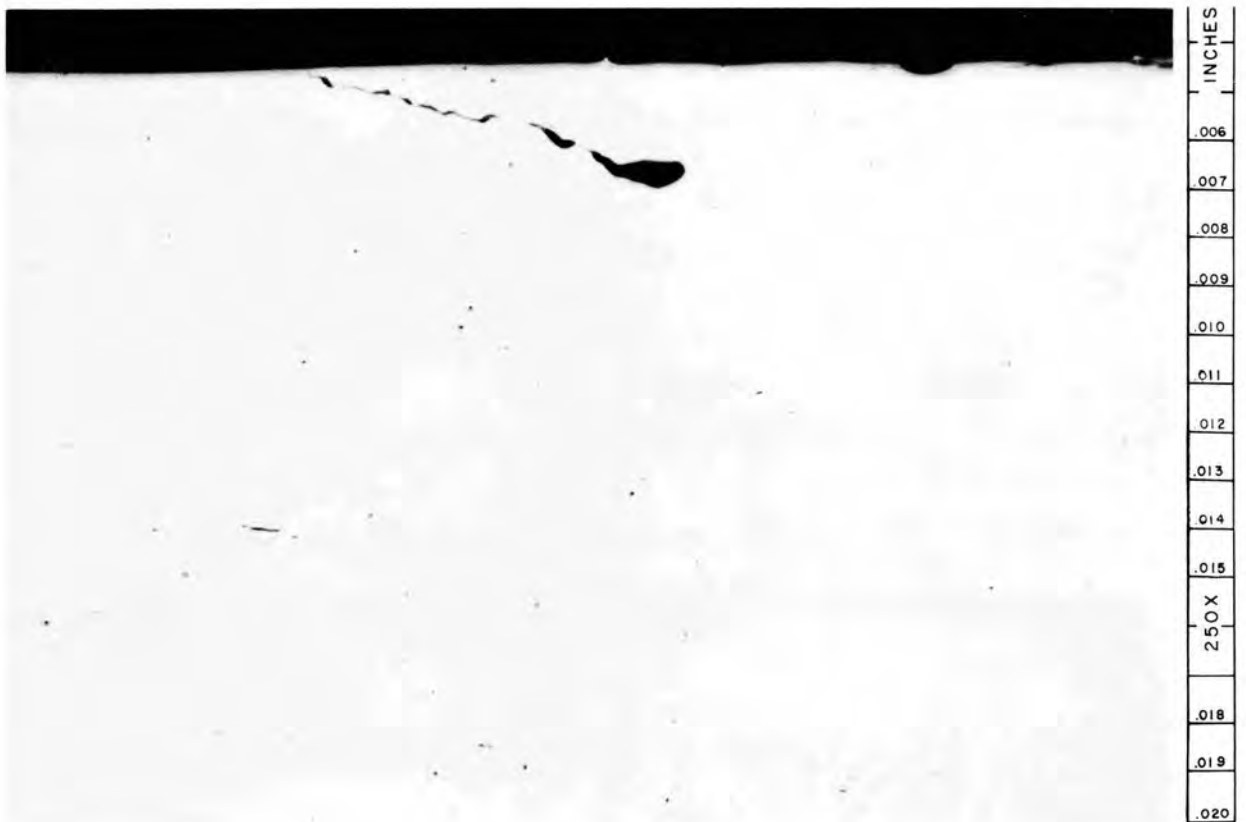
Y-38725

Fig. 24. Other Typical Defects in as-Received Pipe, as Polished, X-250.

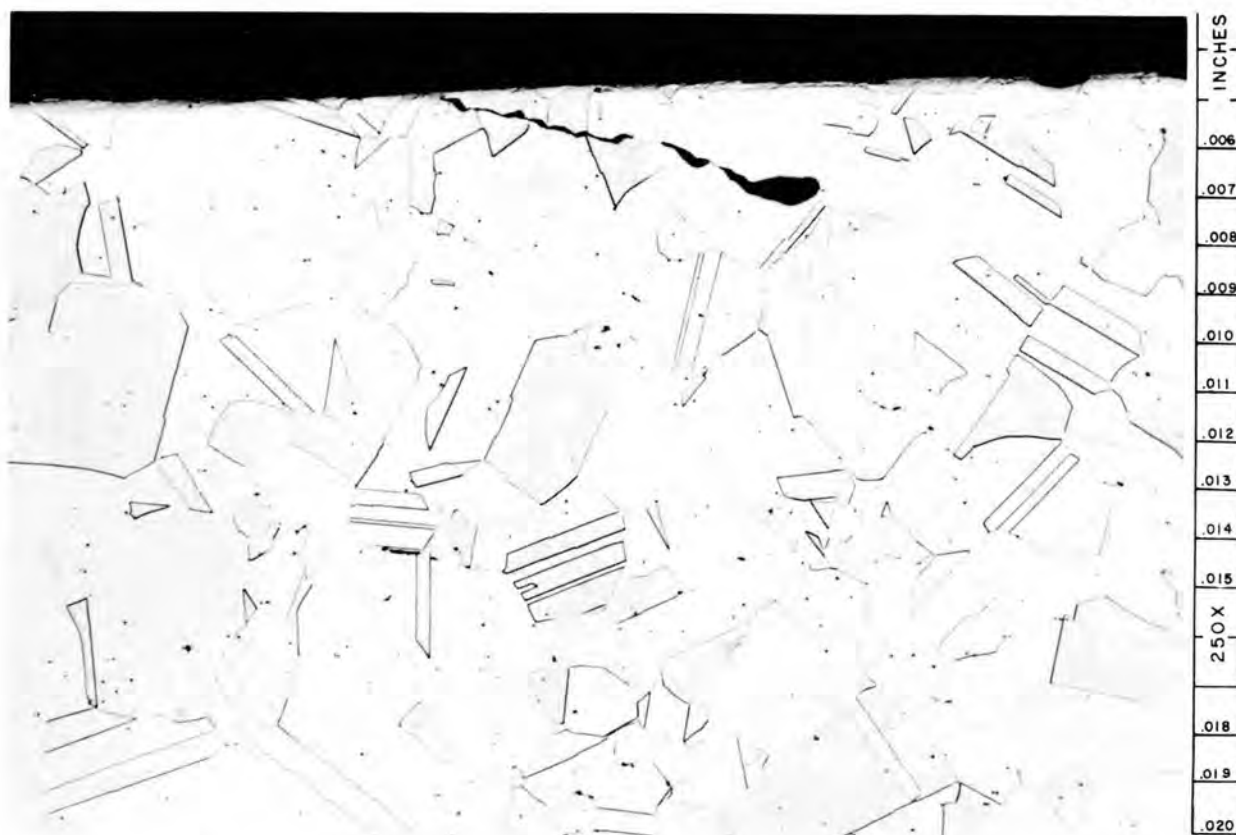
Y-38724

Fig. 25. Other Typical Defects in as-Received Pipe, Modified Aqua Regia Etch, X-250.

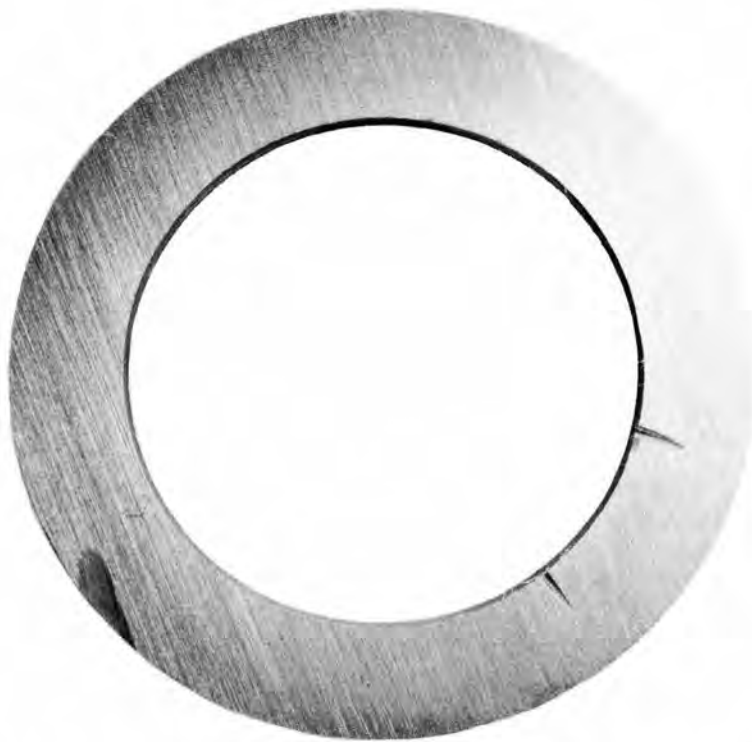
UNCLASSIFIED  
PHOTO 55694

Fig. 26. Pretest Appearance of 2-in., Type 304 Stainless Steel Pipe Specimen, X-1.68 (Test AN-32).
