ORNL-TM-14

N. S. SAVANNAH  
Nuclear Merchant Ship

INVESTIGATION OF THE EFFECTS OF WET,  
CHLORIDE-BEARING, THERMAL INSULATION  
ON AUSTENITIC STEEL PIPE

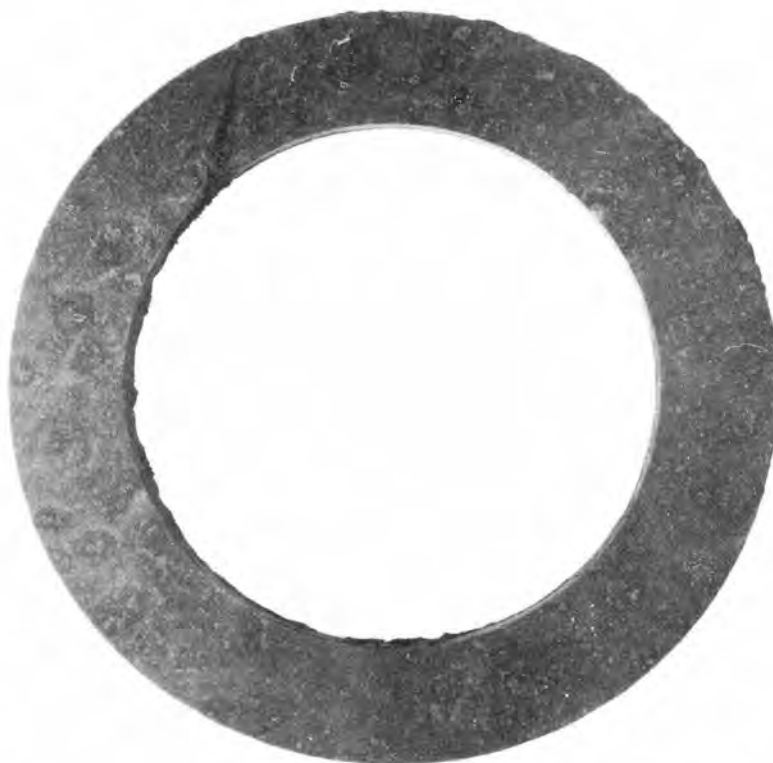
UNCLASSIFIED  
PHOTO 55695

of magnetite,  $\text{Fe}_3\text{O}_4$ . The existence of magnetite was unexpected since calculations based upon the amount of metal corroded and the amount of oxygen added to the autoclave initially showed that only approximately 5 per cent of the added oxygen was consumed in the corrosion process. It is conceivable, however, in view of the thickness of the scale on areas of the specimen, that little or no oxygen diffused into the innermost oxide layers so that in these regions the major corrosion product was magnetite. A photograph showing the condition of the specimen after test appears in Fig. 27.

Fig. 27. Condition of Type 304 Stainless Steel Test Specimen after 100 hr at 250°C in Water Containing 100 ppm of Chloride, X-1.6.

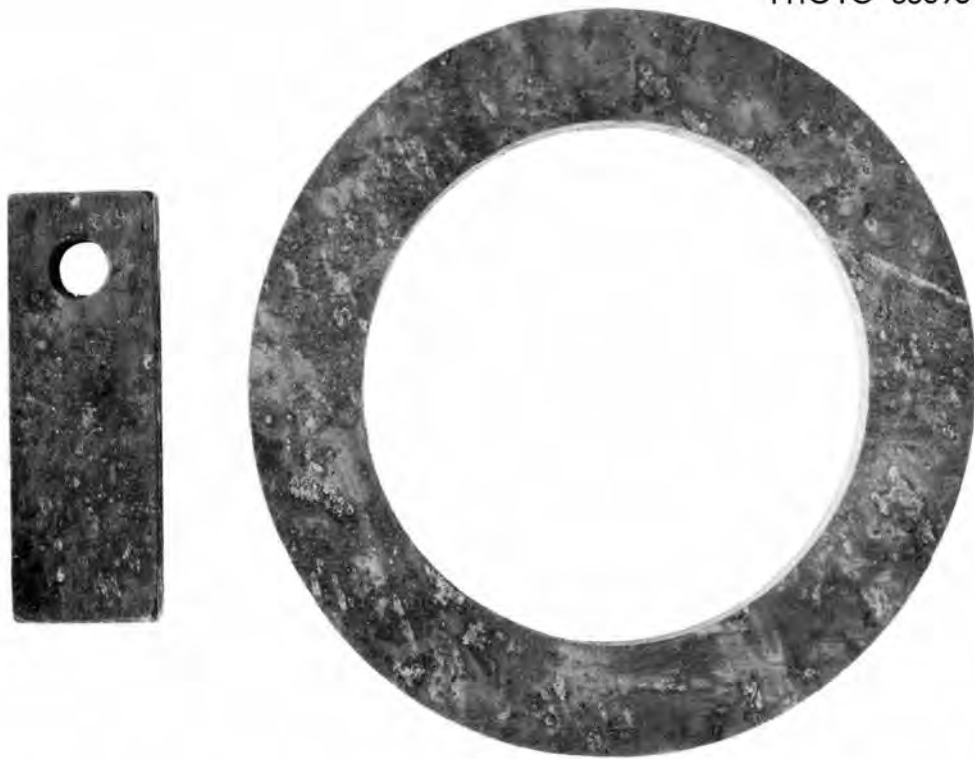
UNCLASSIFIED  
PHOTO 55696

solution pH was 5.5. The specimen was repolished on 120-grit paper and exposed for two consecutive 100-hr periods under identical conditions described for the initial run in the titanium autoclave. Also included in the test was an unstressed control specimen from another heat of type 304 stainless steel. Upon completion of the first 100 hr in the 50-ppm chloride solution, it was evident by visual examination that attack on the specimens was appreciably less severe than was experienced in the 100-ppm chloride solution. Both specimens showed mild accumulations of dark brown-and-black colored corrosion product randomly distributed. In other areas a thin semilustrous, tan-colored film covered the surface. Pitting was in evidence on both the pipe and the control specimens. Microscopic examination showed several suspect areas which appeared to contain fine cracks. The two specimens were exposed for a second 100-hr run using fresh solution. Additional scaling and corrosion occurred; Fig. 28 shows the as-removed appearance after 200 hr.

Fig. 28. Condition of Type 304 Stainless Steel Test Specimens after 200 hr at 250°C in Water Containing 50 ppm Chloride, X-1.6 (Test AN-40).

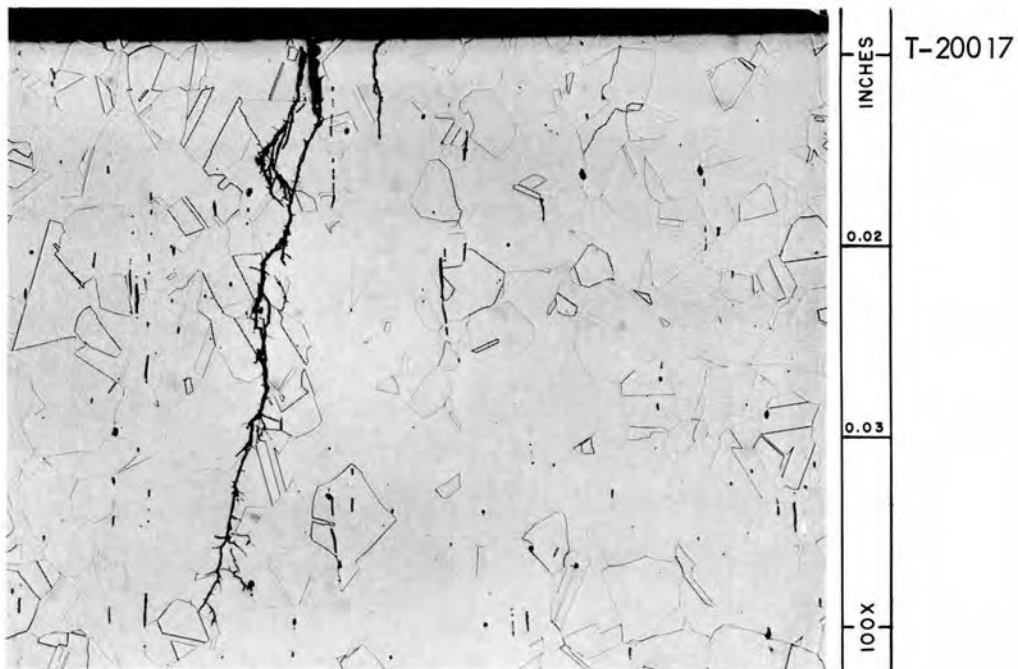
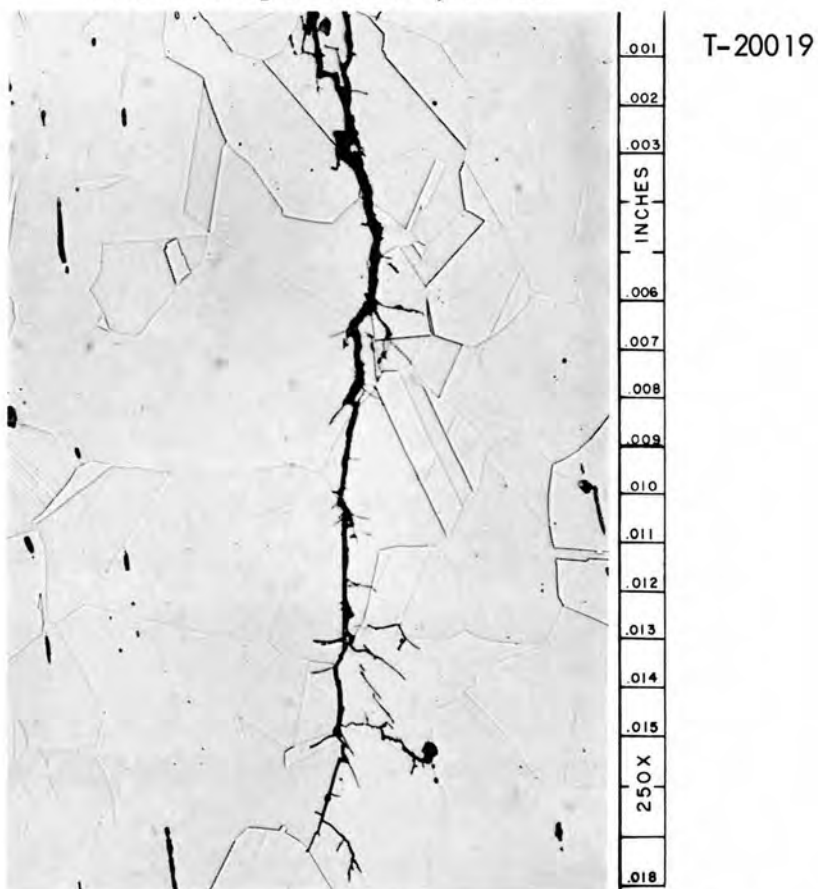
Figures 29, 30, and 31 are photomicrographs of a number of the cracks found in the pipe specimen. In all cases the cracks were transgranular and penetrated to depths up to 35 mils. Cracks were present on both the outer and inner surfaces of the pipe.

View of Complete Crack, X-100.

Fig. 29. Crack on OD of Type 304 Stainless Steel Pipe Specimen after 200 hr at 250°C in Water Containing 50 ppm Chloride, Etched in Glyceria Regia.

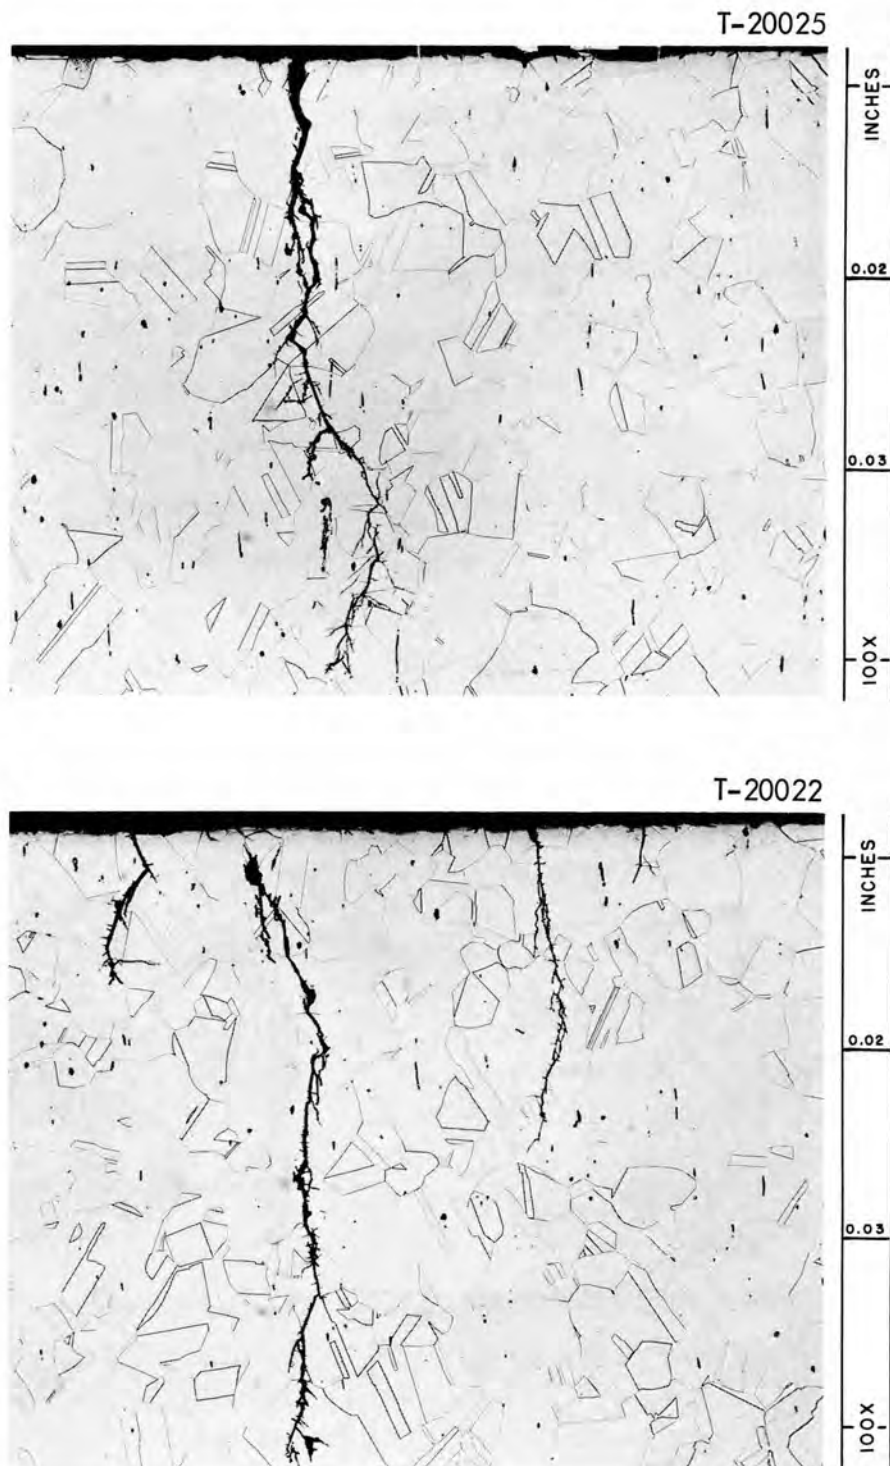
Fig. 30. Cracks on OD of Type 304 Stainless Steel Pipe Specimen after 200 hr at 250°C in Water Containing 50 ppm Chloride, Etched in Glyceria Regia, X-100.

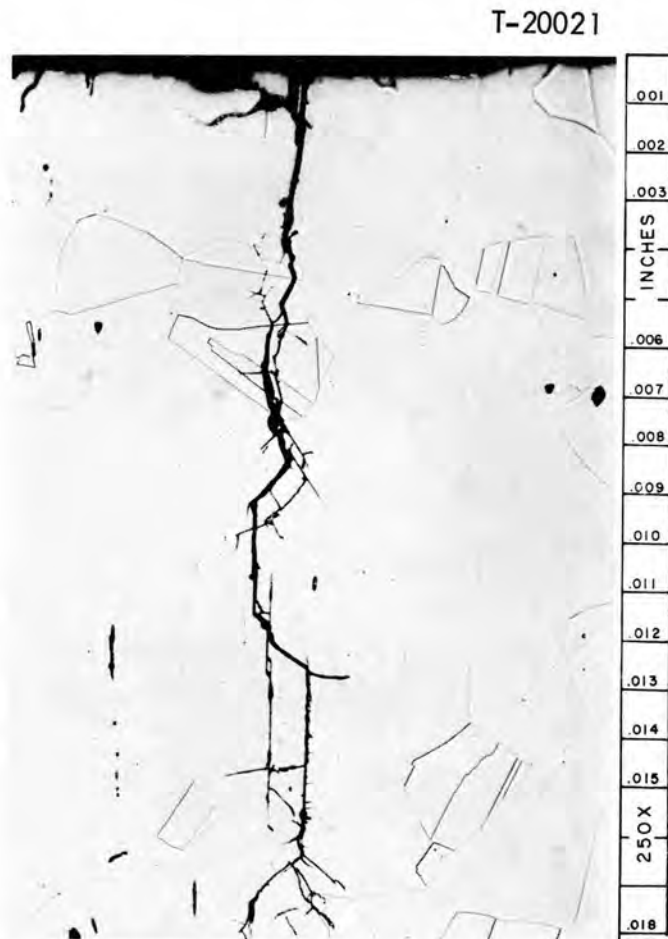
Fig. 31. Crack on ID of Type 304 Stainless Steel Pipe Specimen after 200 hr at 250°C in Water Containing 50 ppm Chloride, Etched in Glycemia Regia, X-250.

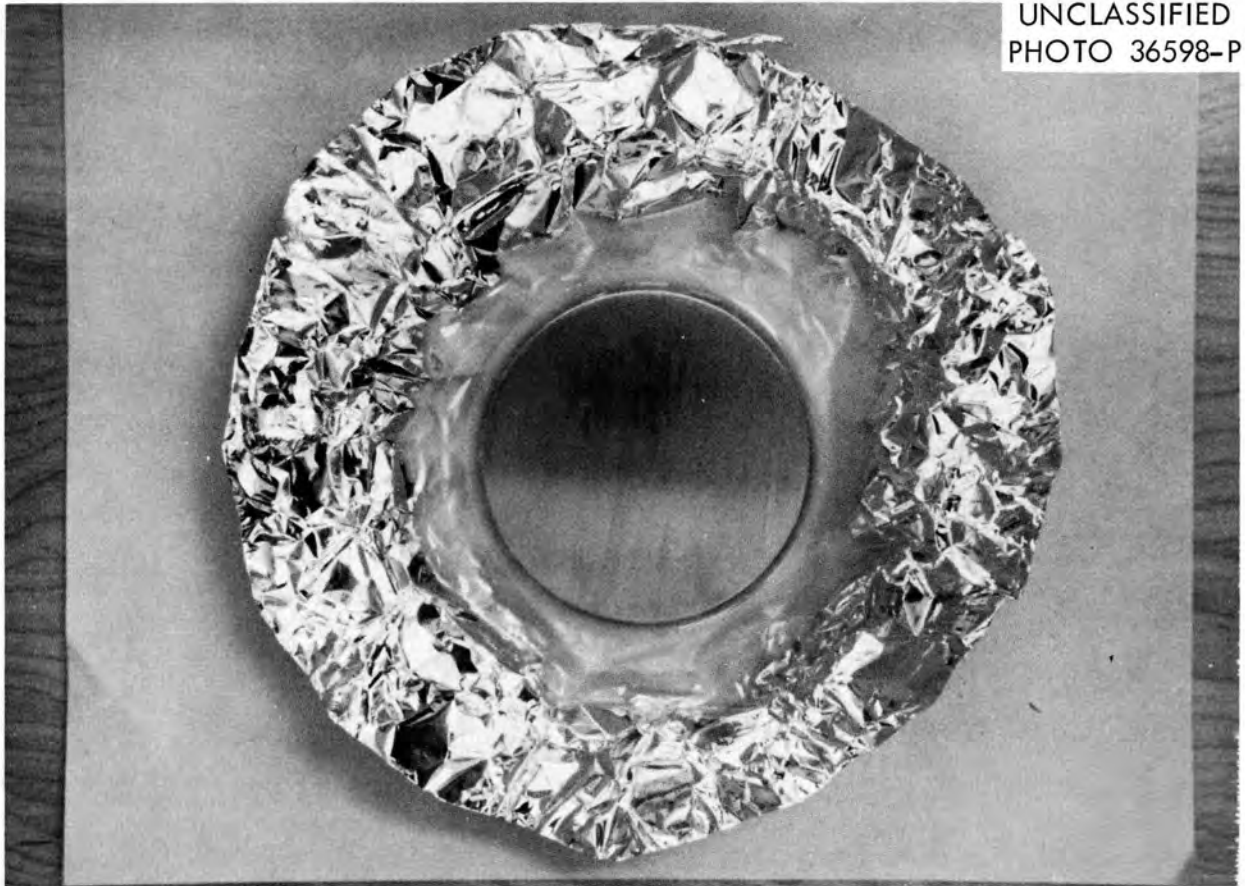
UNCLASSIFIED  
PHOTO 36598-P

Aluminum foil was placed in contact with wet crushed-block insulation at a temperature of approximately 70°C. Brown staining was observed and had the appearance of water stains associated with aluminum. In addition, a waxlike deposit was found on the foil which had been in contact with the moist block for three days (see Fig. 1E). No corrosion was observed on the foil after having been in contact with the moist Thermobestos.

Fig. 1E. Water Discoloration of Aluminum in Contact with Wet Insulation.

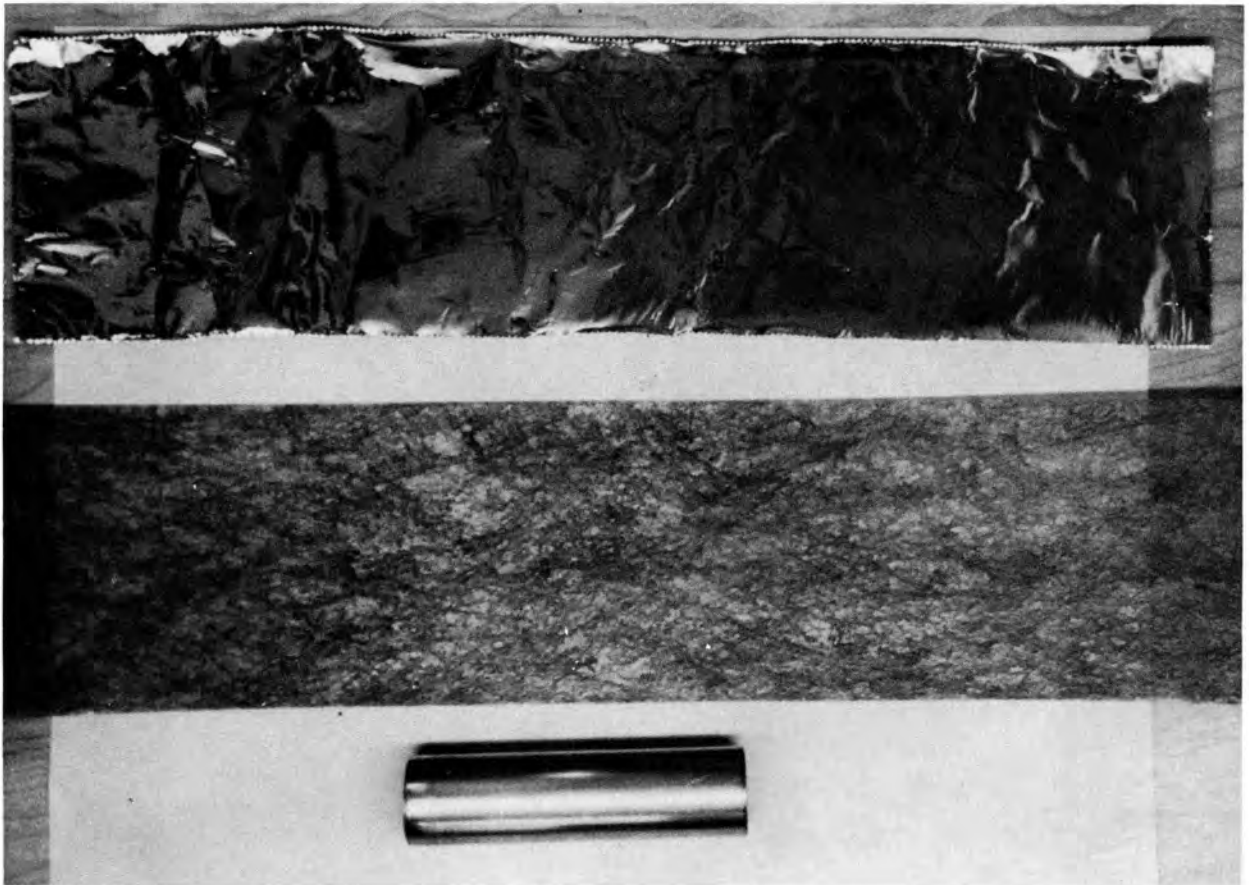
UNCLASSIFIED  
PHOTO 36597-P

Galvanic cells No. 1 and No. 2 were constructed of type 304 stainless steel tubing (5/8 in. OD by 17 gage) with an overwrap of Fiberglas mat and aluminum foil. The parts from which the cells were constructed are shown in Fig. 1E, and the assembled cell in Fig. 2E. The Fiberglas mat was wet with chloride-bearing extract leached from the Thermobestos insulation, and cell No. 1 was installed in the warming oven as shown in Fig. 3E.

Fig. 2E. Components Making up the Aluminum-Stainless Steel Couple--  
Type 304 Stainless Steel Tubing, Fiberglass Mat, Aluminum Foil Alloy 1145.

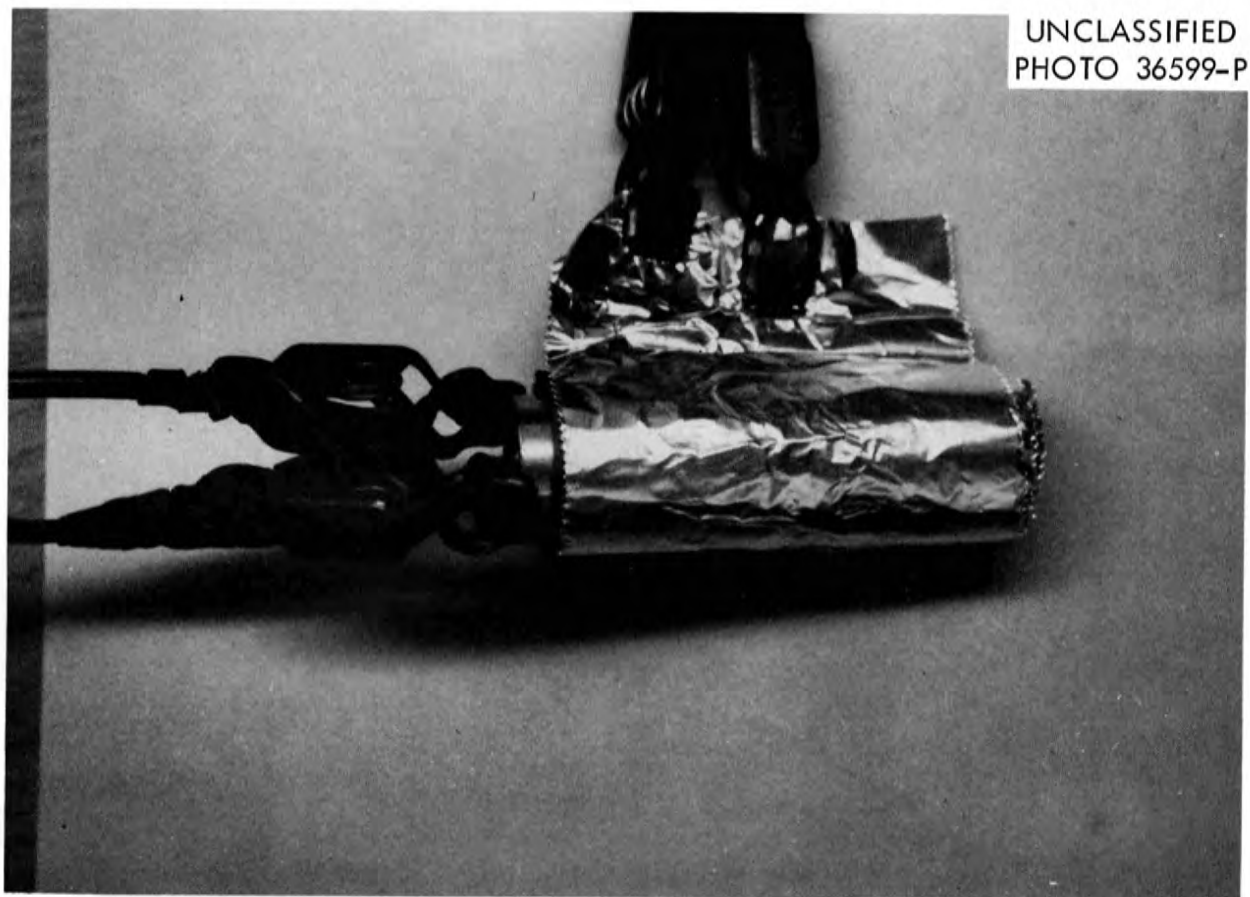
Fig. 3E. Completed Aluminum-Stainless Steel Couple Showing Glass Fiber between the Tube and Foil and Method of Maintaining Electrical Contact.

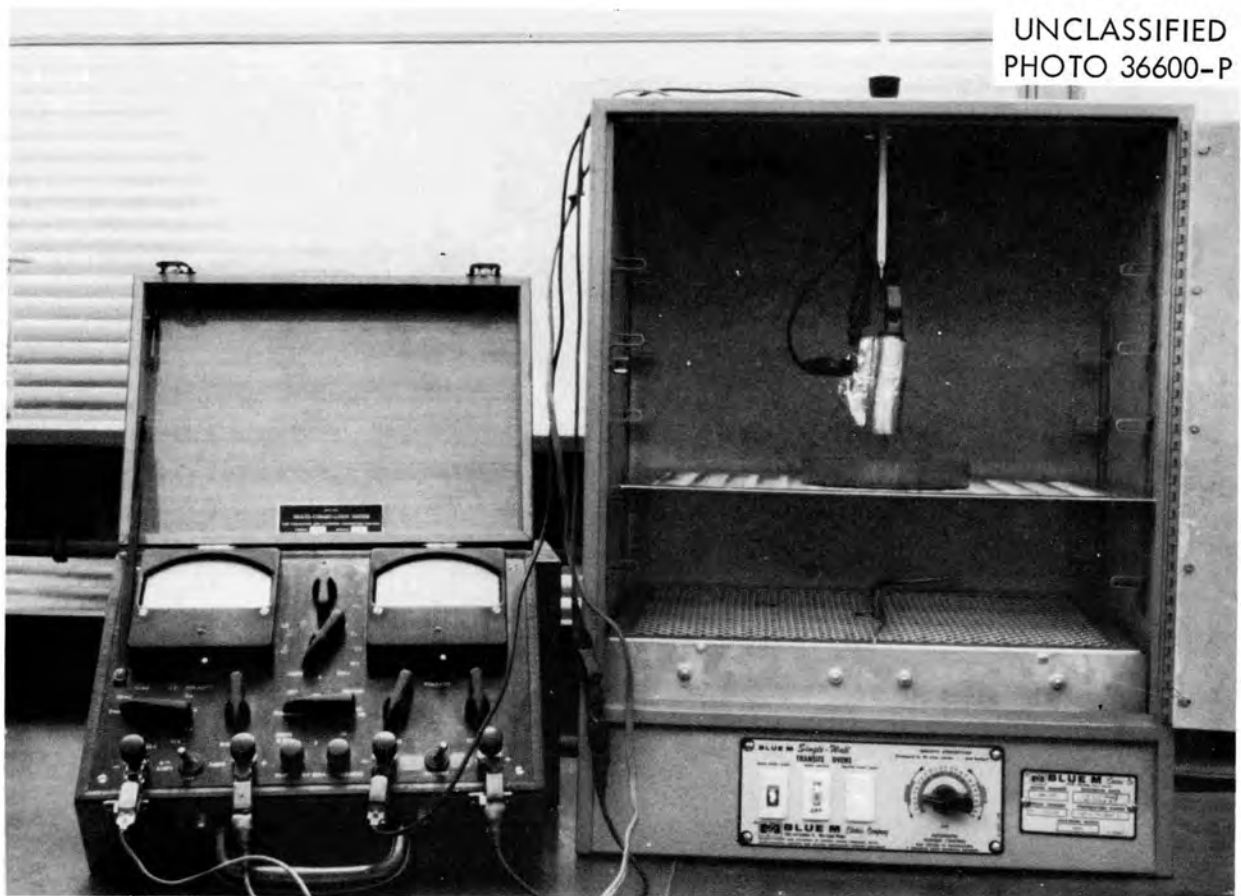
UNCLASSIFIED  
PHOTO 36600-P

did not have a significant stress imposed on them. The cell construction is illustrated on Data Sheet No. 6 and Fig. 4E. Cell No. 5 was wet with extract from the insulation cement, and Cell No. 6 was wet with extract from the block insulation. Both cells produced cathodic protection current which continued without excessive polarization of the cells. Examination of the foil after 18 hr showed pin holes indicating activity of the cells. The amount of current depended upon the resistivity of the electrolyte, which in turn depended upon the chloride concentration.

Fig. 4E. Experimental Set-Up.
