Lightweight Insulating Concrete As a Choice Reroofing System

By Hubert T. Dudley, Ray Wetherholt, Zen Szewczyk, and Herb Cannon

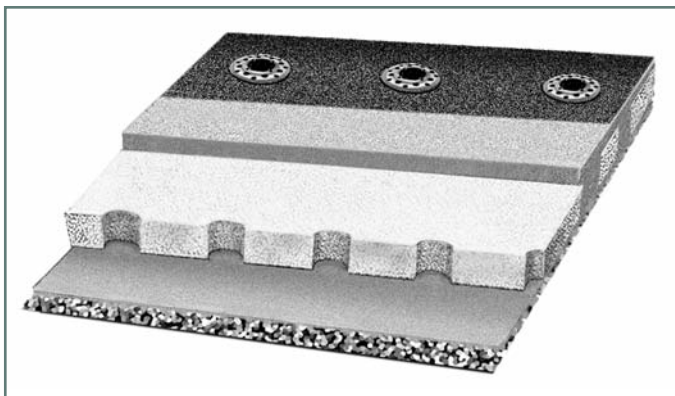
Photo 1—Lightweight Insulating Concrete system cross-section

The slurry corrects any substrate irregularities or low spots, and bonds the polystyrene to the substrate. Type I expanded polystyrene board, designed with a pattern of holes, is placed into the slurry in a stair-step configuration to create the needed slope-to-drain contour and achieve the required insulation values. A top fill of insulating concrete encapsulates the EPS board, bonding it to the substrate. The pour is screeded to a smooth, planar, monolithic surface suitable for membrane application.
