Evaluation and Repair of Fire-Damaged Buildings

By Narendra K. Gosain, Ph.D., P.E., Ray F. Drexler, P.E., and Dilip Choudhuri, P.E.

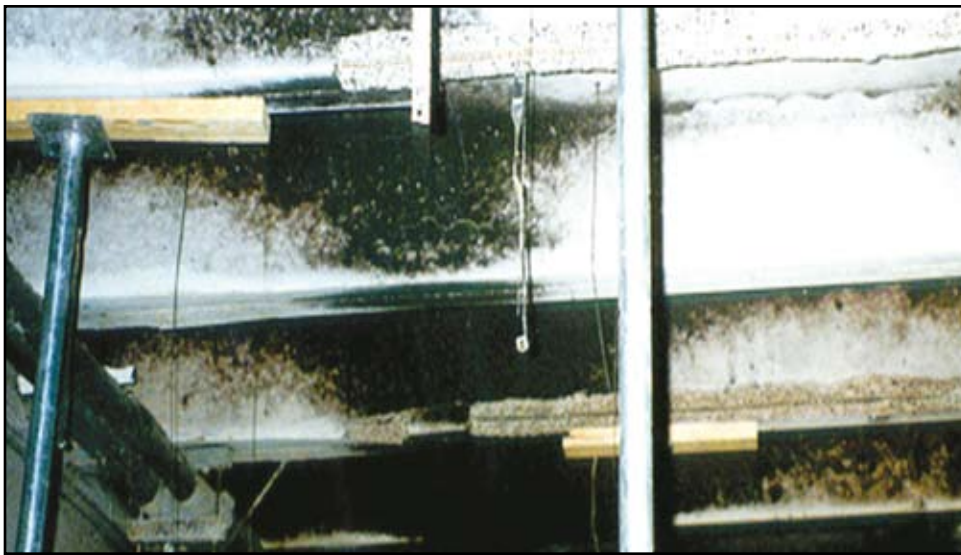
Figure 2: Slab separation and joist spalling.

An arson fire occurred on an elevated level of a reinforced concrete stadium structure. After the fire department approved the area for entry, initial observations were made. The fire severely damaged the concrete in an area approximately 25 feet by 25 feet above the fire; the concrete joists were deeply spalled, the slab separated from the joists, and severe cracking was present (Figure 2).

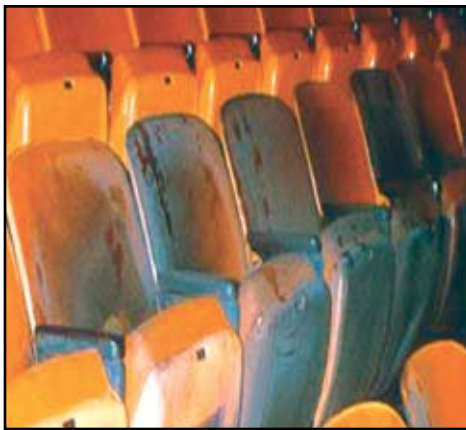
Figure 3: Heat damage of seats at level above fire.

The fire was intense to the extent that the seating area directly above the fire suffered heat damage (Figure 3).

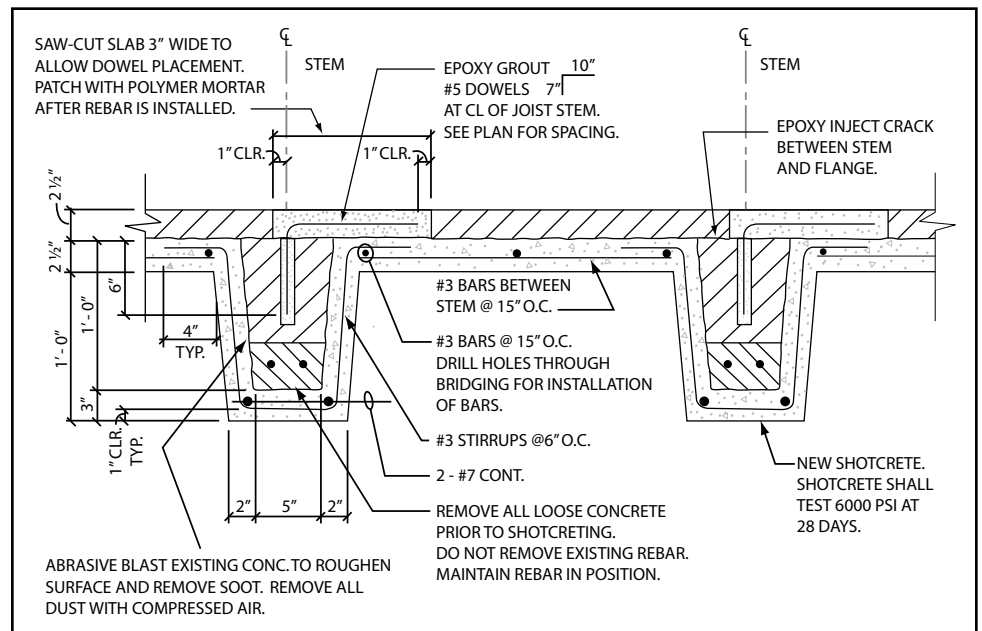
Figure 4: Repair detail for slab-joist separation.

Destructive testing indicated that the strength of reinforcing steel and some concrete above the fire was compromised. Repairs were designed to rebond the slab and joists using L-shaped dowels to hook the slab and joist webs together. The load carrying capacity of the effected slabs and joists were repaired by means of encasing external reinforcement (bars and stirrups) with shotcrete applied to an intentionally cleaned and roughened surface (Figure 4).

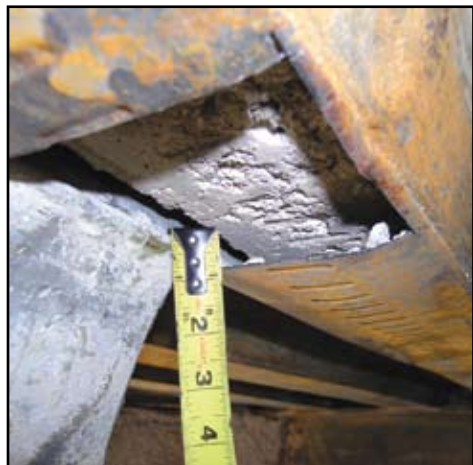
Figure 6: Buckled metal deck. Note separation of concrete from metal deck through exploratory opening.

Fire occurred in an occupied space of a steel framed high rise. The steel framing was protected by a sprayed fire resistive material. The exposed metal deck supports a composite concrete floor system. (Figure 5, page 21). Heat from the fire caused some buckling of the metal decks near the fire (Figure 6, page 21) and deformation of plastic magazine racks (Figure 7) in an adjacent room not directly exposed to the fire.

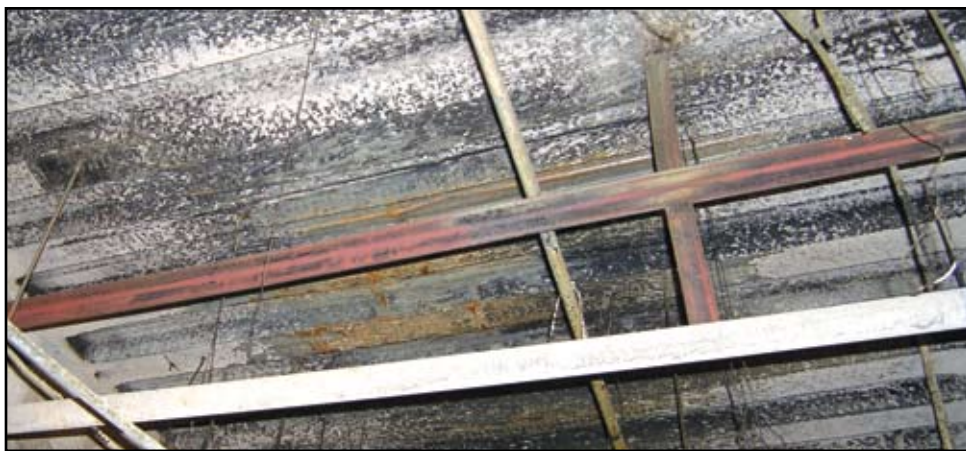
Figure 5: Interior damage due to fire.

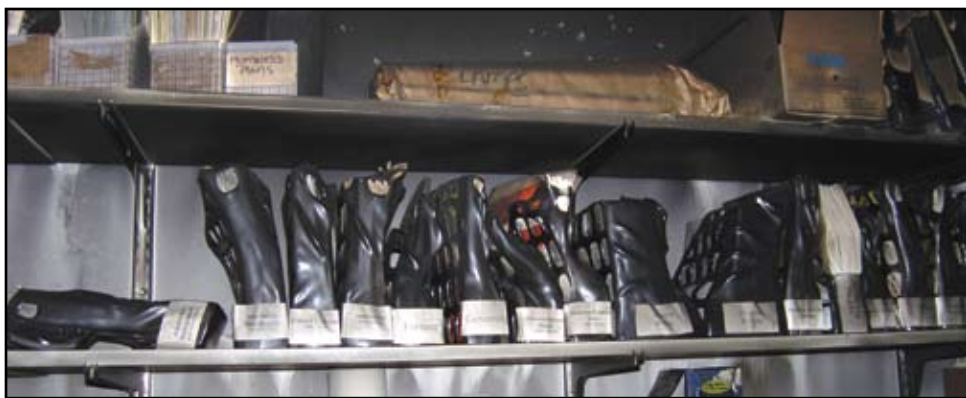
Figure 7: Collateral damage to plastics.

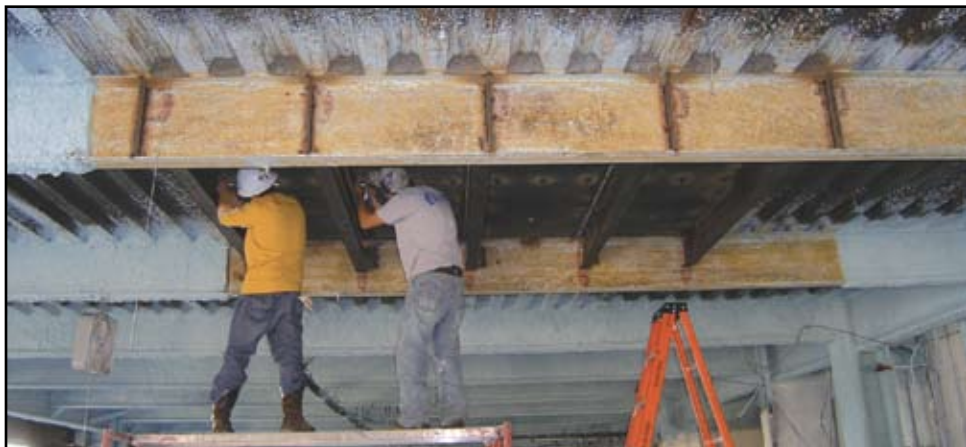
Figure 8: Structural repairs to limit floor slab displacements.

The assessment concluded that the steel frame did not require repairs. However, to prevent displacements of the separated concrete slab above the metal deck, structural repairs were required (Figure 8). The repairs included adding new beams to support the metal deck and the addition of grout to fill the voids between the concrete and metal deck.
