Fontenelle Dam – Lessons

Teton Dam

Teton Dam – Lessons

Lawn Lake Dam

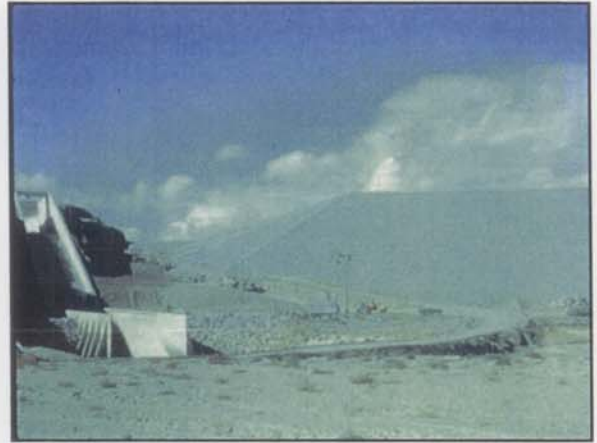
Sinkhole & erosion
hole at downstream side

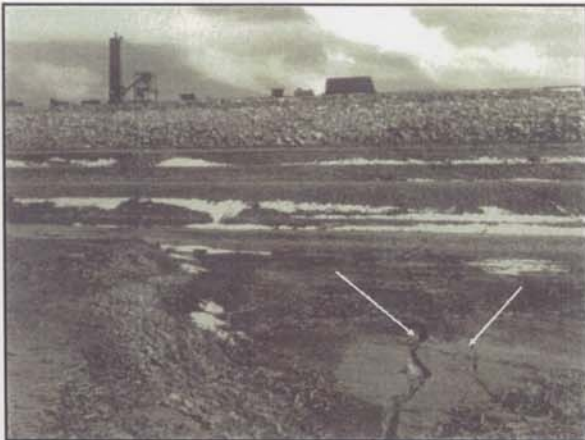
Cracks caused by grouting

gypsum found in
foundation
caused problems
with seepage

Finally constructed vertical concrete central cutoff wall, 50' into foundation! \$50,000,000

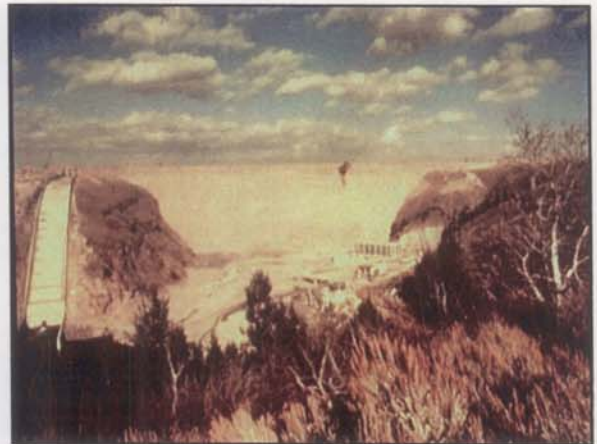
"The Biggie"

300' high
built 1975

PO not functional at
1st filling!

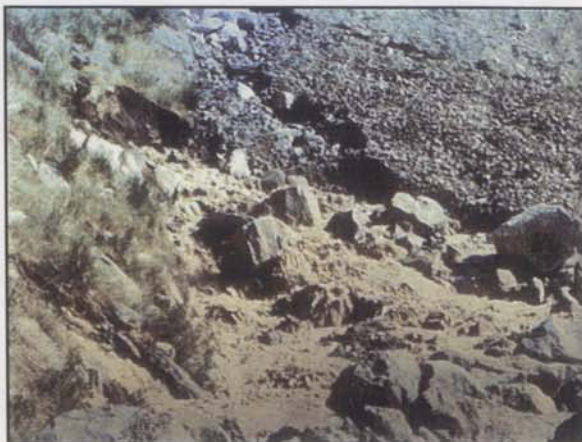
arrow shows leak

25 cfs
seepage!

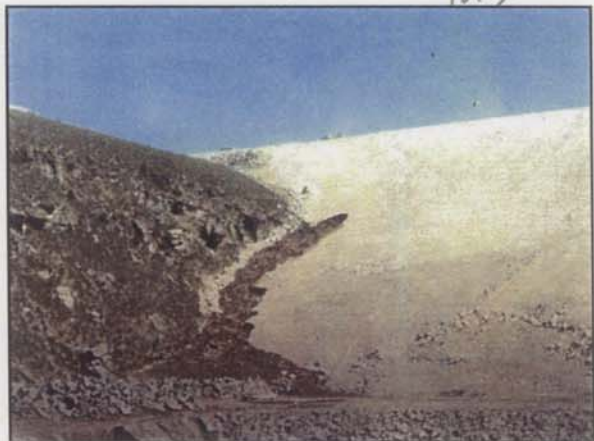
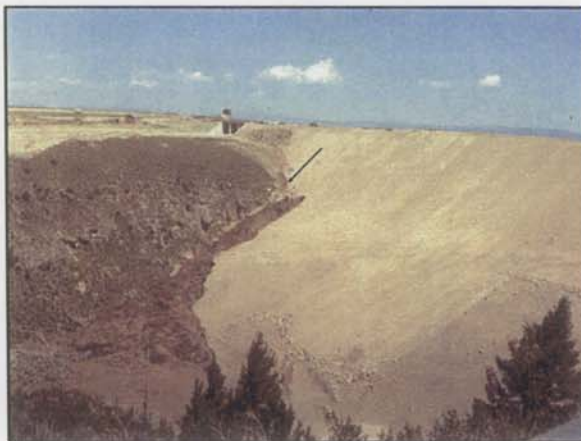
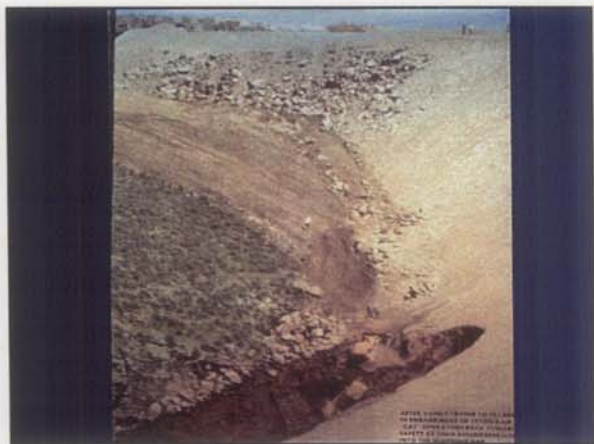
breach in progress! warning issued
10:30

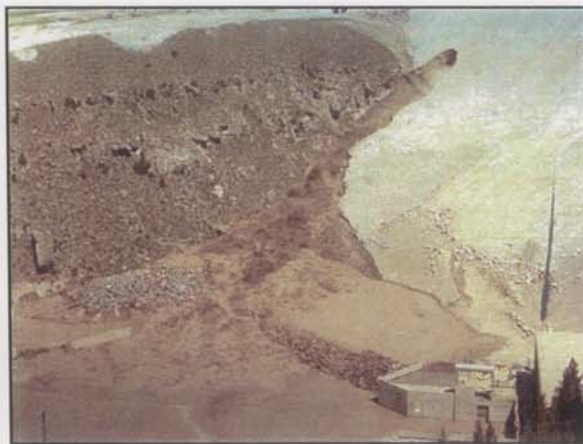
2- doors
lost!

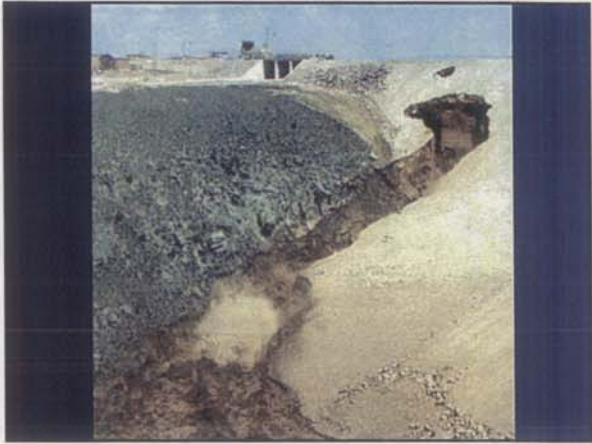
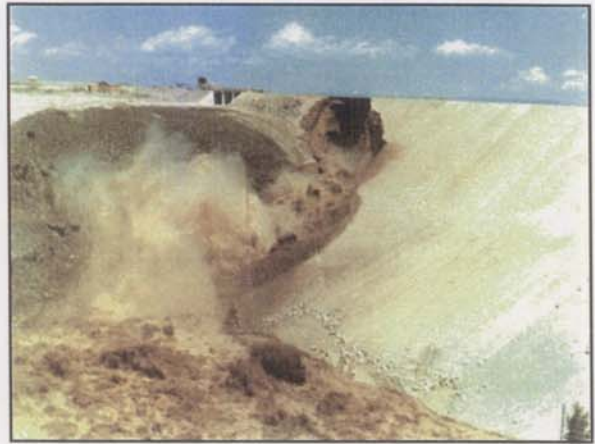
newly formed
alluvial
fan

Sinkhole & whirl pool
observed

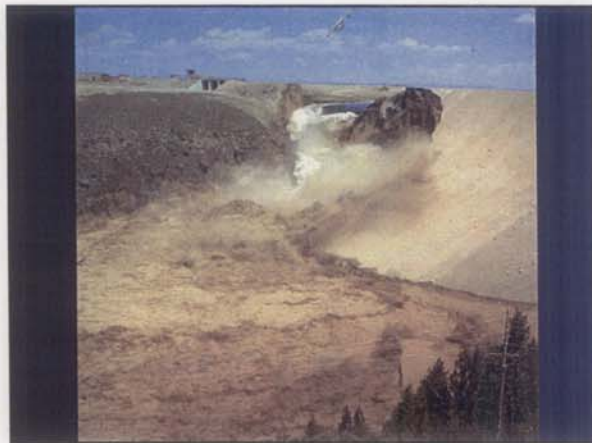
noon
 $\frac{1,000,000 \text{ cfs}}{4}$

drained in 6 hours
250,000 AF IMPOUNDED

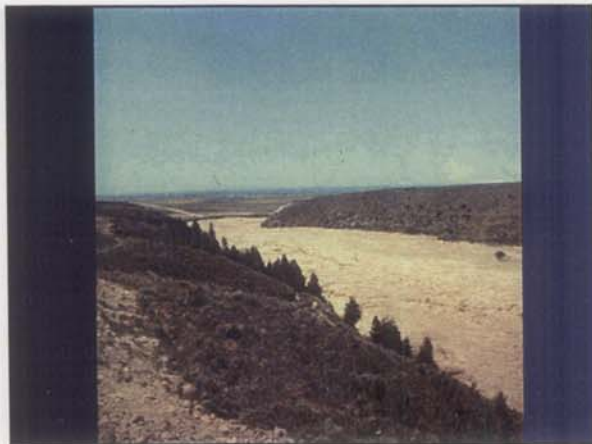
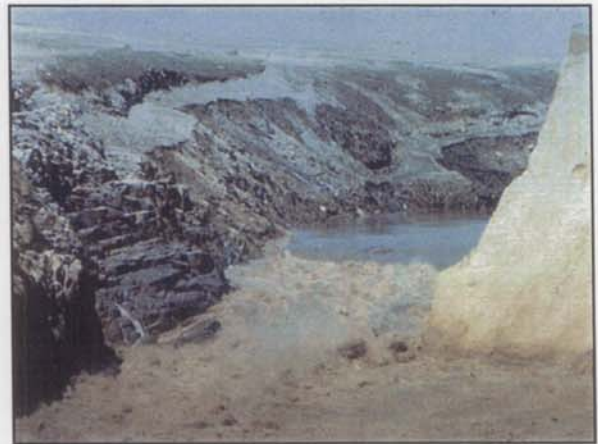
downstream flood wave

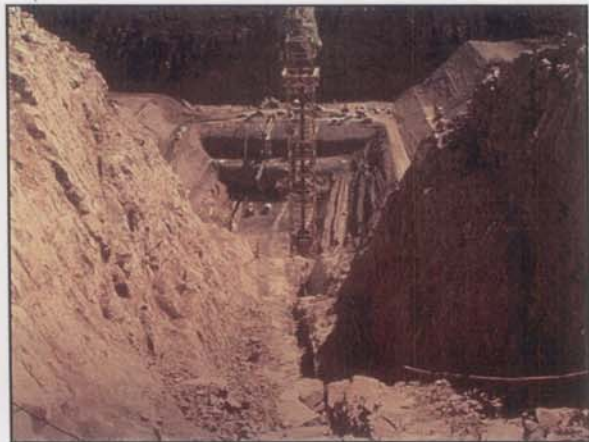
Key trench ↓

Single line grout curtain along E dam

Seepage/Piping failure

No filter material in the dam!

- Importance of foundation treatment – sealing of foundation against erodible fill
- Importance of multiple lines of defense against seepage erosion/piping
- Avoid narrow steeply-sloped cutoff trenches
- Importance of ability to control reservoir filling
- Design engineer must visit site at critical times during construction to substantiate conditions and adjust design accordingly

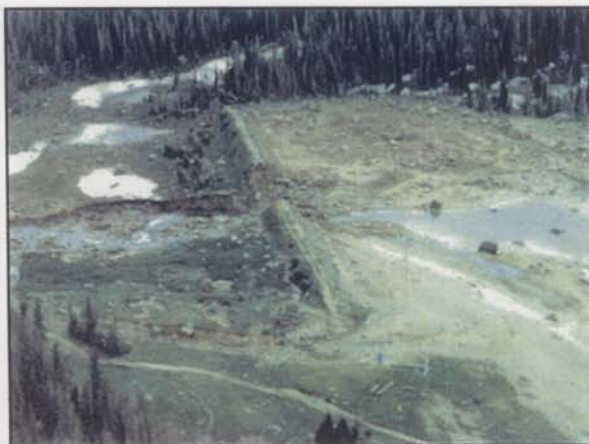
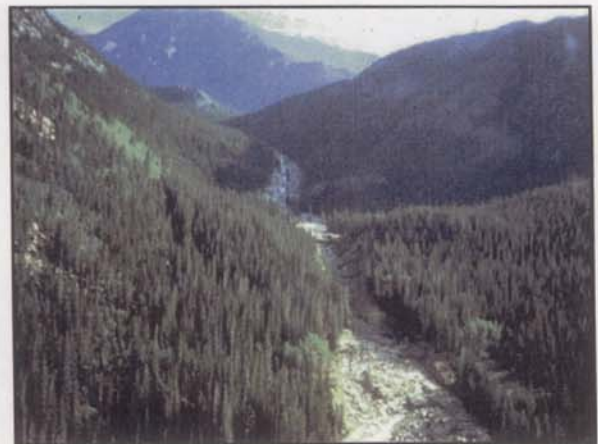
24' High
700 AC-FT

Failed 1982

Key lesson - Design engineer must be on site
