## The Erosion Corrosion Resistance Of Zeron 100

Division	Engineering
Job No.	
Reference No.	OC
Report No:	TN781R3
Iss No.	4
Date:	Dec 2008

## THE EROSION CORROSION RESISTANCE OF ZERON 100

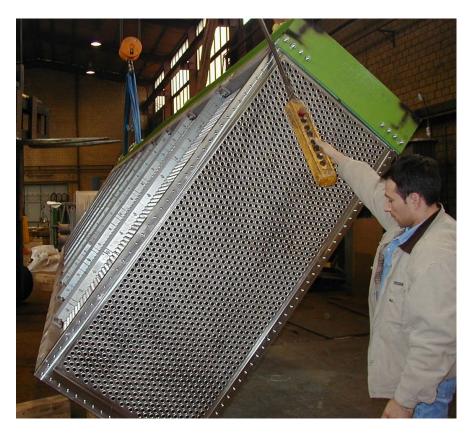
FIGURE 1 Zeron 100 heat exchanger supplied to BOC Cantarell to handle seawater with a high suspended solids content.

The high resistance of Zeron 100 to erosion by silt and sand was used to advantage by the BOC Cantarell plant in Mexico. The seawater for cooling is taken from a shallow bay and the bottom gets stirred up during tropical storms. This means that for several days after a storm there is a high solids burden in the water. The solids are mostly sand and gravel with a peak content of ~50,000 mg/l. The original heat exchangers and seawater pumps were copper alloys and they were suffering severe erosion corrosion. RA Materials won the order to replace the 28 heat exchangers with ones in Zeron 100. At the same time, the aluminium bronze pumps were replaced with eight Zeron 100 pumps feeding the four trains. The cases for these were fabricated from wrought Zeron 100, while the impellers were castings. The Zeron 100 has been in service since 2003 with excellent performance. Figure 1 shows one of the Zeron 100 heat exchangers supplied to Cantarell.

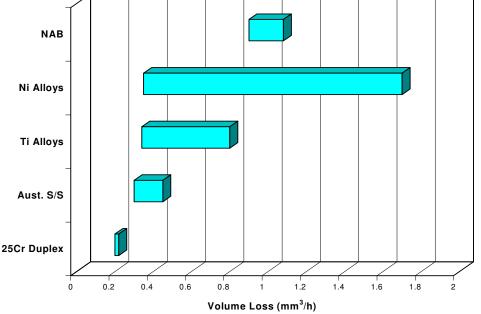
Cavitation occurs where there is a sudden pressure drop in a system. This results in the formation of vapour cavities that migrate along the pressure gradient and eventually implode on the metal walls. The energy release can then lead to loss of metal. Cavitation often occurs in high velocity systems and can be linked with erosion corrosion. Typical sites for cavitation are in pumps or after partly throttled valves. Figure 5 shows some cavitation data generated by the Royal Navy in a flow loop in natural seawater (6). The results clearly show the superior performance of superduplex stainless steel compared with nickel aluminium bronze (NAB) and other alloys commonly used for pumps, such as austenitic stainless steels.
