### THE USE OF ZERON 100 SUPERDUPLEX STAINLESS STEEL IN SWIMMING POOLS

<b>Division</b>	Engineering
<b>Job No.</b>	
<b>Reference No.</b>	
<b>Report No:</b>	TN1503
<b>Iss No.</b>	1
<b>Date:</b>	Dec 2008

## THE USE OF ZERON 100 SUPERDUPLEX STAINLESS STEEL IN SWIMMING POOLS

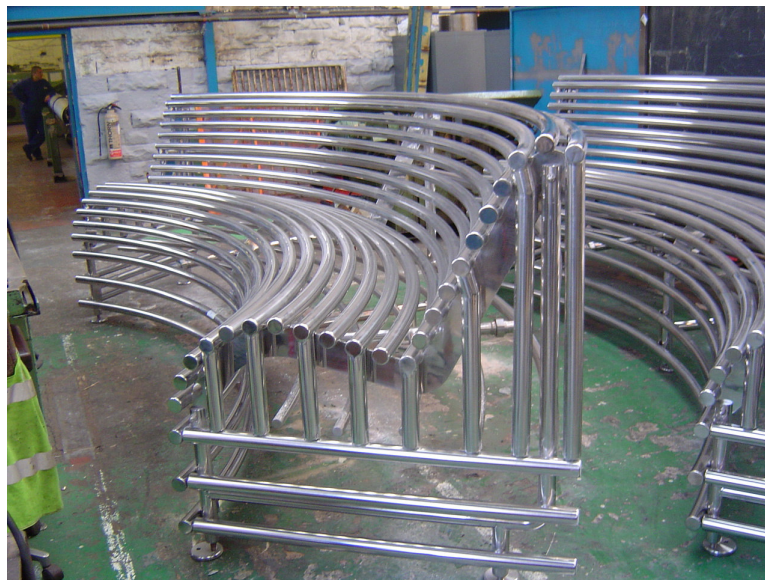
FIGURE 6 Polished Zeron 100 furniture for a hydrotherapy pool in Tenerife.

Zeron 100 has been used in seawater and high chloride brine swimming pools for a variety of fittings, including hand rails and ladders. Zeron 100 bolting has been used to fasten a variety of pool equipment in place. Figure 6 shows Zeron 100 furniture manufactured from plate and pipe for a hydrotherapy pool (seawater at 40°C) in Tenerife. Mechanical polishing produced a high quality finish for this application.

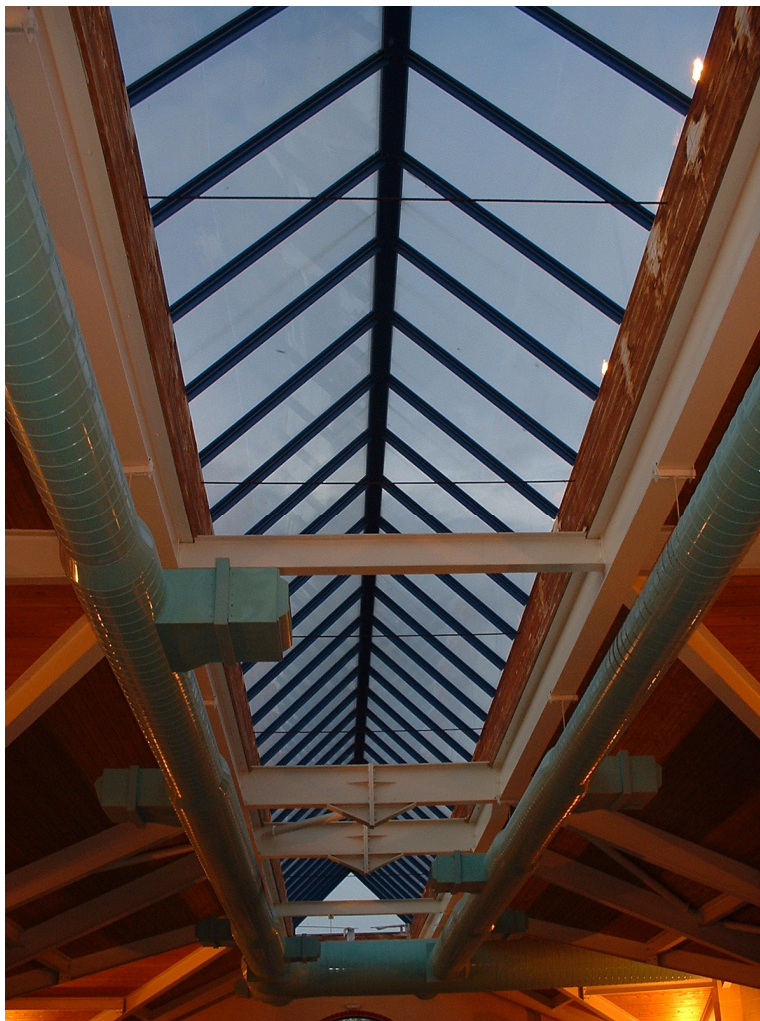
FIGURE 7 Roof of Bedale Leisure Complex swimming pool showing 316 tie bars.

Zeron 100 has also been used for tie bars in swimming pool roofs. Figure 7 shows the pool roof of the Bedale Leisure Complex (UK), with the original 316 tie bars clearly visible. Figure 8 shows the 316 tie bars being removed and the Zeron 100 replacements awaiting installation.
