Title: Effects of Valve Trim Geometry in Flashing Service

Author: Dell Grunenberg, Jordan Valve Product Manager, Richards Industries Valve Group, Cincinnati, Ohio

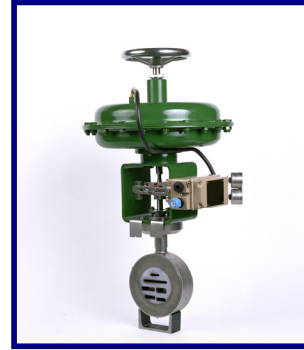
Figure 10 – Wafer Control Valve

While the design features of the sliding gate valve made for a convincing argument, the real proof was in the actual performance compared to that of the original cage guided valve. An actual picture of the valve installed is shown in Figure 10.

This valve was supplied with an emergency handwheel and digital positioner as specified by the customer. The green actuator was also a customer requirement to indicate a normally closed valve configuration, recognizable by users from a distance.

After installed, the user decided to remove the valve for inspection during the next plant shutdown. Approximately 10 months after installation, during which time the valve was in continuous operation, the valve was removed. To the technician's delight, there was no visible damage to the valve body or trim area.

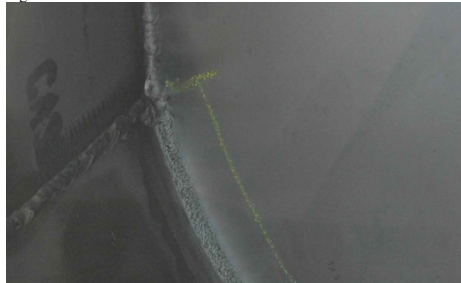
Figure 13 – Monel Deflector Plate

tank from erosion. The plate was also removed by the user for inspection. The condition of the plate was much different than that of the valve. Clear evidence of damage was immediately noticeable (Figure 13). Approximately 10 mm of material had been worn away during the past months, indicating the flash steam was highly erosive as had been experienced previously. The Monel plate certainly performed its expected task, however, the extent of the damage was noteworthy, especially given the fact that the valve was in sufficiently good condition to be placed back into the pipeline without any maintenance or repair being done – which was done.

The yellow markings indicate the area of damage from the flash steam. Keeping in mind this plate was made of an alloy material, located several meters downstream of the valve and after a significant expansion in the downstream pipe diameter, it was clear the medium had potential to damage any metal surface in its flow path. The fact that neither the valve nor the intermediate piping before the tank were damaged is a testament to merits of a streamlined flow path for this type of service. The user was so impressed with the performance and life of this
