SWIFT CREEK PUMP STATION SEWAGE SPILL ASSESSMENT

Prepared for
Town of Cary
October 6, 2006

BROWN AND CALDWELL

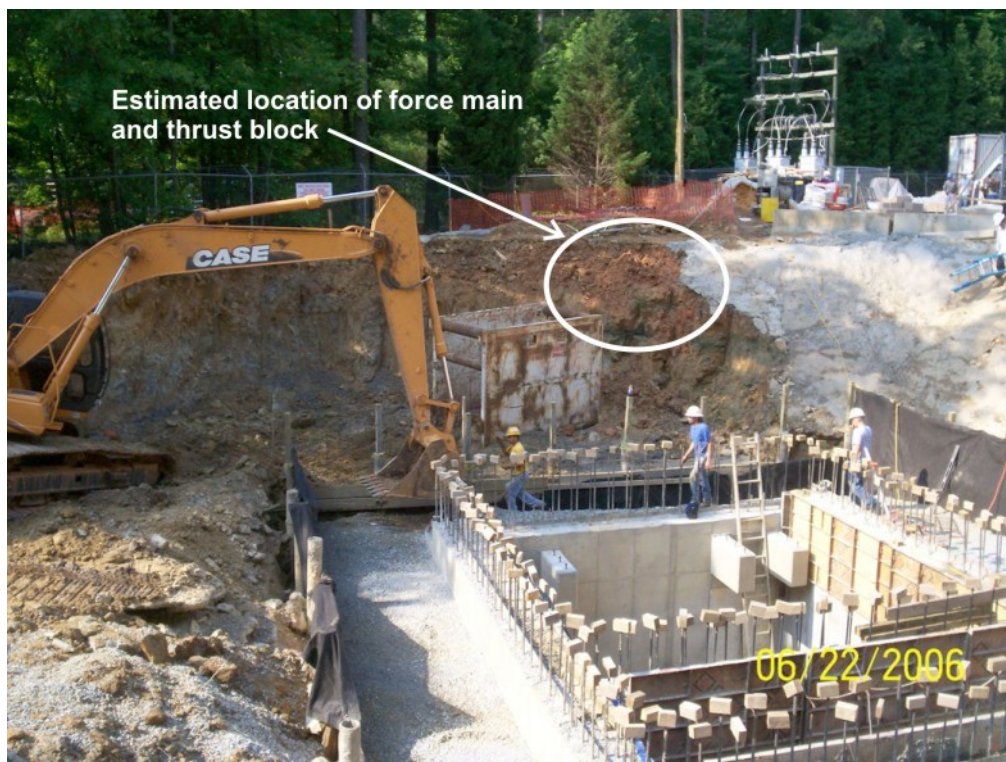
Figure 3-5. Excavation for Placements of Concrete, June 22, 2006

1. Influence on soil conditions/slope stability caused by the excavation of the soil to a side slope of 0.5 horizontal (H) to 1.0 vertical (V) to install the building footings in the near vicinity of the existing thrust block. Figure 3-5 is a photograph that indicates that the pipeline was either very close to being exposed or actually exposed by the steep excavation.
2. Potential failure scenarios that may have been present as the soils supporting the force main and thrust block transferred from passive to active earth pressure coefficients.
3. Influence on slope stability of saturated near surface soils and a rise (increase in elevation) of the water table resulting from the frequent rain events in the weeks and days prior to the pipeline failure.

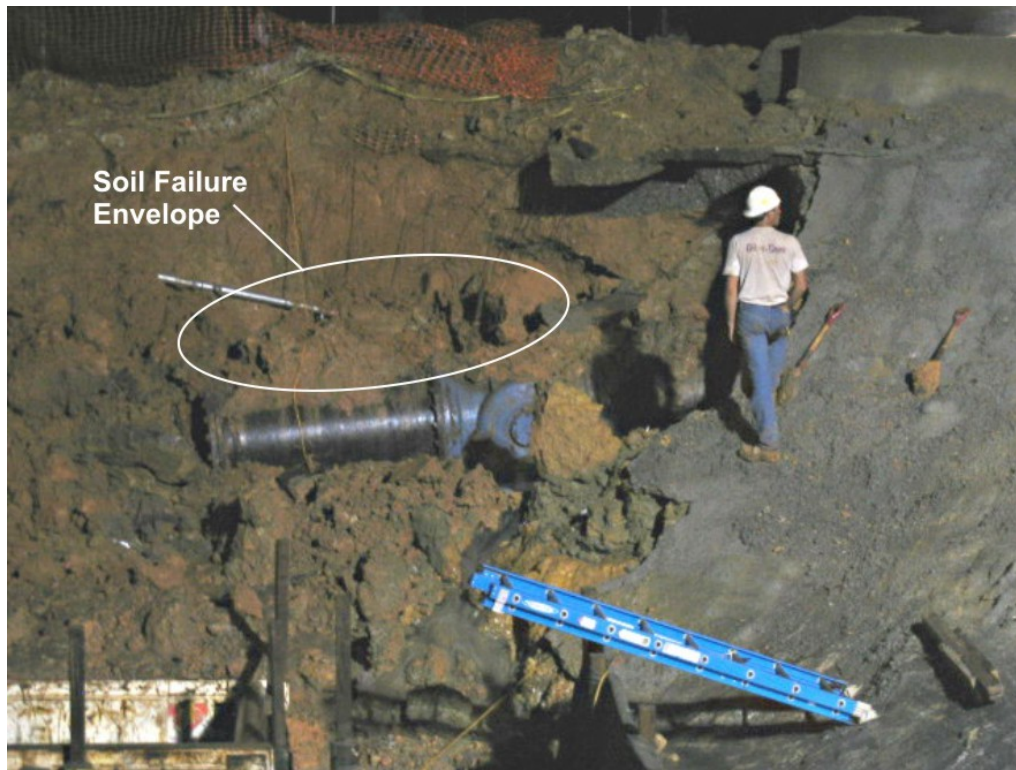
Figure 3-6. Soil Failure Surface, Approximately 10 feet into Slope, June 2006

The slope stability evaluation indicated the top of the failure surface to be 8 ½ to 10 feet from the top of the slope at 0.5H to 1V. It is interesting to note that the location of the failure surface from the slope stability evaluation is very similar to failure conditions identified in site photographs taken after failure, but before the force main was repaired (see Figure 3-6). The soil properties for the slope stability analysis were estimated from the test boring logs and soil index properties in the Tierra report⁴. A sensitivity evaluation of the unit weight, cohesion and internal friction angle was conducted to ensure a representative evaluation of the slope stability at the time of the force main failure. A back calculation analysis was also performed to confirm the validity of the estimated soil properties.

Based on the results of the slope stability evaluation and a review of the pertinent project information, the assessment team concluded that the slope was at failure conditions after the slope was cut to 0.5H to 1V and could stay up only for a short time (i.e. several hours to several days). However, the long-term, effective stress factor of safety typically rules for cut slopes that are excavated to a slope angle steeper than the soil's effective stress friction angle. This means that the unsupported and partially saturated soil slope adjacent to and/or beneath the force main/thrust block was already in the process of failure (more driving forces than resisting) as soon as the slope was cut to 0.5H to 1V. Based upon the slope stability evaluation, the assessment team concluded that, after the soil was removed from the slope to make room for the footing excavation, it was only a matter of time until the evidence of slope failure and movement of the thrust block occurred.
