Strengthening of Masonry Walls with FRP Bars

Gustavo Tumialan and Antonio Nanni
Center for Infrastructure Engineering Studies
University of Missouri – Rolla

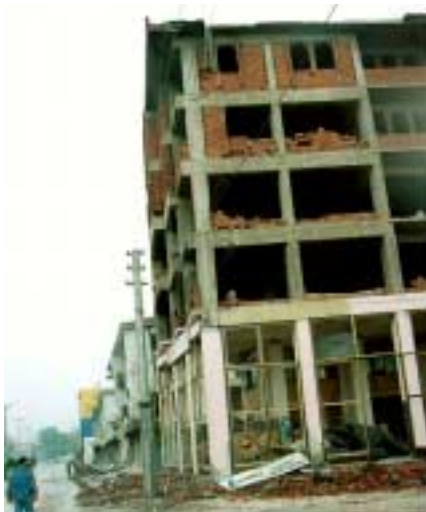
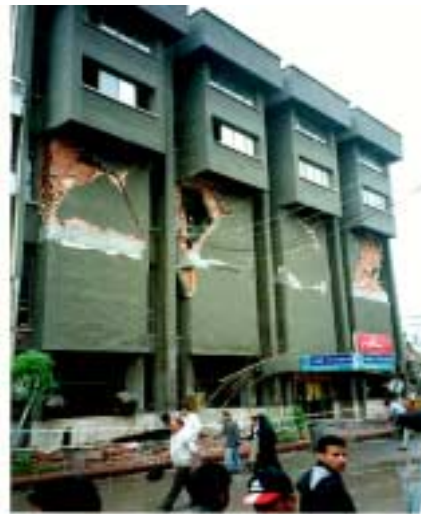
Figure 1. Failure in URM Walls, Izmit Turkey, 1999

(a) Failure due to Out-of-Plane Loads

(b) Failure due to In-Plane Loads

Structural weakness or overloading, dynamic vibrations, settlements, and in-plane and out-of-plane deformations can cause failure of unreinforced masonry (URM) structures. URM buildings have features that, in case of overstressing, can threaten human lives. These include unbraced parapets, inadequate connections to the roof, floor and slabs, and the brittle nature of the URM elements. Organizations such as The Masonry Society (TMS) and the Federal Emergency Management Agency (FEMA) have determined that failures of URM walls result in more material damage and loss of human life during earthquakes than any other type of structural element. This was evident from the post-earthquake observations in Northridge, California (1994) and Izmit, Turkey (1999) (see Figure 1).

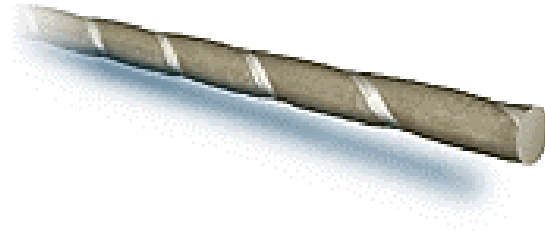
Figure 2. GFRP Bar

In both applications glass FRP (GFRP) bars were used to increase either the flexural or shear capacity. The GFRP bars are deformed by a helical wrap with a sand coating to improve the bond between the bar and the embedding paste (see Figure 2). The bars are produced using a variation of the pultrusion process using 100% vinylester resin and e-glass fibers. Typical fiber content is 75% by weight. The bars are commercially available in high volumes with stocking locations in several points throughout North America and Europe.

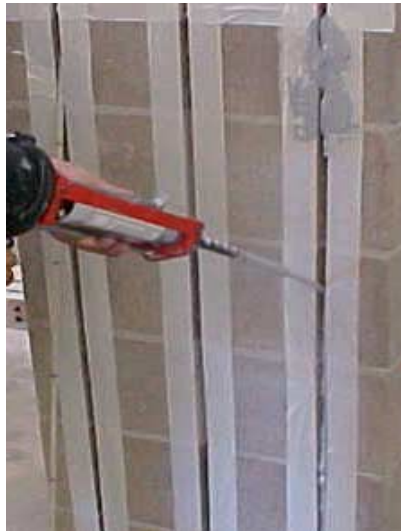
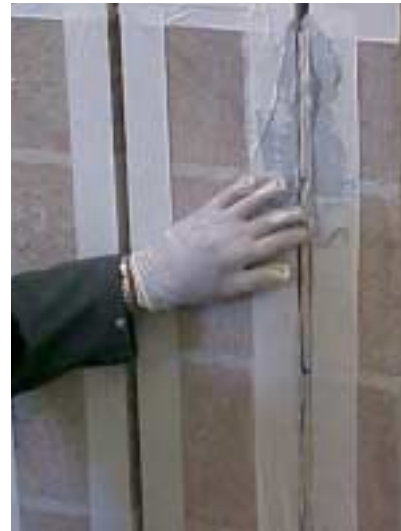
Figure 3. Installation of NSM FRP Bars

The NSM technique consists of the installation of FRP reinforcing bars in slots grooved in the masonry surface. An advantageous aspect of this method is that it does not require sandblasting and puttying. The strengthening procedure can be summarized as: (1) grooving of slots having a width of approximately one half times the bar diameter and cleaning of surface, (2) application of embedding paste (epoxy-based or cementitious-based paste) (see Figure 3a), (3) encapsulation of the bars in the joint (see Figure 3b), and (4) finishing. If hollow masonry units are present, special care must be taken to avoid that the groove depth exceeds the thickness of the masonry unit shell, and that local fracture of the masonry occurs. In addition, if an epoxy-based paste is used, strips of masking tape or other similar adhesive tape can be attached at each edge of the groove to avoid staining of the masonry surface (see Figure 3).

(a) Application of Embedding Paste

(b) Encapsulation of FRP Bar

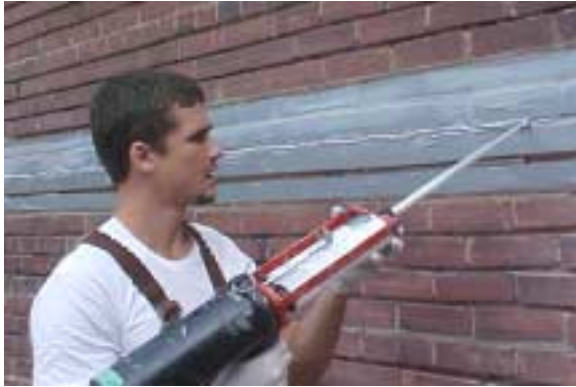
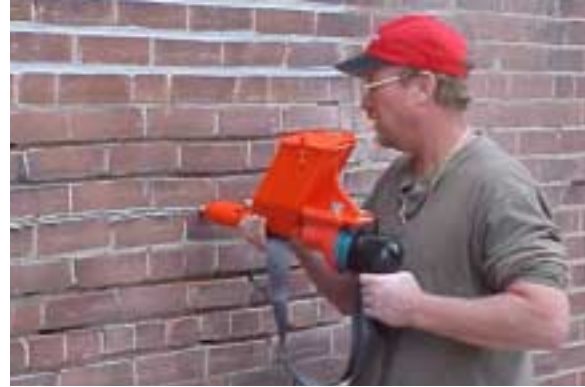
Figure 4. Guns for Installation of Embedding Paste

Depending on the kind of embedding material, cementitious-based or epoxy-based, a mortar gun used for tuckpointing or an epoxy gun can be used. The guns can be hand, air or electric powered, being the latter two, the most efficient in terms of efficiency. Figure 4a illustrates the application of an epoxy-based paste using an air powered gun. Figure 4b shows the application of a cementitious-based paste with an electric powered gun.

(a) Air Powered Gun

(b) Electric Powered Gun

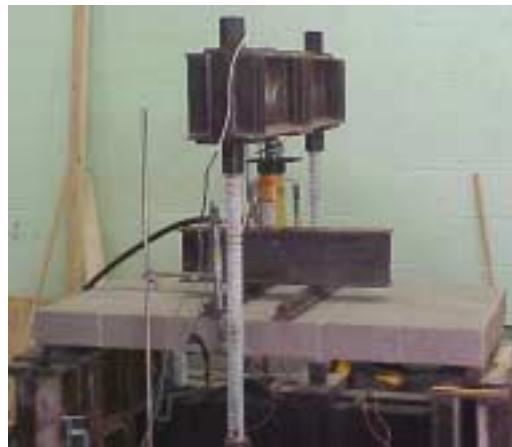
Figure 5. Test Setup

The test results of three masonry specimens, constructed with concrete blocks, are presented. Their dimensions were 3.75x24x48 in. The masonry specimens were strengthened with #3 GFRP bars having a tensile strength of 110 ksi and modulus of elasticity of 5900 ksi. The strengthening layout intended to represent URM wall strips with GFRP bars at different spacing. Thus, Wall R1 was strengthened with one GFRP bar (spacing = 24 in.), Wall R2 with two GFRP bars (spacing = 12 in.). In order to compare the performance of FRP bars and laminates, Wall L1 was strengthened with one 3 in. wide GFRP laminate. The amount of strengthening reinforcement was equivalent to that of Wall R1 in terms of axial stiffness. The load capacity of an URM wall was estimated to be equal to 800 lbs. The walls were tested under simply supported conditions (see Figure 5).

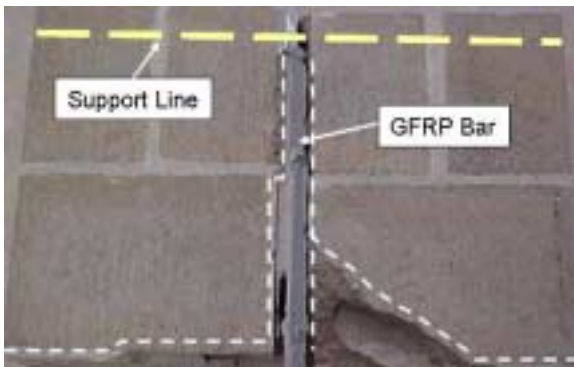
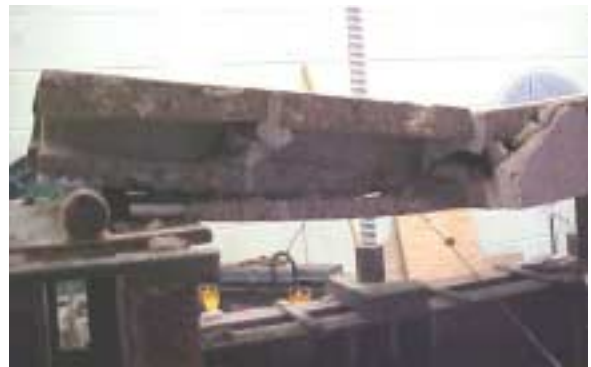
Figure 6. Specimens after Failure

Wall R1 failed due to debonding of the embedding material from the masonry. Initial flexural cracks were primarily located at the mortar joints. A cracking noise during the test revealed a progressive cracking of the embedding material. Since the tensile stresses at the level of the

mortar joints were being taken by the FRP reinforcement, a redistribution of stresses occurred. As a consequence, cracks developed in the masonry units oriented at 45° (see Figure 6a) or in the head mortar joints. Some of these cracks followed the epoxy paste and masonry interface causing their debonding and subsequent wall failure. Wall R2 failed due to shear (see Figure 6b). Similarly to Wall R1, cracking started in the mortar joints at the maximum bending region. In general, initial cracking was delayed and the crack widths were thinner as the amount of FRP reinforcement increased.

(a) Debonding Failure (Wall R1)

(b) Shear Failure (Wall R2)

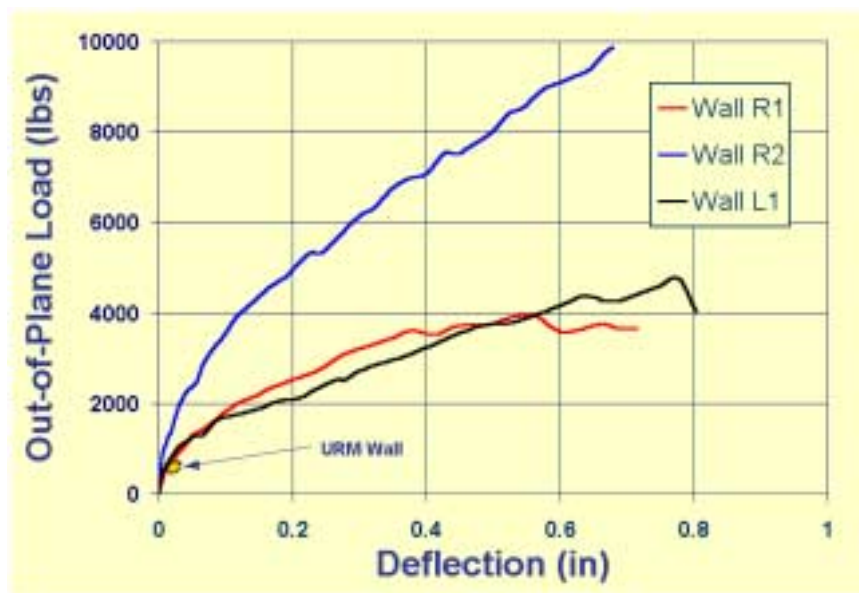
Figure 7. Moment vs. Deflection Curves

Figure 7 illustrates the Moment vs. Deflection curves for the test specimens. The flexural strength and stiffness of the FRP strengthened walls increased as the amount of reinforcement increased. It is observed that increments of 4 and 14 times the original masonry capacity were achieved for Walls R1 and R2, respectively.

- Masonry walls strengthened with NSM FRP bars exhibited similar performance to walls strengthened with FRP laminates.
- For flexural strengthening, increments ranging between 4 and 14 times of the original masonry capacity may be achieved.
- Remarkable increases in shear capacity were achieved by strengthening URM walls by FRP structural repointing.

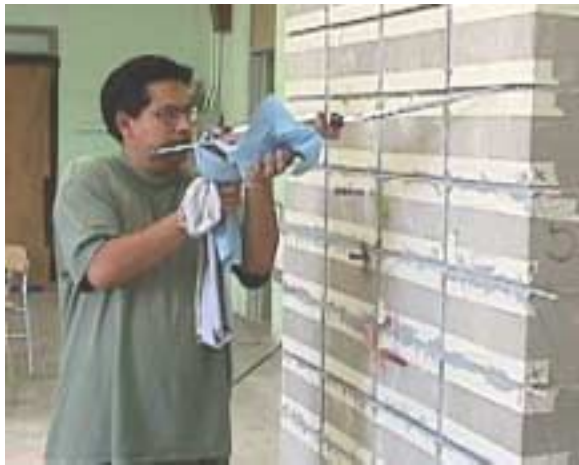
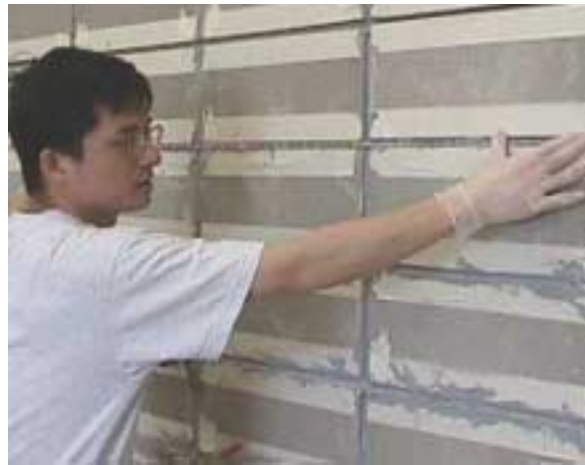
Figure 8. Strengthening by Structural Repointing

FRP structural repointing offers advantages compared to the use of FRP laminates. The method itself is simpler since the surface preparation is reduced, sandblasting and puttying is not required. In addition, the aesthetics of masonry can be preserved. In this technique, the diameter size of the FRP bars is limited by the thickness of the mortar joint, which usually is not larger than $\frac{3}{8}$ inches. The strengthening procedure consists of: (1) cutting out part of the mortar using a grinder, (2) filling the bed joints with a epoxy-based or cementitious-based paste (see Figure 8a), (3) embedding the bars in the joint (see Figure 8b), and (4) retooling.

(a) Application of Embedding Paste

(b) Installation of GFRP Bars

To ensure a proper bonding between the epoxy-based paste and masonry, dust must be removed from the grooves by means of an air blower prior to filling the bed joints. A masking tape or another suitable adhesive tape can be used to avoid staining. Stack bond masonry allows to install FRP bars in the vertical joints, if required (see Figure 8b). In this case since the faceshell thickness of the masonry units does not limit the groove depth, this can be deeper.

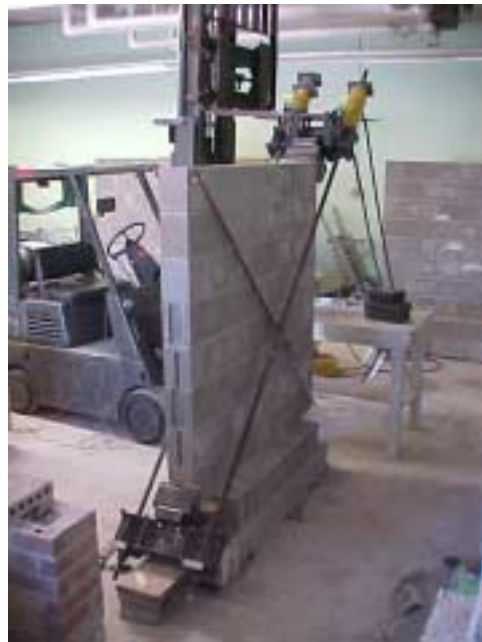
Figure 9. Test Setup

modulus of elasticity of 5900 ksi. One URM wall, Wall R0, was selected as control specimen. Wall R2 was strengthened with GFRP bars at every horizontal joint. Wall L2 was strengthened with GFRP laminates; the amount of FRP was equivalent to that of Wall R2 in terms of axial stiffness. Thus, Wall L2 was strengthened with four horizontal 4 in. wide GFRP strips. The specimens, tested in a close loop fashion, were loaded along one diagonal of the specimen. Figure 9 illustrates the test setup.

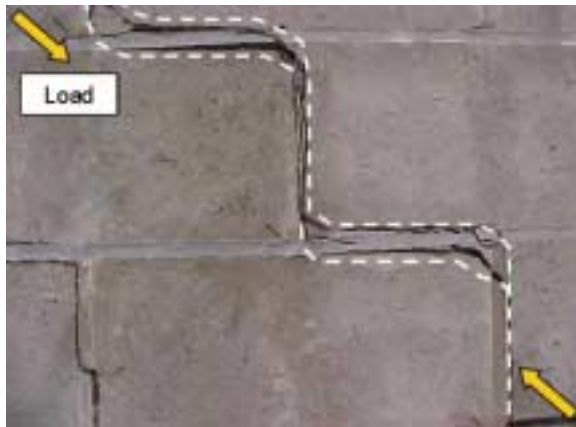
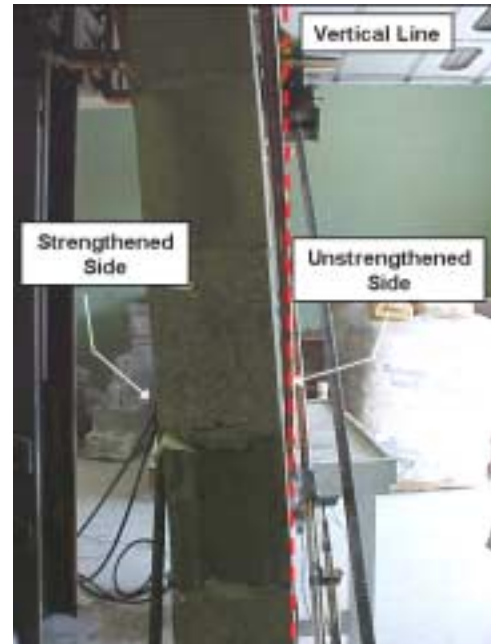
Figure 10. Specimens after Failure

The tests results showed that in the control Wall R1 the failure was brittle, controlled by bonding between the masonry units and mortar. When the tensile strength of masonry is overcome, the wall cracks along the diagonal, following the mortar joints (stepped crack vertical/horizontal). In the strengthened Wall R2 failure occurs when the shear cracks widen and GFRP bars are not able to carry tensile stresses due to debonding at the top and bottom epoxy/block interface (see Figure 10a). The shear capacity was increased in about 80%. The strengthened walls showed stability (i.e. no loose material was observed) after failure. This fact can reduce risk of injuries due to partial or total collapse of walls also subjected to out-of-plane loads. In addition, due to the reinforcement eccentricity, Wall R2 tilted to the direction of the strengthened face (see Figure 10b). In addition, due to the reinforcement eccentricity, which caused the crack growth on the unstrengthened side to increase at a higher rate than the strengthened side, Wall 2 tilted to the direction of the strengthened face (see Figure 10b). Data showing the crack opening is presented elsewhere (Tumialan et al., 2001). Failure in Wall L2 was due to sliding shear along an unstrengthened joint.

(a) Debonding of epoxy/block interface

(b) Tilting of Wall R2

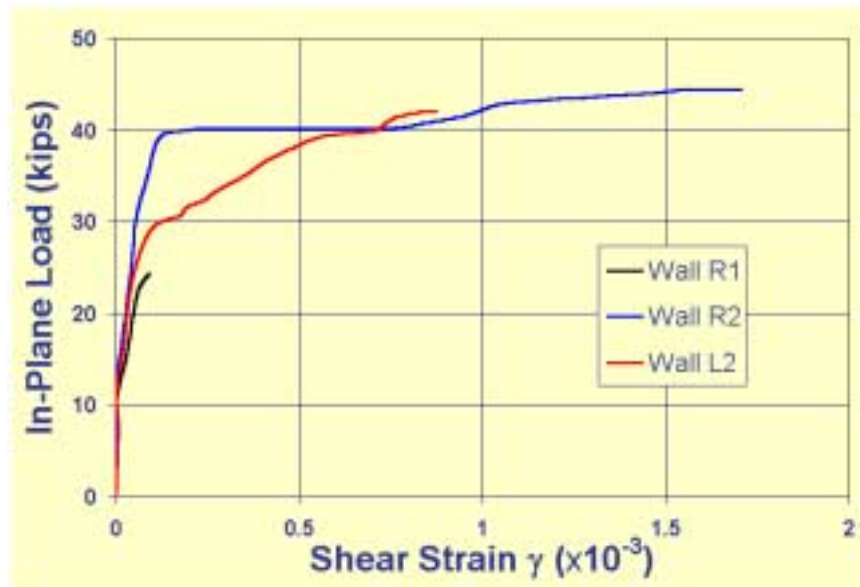
Figure 11. In-Plane Load vs. Shear Strain

From Figure 11 it is observed that the walls strengthened with FRP bars (Wall R2) and FRP laminates (Wall L2) had similar shear capacity; however, the pseudo-ductility was less in the Wall L2, which can be attributed to the occurrence of the sliding shear failure.
