11B Vapor Extractor seal. (zoom-in next slide)

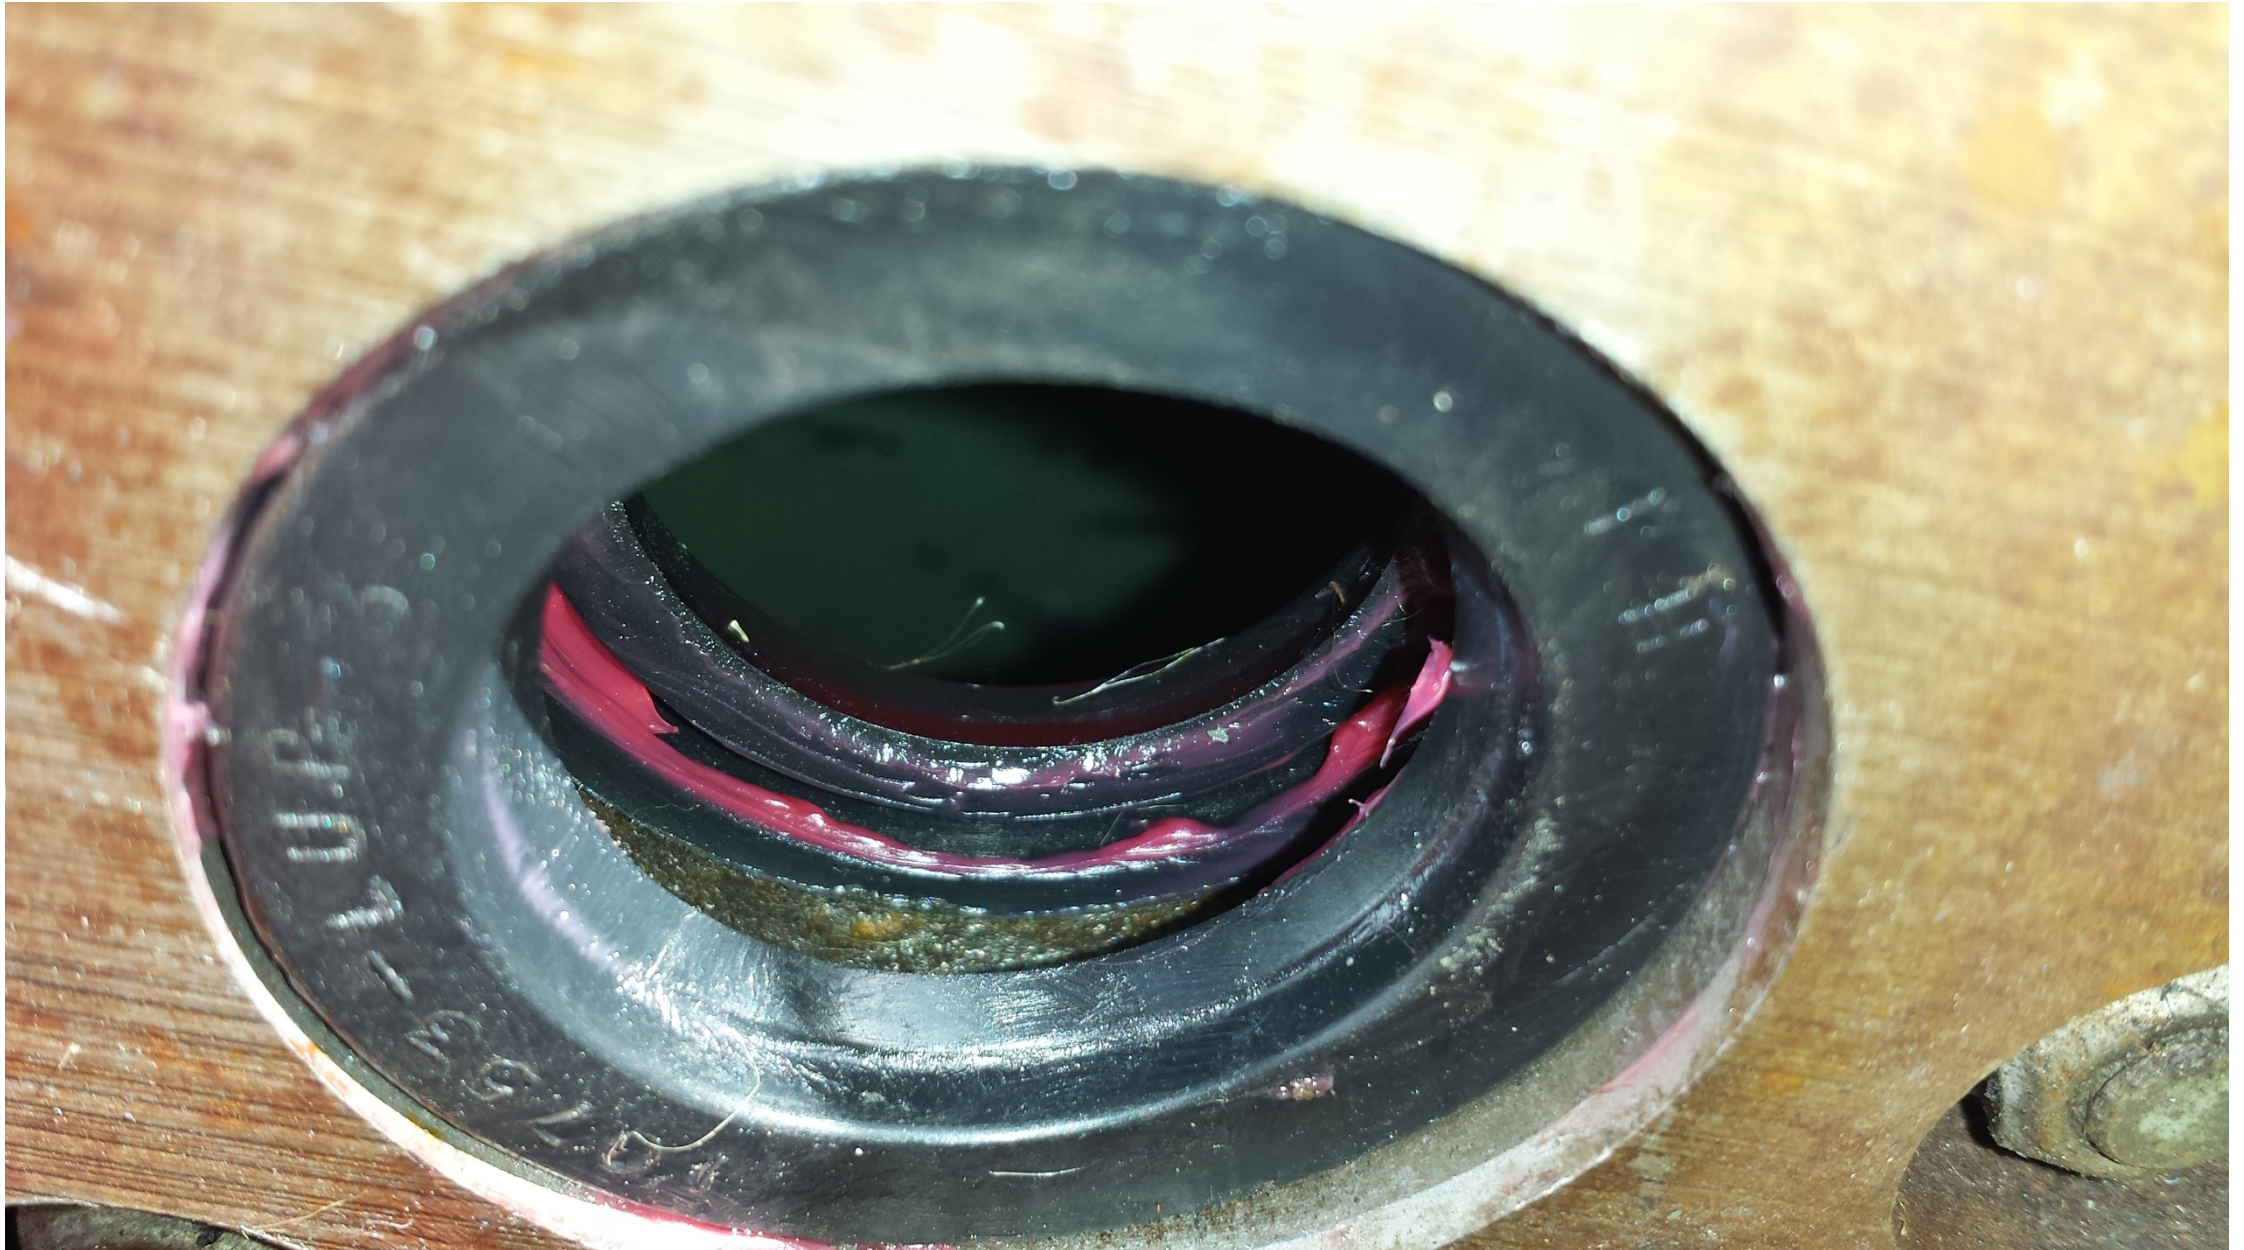
Two rubber seals lip seals, with grease in between.

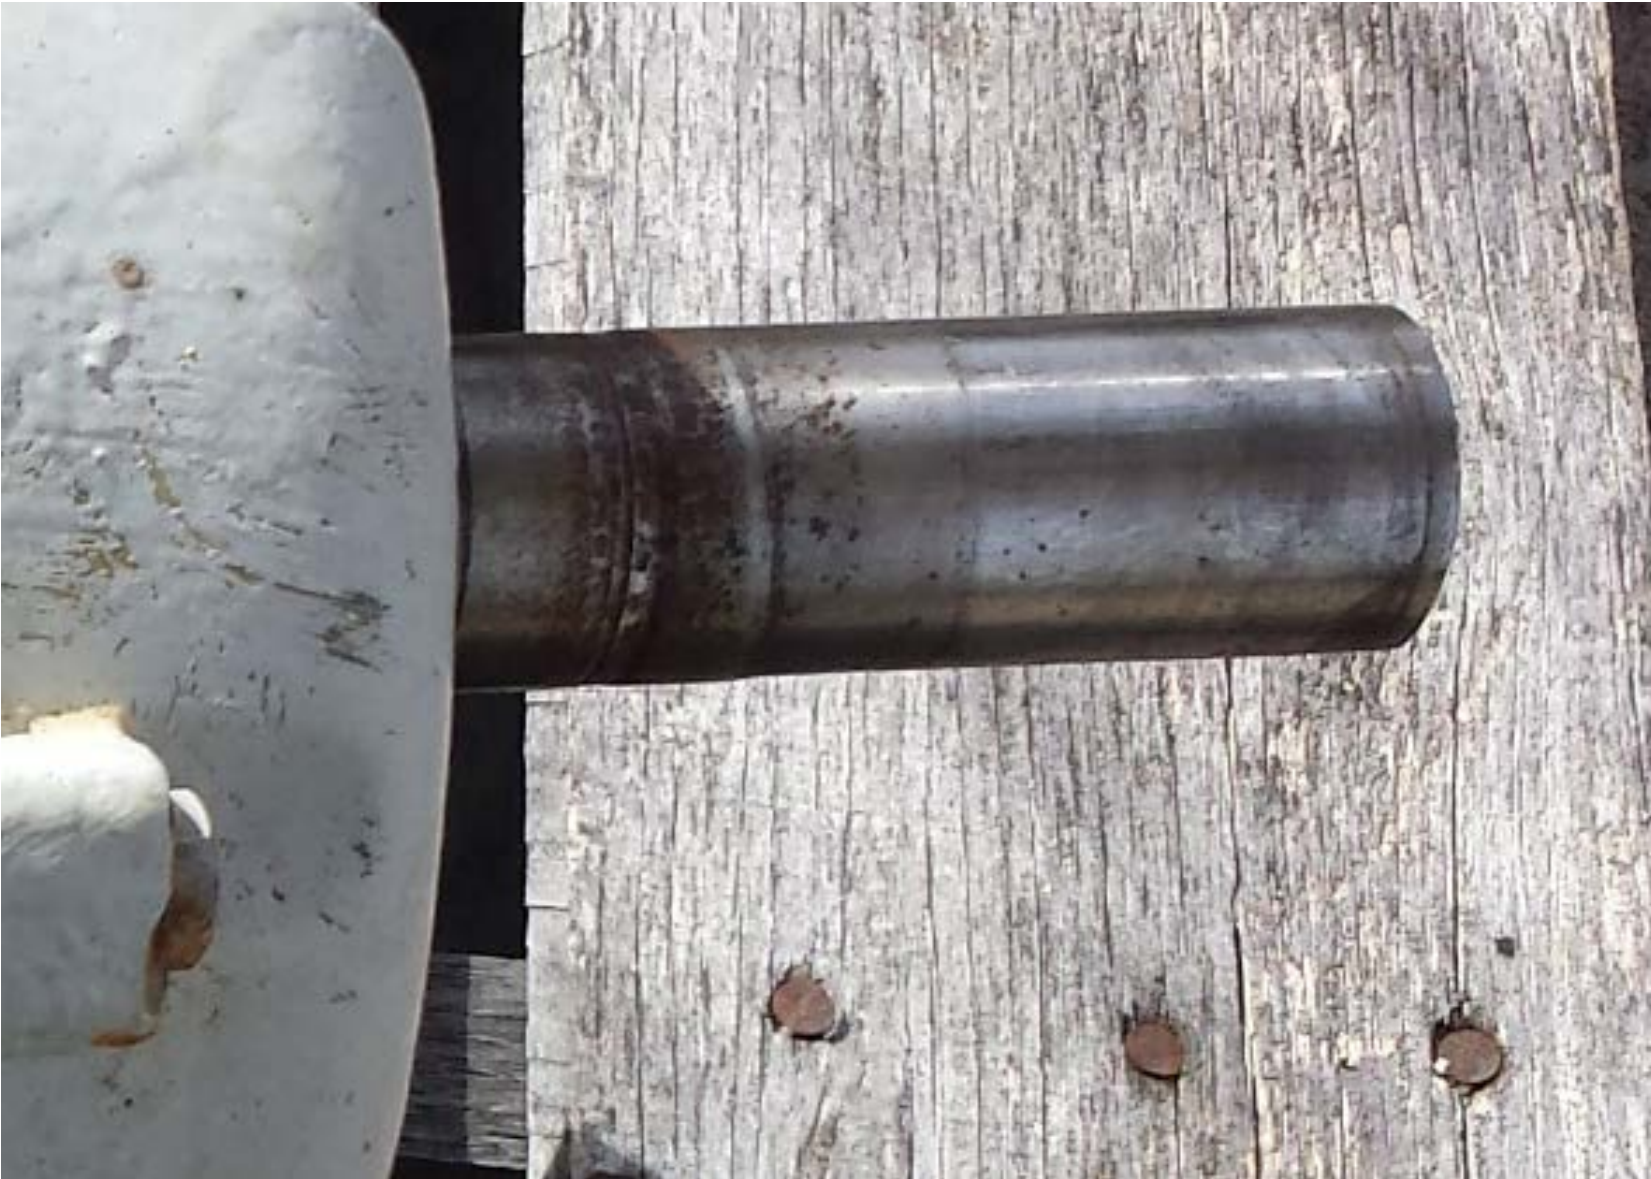
Motor Shaft Before repair (not a great picture)

Repaired motor shaft. Machinist repaired the two areas that had grooves in as-found condition by using Speedi-Sleeve. I think these two areas correspond to the lip seals
