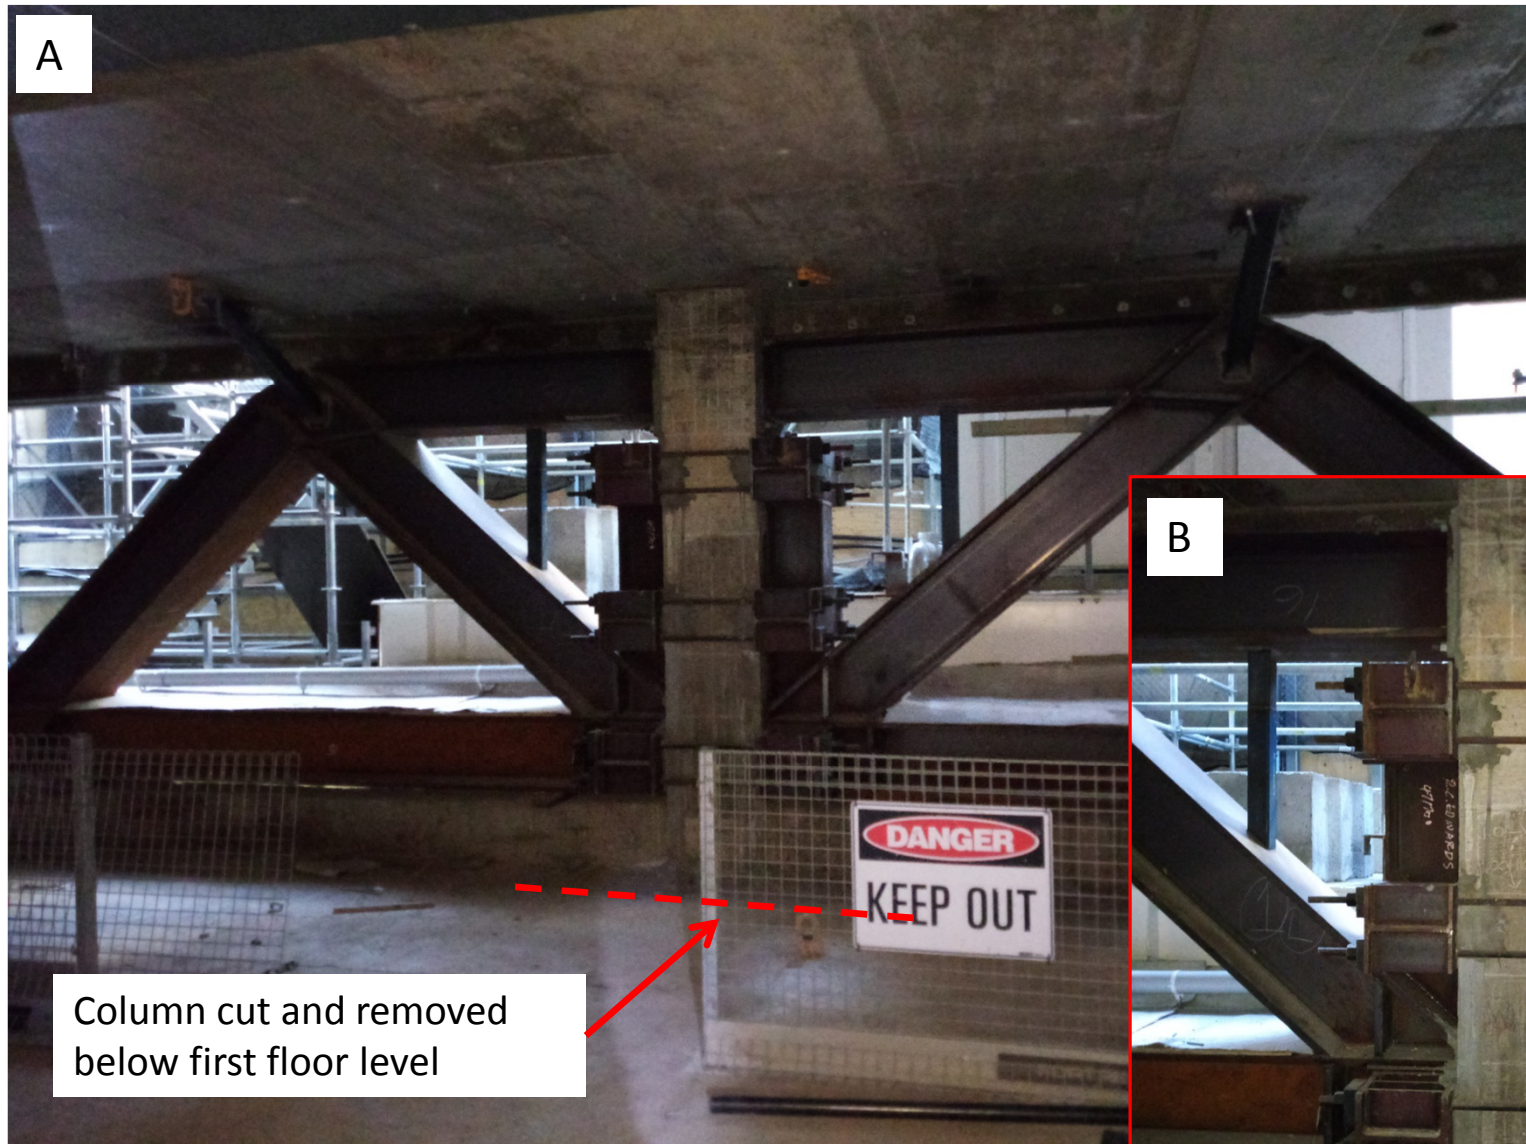
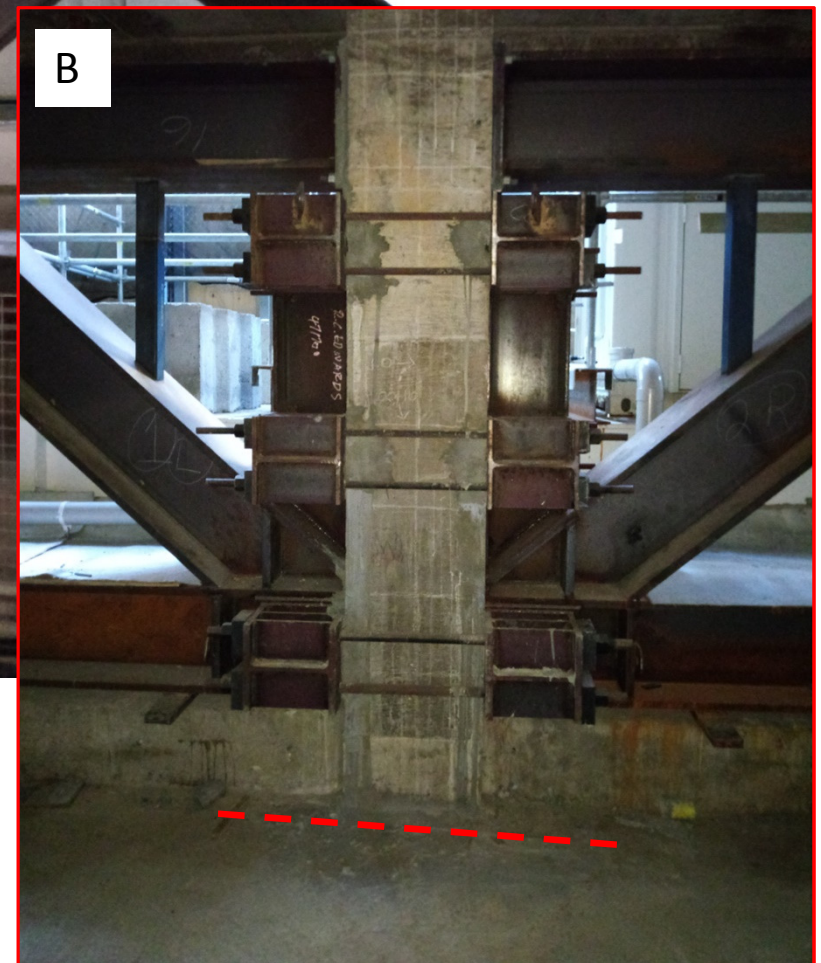
Figure 1. A – photograph of truss from inside of building at first floor level. B – close-up photograph of shear-key
