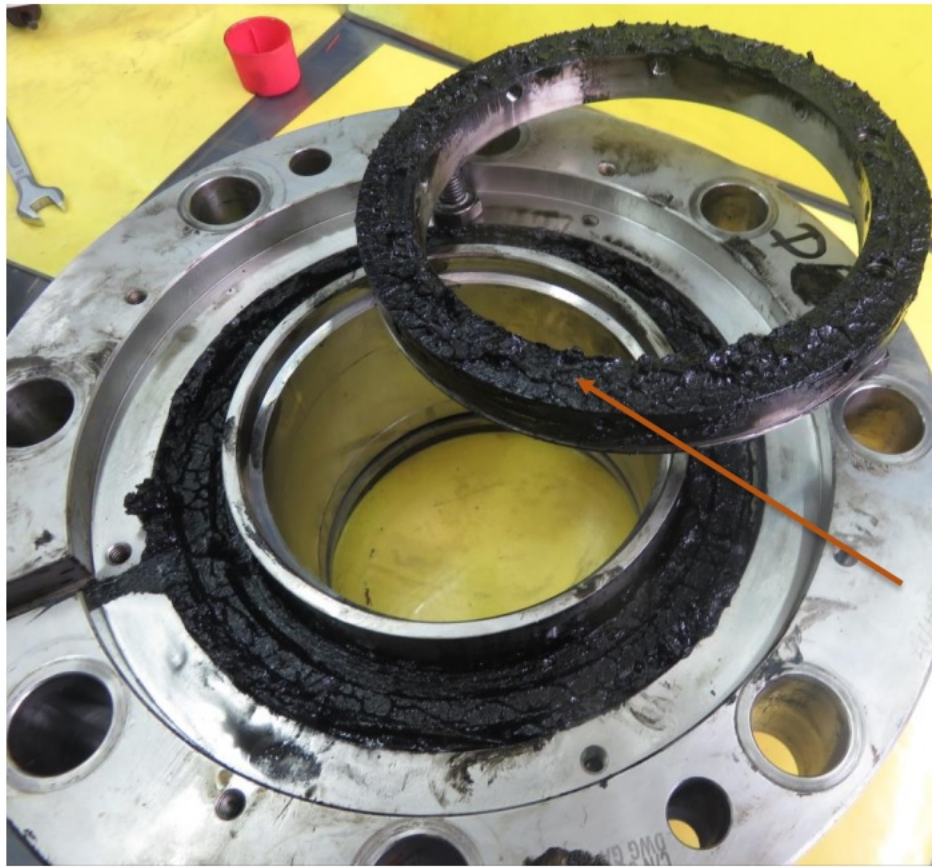
Locking collar (Pos # 17) was full of black sludge.

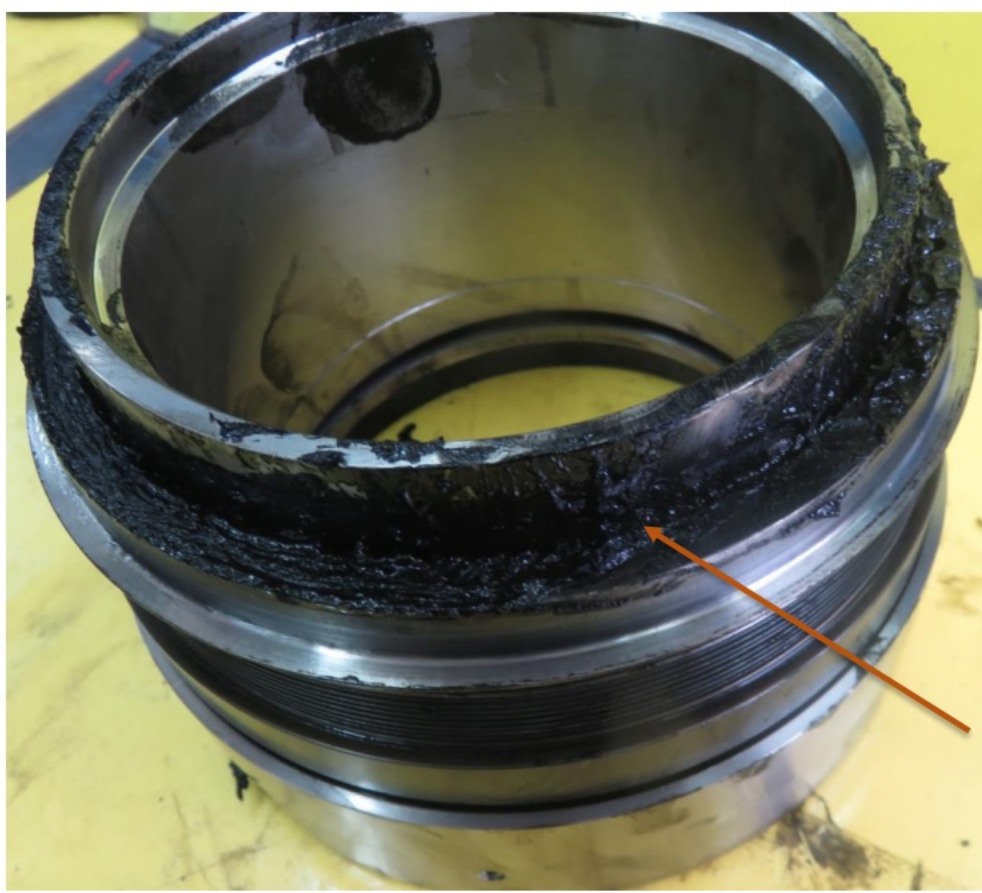
Outboard bellows (Pos # 6) observed stuck on the sleeve OD.

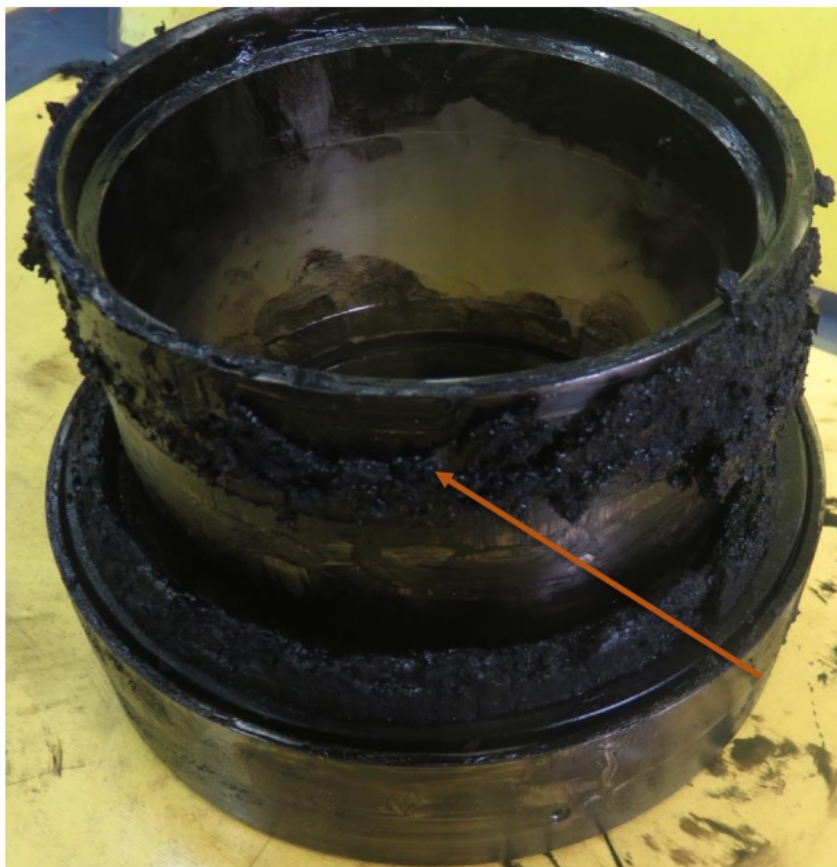
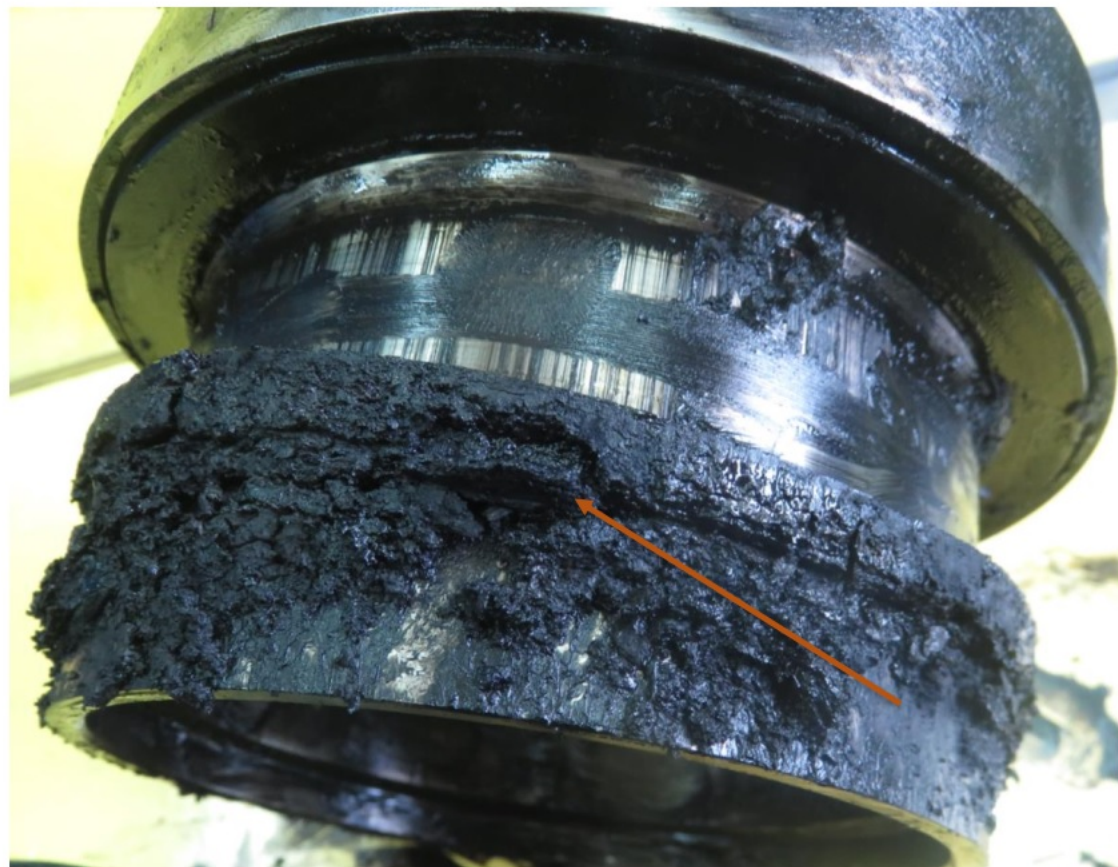
Sleeve (Pos # 12) OD under the outboard bellows area is covered with thick layer of sludge deposits.

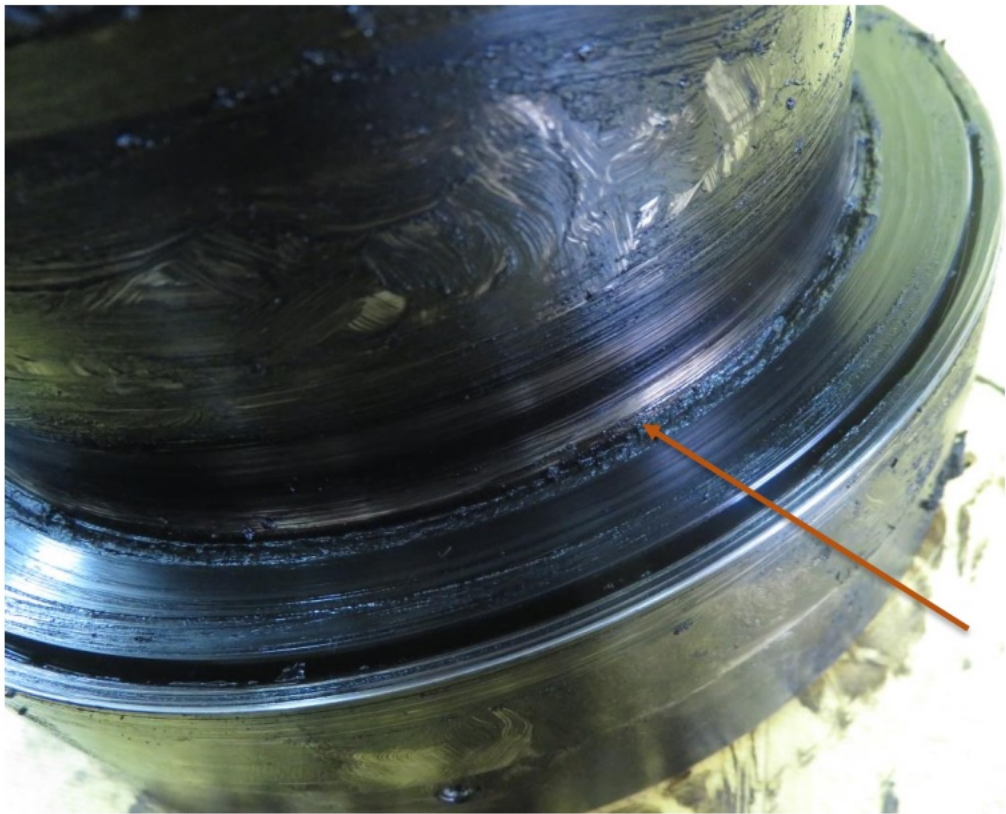
OB Mating ring (Pos # 8) ID area is full of hard coke deposits.

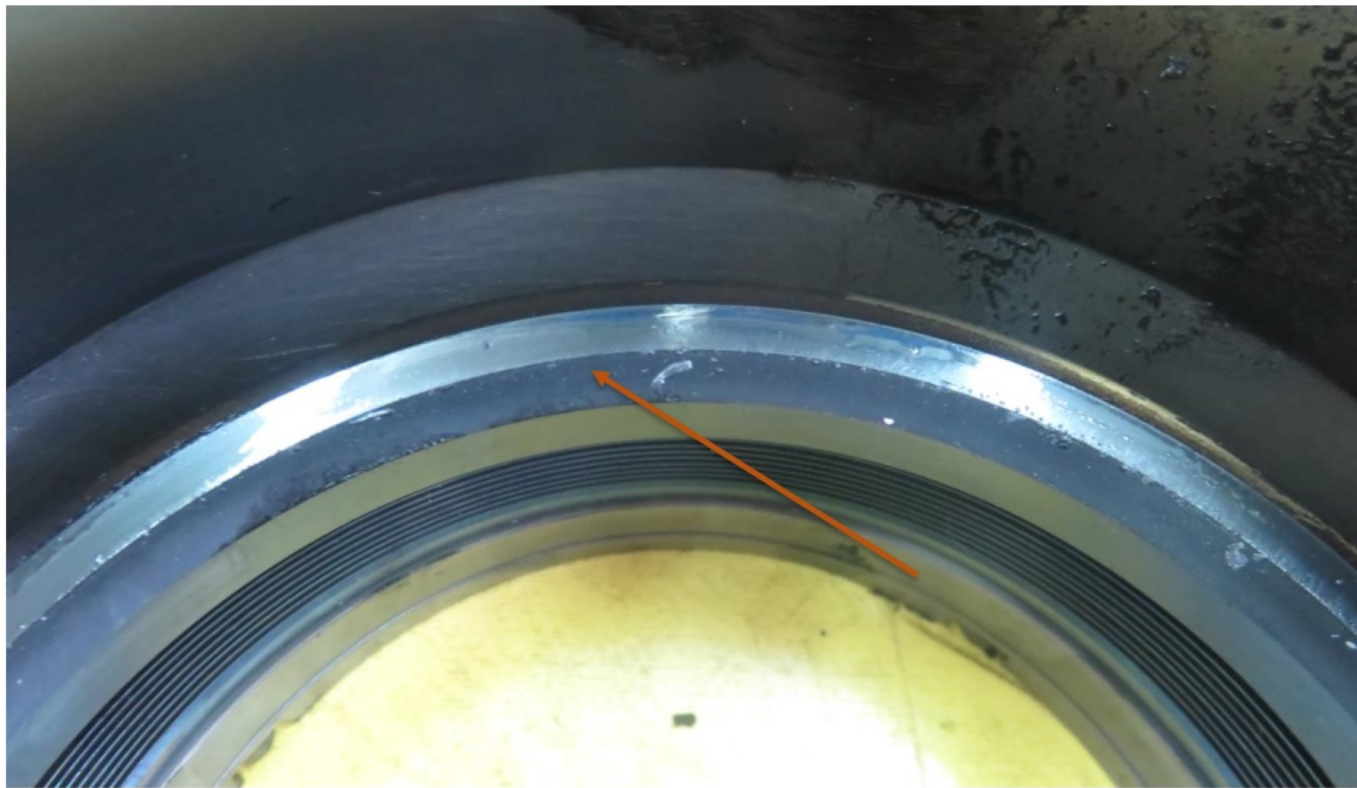
Inboard bellows (Pos # 1) shows hard debris.

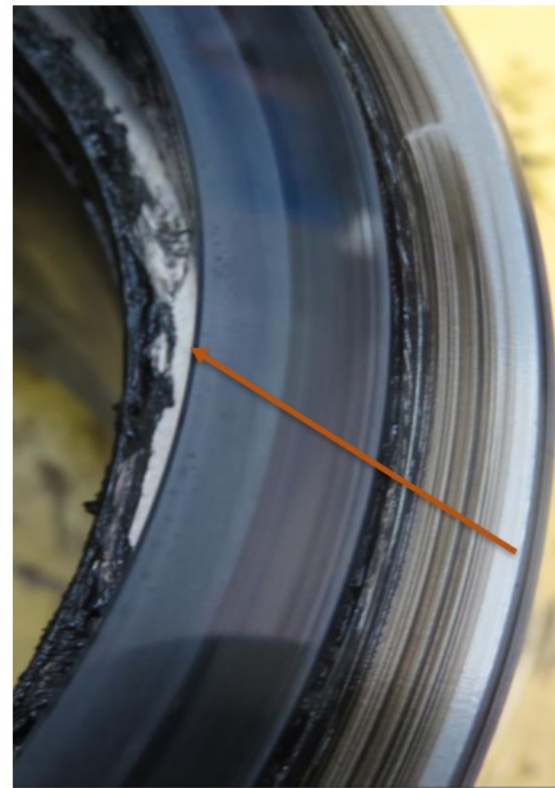
IB Mating ring (Pos # 4) shows gramophonic wear marks.
