Surfside condo was 'screaming' as an alarming crack formed just weeks before the collapse

BY [SARAH BLASKEY](#), [BEN CONARCK](#) AND [NICHOLAS NEHAMAS](#)

UPDATED MAY 14, 2022 12:26 PM

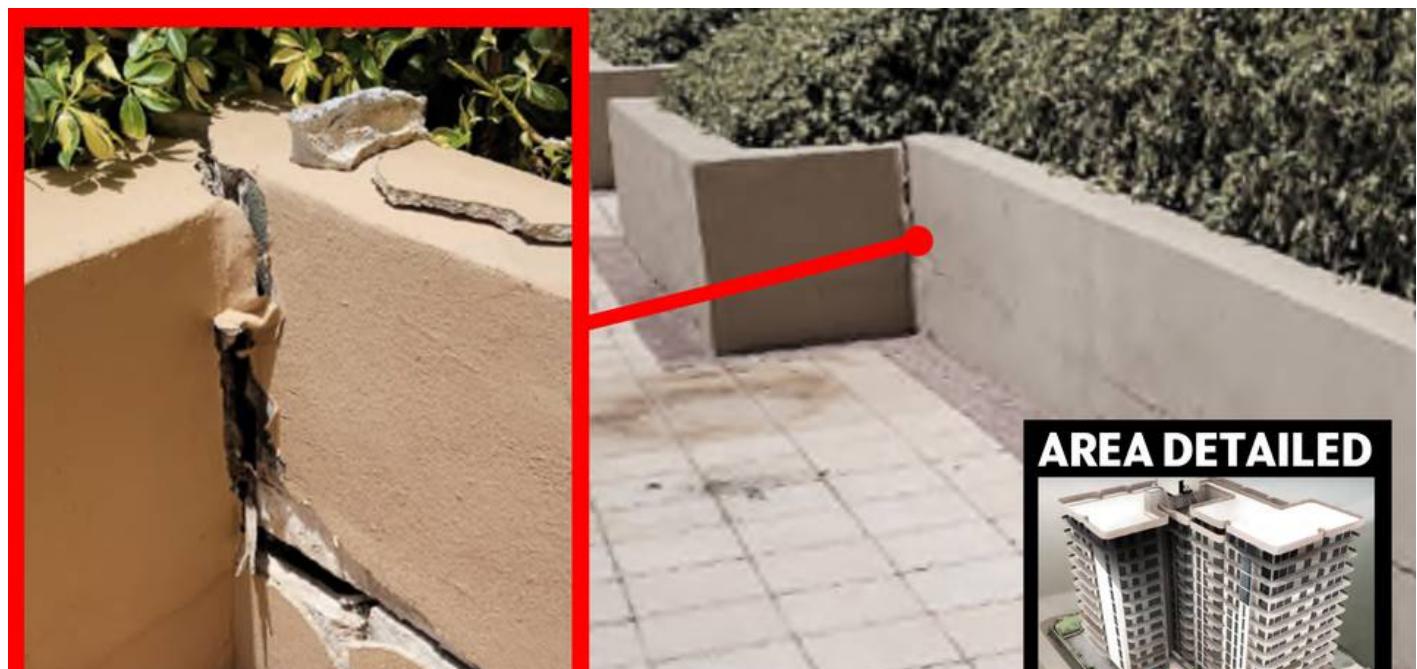
Cracks that opened up in a planter on Champlain Towers South's western pool deck were a potential warning sign of imminent collapse, according to engineers interviewed by the Miami Herald.

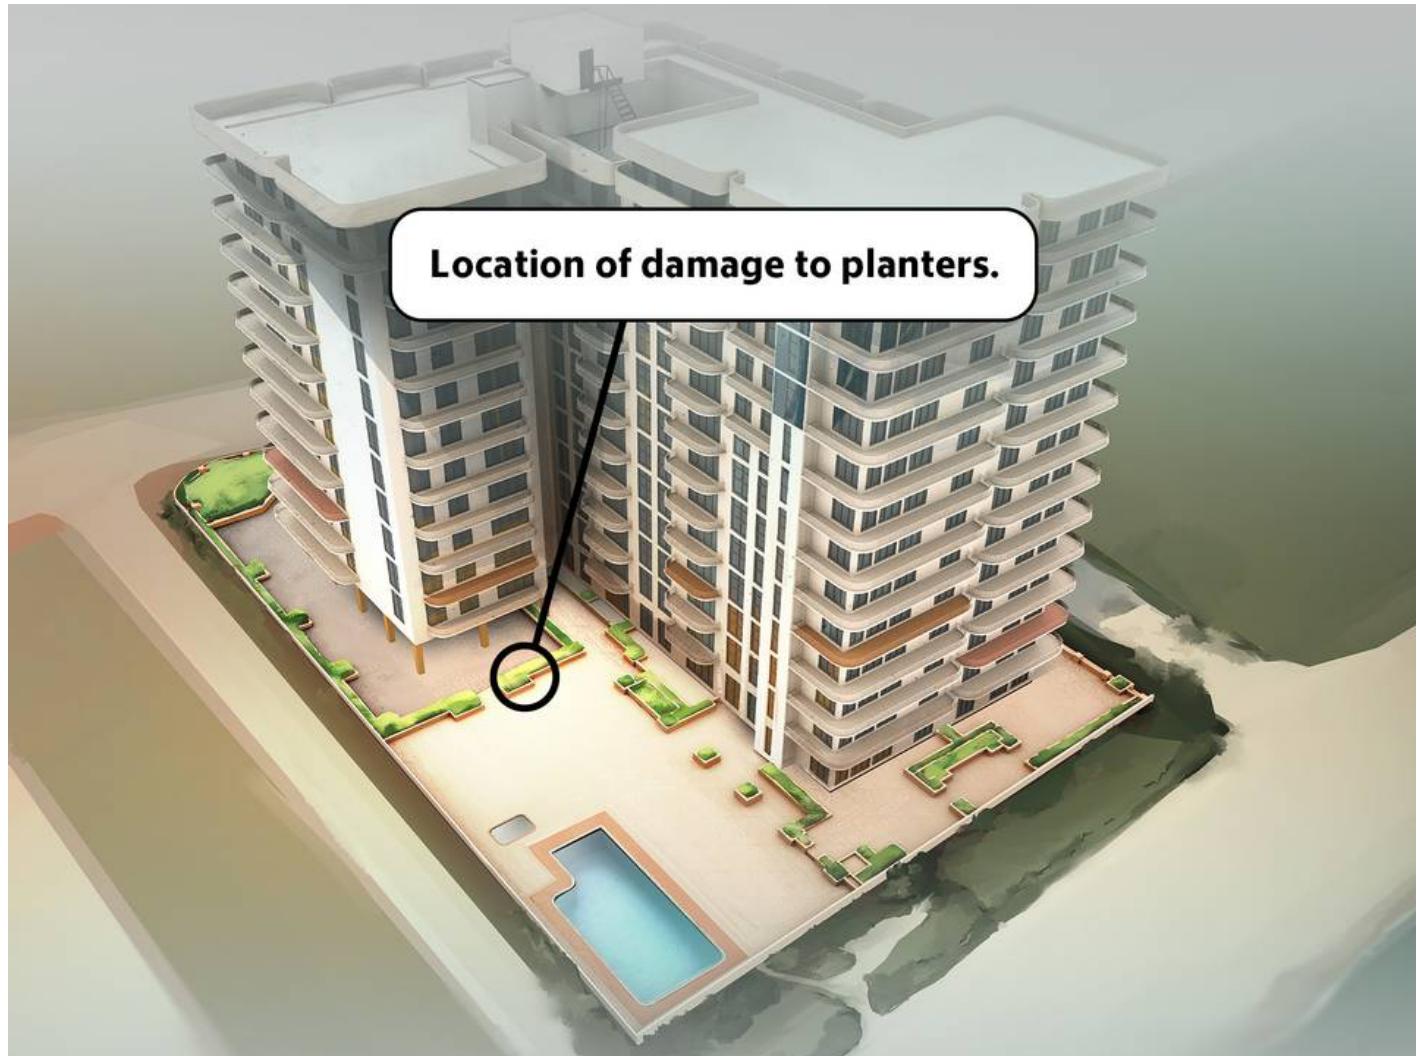
Location of a large crack discovered in a planter on the western pool deck of Champlain Towers South just weeks before the slab below it collapsed. *Rachael Handley*

The crack in the planter months later suggested the problems in the pool deck slab had likely worsened, although more inspection was necessary to be certain the two problems were linked, the engineers consulted by the Herald said. Although it's unclear exactly when the problem in the planter started, a photo dated April 20, 2020, shows no vertical displacement between the two planter walls and no cracking at all.

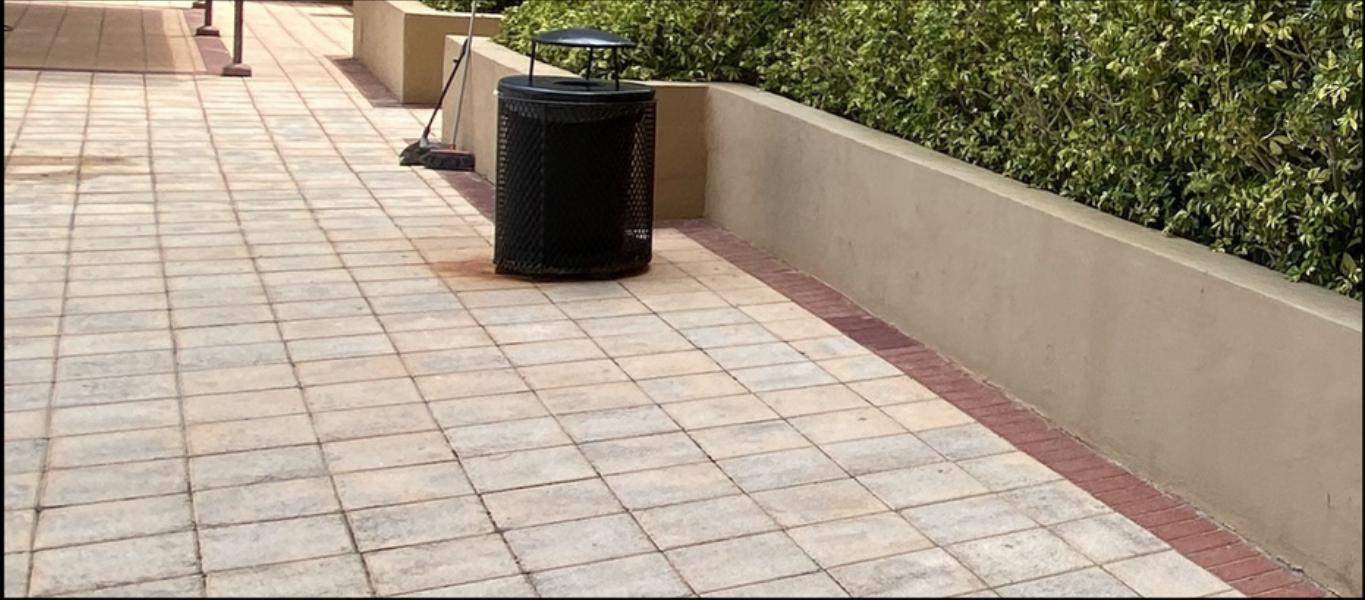
APRIL 2020

An engineer hired by Champlain South's condo association took photos of the same pool deck planter 14 months apart. The large crack that appears in the June 2021 photo was not present in the April 2020 photo. *Eduardo Alvarez*

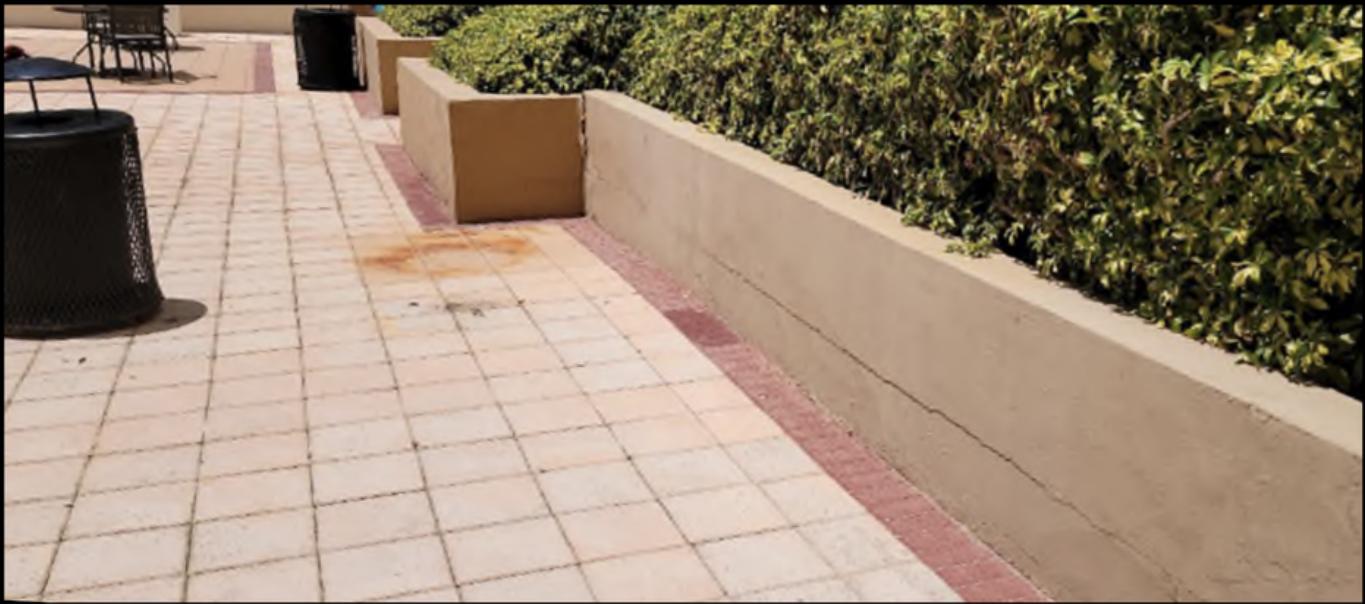
JUNE 2021

The long crack hooked upward on one end in a gaping vertical fracture as if the planter was being torn apart at one corner, photos taken during the June 8, 2021, inspection and included in court records showed. The concrete-block wall on one side of the vertical crack appeared to be about an inch lower than the other, as if part of the planter had started to slump into the garage below.

The planter itself did not play a role in the building's structural integrity. But the dramatic change in the height of the wall on one side of the vertical crack suggested the structural slab below could have been starting to fail — a possible canary in a coal mine warning of the deadly collapse that would happen on June 24, six structural engineers who reviewed the photos told the Miami Herald.

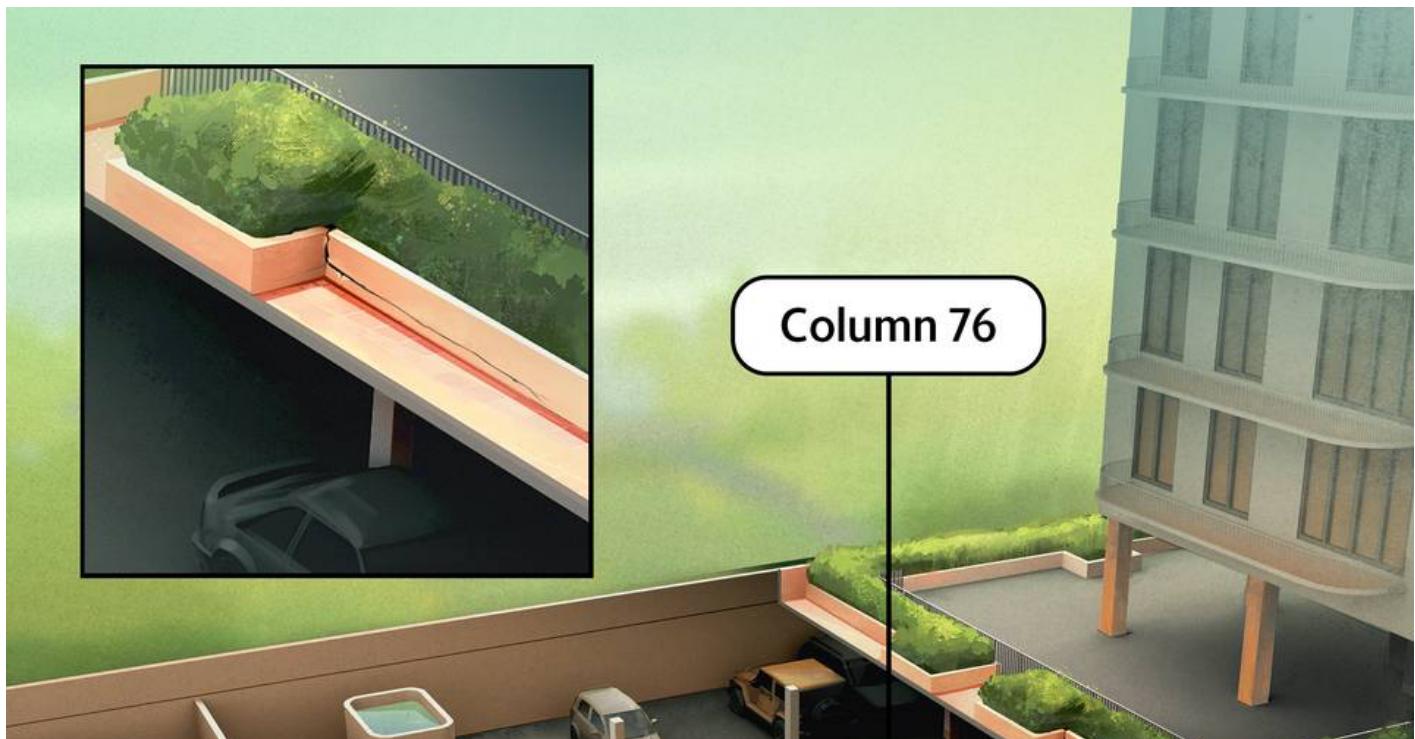
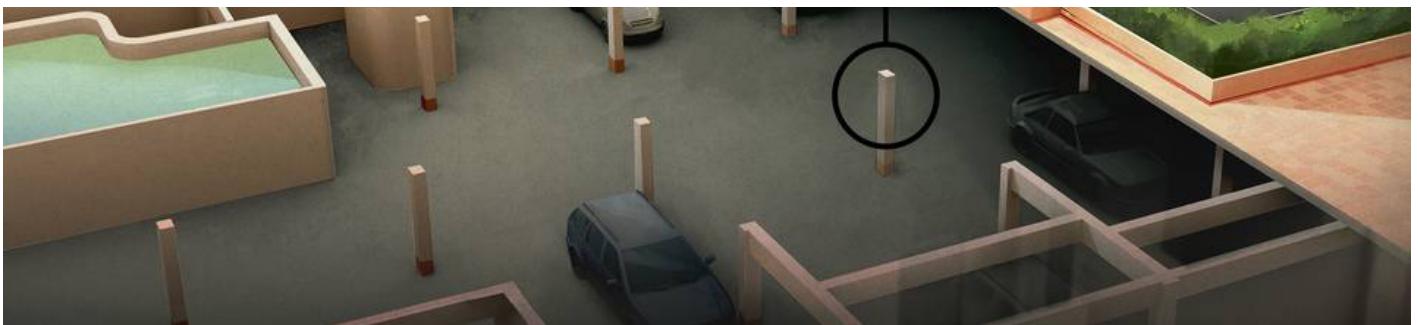
His concern was more than water damage to the column. The amount of water streaming down it was a sign that the slab was already severely cracked around the top of the column, Porter said. It looked to him like the slab might soon break away from the column supporting it.

Water had cascaded down column 76 in the basement garage of Champlain Towers South, which experts said suggested serious problems in the slab just 20 feet from the area where a troubling crack in a pool deck planter was discovered weeks before the collapse. *Rachael Handley*
